Asbestos Register & Management Plan

BLACKHEATH MEMORIAL COMMUNITY HALL

265 GREAT WESTERN HIGHWAY, BLACKHEATH city Council

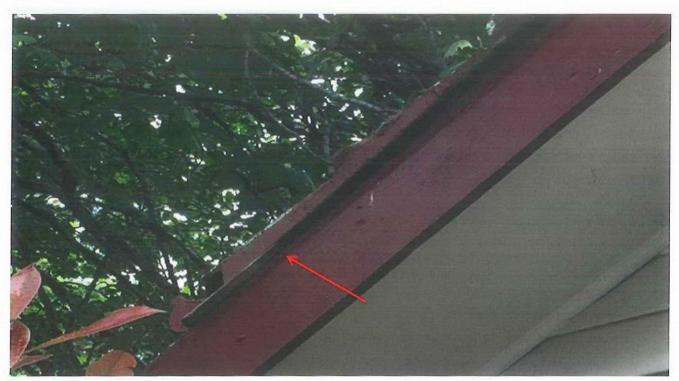
Photo 21: Asset D00081 – Blackheath Hall, Library and Neighbourhood Centre – fibreboard containing asbestos weather strips on the cloaked verges of the roof throughout.

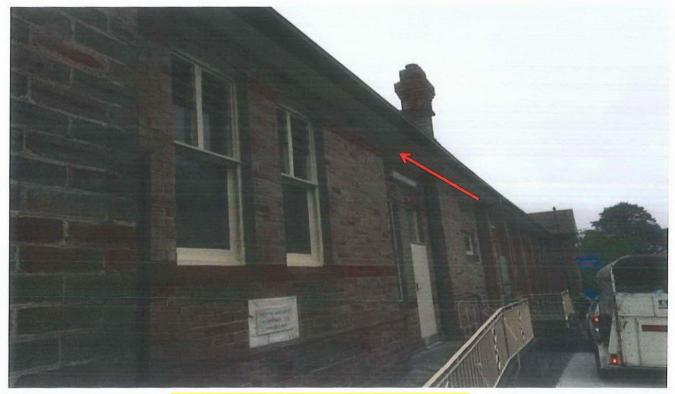
Photo 22: Asset D00081 - Blackheath Hall, Library and Neighbourhood Centre - asbestos cement sheet eave's throughout the Sandy Phillip's Hall.

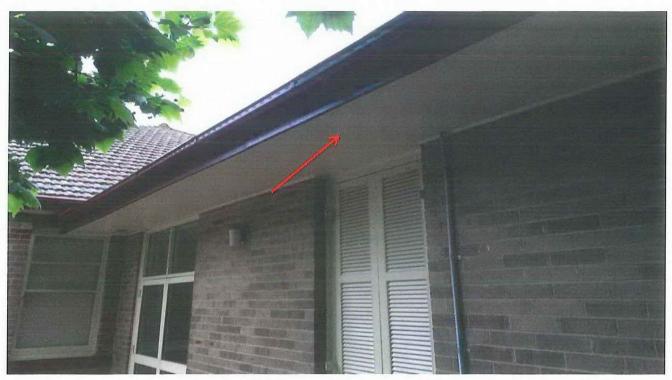
Photo 23: Asset D00081 - Blackheath Hall, Library and Neighbourhood Centre - fibreboard containing asbestos northern perimeter eaves of the KC Bates Hall.

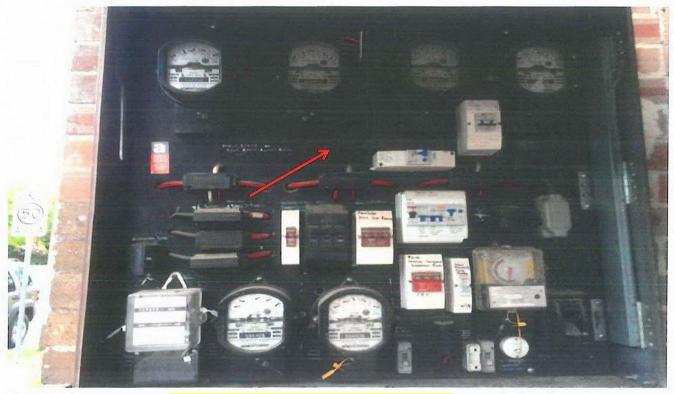
Photo 24: Asset D00081 - Blackheath Hall, Library and Neighbourhood Centre - electrical backing board containing asbestos in the southern perimeter on the KC Bates Hall.

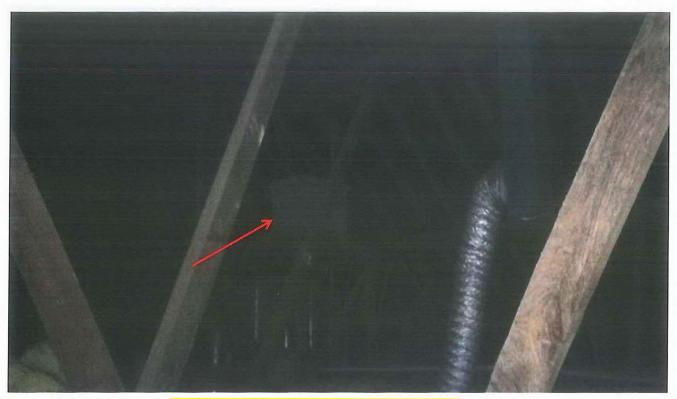
Photo 25: Asset D00081 - Blackheath Hall, Library and Neighbourhood Centre - asbestos cement water tank and base plate in the ceiling space above the central amenities.

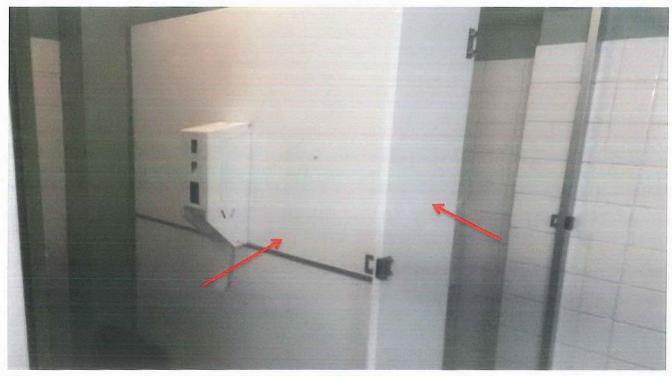
Photo 26: Asset D00081 - Blackheath Hall, Library and Neighbourhood Centre - asbestos cement sheet toilet partition walls and cover panels in the female toilets adjacent the stage in the Sandy Phillips Hall.

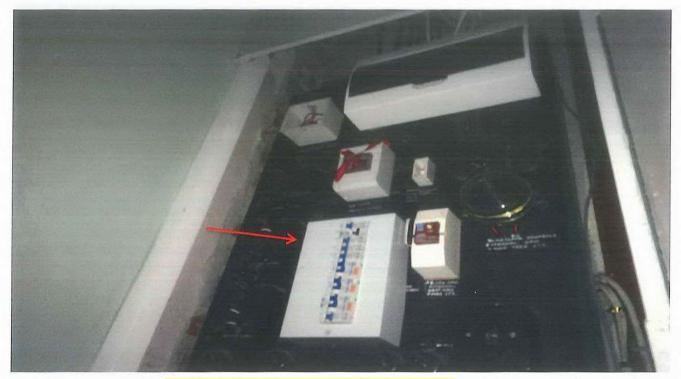
Photo 27: Asset D00081 – Blackheath Hall, Library and Neighbourhood Centre – electrical backing board containing asbestos in the eastern area of the KC Bates Hall.
