Asbestos Register

Lapstone Rugby Clubhouse, 2 Explorers Road, Lapstone

Asbestos Register and Management Plan

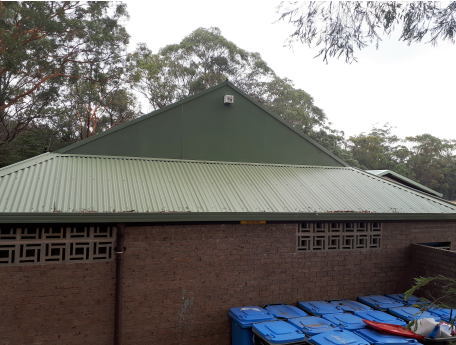
Clubhouse

Accessibility	Material	Extent	Result	
	Accessible	Fibreboard	5m2	Assumed Positive	
	Friability	Sealed / Surface Treatment	Risk Assessment	Control Actions	Labels Affixed
	Non Friable	Sealed	RA04 - Very Low	No Action Required - No ACM Identified	No
Specific Location					
Lapstone Rugby Union Clubhouse - External Southern Gable End					
Additional Comments					GPS Lat,Long
Assumed Positive
