Office & Residence

Asbestos Register & Management Plan

Blue Mountains City Council were commissioned by Blue Mountains City Council to conduct Asbestos Management Register for the building located at 67 Prince Edward Street Blackheath NSW 2785.

The inspection was conducted on 13/10/2022, and the following items were identified:

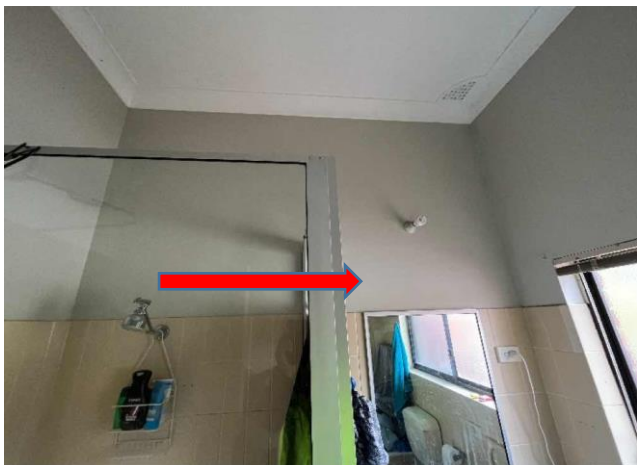
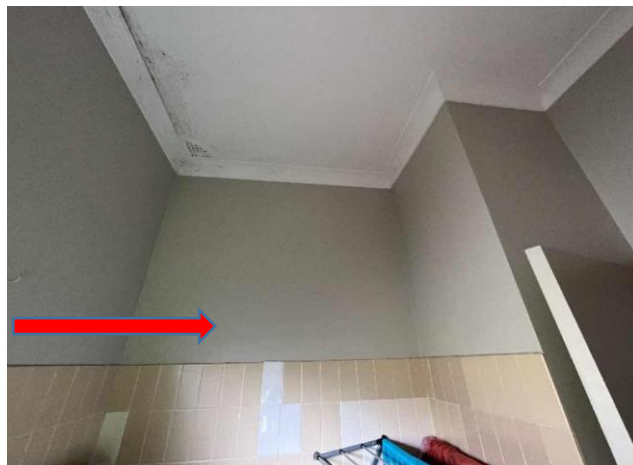
Location	Material Description	Risk Rating
Internal / GF / Bathroom / Wall Cladding	Fibreboard	Very Low

#	REF #	HAZARD	RESULT	SPECIFIC LOCATION	MATERIAL	QUANTITY	FRIABILITY	OVERALL RISK	ACTION CODE	TIMEFRAME	COMMENTS
1 & 2	28781-4-6	Asbestos	Chrysotile Asbestos	Wall Cladding	Fibreboard	10 m ²	Non-Friable	Very Low	A4	5 Yearly Reinspection	-

Internal, GF, Bathroom, Wall Cladding - Fibreboard, Chrysotile Asbestos, 28781-4-6
