Asbestos Register

Management Plan

Lapstone Pre-School Kindergarten (Part of),

9 Explorers Road, LAPSTONE NSW 2773

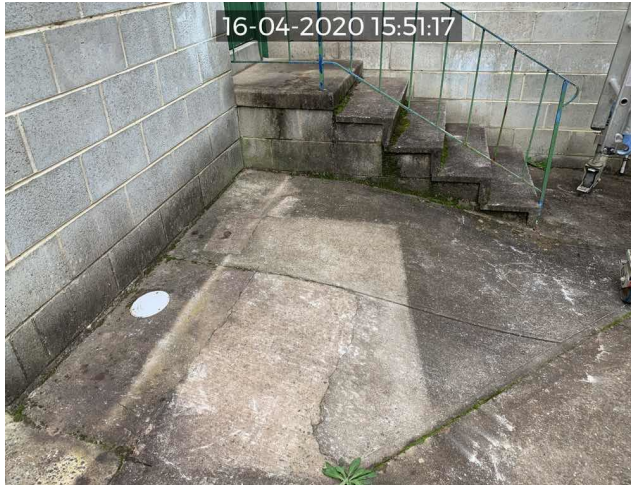
Stage 2 : Surface below work area southern side

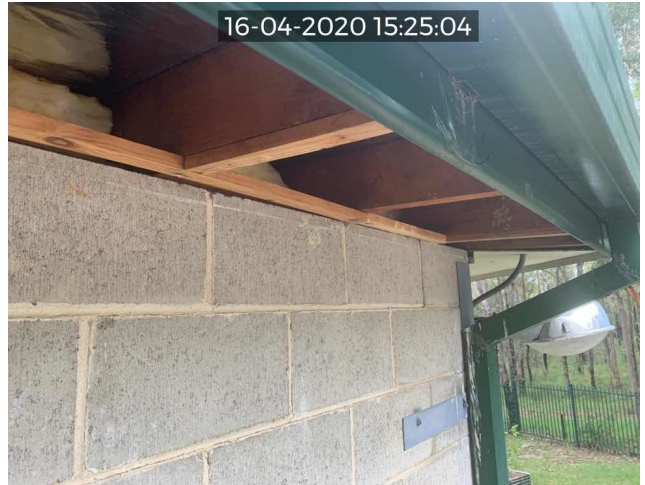
Stage 2 : Removal areas southern side

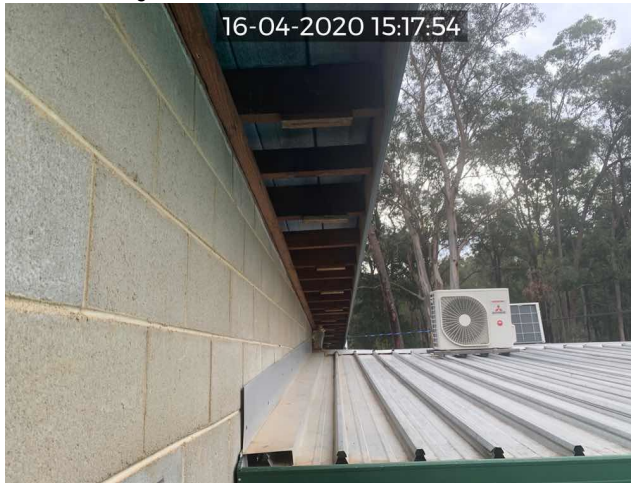
Stage 2 : Removal area northern side

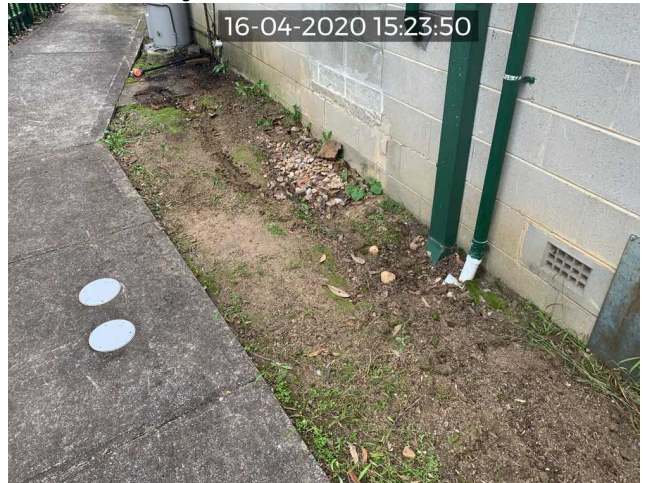
Stage 2 : Surface below removal area western side

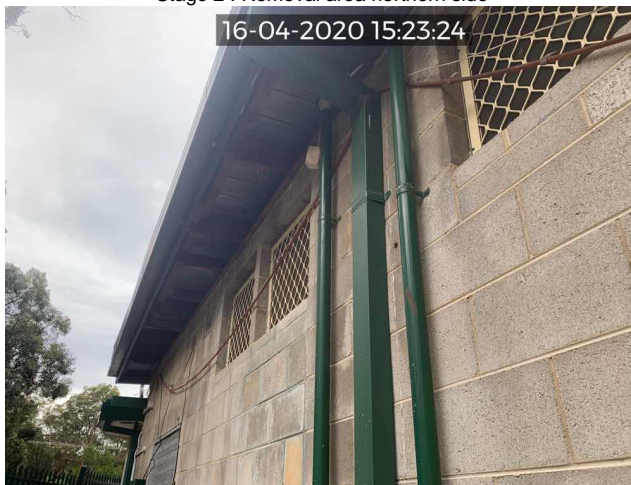
Stage 2 : Removal area western side

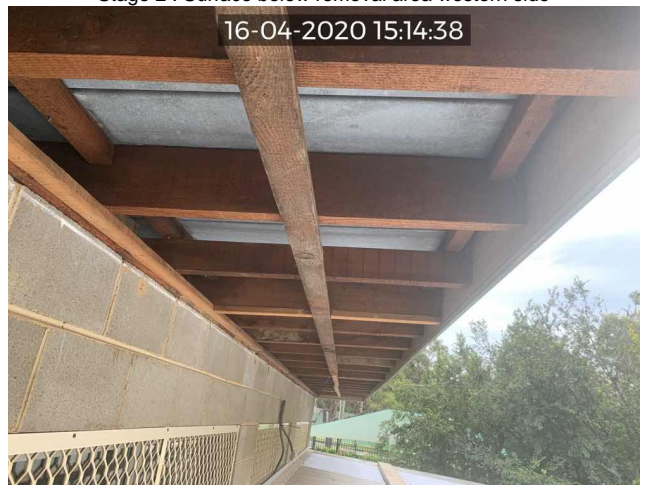
Stage 2 : Removal area eastern side

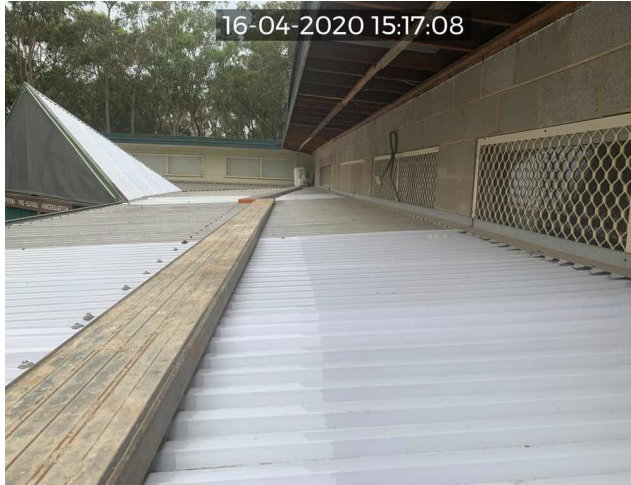
Stage 2 : Surface below removal area eastern side

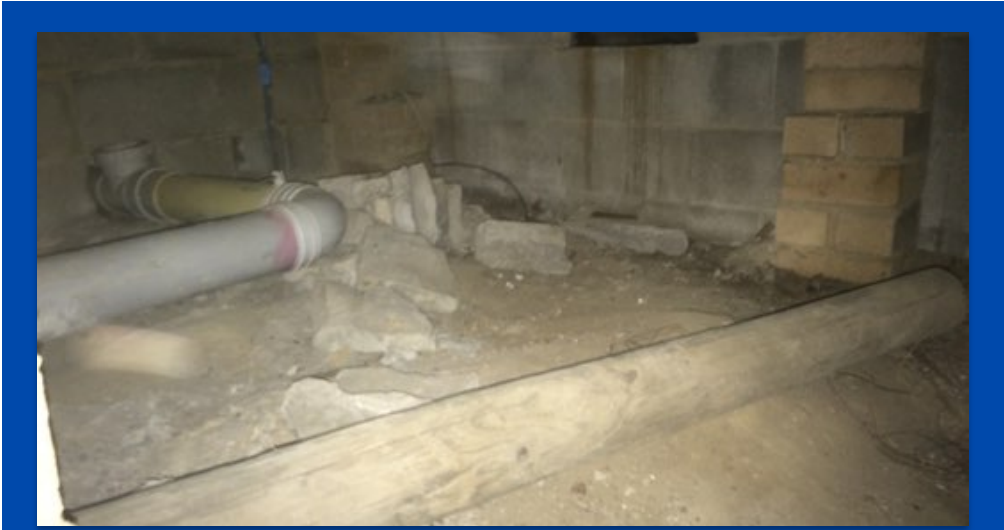
Photo 1

Asbestos cement sheeting fragments following the removal works.

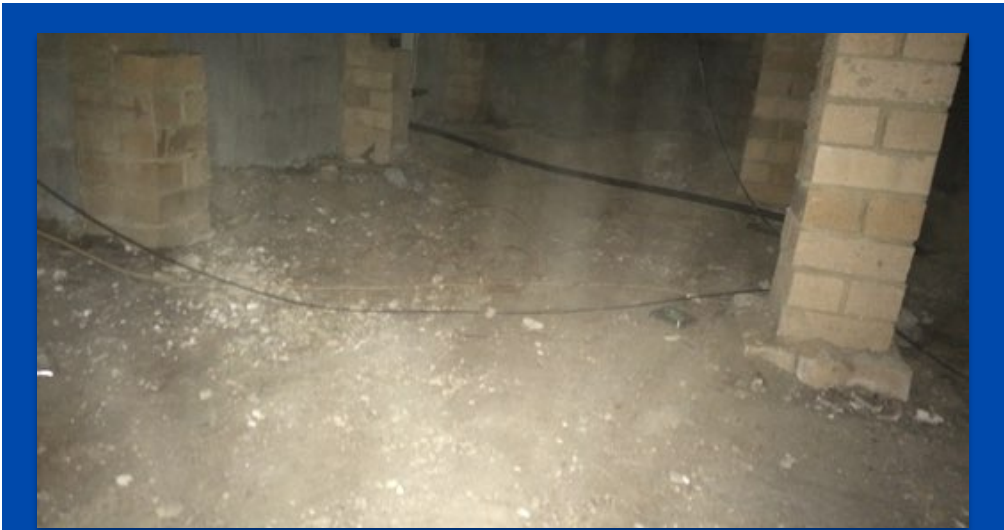
Photo 2

Asbestos cement sheeting fragments following the removal works.
