**ASBESTOS REGISTER**

**LENNOX PARK TENNIS  
CLUBHOUSE**

**29-39 MATTHEW PARADE, BLAXLAND**

**Extract from Asbestos Report AS28781  
November 2015**

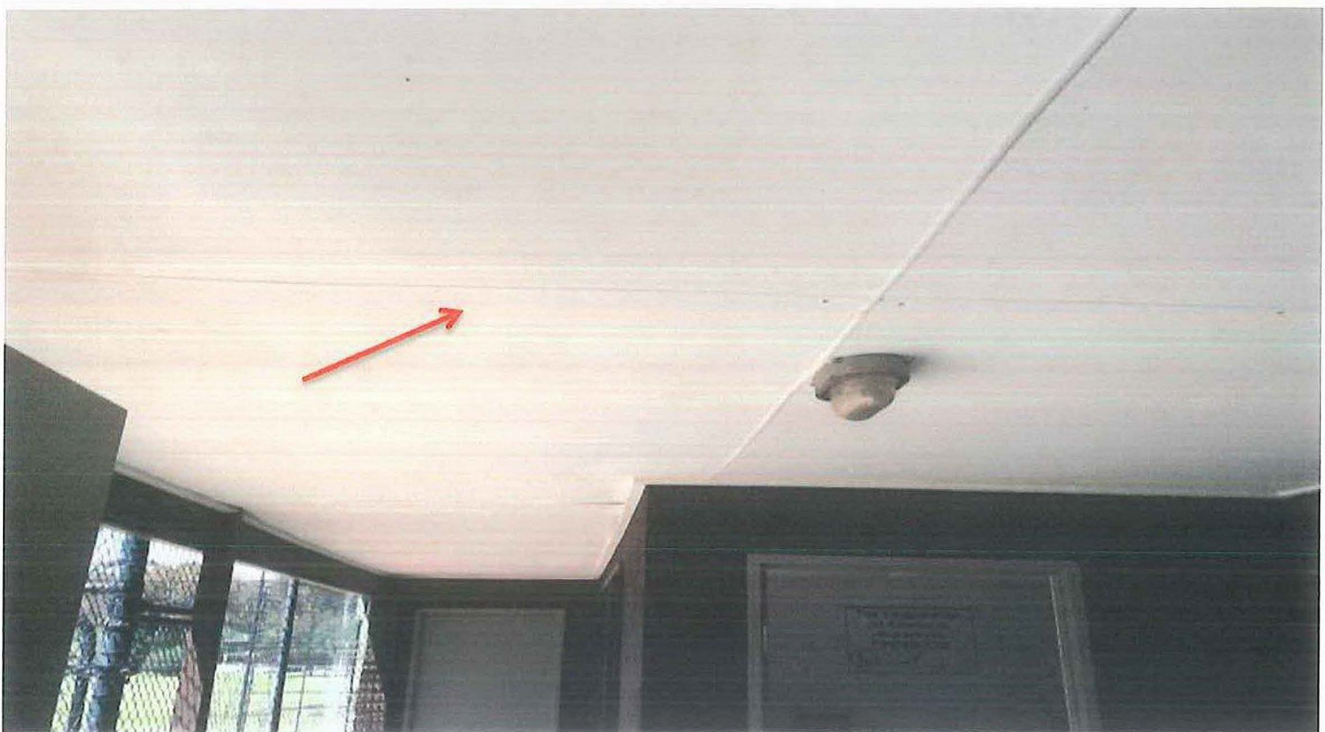
**Photo 30:** Asset D00149 – **Lennox Park, Blaxland – Tennis Clubhouse** – fibreboard containing asbestos awning lining.

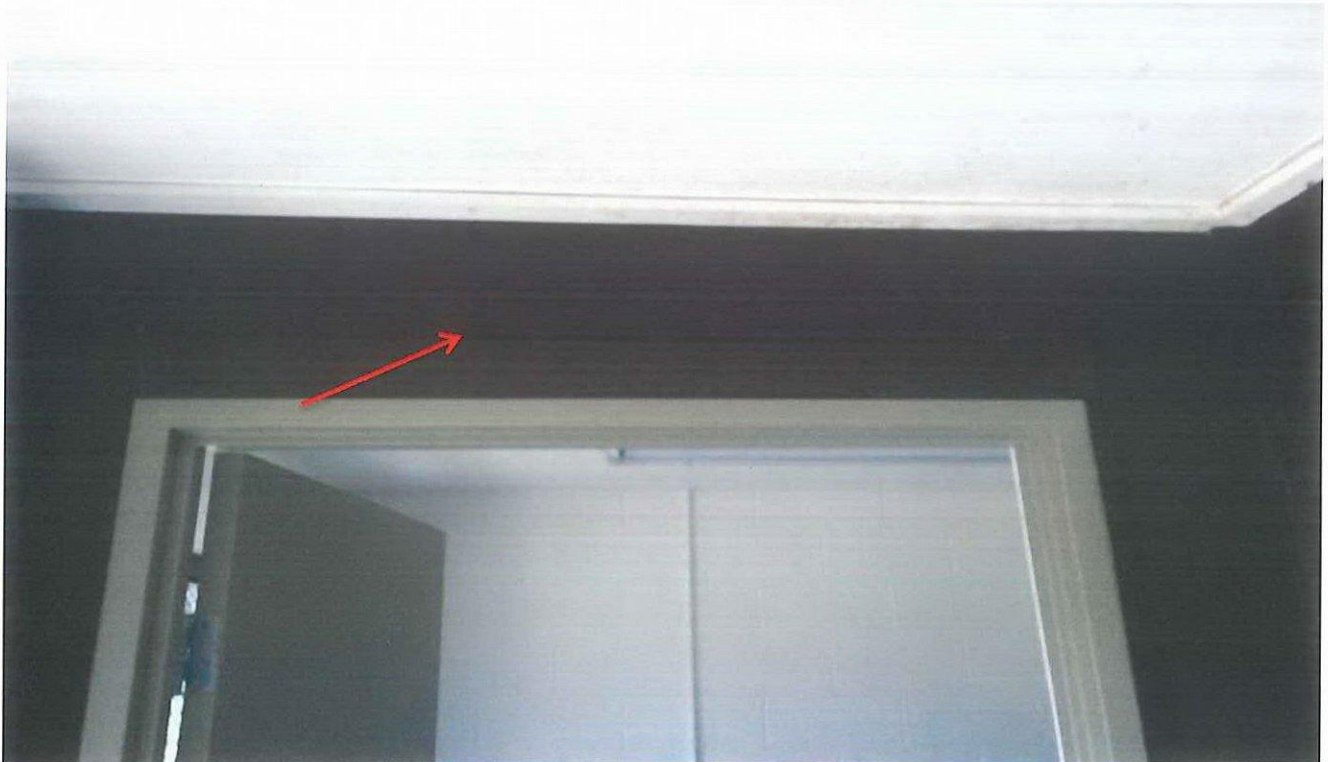
Photo 31: Asset D00149 – Lennox Park, Blaxland – Tennis Clubhouse – fibreglass assumed to contain asbestos above the entrance to the storeroom.

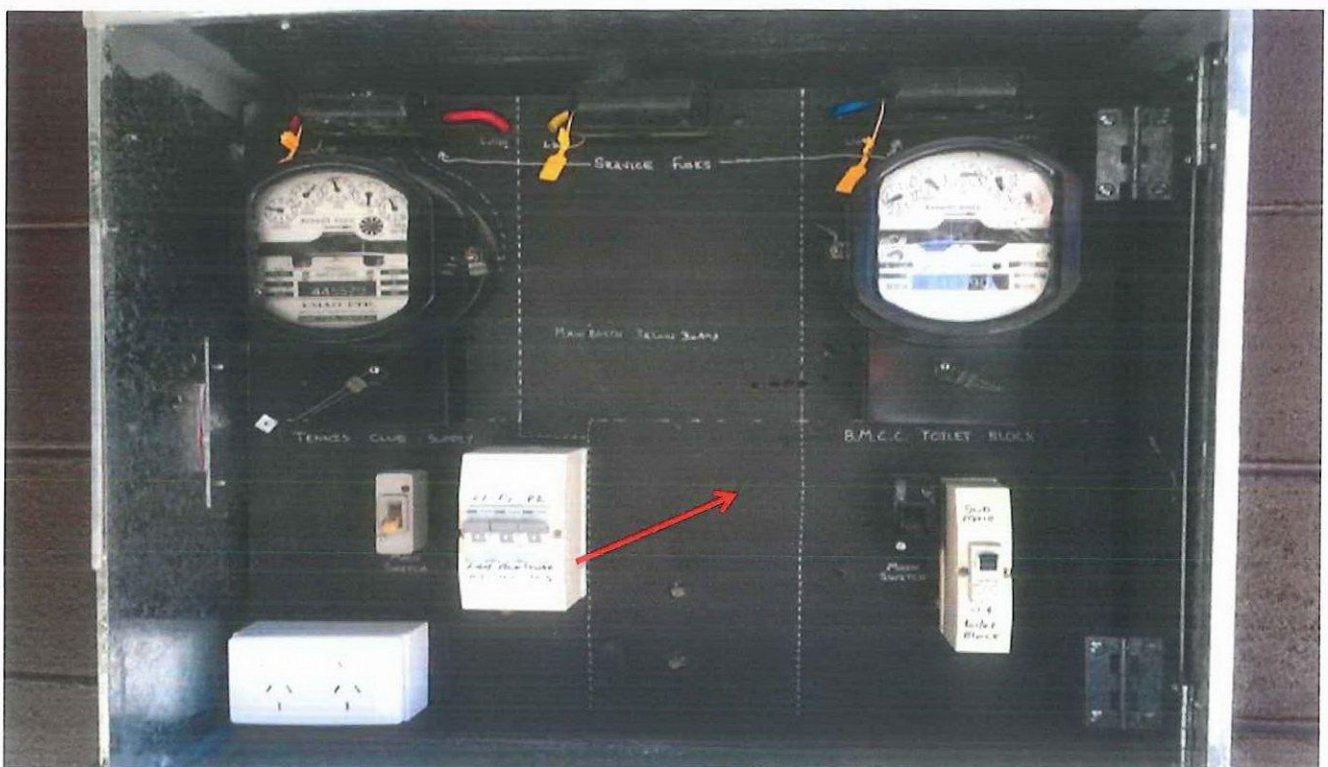
Location	Material	Sample ID	Sample Status	Photo No.	Asbestos Classification	Condition	Accessibility	Re-inspect	Current Label	Control Measure	Record of Works Undertaken
<b>Asset D00149 – Lennox Park, Blaxland – Tennis Clubhouse</b>											
<b>External</b>											
Eastern Perimeter – roof – gable end	Fibreboard	28781-7-1	Negative	-	-	-	-	-	-	-	-
Awning lining	Fibreboard	28781-7-2	Positive	30	Bonded	Stable	Low	November 2020	Not labeled	4	-
Above entrance to Main Room – external wall panel	Fibreboard	Similar to 28781-7-2	Assumed Positive	31	Bonded	Stable	Low	November 2020	Not labeled	4	
Eastern Perimeter – Electrical Box – electrical backing board	Bituminous backing board	28781-7-3	Positive	32	Bonded	Stable	Low	November 2020	Not labeled	4

Photo 32: Asset D00149 – Lennox Park, Blaxland – Tennis Clubhouse – electrical backing board containing asbestos on the eastern perimeter.
