Asbestos Register

Management Plan

The site is located: 879 Megalong Road, Megalong Valley

Asset Name:	Megalong Valley Community Hall	Date:	12-6-2019	RAR No:	30
Asset Address:	879 Megalong Road Megalong Valley	Inspection Carried Out By:	Brian Ashton	HPE No:	18/239258
Are Staff/PCBU aware that there is ACM onsite?		Yes			
Is there a copy of the Asbestos Register for this location onsite?		Yes			
Is there a copy of the Asbestos Management Plan for this location onsite?		Yes			
Is there a Warning Asbestos Onsite Label		Yes

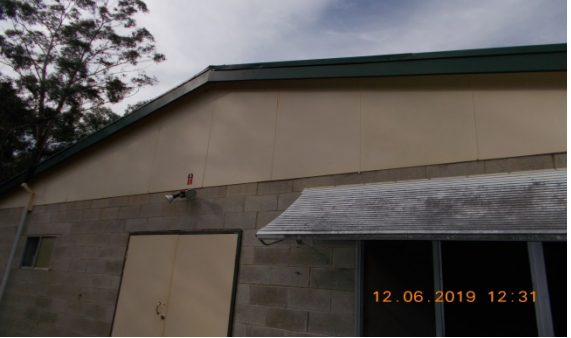
Reference Number Int / Ext Floor Specific Location	Photographs
<p style="text-align: center;">129 External Gable Ends</p>

25132-43-1	Megalong Valley Community Hall – External – gable ends	33x11x5mm fibreboard fragment	Chrysotile asbestos detected [Organic fibres detected]
25132-43-2	Megalong Valley Community Hall – External – eave linings	13x10x5mm fibreboard fragment	Chrysotile asbestos detected [Organic fibres detected]
25132-43-3	Megalong Valley Community Hall – External – Northern Perimeter – Electrical Box – electrical backing board	3x2x2mm bituminous backing board fragment	Chrysotile asbestos detected
25132-43-4	Megalong Valley Community Hall – Internal – Hall – ceiling panel	22x15x4mm fibreboard fragment	No asbestos detected [Organic fibres detected]
25132-43-5	Megalong Valley Community Hall – Internal – Kitchen – ceiling lining	22x14x2mm fibreboard fragment	Chrysotile asbestos detected [Organic fibres detected]
25132-44-1	Warimoo Community Hall – External – Main Entrance (east) – awning lining	13x8x2mm fibrous cement sheet fragment	Chrysotile asbestos detected Amosite asbestos detected

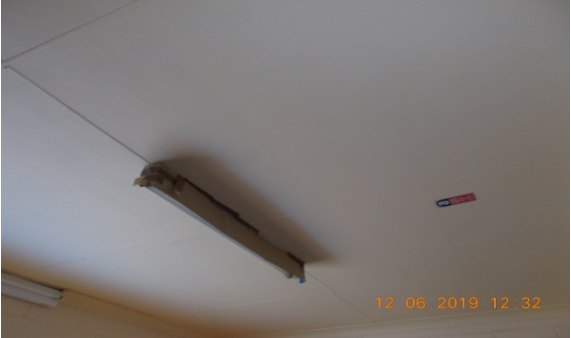
<p style="text-align: center;">132 Kitchen Ceiling Lining</p>

132	25132-43-5	Kitchen Ceiling Lining	Fibreboard	8m2	Positive	1 Non Accessible	1 Good	1 Non Friable	1 Sealed	4 Very Low	A4 No remedial Action Required	Yes		June 2024
