ASBESTOS REGISTER

**GLENBROOK PARK TENNIS
CLUBHOUSE**

20-28 PARK STREET, GLENBROOK

**Extract from Asbestos Report AS28781
November 2015**

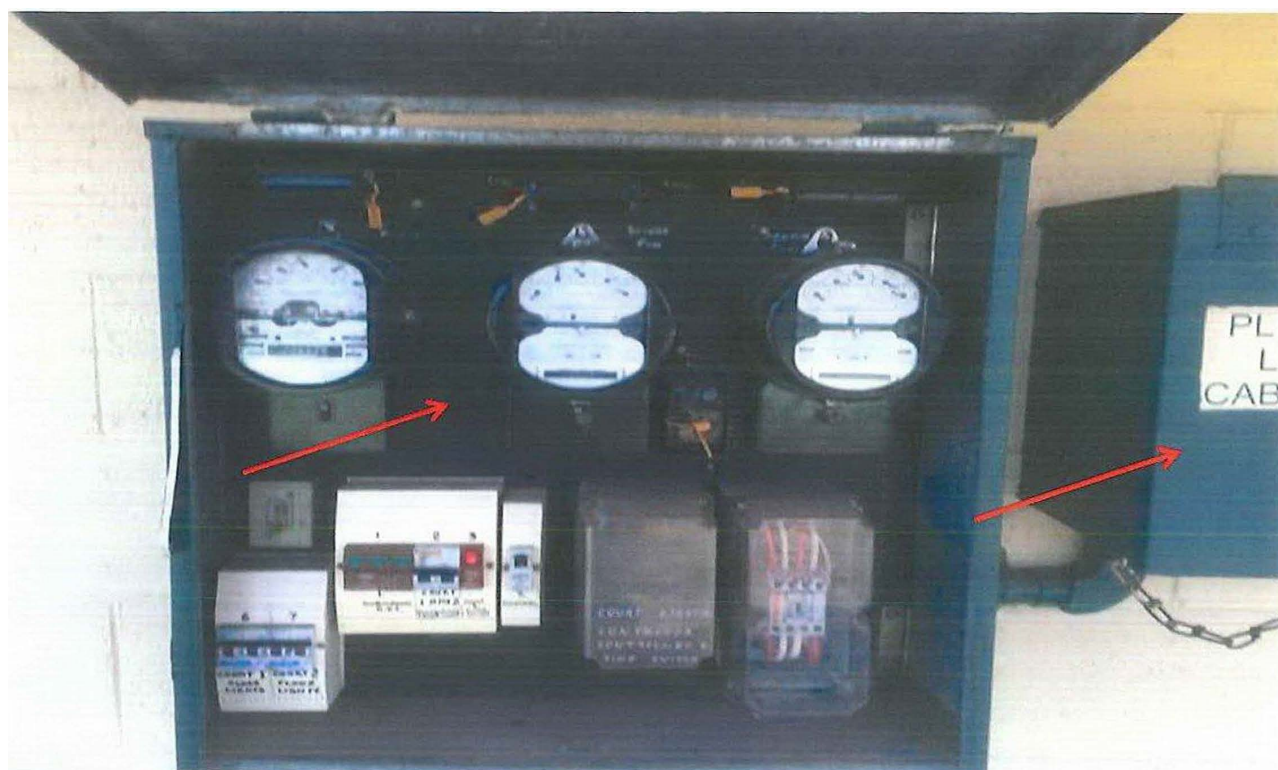
Location	Material	Sample ID	Sample Status	Photo No.	Asbestos Classification	Condition	Accessibility	Re-inspect	Current Label	Control Measure	Record of Works Undertaken
Asset D00165 – Glenbrook Park – Tennis Clubhouse											
External											
Awning lining 1409	Fibreboard	28781-9-1	Negative	-	-	-	-	-	-	-	-
Eave lining's 1410	Fibreboard	28781-9-2	Negative	-	-	-	-	-	-	-	-
Southern Perimeter – Electrical Box (large) – electrical backing board 1422	Bituminous backing board	28781-9-3	Positive	48	Bonded	Stable	Low	November 2020	Not labeled	4	
Southern Perimeter – Electrical Box (small) – electrical backing board 1423	Bituminous backing board	Similar to 28781-9-3	Assumed Positive	48	Bonded	Stable	Low	November 2020	Not labeled	4

Photo 48: Asset D00165 – **Glenbrook Park – Tennis Clubhouse** – Southern Perimeter – electrical backing board's containing asbestos.
