Springwood Early Childhood Centre,
169-171 Macquarie Road, SPRINGWOOD NSW 2777

Asbestos Register and Management Plan

Asbestos Register

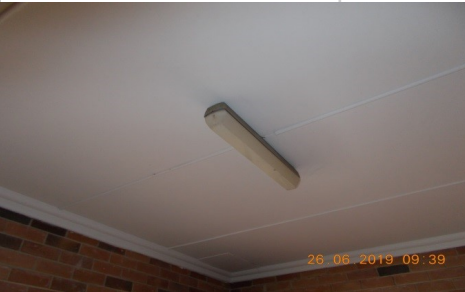
| Licence Number | Address | Asset Type | Property Owner | Activity Level | | |
|---|--|---|---|---|---|---|
| | 1273 | 19/12/2014 | | Yes | 26-Jun-2019 | 26-Jun-2024 |

| Licence Number | Address | Asset Type | Property Owner | Activity Level | | |
|---|--|---|---|---|---|---|
| | Accessible | Fibrous Cement Sheeting | 7m2 | Chrysotile | | |
| | Non Friable | Sealed | RA04 - Very Low | No Remedial Action - Reinspect Periodically | No | |
| Springwood Early Childhood Health Centre - External Entrance Area Ceiling Lining | | | | | | |
| Sample - 25132-52-1 | | | | | | |

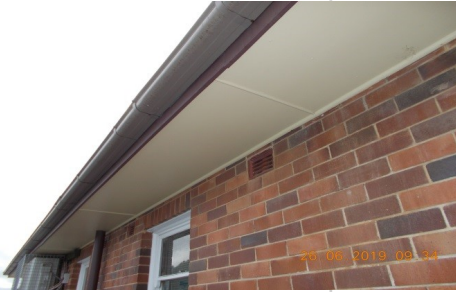
| | 1276 | 19/12/2014 | | Yes | 26-Jun-2019 | 26-Jun-2024 |

| | Accessible | Fibrous Cement Sheeting | 20m2 | Assumed Positive | | |
| Non Friable | Sealed | RA04 - Very Low | No Remedial Action - Reinspect Periodically | No | | |
| Springwood Early Childhood Health Centre - External Eaves Linings | | | | | | |
| Sample - Similar to 25132-52-1 | | | | | | |

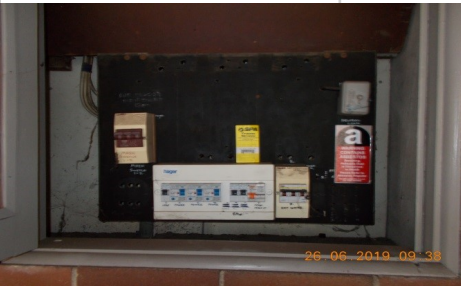
| | 1282 | 19/12/2018 | | Yes | 26-Jun-2019 | 26-Jun-2020 |

| | Accessible | Bituminous backing board | .25m2 | Chrysotile | | |
| Non Friable | Sealed | RA03 - Low | Remove During Refurb or Maintenance | Yes | | |
| Springwood Early Childhood Health Centre - External Entrance Area Eastern Wall Cabinet Electrical Backing Board | | | | | | |
| Sample - 25132-52-3 | | | | | | |
