Springwood Preschool Kindergarten
9-11 Macquarie Road Springwood

Asbestos Register and Management Plan

Asbestos Register

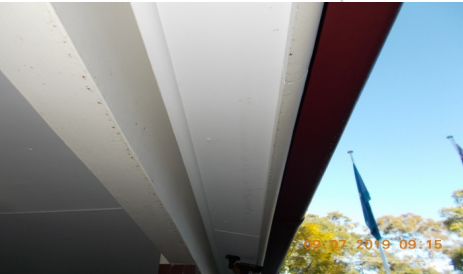
Ref No.	Date Identified	Clearance Cert Date	Onsite Register	Last Inspection Date	Next Inspection Date		
	1252	19/12/2014		Yes	09-Jul-2019	09-Jul-2024		
	Accessibility	Material	Extent	Result				
	Accessible	Fibreboard	25m2	Chrysotile				
	Friability	Sealed / Surface Treatment	Risk Assessment	Control Actions	Labels Affixed			
	Non Friable	Sealed	RA04 - Very Low	No Remedial Action - Reinspect Periodically	No			
	Specific Location							
		Springwood Preschool KindergartenExternal - Eave linings						
		Additional Comments					GPS Lat,Long	
		Sample - 25132-64-1

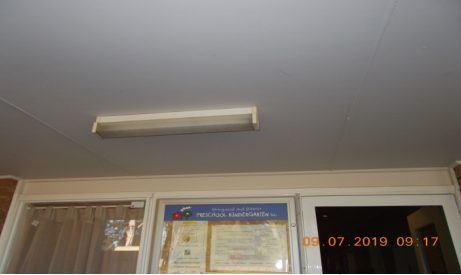
Ref No.	Date Identified	Clearance Cert Date	Onsite Register	Last Inspection Date	Next Inspection Date
	1255	19/12/2014		Yes	09-Jul-2019	09-Jul-2024
	Accessibility	Material	Extent	Result		
	Accessible	Fibreboard	.5m2	Assumed Positive		
	Friability	Sealed / Surface Treatment	Risk Assessment	Control Actions	Labels Affixed	
	Non Friable	Sealed	RA04 - Very Low	No Remedial Action - Reinspect Periodically	No	
Specific Location						
Springwood Preschool Kindergarten - External Main Entrance Flashing Above Door						
Additional Comments						GPS Lat,Long
Sample - Similar to 25132-64-1

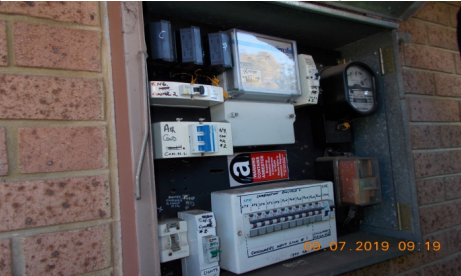
Ref No.	Date Identified	Clearance Cert Date	Onsite Register	Last Inspection Date	Next Inspection Date
	1257	19/12/2014		Yes	09-Jul-2019	09-Jul-2024
	Accessibility	Material	Extent	Result		
	Accessible	Bituminous backing board	.5m2	Chrysotile		
	Friability	Sealed / Surface Treatment	Risk Assessment	Control Actions	Labels Affixed

Non Friable	Sealed	RA04 - Very Low	No Remedial Action - Reinspect Periodically	No	
Specific Location						
Springwood Preschool Kindergarten - External Eastern Perimeter Electrical Backing Board						
Additional Comments						GPS Lat,Long
Sample - 25132-64-4

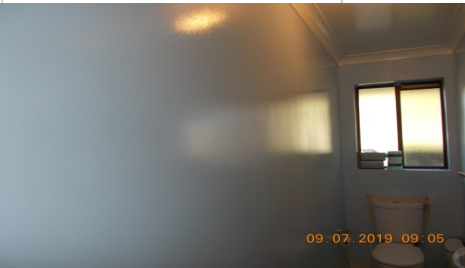
Ref No.	Date Identified	Clearance Cert Date	Onsite Register	Last Inspection Date	Next Inspection Date
	1258	19/12/2014		Yes	09-Jul-2019	09-Jul-2024
	Accessibility	Material	Extent	Result		
	Accessible	Fibreboard	16m2	Chrysotile		
	Friability	Sealed / Surface Treatment	Risk Assessment	Control Actions	Labels Affixed	
	Non Friable	Sealed	RA04 - Very Low	No Remedial Action - Reinspect Periodically	No	
Specific Location						
		Springwood Preschool Kindergarten - Internal Adult Toilet Wall Cladding				
		Additional Comments				GPS Lat,Long
		Sample - 25132-64-5

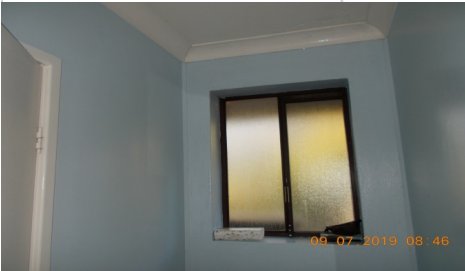
Ref No.	Date Identified	Clearance Cert Date	Onsite Register	Last Inspection Date	Next Inspection Date
	1263	19/12/2014		Yes	09-Jul-2019	09-Jul-2024
	Accessibility	Material	Extent	Result		
	Accessible	Fibreboard	12m2	Chrysotile		
	Friability	Sealed / Surface Treatment	Risk Assessment	Control Actions	Labels Affixed	
	Non Friable	Sealed	RA04 - Very Low	No Remedial Action - Reinspect Periodically	No	
Specific Location						
		Springwood Preschool Kindergarten - Internal Storeroom adjacent Staff Area Toilet Wall Cladding				
		Additional Comments				GPS Lat,Long
		Sample - 25132-64-9

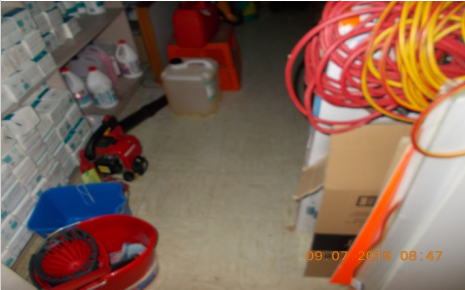
Ref No.	Date Identified	Clearance Cert Date	Onsite Register	Last Inspection Date	Next Inspection Date
	1264	19/12/2014		Yes	09-Jul-2019	09-Jul-2024
		Accessibility	Material	Extent	Result	
		Accessible	White vinyl floor tiles		Chrysotile	
		Friability	Sealed / Surface Treatment	Risk Assessment	Control Actions	Labels Affixed
		Non Friable	Sealed	RA04 - Very Low	No Remedial Action - Reinspect Periodically	No
Specific Location						
Springwood Preschool Kindergarten - Internal - Storeroom adjacent Playroom 2 - Vinyl Floor Tiles						
Additional Comments						GPS Lat,Long
Sample - 25132-64-10						
Note* black adhesive glue is present beneath the vinyl floor tiles in the area. Testing of this material was not possible without intrusive sampling methods and extensive damage to the vinyl floor tiles. The status of this material should be checked before any major refurbishment works that may disturb the material.
