## ASBESTOS REGISTER

LAWSON POOL  
CHANGE ROOMS,  
PUMP & ELECTRICAL ROOMS,  
CANTEEN & OFFICE

2-16 ST BERNARDS DRIVE, LAWSON

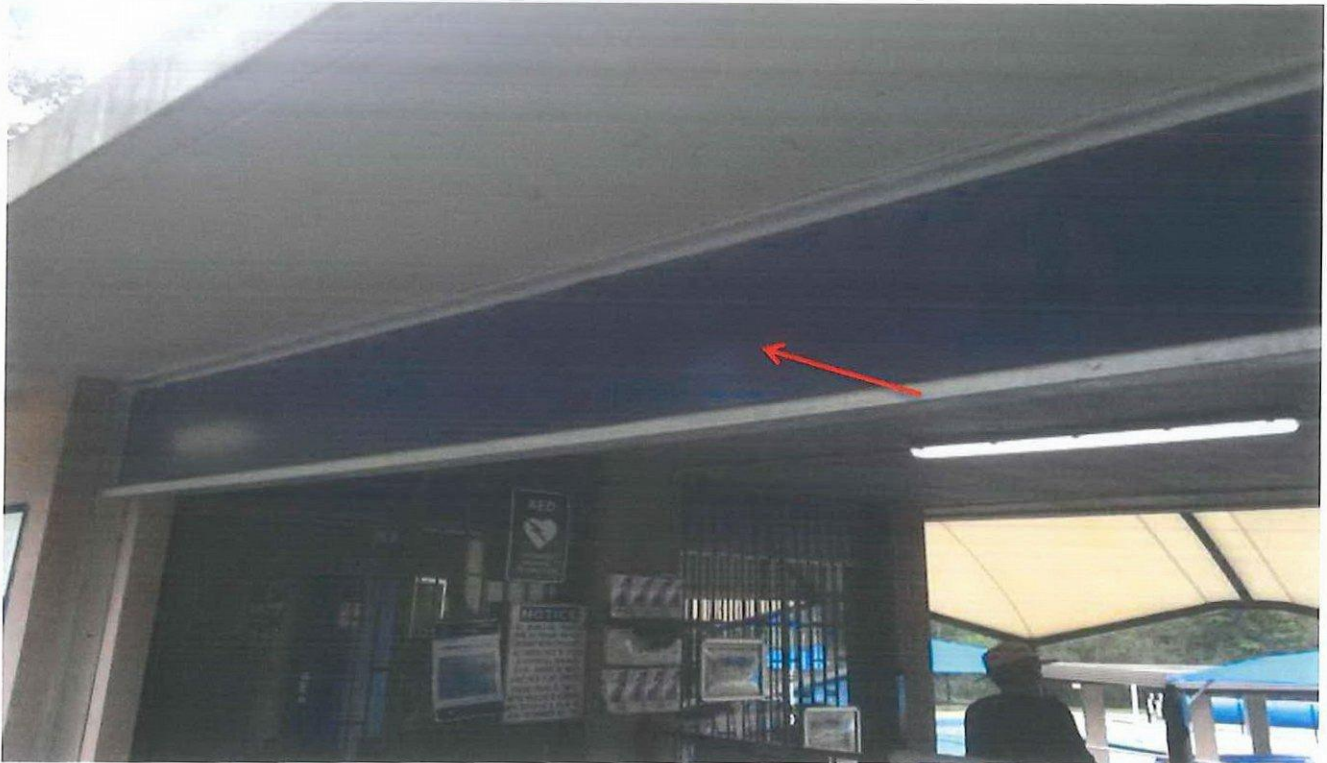
**Photo 87:** Asset D00097 – Lawson Pool – Canteen and Office – Entrance Area – asbestos cement sheet infill panel above gates.

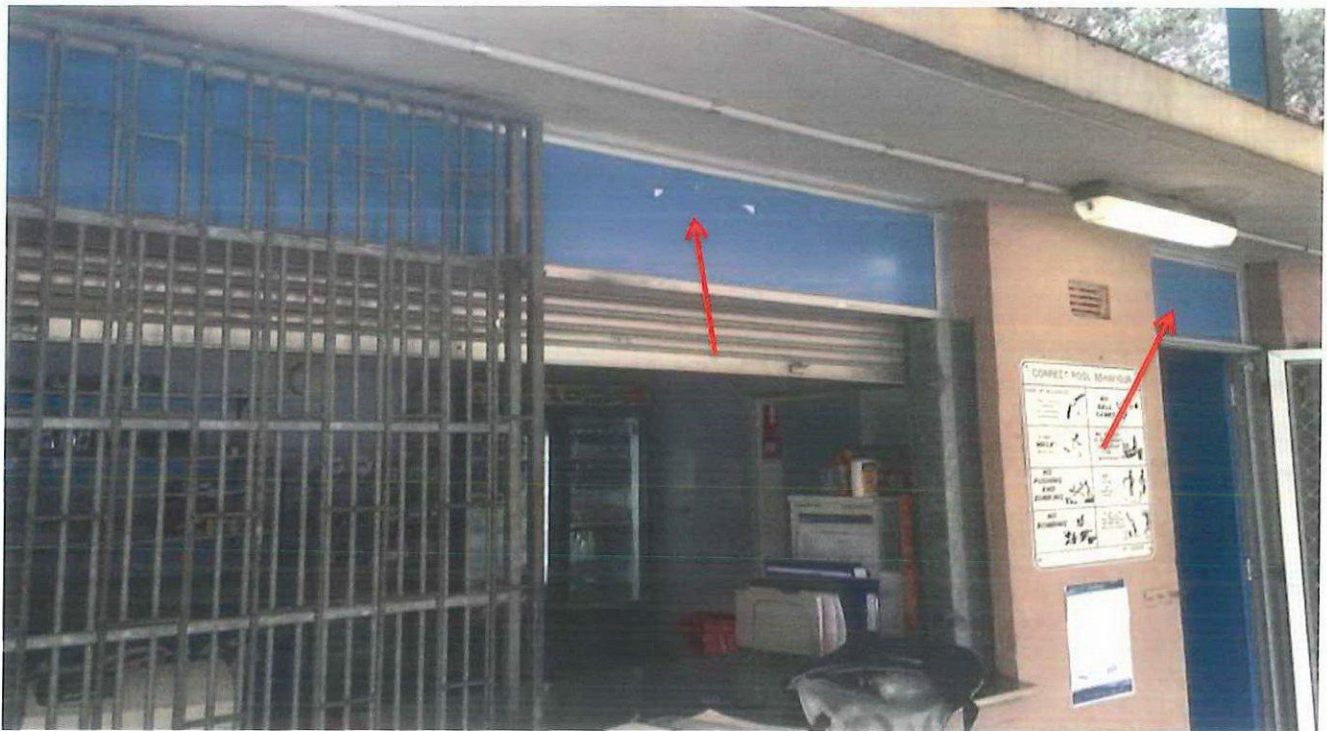
**Photo 88:** Asset D00097 – Lawson Pool – Canteen and Office – Canteen – asbestos cement sheet infill panels above windows and doorway.

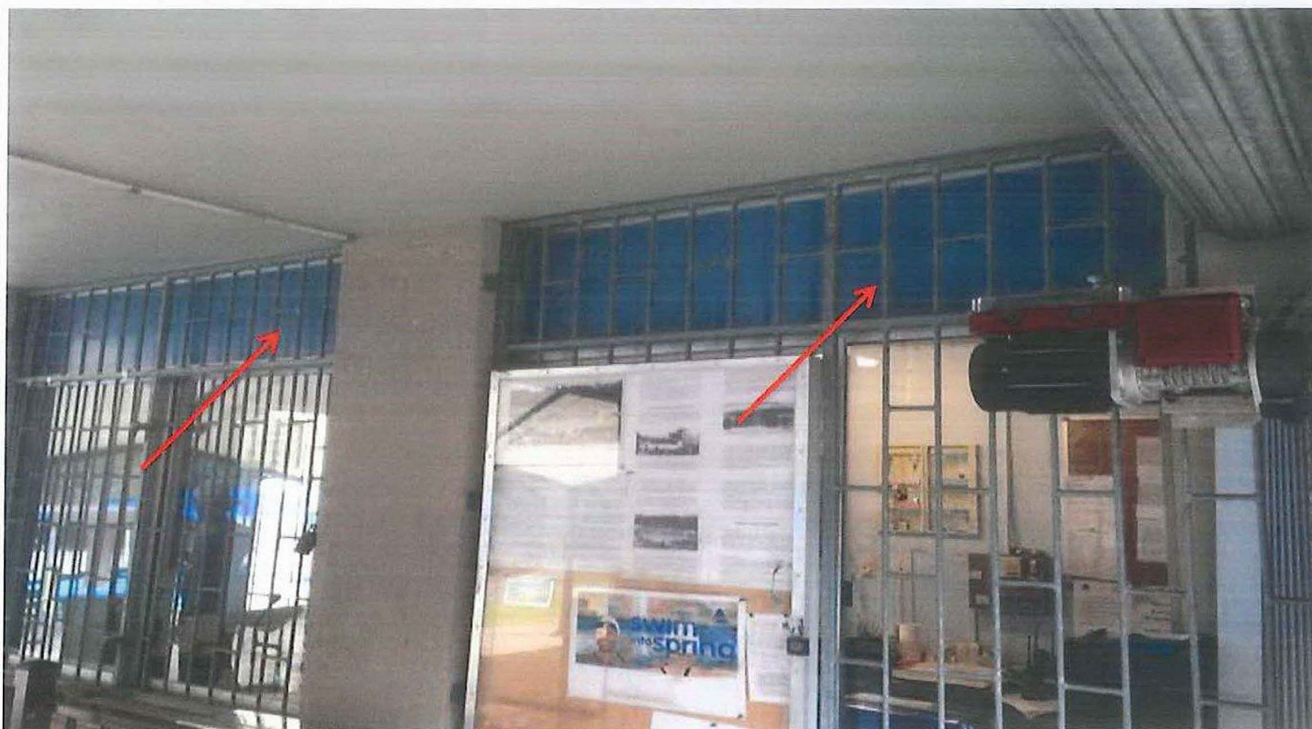
**Photo 89:** Asset D00097 - Lawson Pool - Canteen and Office - Office - asbestos cement sheet infill panels above windows and doorway.

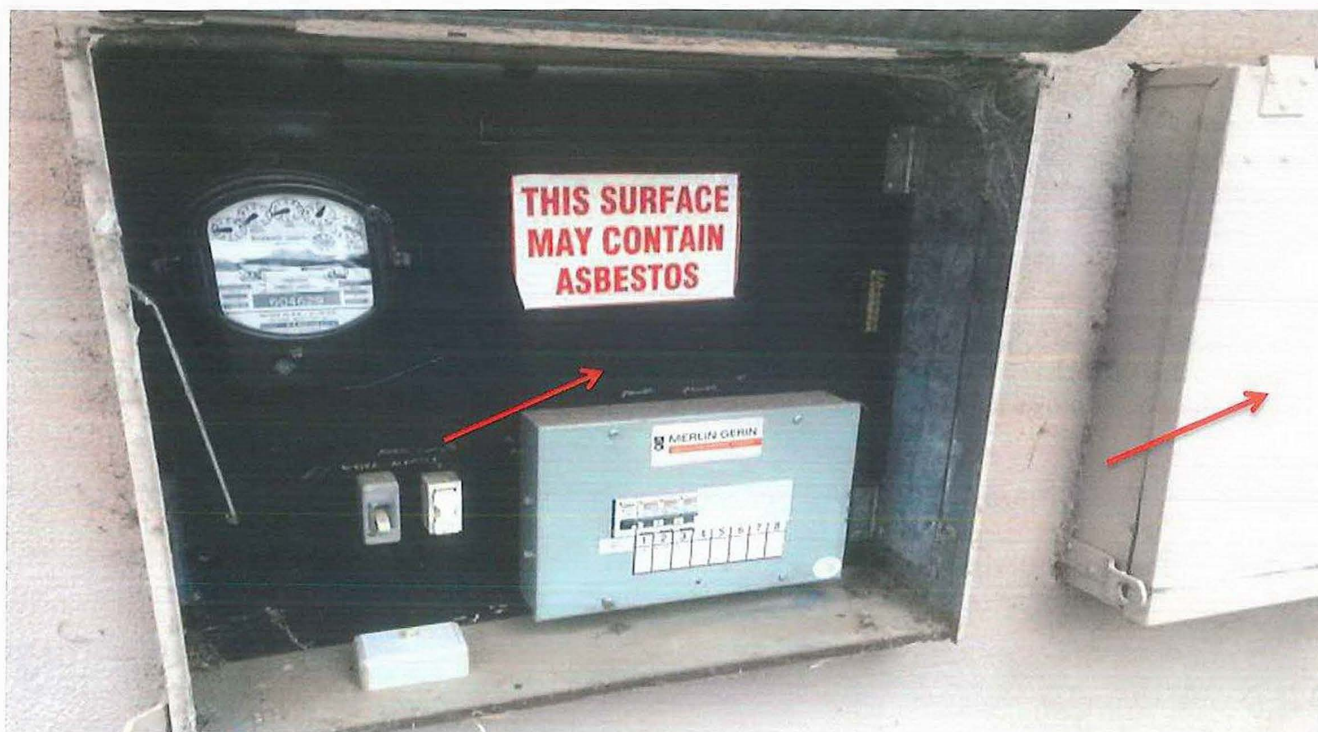
Location	Material	Sample ID	Sample Status	Photo No.	Asbestos Classification	Condition	Accessibility	Re-inspect	Current Label	Control Measure	Record of Works Undertaken
<b>Asset D00097 – Lawson Pool – Canteen and Office</b>											
<b>External</b>											
Entrance Area – in-between Canteen and Office – infill panel above gates <b>1888</b>	Fibrous cement sheeting	Similar to 28781-27-1	Assumed Positive	87	Bonded	Stable	Low	November 2020	Not labeled	4	
Canteen – infill panels above windows and doorway (x4) <b>1889</b>	Fibrous cement sheeting	28781-27-1	Positive	88	Bonded	Stable	Low	November 2020	Not labeled	4	
Office – infill panels above windows and doorway (x9) <b>1890</b>	Fibrous cement sheeting	Similar to 28781-27-1	Assumed Positive	89	Bonded	Stable	Low	November 2020	Not labeled	4	
Office – eastern perimeter – electrical box's – electrical backing boards (x2) <b>1891</b>	Bituminous backing board	28781-27-2	Positive	90	Bonded	Stable	Low	November 2020	Labeled Incorrectly	4

**Photo 90:** Asset D00097 - Lawson Pool - Canteen and Office - Office - eastern perimeter - electrical backing boards containing asbestos.
