ASBESTOS REGISTER

LEURA - 156 MEGALONG STREET

**Blue Mountains City
Council – Round 2**

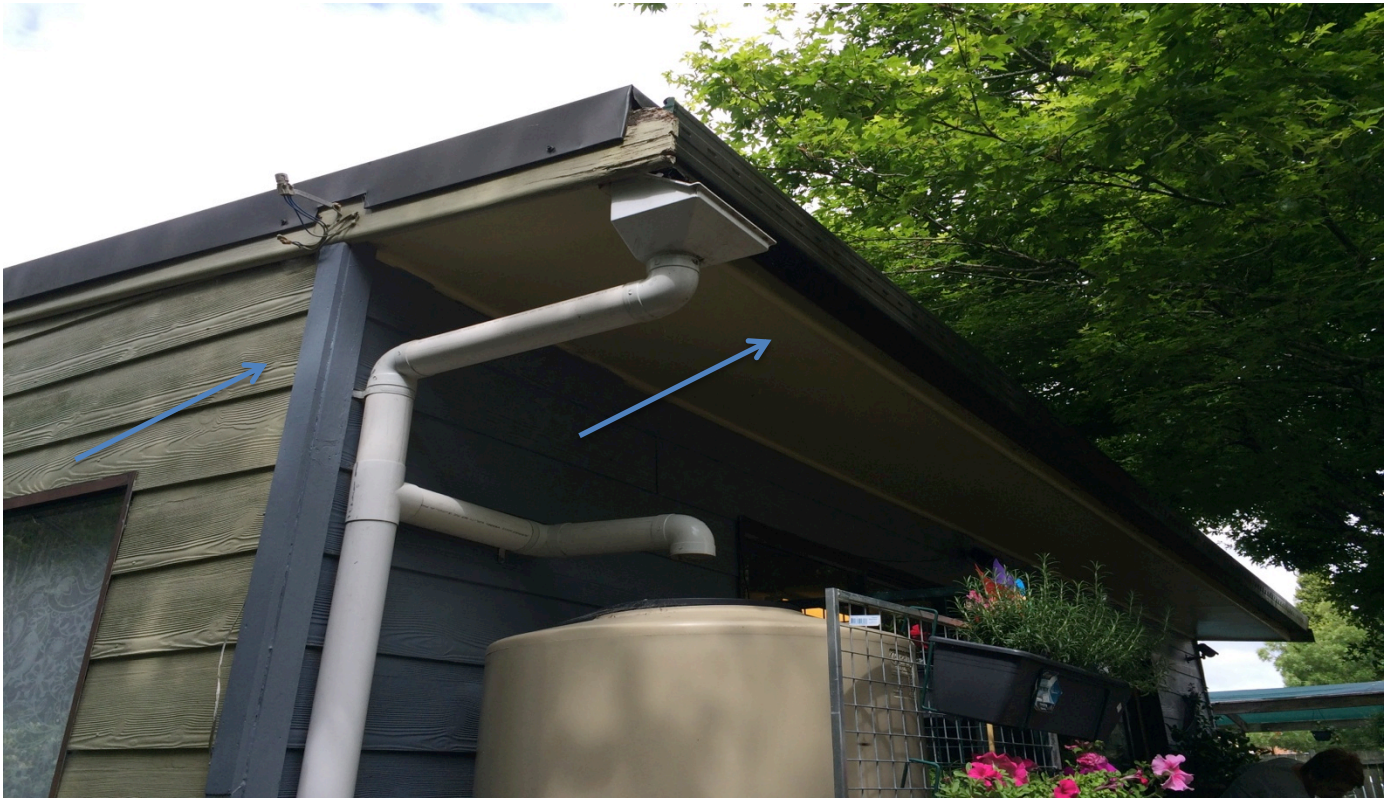
Photo 157: Fibreboard containing asbestos eave lining and external wall cladding of the Nursery area of 156 Megalong Street, Leura.

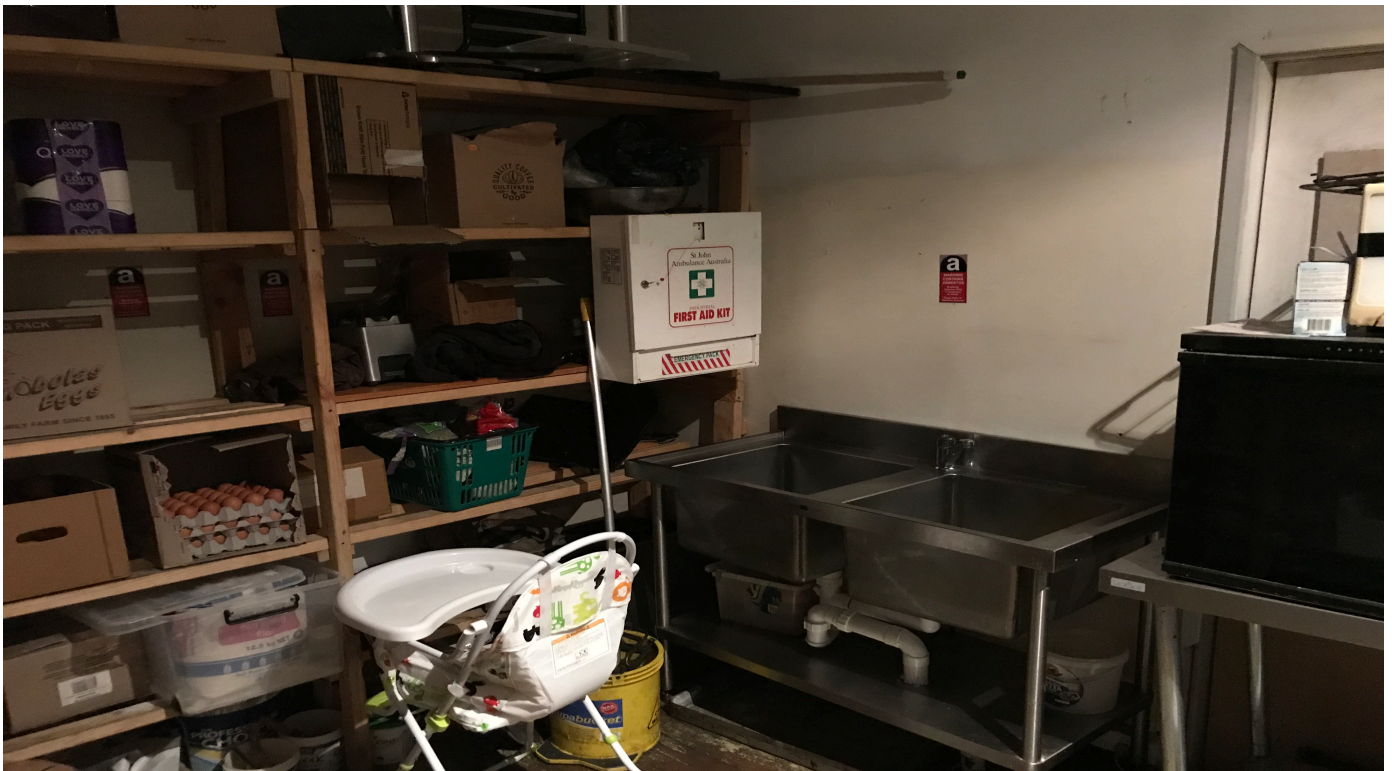
Photo 158: Asbestos cement sheet ceiling internal wall cladding of the café – storeroom of 156 Megalong Street, Leura.

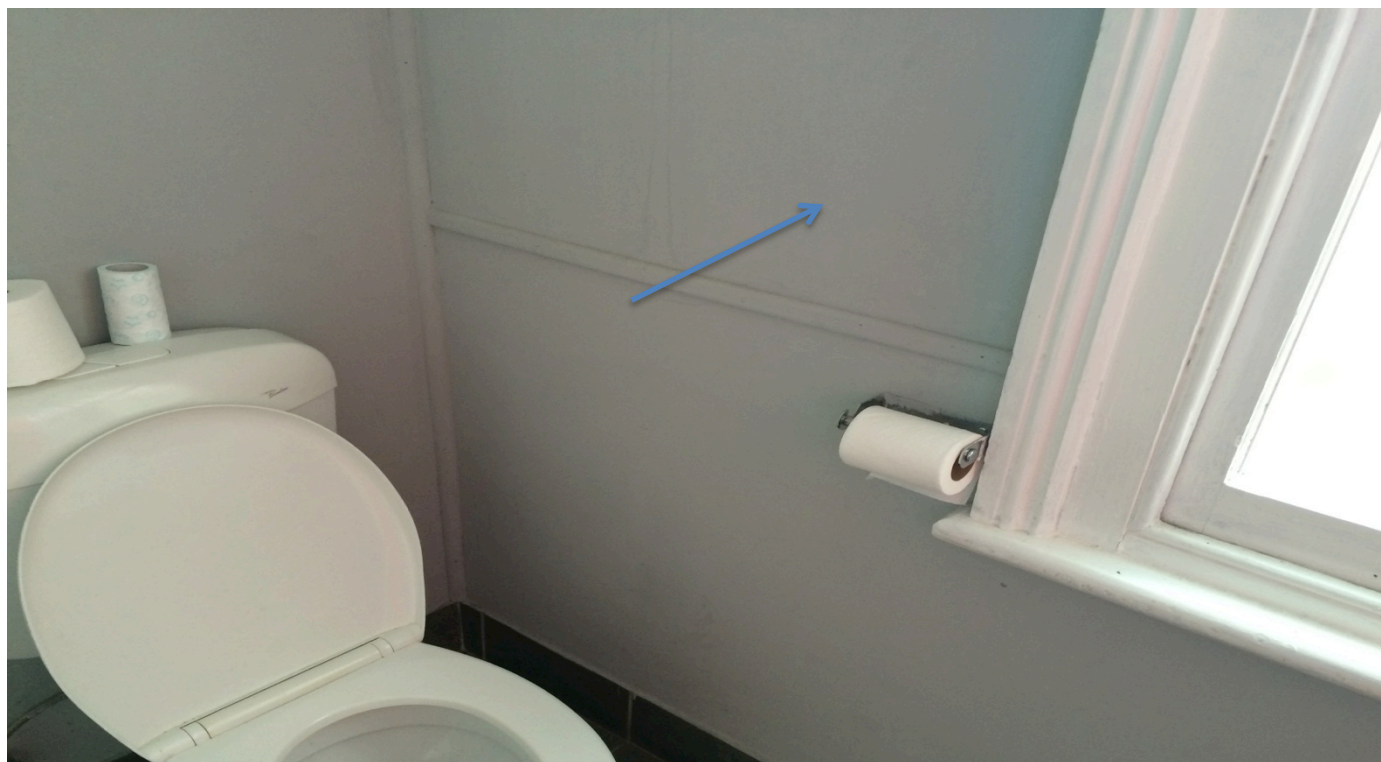
Photo 159: Asbestos cement sheet northern internal wall cladding of the Customer Toilet in the Cafe area of 156 Megalong Street, Leura.
