Leura Carpark and Buildings

152 Megalong Street, Leura, NSW 2780

Asbestos Register and Management Plan

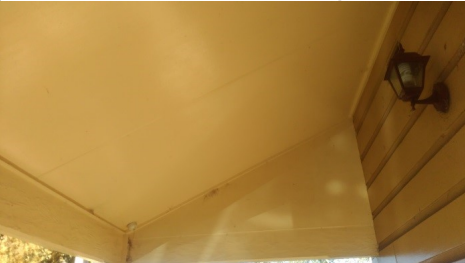
Licence Number	Address	Asset Type	Property Owner	Activity Level		
LEURA NSW 2780						
RAR-177	Car Park - Leura 152 Megalong Street LEURA	Commerical leasing	BMCC	Risks on site		
Commercial Dwelling						
Status: Active						
	Ref No.	Date Identified	Clearance Cert Date	Onsite Register	Last Inspection Date	Next Inspection Date
	260	19/12/2014		Yes	19-Jun-2019	19-Jun-2024

Accessibility	Material	Extent	Result		
	Inaccessible	Fibreboard	2.5m2	Chrysotile		
	Friability	Sealed / Surface Treatment	Risk Assessment	Control Actions	Labels Affixed	
	Non Friable	Sealed	RA04 - Very Low	No Remedial Action - Reinspect Periodically	No	
Specific Location						
Shop/Cottage - External South-Eastern Verandah Ceiling Lining						
Additional Comments					GPS Lat,Long	
Sample - 25132-48-1

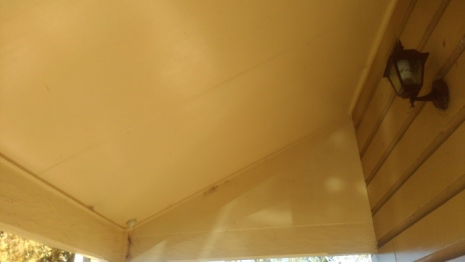
Ref No.	Date Identified	Clearance Cert Date	Onsite Register	Last Inspection Date	Next Inspection Date
	261	19/12/2014		Yes	16-Jun-2019	16-Jun-2024

Accessibility	Material	Extent	Result		
	Accessible	Fibreboard	1m2	Assumed Positive		
	Friability	Sealed / Surface Treatment	Risk Assessment	Control Actions	Labels Affixed	
	Non Friable	Sealed	RA04 - Very Low	No Remedial Action - Reinspect Periodically	No	
Specific Location						
Shop/Cottage - External South-Eastern Verandah Internal Gable Ends						
Additional Comments					GPS Lat,Long	
Sample - Similar to 25132-48-1						
	Ref No.	Date Identified	Clearance Cert Date	Onsite Register	Last Inspection Date	Next Inspection Date
	262	19/12/2014		Yes	19-Jun-2019	19-Jun-2024

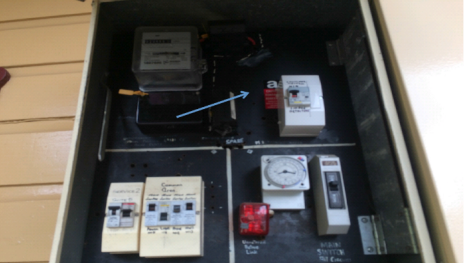
Accessibility	Material	Extent	Result		
	Accessible	Bituminous backing board	0.5m2	Chrysotile		
	Friability	Sealed / Surface Treatment	Risk Assessment	Control Actions	Labels Affixed	
	Non Friable	Sealed	RA04 - Very Low	No Remedial Action - Reinspect Periodically	Yes

Specific Location						
External - South-eastern verandah – southern electrical box – electrical backing board						
Additional Comments					GPS Lat,Long	
Sample - 25132-48-2

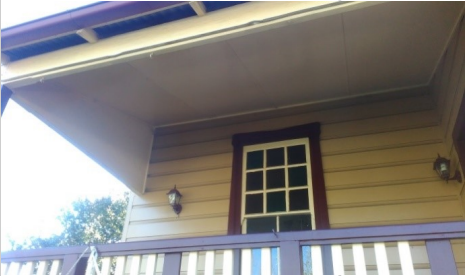
Ref No.	Date Identified	Clearance Cert Date	Onsite Register	Last Inspection Date	Next Inspection Date	
	263	19/12/2014		Yes	19-Jun-2019	19-Jun-2024	
	Accessibility	Material	Extent	Result			
	Accessible	Fibreboard	6m2	Assumed Positive			
	Friability	Sealed / Surface Treatment	Risk Assessment	Control Actions	Labels Affixed		
	Non Friable	Sealed	RA04 - Very Low	No Remedial Action - Reinspect Periodically	No		
	Specific Location						
Shop/Cottage - External South-Western Verandah Ceiling Lining							
Additional Comments					GPS Lat,Long		
Sample - Similar to 25132-48-1

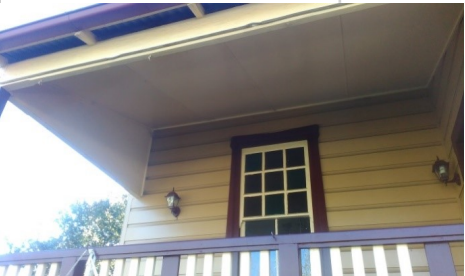
Ref No.	Date Identified	Clearance Cert Date	Onsite Register	Last Inspection Date	Next Inspection Date	
	264	19/12/2014		Yes	19-Jun-2019	19-Jun-2024	
	Accessibility	Material	Extent	Result			
	Accessible	Fibreboard	1m2	Chrysotile			
	Friability	Sealed / Surface Treatment	Risk Assessment	Control Actions	Labels Affixed		
	Non Friable	Sealed	RA04 - Very Low	No Remedial Action - Reinspect Periodically	No

Specific Location						
Shop/Cottage - External South-Western Verandah Internal Gable Ends							
Additional Comments					GPS Lat,Long		
Sample - Similar to 25132-48-1

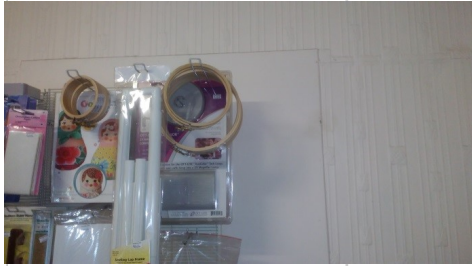
Ref No.	Date Identified	Clearance Cert Date	Onsite Register	Last Inspection Date	Next Inspection Date
265	19/12/2014		Yes	19-Jun-2019	19-Jun-2024

Accessibility	Material	Extent	Result	
	Accessible	Fibrous cement sheeting	1m2	Chrysotile	
	Friability	Sealed / Surface Treatment	Risk Assessment	Control Actions	Labels Affixed
	Non Friable	Sealed	RA04 - Very Low	No Remedial Action - Reinspect Periodically	No
	Specific Location				
Shop/Cottage - Internal Fudge Room Eastern Internal Wall Panel					
Additional Comments					GPS Lat,Long
Sample - 25132-48-5					
Ref No.	Date Identified	Clearance Cert Date	Onsite Register	Last Inspection Date	Next Inspection Date
266	19/12/2014		Yes	19-Jun-2019	19-Jun-2024

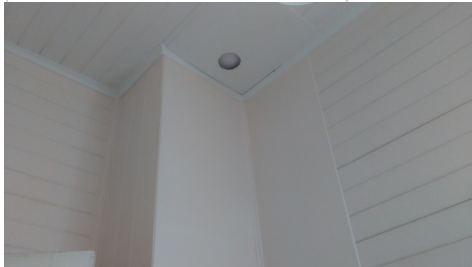
Accessibility	Material	Extent	Result	
	Accessible	Fibrous cement sheeting	0.25m2	Chrysotile	
	Friability	Sealed / Surface Treatment	Risk Assessment	Control Actions	Labels Affixed
	Non Friable	Sealed	RA04 - Very Low	No Remedial Action - Reinspect Periodically	Yes

Specific Location				
Shop/Cottage - Internal Bathroom Ceiling Panels					
Additional Comments					GPS Lat,Long
Sample - 25132-47-6

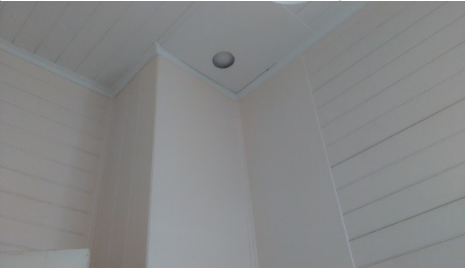
Ref No.	Date Identified	Clearance Cert Date	Onsite Register	Last Inspection Date	Next Inspection Date
	267	19/12/2014		Yes	19-Jun-2019	19-Jun-2024

Accessibility	Material	Extent	Result		
	Accessible	Fibrous cement sheeting	1m2	Assumed Positive		
	Friability	Sealed / Surface Treatment	Risk Assessment	Control Actions	Labels Affixed	
	Non Friable	Sealed	RA04 - Very Low	No Remedial Action - Reinspect Periodically	Yes	
Specific Location						
Shop/Cottage - Internal Bathroom Internal Wall Panel Above Sink (x2)						
Additional Comments					GPS Lat,Long	
Sample - Similar to 25132-48-6						
Status: Closed						
	Ref No.	Date Identified	Clearance Cert Date	Onsite Register	Last Inspection Date	Next Inspection Date
	3221	19/12/2014		Yes		
	Accessibility	Material	Extent	Result		
		Timber		No Asbestos identified		
	Friability	Sealed / Surface Treatment	Risk Assessment	Control Actions	Labels Affixed	
				No Action Required - No ACM Identified

Specific Location						
Shop/Cottage - External South-Eastern Verandah Northern Electrical Box Electrical Backing Board						
Additional Comments					GPS Lat,Long
