Asbestos Register

Blackheath Pre-School,

11 Park Avenue, BLACKHEATH, NSW, 2785

Asbestos Register and Management Plan

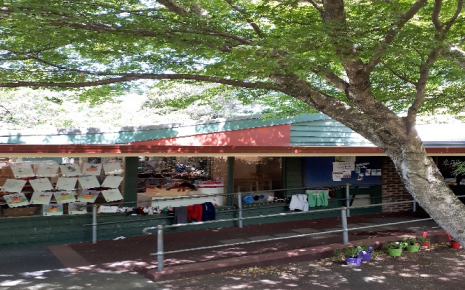
Asbestos Register

Accessibility	Material	Extent	Result		
	Accessible	Fibreboard	1m2	Assumed Positive		
	Friability	Sealed / Surface Treatment	Risk Assessment	Control Actions	Labels Affixed	
	Non Friable	Sealed	RA04 - Very Low	No Remedial Action - Reinspect Periodically	No	
Specific Location						
Blackheath Preschool Kindergarten - External Roof Fascia Panels						
Additional Comments						GPS Lat,Long
Sample - Similar to 25132-61-1 - Assumed Chrysotile

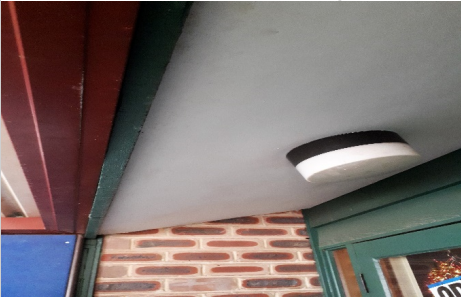
Ref No.	Date Identified	Clearance Cert Date	Onsite Register	Last Inspection Date	Next Inspection Date
	301	19/12/2014		Yes	04-Dec-2019	04-Dec-2024
	Accessibility	Material	Extent	Result		
	Accessible	Fibreboard	1.5m2	Assumed Positive		
	Friability	Sealed / Surface Treatment	Risk Assessment	Control Actions	Labels Affixed	
	Non Friable	Sealed	RA04 - Very Low	No Remedial Action - Reinspect Periodically	No	
	Specific Location					
Blackheath Preschool Kindergarten - External Entrance Ceiling Lining						
Additional Comments					GPS Lat,Long	
Sample - Similar to 25132-61-1 - Assumed Chrysotile

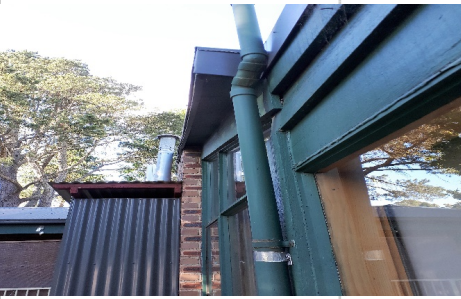
Ref No.	Date Identified	Clearance Cert Date	Onsite Register	Last Inspection Date	Next Inspection Date
	302	19/12/2014		Yes	04-Dec-2019	04-Dec-2024
	Accessibility	Material	Extent	Result		
	Accessible	Fibreboard	0.5m2	Chrysotile		
	Friability	Sealed / Surface Treatment	Risk Assessment	Control Actions	Labels Affixed

Non Friable	Sealed	RA04 - Very Low	No Remedial Action - Reinspect Periodically	No	
	Specific Location					
Blackheath Preschool Kindergarten - External Eastern Perimeter Above Windows Eave Linings						
Additional Comments					GPS Lat,Long	
Sample - 25132-61-1

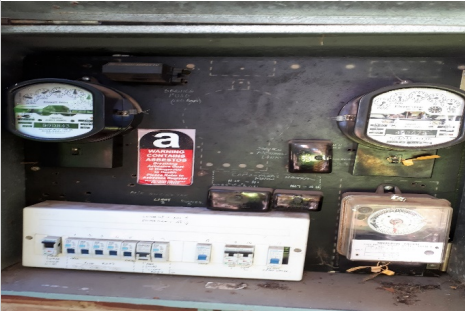
Ref No.	Date Identified	Clearance Cert Date	Onsite Register	Last Inspection Date	Next Inspection Date	
	303	19/12/2014		Yes	04-Dec-2019	04-Dec-2024	
	Accessibility	Material	Extent	Result			
	Accessible	Bituminous backing board	0.5m2	Chrysotile			
	Friability	Sealed / Surface Treatment	Risk Assessment	Control Actions	Labels Affixed		
	Non Friable	Sealed	RA04 - Very Low	No Remedial Action - Reinspect Periodically	Yes		
	Specific Location						
Blackheath Preschool Kindergarten - External Eastern Perimeter Electrical Box Electrical Backing Board							
Additional Comments						GPS Lat,Long	
Sample - 25132-61-2

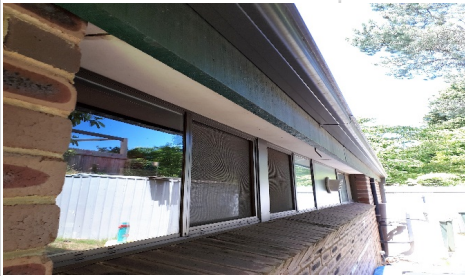
Ref No.	Date Identified	Clearance Cert Date	Onsite Register	Last Inspection Date	Next Inspection Date	
	304	19/12/2014		Yes	04-Dec-2019	04-Dec-2024	
	Accessibility	Material	Extent	Result			
	Accessible	Fibreboard	1m2	Assumed Positive			
	Friability	Sealed / Surface Treatment	Risk Assessment	Control Actions	Labels Affixed

Non Friable	Sealed	RA04 - Very Low	No Remedial Action - Reinspect Periodically	No		
	Specific Location						
Blackheath Preschool Kindergarten - External Northern Perimeter Adjacent Playroom Eave Lining							
Additional Comments						GPS Lat,Long	
Sample - Similar to 25132-61-1 - Assumed Chrysotile

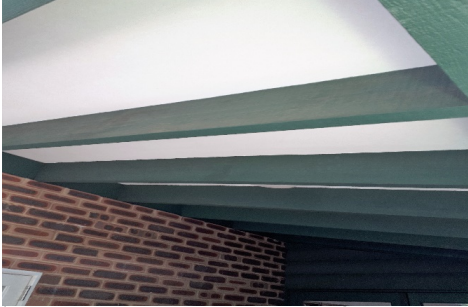
Ref No.	Date Identified	Clearance Cert Date	Onsite Register	Last Inspection Date	Next Inspection Date
	305	19/12/2014		Yes	04-Dec-2019	19-Dec-2024
	Accessibility	Material	Extent	Result		
	Accessible	Fibreboard	5m2	Chrysotile		
	Friability	Sealed / Surface Treatment	Risk Assessment	Control Actions	Labels Affixed	
	Non Friable	Sealed	RA04 - Very Low	No Remedial Action - Reinspect Periodically	No	
	Specific Location					
Blackheath Preschool Kindergarten - External Northern Patio Ceiling Lining						
Additional Comments					GPS Lat,Long	
Sample - 25132-61-4

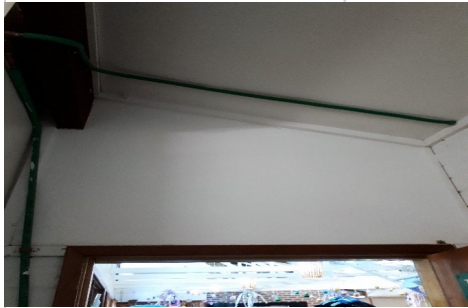
Ref No.	Date Identified	Clearance Cert Date	Onsite Register	Last Inspection Date	Next Inspection Date
	3201	19/12/2014		Yes	04-Dec-2019	04-Dec-2024
	Accessibility	Material	Extent	Result		
	Accessible	Fibreboard	1m2	Chrysotile		
	Friability	Sealed / Surface Treatment	Risk Assessment	Control Actions	Labels Affixed	
	Non Friable	Sealed	RA04 - Very Low	Investigate	No

Specific Location					
Blackheath Preschool Kindergarten - Internal Northern Office Panel Above Doorway						
Additional Comments					GPS Lat,Long	
Sample - ART131
