ASBESTOS REGISTER

ELISE LANGFORD CENTRE

16-18 RAILWAY PARADE, MEDLOW

**Blue Mountains City
Council – Stage 3**

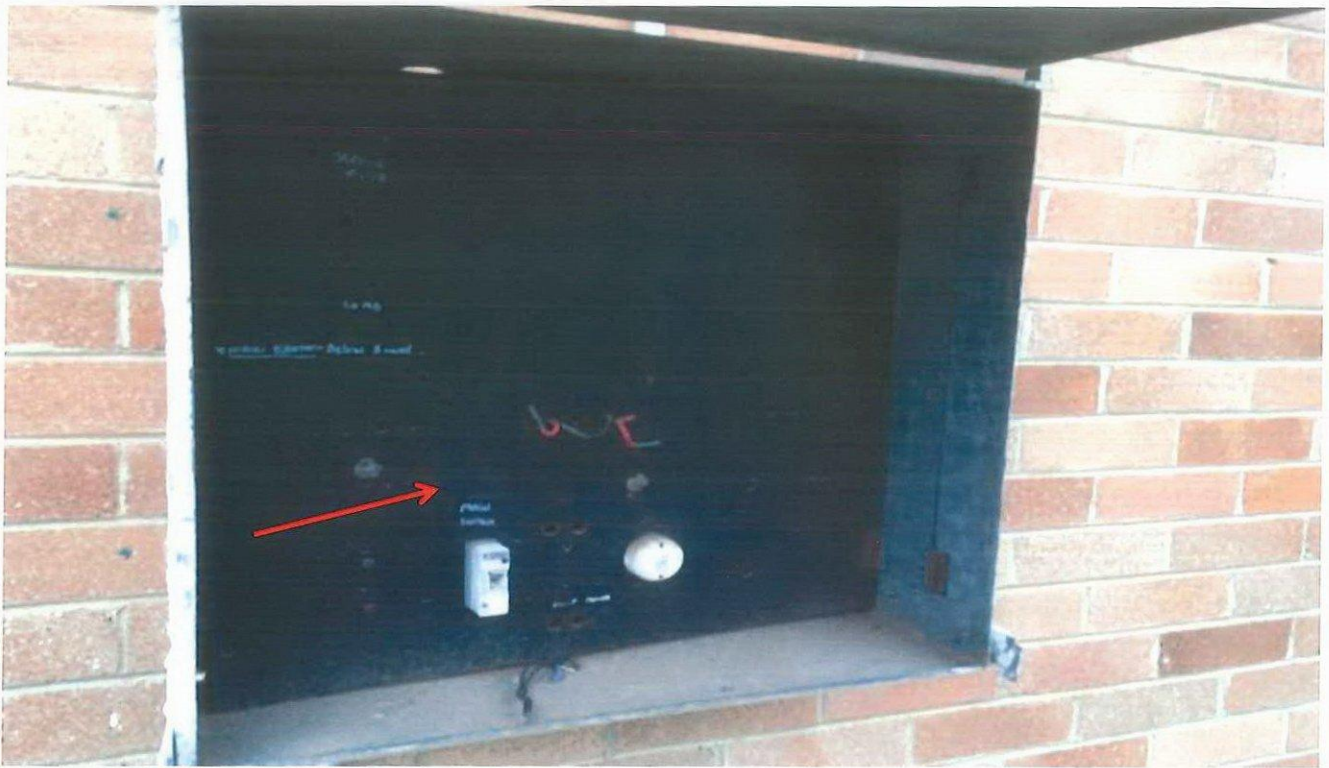
Photo 111: Asset D00151 – The Elise Langford Centre, Medlow Bath – electrical backing board containing asbestos on the western perimeter.

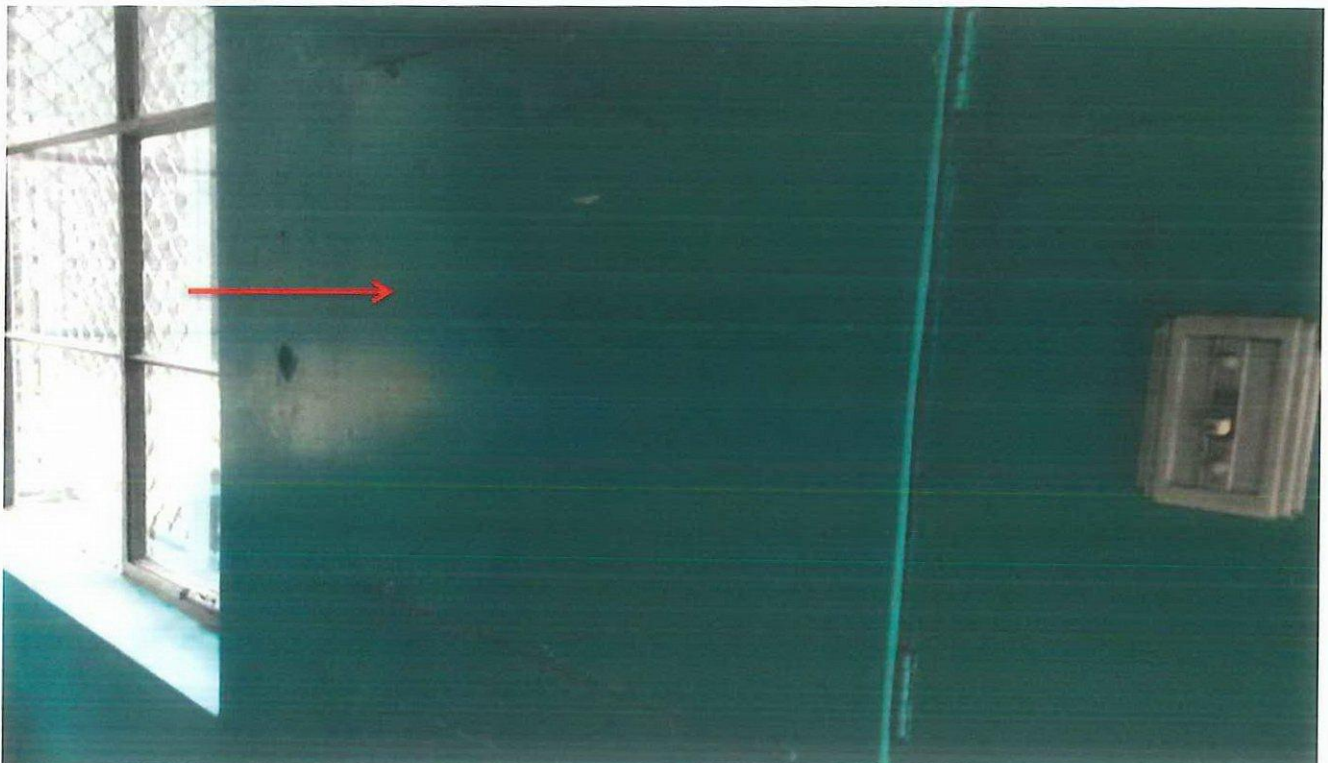
Photo 112: Asset D00151 – The Elise Langford Centre, Medlow Bath – asbestos cement sheet wall panel on the southern perimeter of the Main Room.

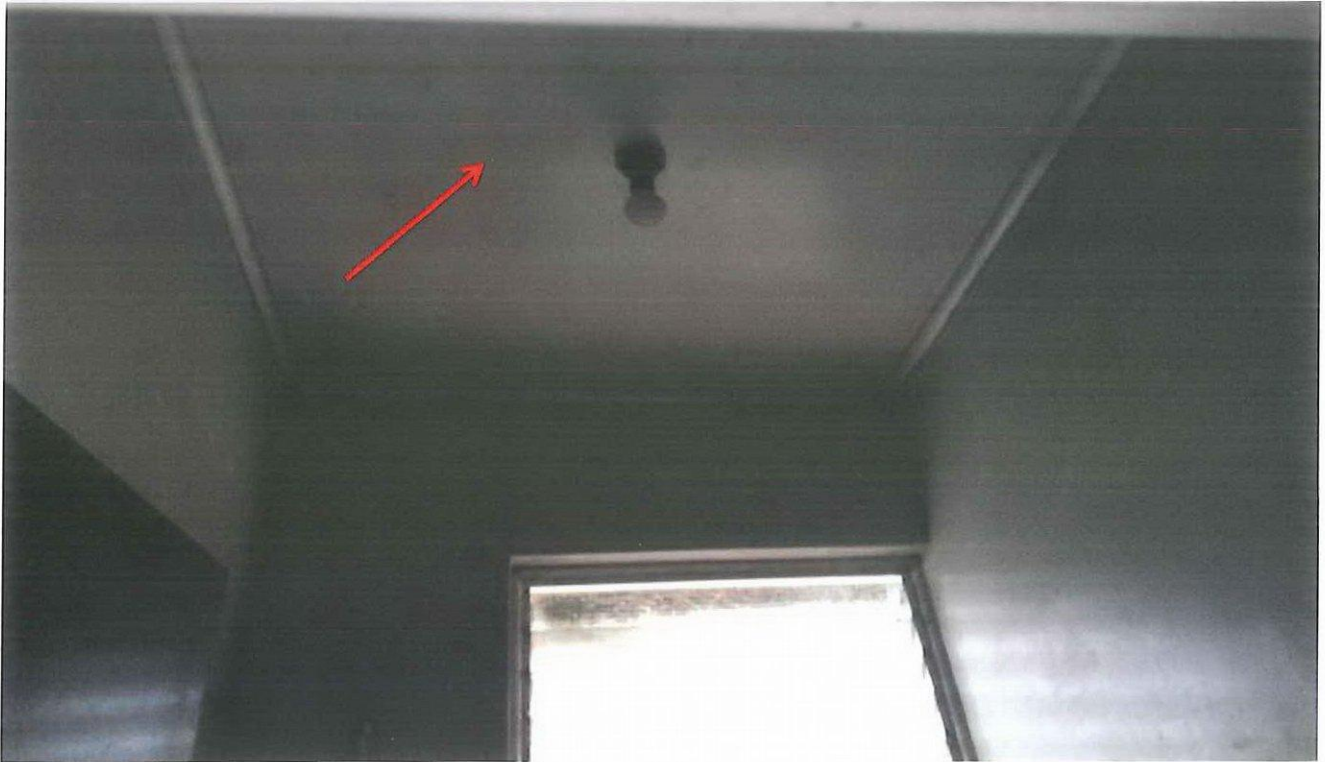
28781-32-5	The Elise Langford Centre, Medlow Bath – Internal – Toilet #1 (north) – ceiling lining	3x3x2mm fibrous cement sheet fragment	Chrysotile asbestos detected
28781-33-1	Mt Riverview Woodcraft Centre/Men's Shed – External – awning lining	8x6x1mm fibreboard fragment	No asbestos detected Organic fibres detected
28781-33-2	Mt Riverview Woodcraft Centre/Men's Shed – External – eave linings	10x8x2mm fibreboard fragment	No asbestos detected Organic fibres detected
28781-33-3	Mt Riverview Woodcraft Centre/Men's Shed – External – Windows – panels above	13x8x2mm fibreboard fragment	No asbestos detected Organic fibres detected
28781-35-1	Springwood Cemetery – Shelter, Store and Toilet – Internal – Toilet – ceiling lining	17x12x4mm fibreboard fragment	No asbestos detected Organic fibres detected
28781-35-2	Springwood Cemetery – Shelter, Store and Toilet – Internal – Storeroom – ceiling lining	72x30x6mm fibreboard fragment	No asbestos detected Organic fibres detected

Photo 113: Asset D00151 – The Elise Langford Centre, Medlow Bath – asbestos cement sheet ceiling lining of toilet #1 (north).

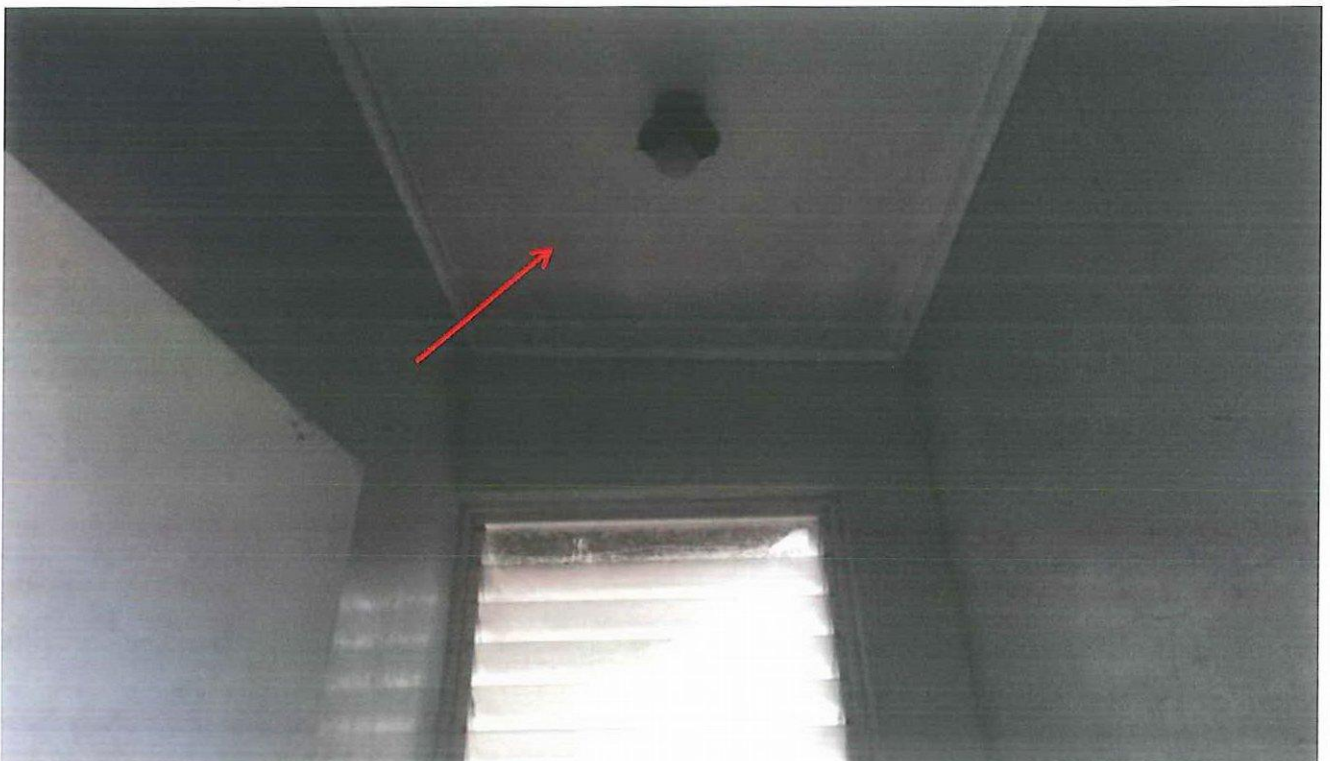
Photo 114: Asset D00151 – The Elise Langford Centre, Medlow Bath – asbestos cement sheet ceiling lining of toilet #2 (south).
