ASBESTOS REGISTER

FORMER LAWSON GOLF COURSE - CLUBHOUSE

**Project No.
28781**

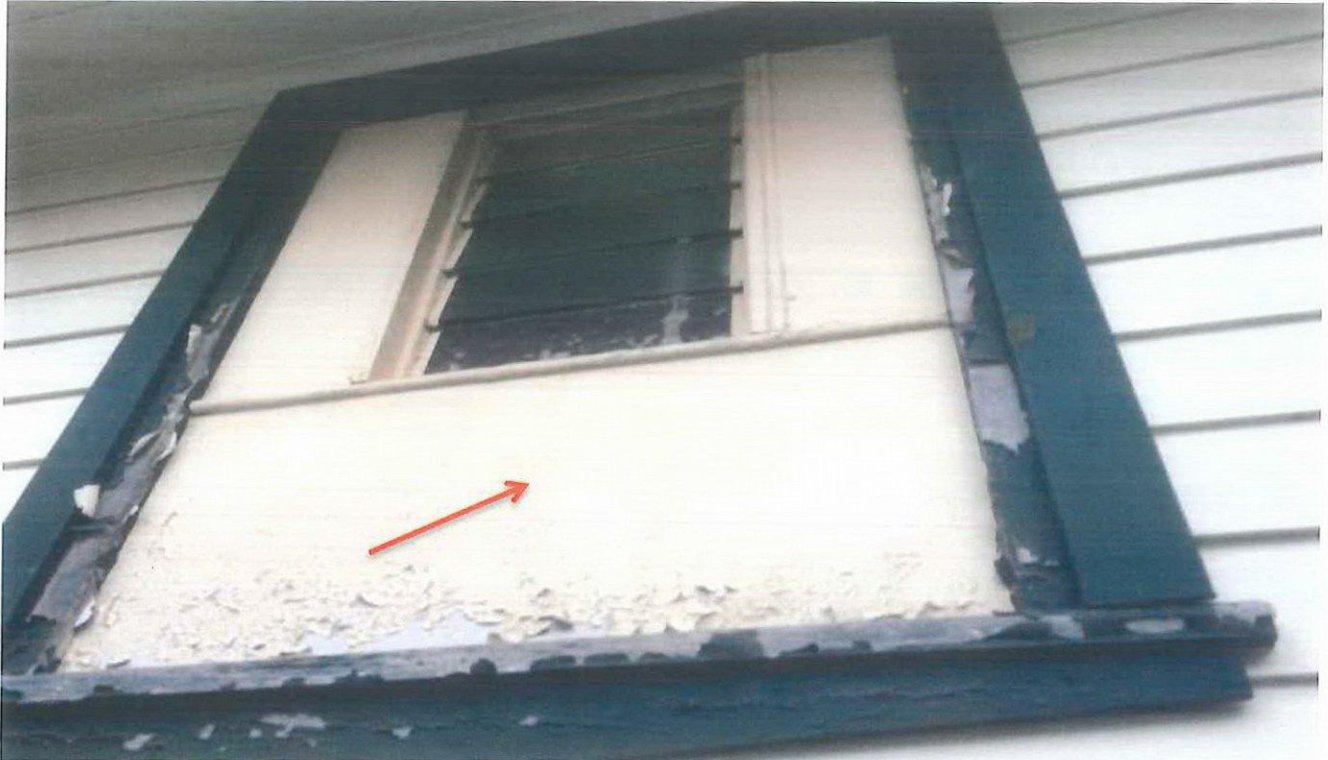
Location	Material	Sample ID	Sample Status	Photo No.	Asbestos Classification	Condition	Accessibility	Re-inspect	Current Label	Control Measure	Record of Works Undertaken
Asset D00040 – Former Lawson Golf Course – Clubhouse											
External											
Eave linings 2237	Fibrous cement sheeting	28781-28-1	Negative	-	-	-	-	-	-	-	-
Window Frames – mastic 2238	Mastic	28781-28-2	Negative	-	-	-	-	-	-	-	-
Northern Perimeter – Cool Room area – external wall panel 2239	Mastic	28781-28-3	Negative	-	-	-	-	-	-	-	-
Male Toilets – infill panel around eastern window 274	Fibrous cement sheeting	28781-28-4	Positive	91	Bonded	Stable	Medium	November 2020	Not labeled	4

Photo 91: Asset D00040 – Former Lawson Golf Course – Clubhouse – Male Toilets – asbestos cement sheet infill panel around eastern window.

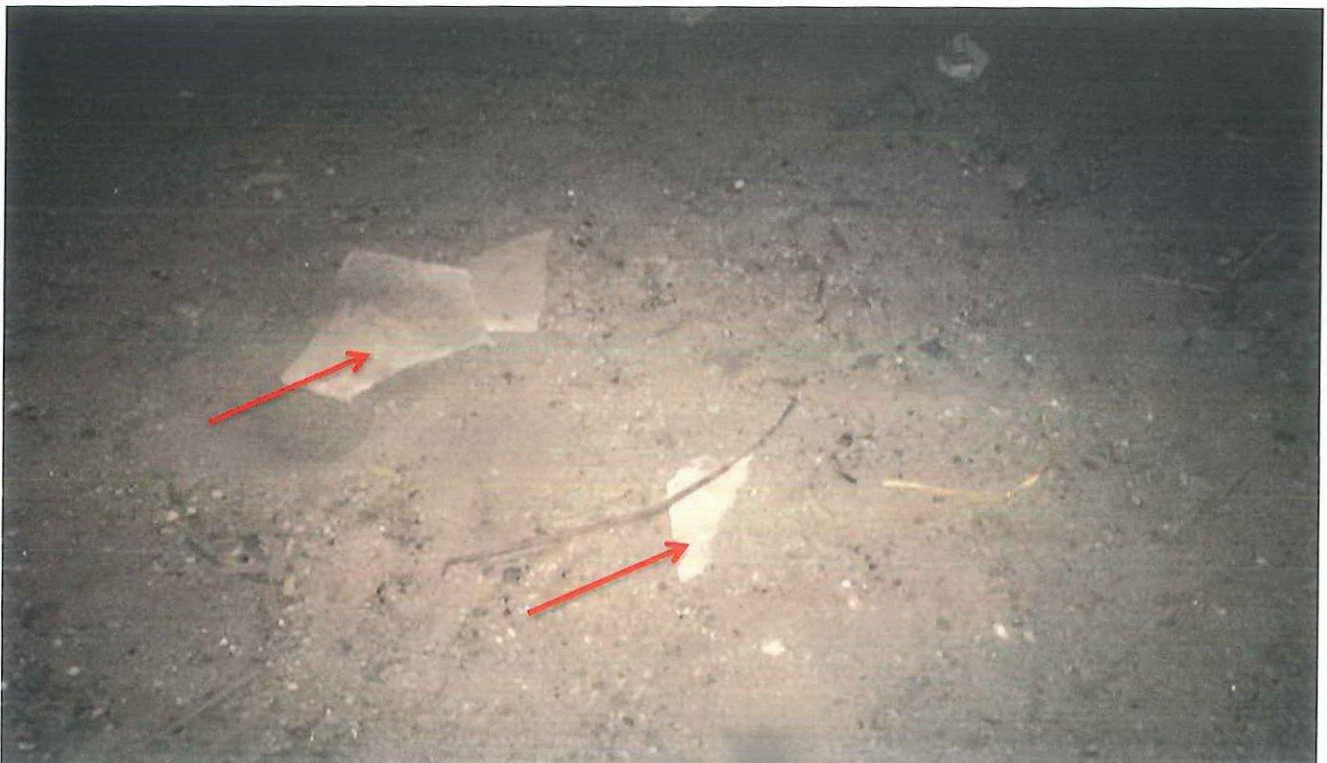
Location	Material	Sample ID	Sample Status	Photo No.	Asbestos Classification	Condition	Accessibility	Re-inspect	Current Label	Control Measure	Record of Works Undertaken
Sub-floor – debris on surface 275	Fibrous cement sheeting	Similar to 28781-28-4	Assumed Positive	92	Bonded	Stable	Medium	November 2020	Not labeled	4	
Southern Perimeter – Electrical Box – electrical backing board 2240	Timber	-	-	-	-	-	-	-	-	-	-
Internal											
North-eastern Room – man-hole cover 2241	Fibreboard	28781-28-5	Negative	-	-	-	-	-	-	-	-
Bar Area – linoleum 2242	Grey linoleum	Not suspect	-	-	-	-	-	-	-	-	-
Cool Room Area – internal wall panel 2243	Fibreboard	Similar to 28781-28-3	Assumed Negative	-	-	-	-	-	-	-	-
Female Change Rooms – throughout – lower internal wall cladding (tiled finish) 276	Fibrous cement sheeting	28781-28-6	Positive	93	Bonded	Stable	Medium	November 2020	Not labeled	4	
Female Change Rooms – toilet partition wall cladding and cover panels 277	Fibrous cement sheeting	28781-28-7	Positive	94	Bonded	Stable	Medium	November 2020	Not labeled	4

Photo 92: Asset D00040 – Former Lawson Golf Course – Clubhouse – Sub-floor – asbestos cement sheet debris.

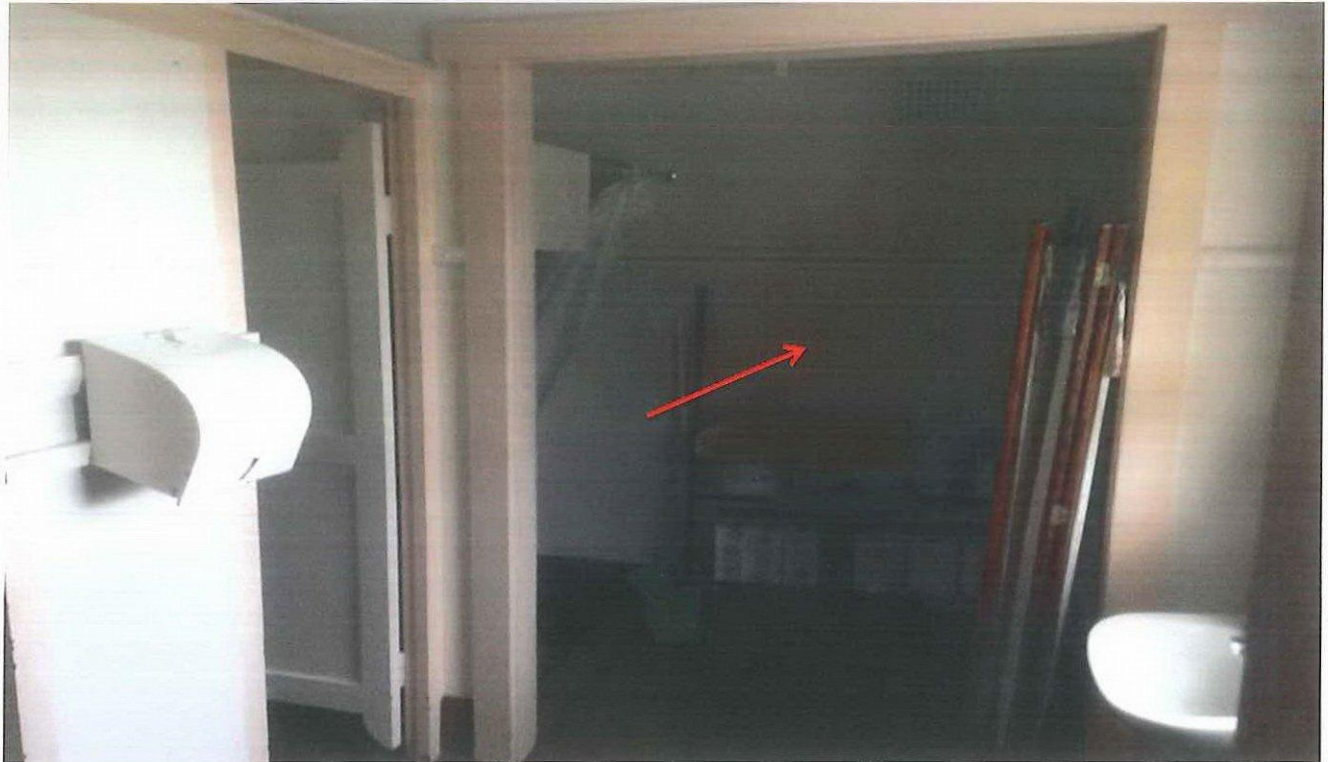
Photo 93: Asset D00040 – Former Lawson Golf Course – Clubhouse – Female Change Rooms – asbestos cement sheet lower internal wall cladding.

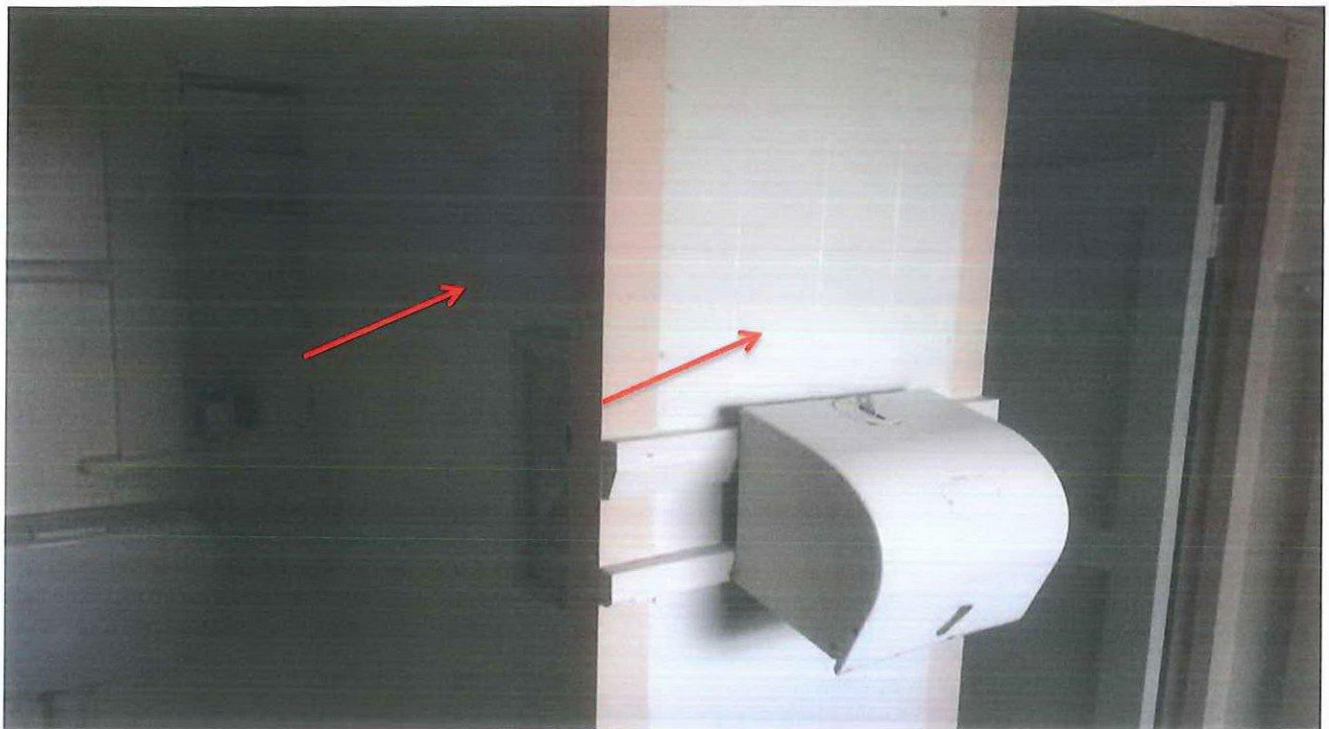
Photo 94: Asset D00040 – Former Lawson Golf Course – Clubhouse – Female Change Rooms – asbestos cement sheet toilet partition wall cladding and cover panels.

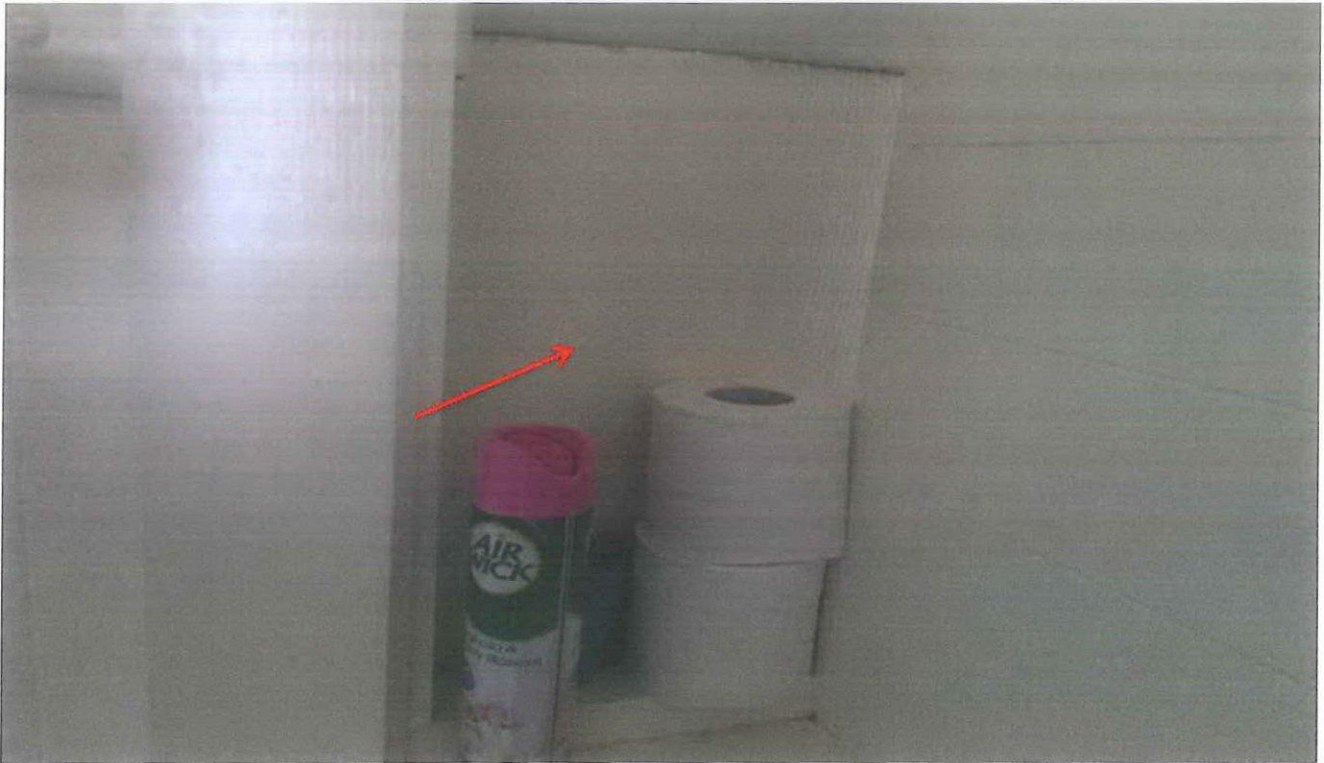
Location	Material	Sample ID	Sample Status	Photo No.	Asbestos Classification	Condition	Accessibility	Re-inspect	Current Label	Control Measure	Record of Works Undertaken
Female Change Rooms – western window in toilets – infill panel 278	Fibrous cement sheeting	Similar to 28781-28-7	Assumed Positive	95	Bonded	Stable	Medium	November 2020	Not labeled	4	
Male Change Rooms – Entrance – linoleum 224	Grey linoleum	-	-	-	-	-	-	-	-	-	-
Male Change Rooms – toilet area – internal wall cladding 279	Fibrous cement sheeting	28781-28-8	Positive	96	Bonded	Stable	Medium	November 2020	Not labeled	4	
Male Change Rooms – toilet area – toilet partition wall cladding and cover panels 280	Fibrous cement sheeting	28781-28-9	Positive	97	Bonded	Stable	Medium	November 2020	Not labeled	4	
Male Change Rooms – toilet area – Shower Area – ceiling lining 281	Fibrous cement sheeting	28781-28-10	Positive	98	Bonded	Stable	Low	November 2020	Not labeled	4

Photo 95: Asset D00040 – Former Lawson Golf Course – Clubhouse – Female Change Rooms – asbestos cement sheet infill panel in the western window.

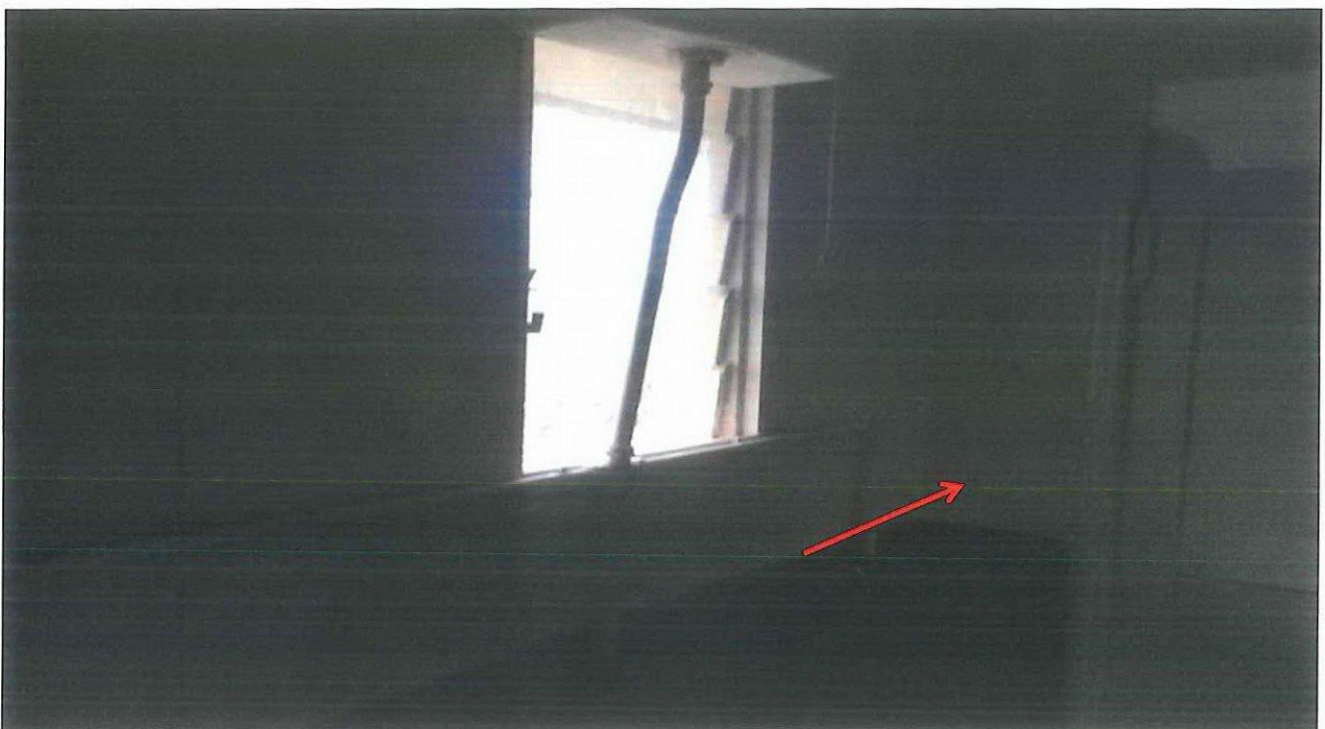
Photo 96: Asset D00040 – Former Lawson Golf Course – Clubhouse – Male Change Rooms – toilet area – asbestos cement sheet internal wall cladding.

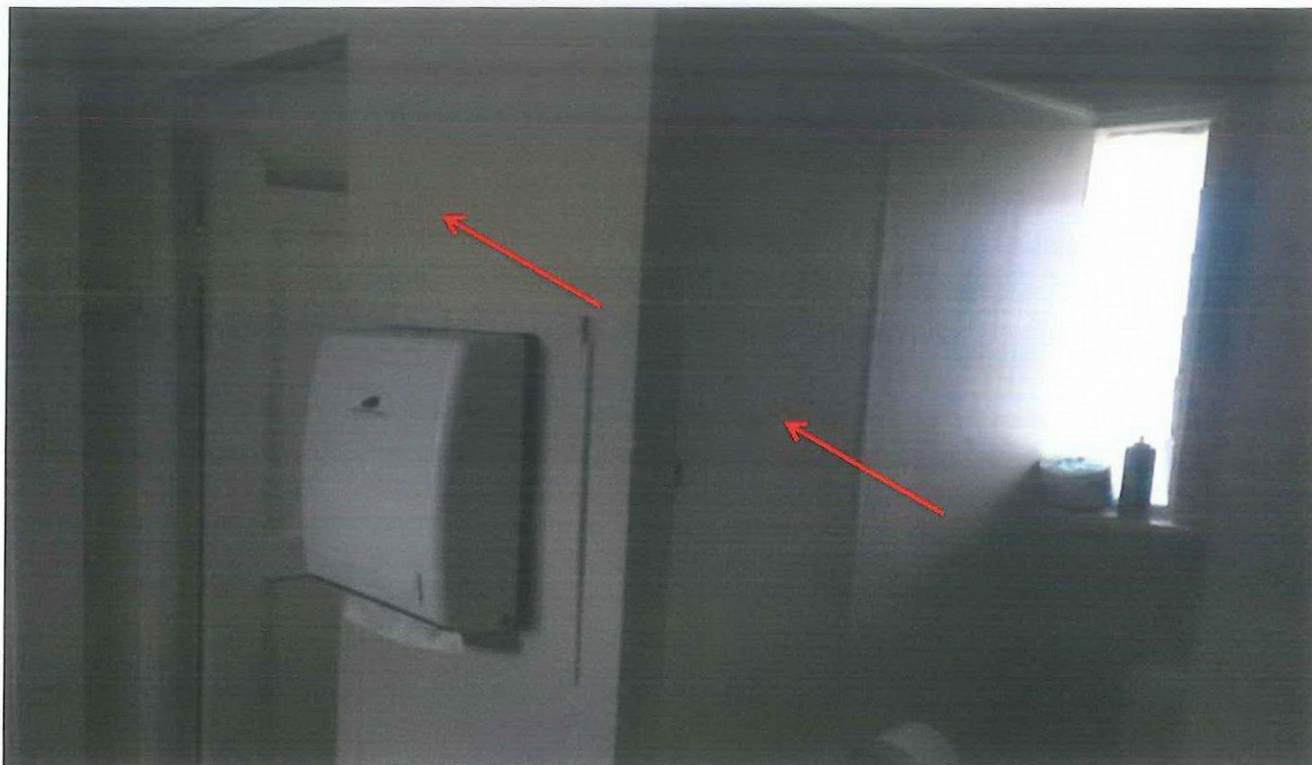
Photo 97: Asset D00040 – Former Lawson Golf Course – Clubhouse – Male Change Rooms – toilet area – asbestos cement sheet toilet partition wall cladding and cover panels.

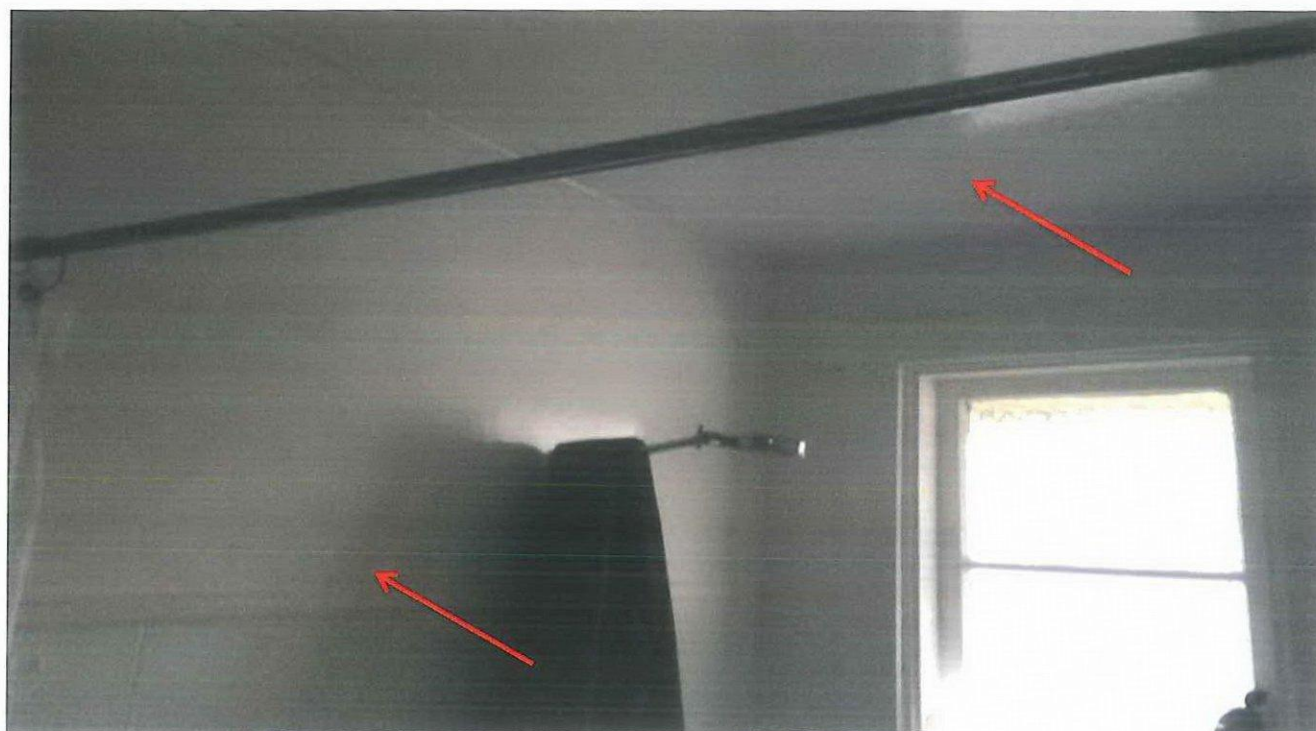
Male Change Rooms – toilet area – Shower Area – internal wall cladding 282	Fibrous cement sheeting	Similar to 28781-28-8	Assumed Positive	98	Bonded	Stable	Medium	November 2020	Not labeled	4	
Disabled Toilets – internal wall cladding 2245	Fibreboard	28781-28-11									
Lower Level Change Rooms – Southern Toilet – ceiling lining 283	Fibrous cement sheeting	28781-28-12	Positive	99	Bonded	Unstable, broken	Low	November 2016	Not labeled	3

Photo 98: Asset D00040 – Former Lawson Golf Course – Clubhouse – Male Change Rooms – Shower Area – asbestos cement sheet ceiling lining and internal wall cladding.

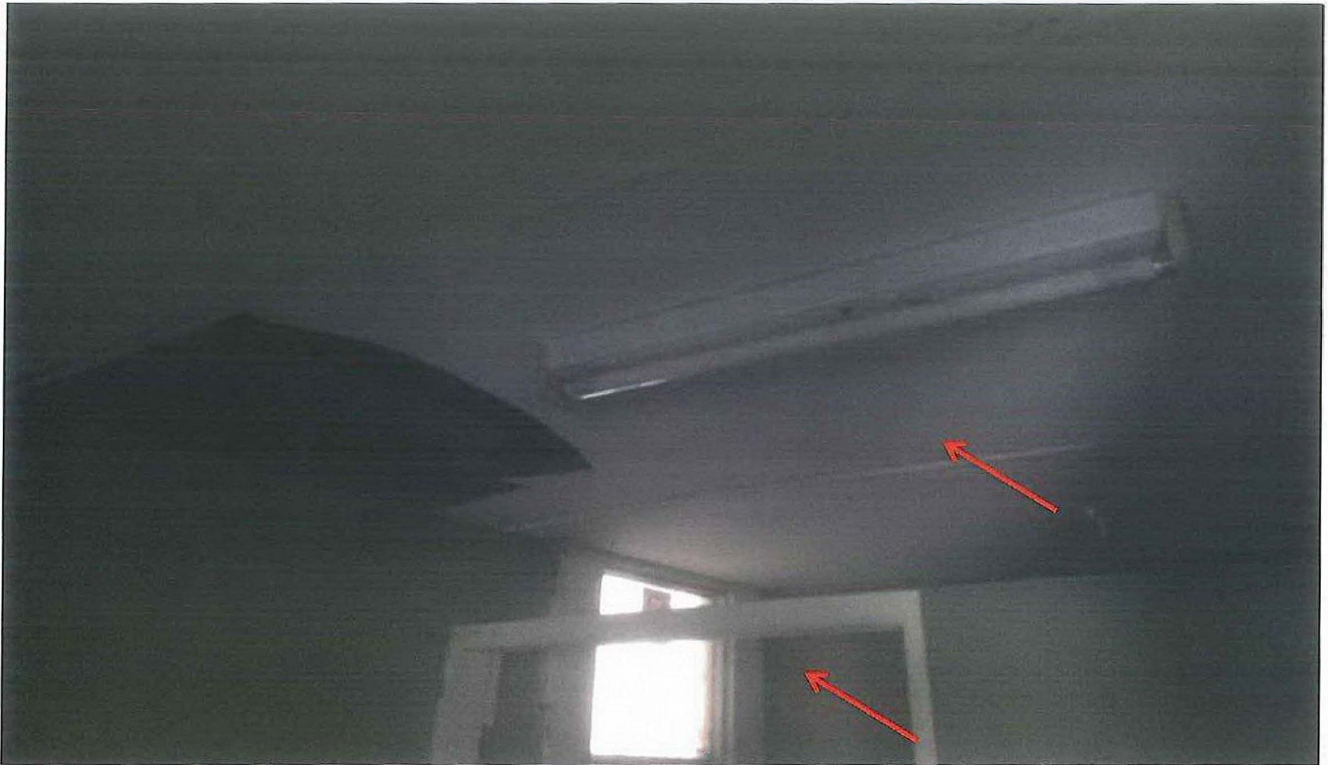
Location	Material	Sample ID	Sample Status	Photo No.	Asbestos Classification	Condition	Accessibility	Re-inspect	Current Label	Control Measure	Record of Works Undertaken
Lower Level Change rooms – Southern Toilet – upper internal wall cladding 284	Fibrous cement sheeting	28781-28-13	Positive	99	Bonded	Stable	Medium	November 2020	Not labeled	4

Photo 99: Asset D00040 – Former Lawson Golf Course – Clubhouse – Lower Level Change Rooms – Southern Toilet – asbestos cement sheet ceiling lining and upper internal wall cladding.
