**Katoomba Gully Cottage Building,
25-31 Catalina Avenue, KATOOMBA NSW 2780**

Asbestos Register and Management Plan

Asbestos Register

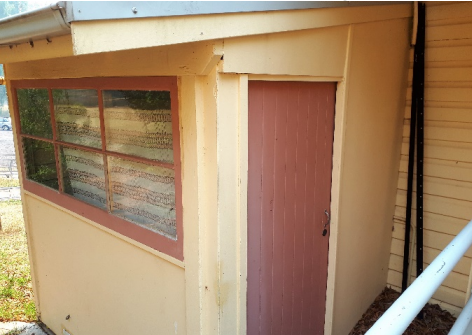
Ref No.	Date Identified	Clearance Cert Date	Onsite Register	Last Inspection Date	Next Inspection Date
	3033	19/12/2014		Yes	16-Dec-2019	16-Dec-2024
	Accessibility	Material	Extent	Result		
	Accessible	Fibreboard	4m2	Chrysotile and Crocidolite		
	Friability	Sealed / Surface Treatment	Risk Assessment	Control Actions	Labels Affixed	
	Non Friable	Sealed	RA04 - Very Low	No Remedial Action - Reinspect Periodically	No	
Specific Location						
The Gully - External Laundry External Wall Cladding						
Additional Comments						GPS Lat,Long
Sample No. 25132-50-1

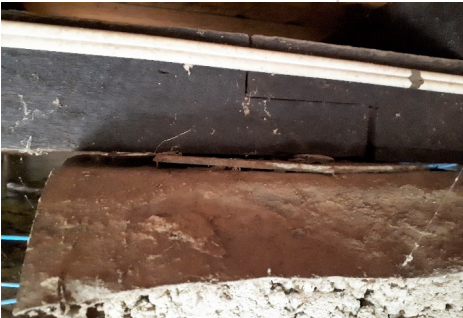
Ref No.	Date Identified	Clearance Cert Date	Onsite Register	Last Inspection Date	Next Inspection Date	
	3035	19/12/2014		Yes	16-Dec-2019	16-Dec-2024	
	Accessibility	Material	Extent	Result			
	Accessible	Fibrous cement sheeting	<1m2	Chrysotile and Crocidolite			
	Friability	Sealed / Surface Treatment	Risk Assessment	Control Actions	Labels Affixed		
	Non Friable	Unsealed	RA03 - Low	Remove During Refurb or Maintenance	No		
	Specific Location						
The Gully - External Sub-floor Packers within Structural Beams							
Additional Comments					GPS Lat,Long		
Sample No.25132-50-3

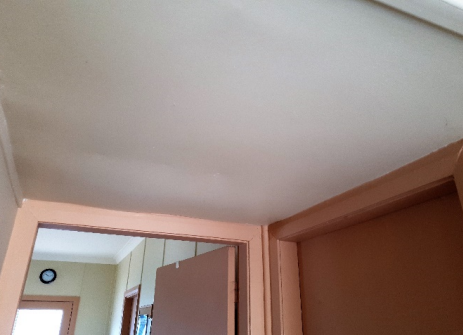
Ref No.	Date Identified	Clearance Cert Date	Onsite Register	Last Inspection Date	Next Inspection Date	
	3036	19/12/2014		Yes	16-Dec-2019	16-Dec-2024	
	Accessibility	Material	Extent	Result			
	Accessible	Fibrous cement sheeting	1m2	Assumed Positive			
	Friability	Sealed / Surface Treatment	Risk Assessment	Control Actions	Labels Affixed

Non Friable	Sealed	RA04 - Very Low	No Remedial Action - Reinspect Periodically	No		
	Specific Location						
The Gully - Internal Kitchen Walkway to Main Room Ceiling Panel							
Additional Comments					GPS Lat,Long		
Sample: Similar to 25132-50-4

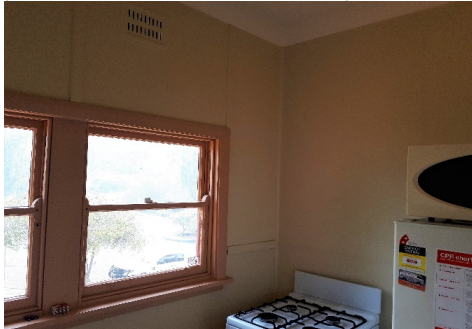
Ref No.	Date Identified	Clearance Cert Date	Onsite Register	Last Inspection Date	Next Inspection Date
3037	19/12/2014		Yes	16-Dec-2019	16-Dec-2024

Accessibility	Material	Extent	Result	
	Accessible	Fibrous cement sheeting	16m2	Chrysotile and Crocidolite	
	Friability	Sealed / Surface Treatment	Risk Assessment	Control Actions	Labels Affixed
	Non Friable	Sealed	RA04 - Very Low	No Remedial Action - Reinspect Periodically	No
	Specific Location				
The Gully - Internal Kitchen Wall Cladding					
Additional Comments					GPS Lat,Long
Sample No. 25132-50-4					
Ref No.	Date Identified	Clearance Cert Date	Onsite Register	Last Inspection Date	Next Inspection Date
3041	19/12/2014		Yes	16-Dec-2019	16-Dec-2024

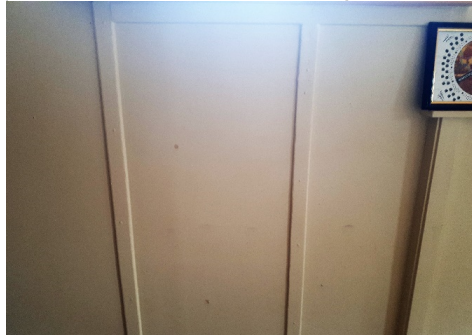
Accessibility	Material	Extent	Result	
	Accessible	Fibrous cement sheeting	<1m2	Assumed Positive	
	Friability	Sealed / Surface Treatment	Risk Assessment	Control Actions	Labels Affixed
	Non Friable	Sealed	RA04 - Very Low	No Remedial Action - Reinspect Periodically	No

Specific Location				
The Gully - Internal Wall Batons					
Additional Comments					GPS Lat,Long
Sample: Similar to 25132-50-6

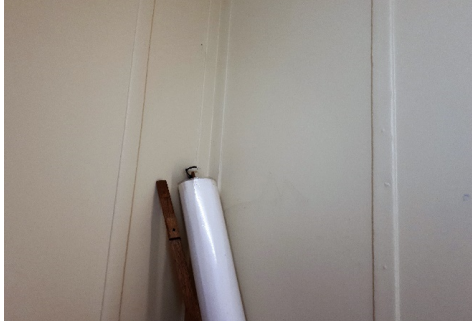
Ref No.	Date Identified	Clearance Cert Date	Onsite Register	Last Inspection Date	Next Inspection Date
	3043	19/12/2014		Yes	16-Dec-2019	16-Dec-2024

Accessibility	Material	Extent	Result		
	Accessible	Fibrous Cement Sheeting	<1m2	Chrysotile and Crocidolite		
	Friability	Sealed / Surface Treatment	Risk Assessment	Control Actions	Labels Affixed	
	Non Friable	Sealed	RA04 - Very Low	No Remedial Action - Reinspect Periodically	No	
Specific Location						
The Gully - Internal South-Eastern Storeroom Wall Batons						
Additional Comments						GPS Lat,Long
Sample No. 25132-50-6						
	Ref No.	Date Identified	Clearance Cert Date	Onsite Register	Last Inspection Date	Next Inspection Date
	3045	19/12/2014		Yes	16-Dec-2019	16-Dec-2024

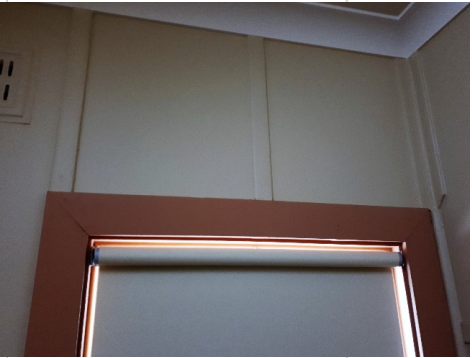
Accessibility	Material	Extent	Result		
	Accessible	Fibrous Cement Sheeting	<1m2	Chrysotile and Crocidolite		
	Friability	Sealed / Surface Treatment	Risk Assessment	Control Actions	Labels Affixed

Non Friable	Sealed	RA04 - Very Low	No Remedial Action - Reinspect Periodically	No	
Specific Location						
The Gully - Internal Southern Storeroom Wall Batons						
Additional Comments						GPS Lat,Long
Sample No. 25132-50-7
