ASBESTOS REGISTER

BLACKHEATH TENNIS CLUBHOUSE

**9-41 LEICHHARDT STREET,
BLACKHEATH**

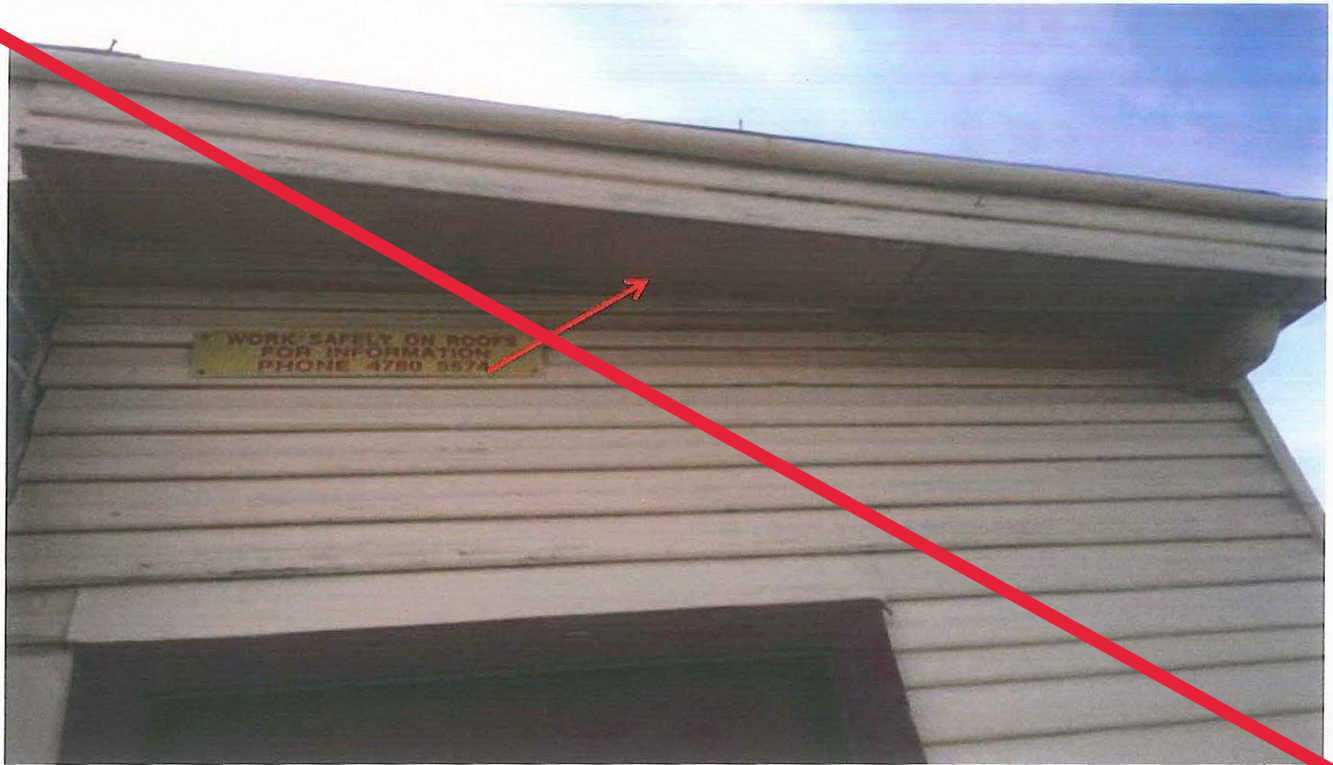
Location	Material	Sample ID	Sample Status	Photo No.	Asbestos Classification	Condition	Accessibility	Re-inspect	Current Label	Control Measure	Record of Works Undertaken
Asset D00153 – Jubilee Park, Blackheath – Tennis Clubhouse											
External											
Western Perimeter – eave lining 1042	Fibreboard	28781-1-1	Positive	1	Bonded	Stable	Low	November 2020	Not labeled	4	JMB CC 19/273232 Removed 26/11/2019
Eastern and Western Perimeters – Roof – flashing 1043	Fibrous cement sheeting	28781-1-2	Positive	2	Bonded	Stable	Low	November 2020	Not labeled	4	JMB CC 19/273232 Removed 26/11/2019

Photo 1: Asset D00153 – Jubilee Park, Blackheath – Tennis Clubhouse – western perimeter – fibreboard eave lining containing asbestos.

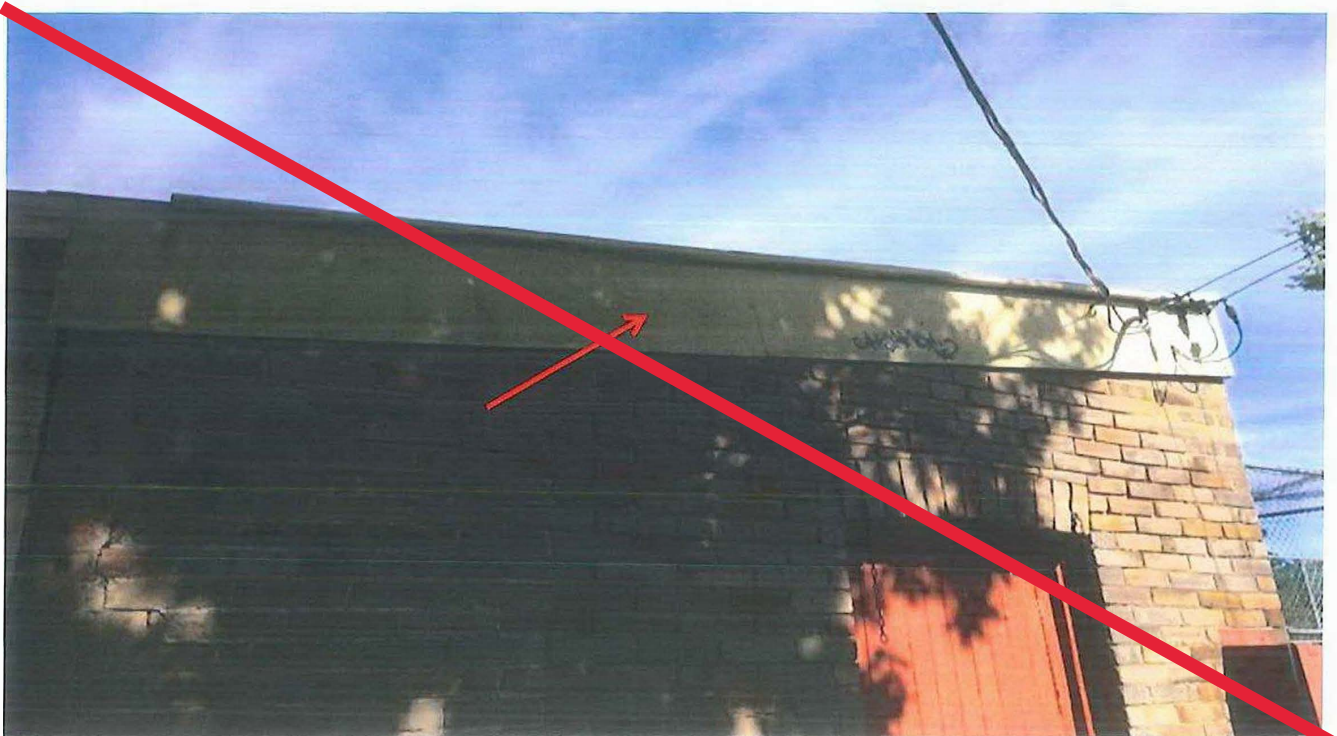
Photo 2: Asset D00153 – Jubilee Park, Blackheath – Tennis Clubhouse – eastern/western perimeter's – asbestos cement sheet flashing.

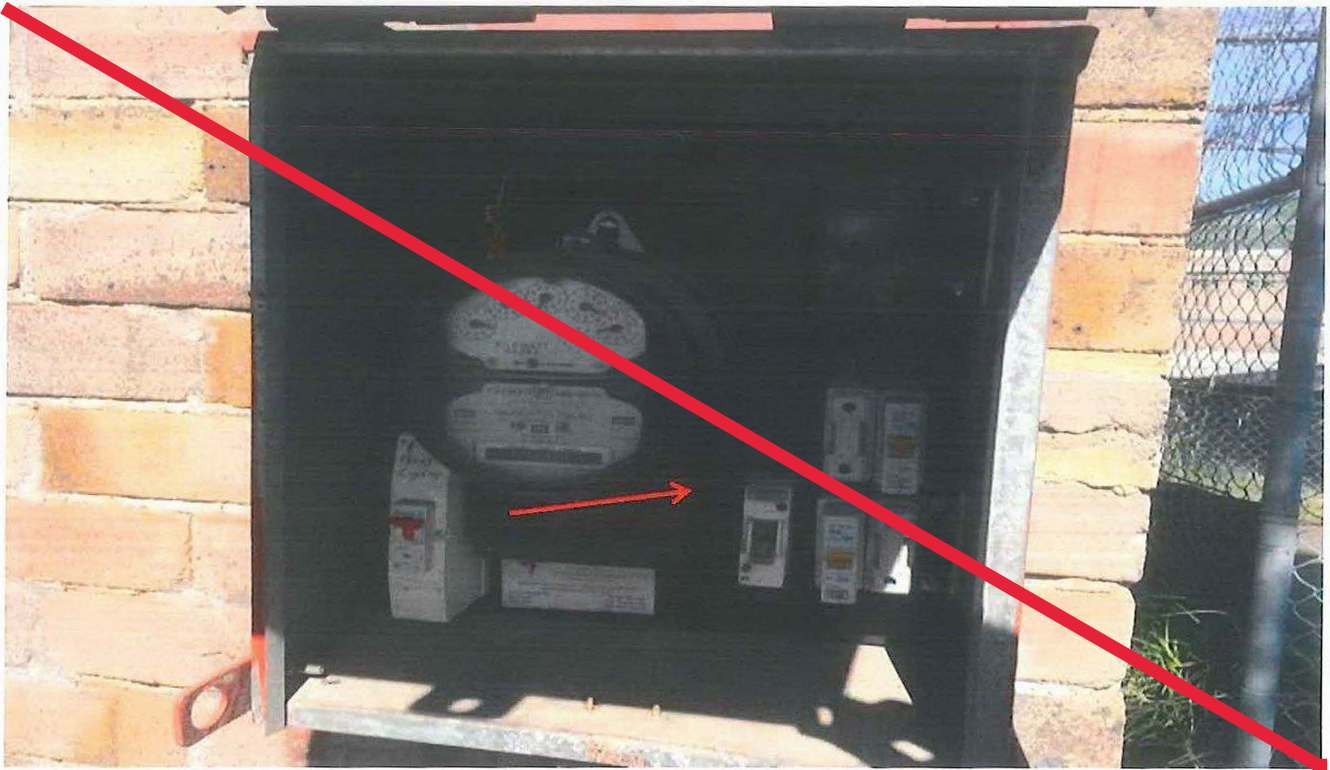
Location	Material	Sample ID	Sample Status	Photo No.	Asbestos Classification	Condition	Accessibility	Re-inspect	Current Label	Control Measure	Record of Works Undertaken
Eastern Perimeter – Electrical Box – electrical backing board 1044	Bituminous backing board	28781-1-3	Positive	3	Bonded	Stable	Medium	November 2020	Not labeled	4	JMB CC 19/273232 Removed 26/11/2019
Northern Perimeter – infill panel over doorway to storeroom 1046	Fibrous cement sheeting	28781-1-4	Positive	4	Bonded	Stable	Medium	November 2020	Not labeled	4	JMB CC 19/273232 Removed 26/11/2019
Northern Perimeter – ground surface – debris 1047	Fibrous cement sheeting	28781-1-5	Positive	5	Bonded	Unstable	High	November 2020	Not labeled	3	CC 27/6/2016 17/122587
Car Park – ground surface – debris *only 1 piece sighted; potential for more material beneath the surface 1050	Fibrous cement sheeting	28781-1-6	Positive	6	Bonded	Unstable	High	November 2020	Not labeled	3	CC 27/6/2016 17/122587

Photo 3: Asset D00153 – Jubilee Park, Blackheath – Tennis Clubhouse – eastern perimeter – bituminous electrical backing board containing asbestos.

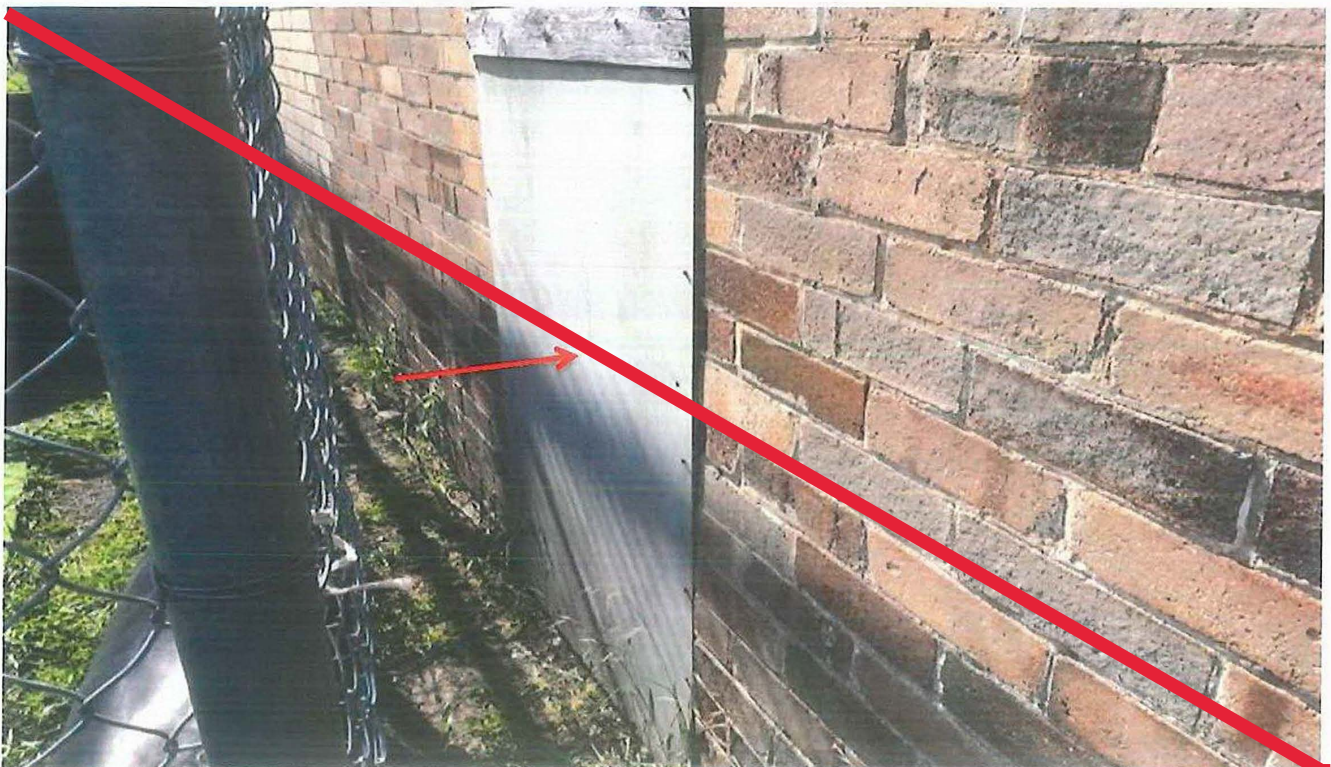
Photo 4: Asset D00153 – Jubilee Park, Blackheath – Tennis Clubhouse – northern perimeter – asbestos cement sheet infill panel over doorway.

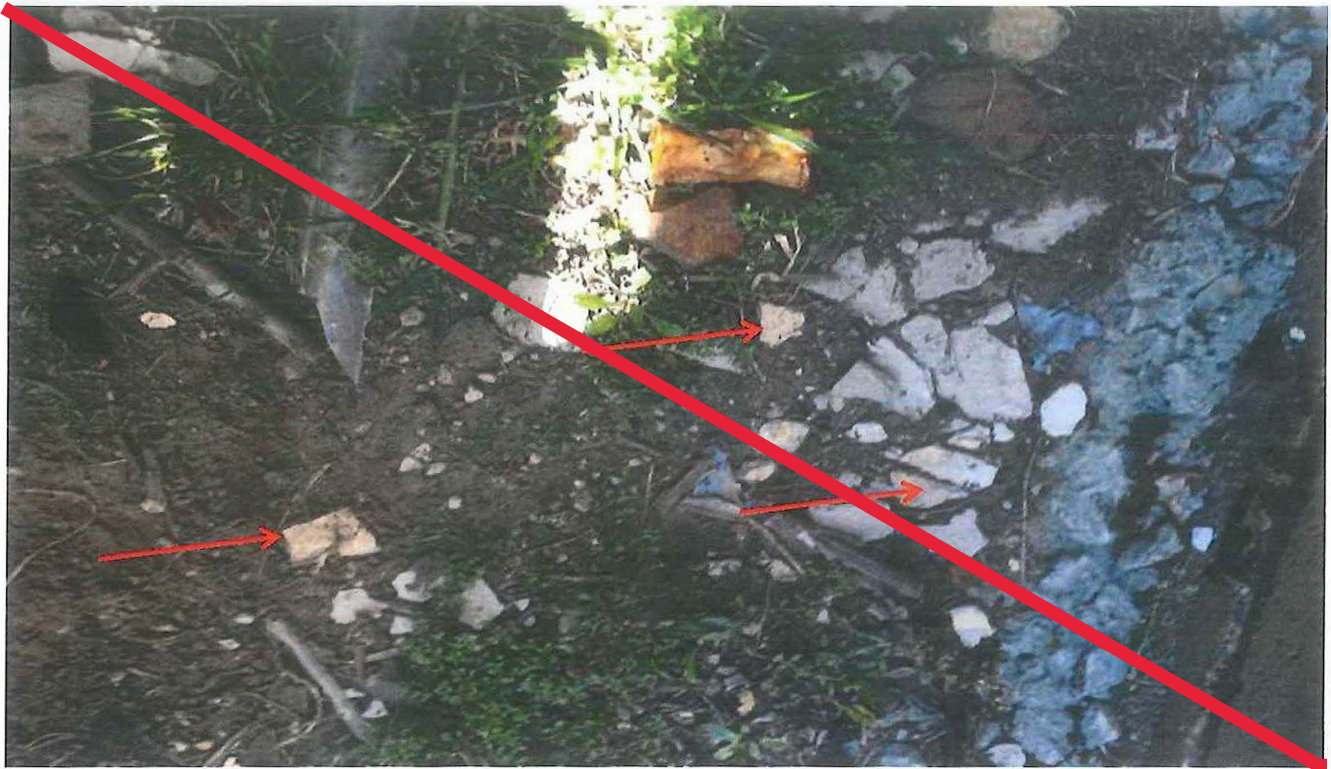
Photo 5: Asset D00153 – Jubilee Park, Blackheath – Tennis Clubhouse – northern perimeter – asbestos cement sheet debris.

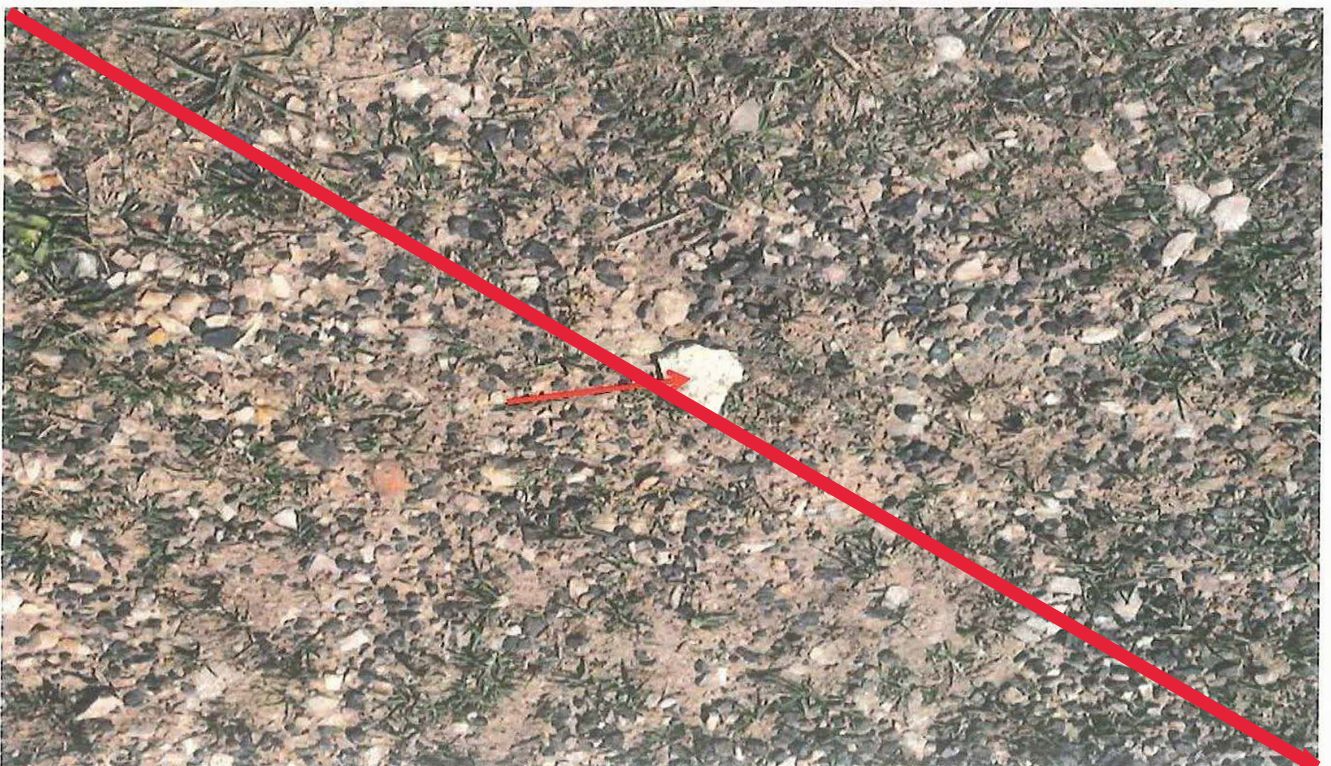
Photo 6: Asset D00153 – Jubilee Park, Blackheath – Tennis Clubhouse – carpark area – asbestos cement sheet debris.

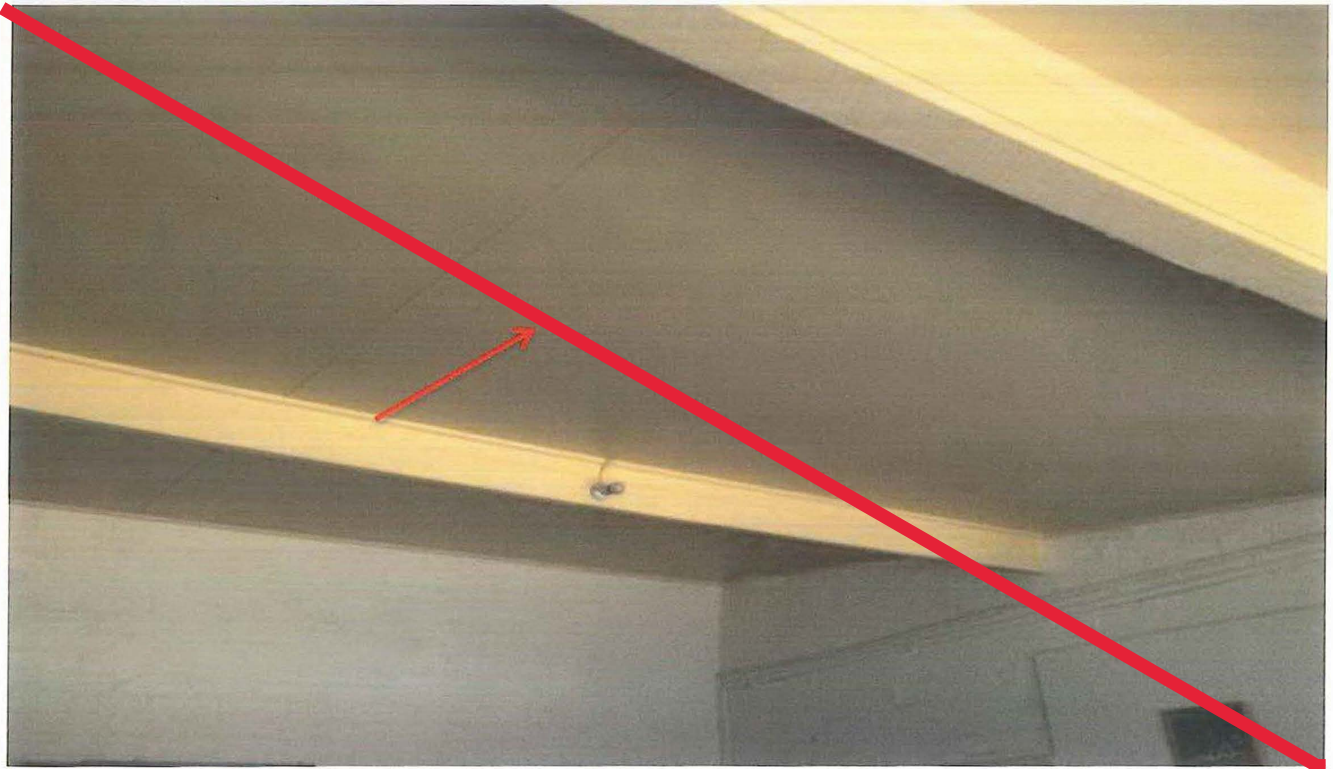
Internal											
Kitchen – ceiling lining 1055	Fibreboard	28781-1-7	Positive	7	Bonded	Stable	Low	November 2020	Not labeled	4	JMB CC 19/273232 Removed 26/11/2019
Kitchen – riser – external wall cladding 1058	Fibreboard	Similar to 28781-1-9	Assumed Positive	8	Bonded	Stable	Medium	November 2020	Not labeled	4	JMB CC 19/273232 Removed 26/11/2019

Photo 7: Asset D00153 – Jubilee Park, Blackheath – Tennis Clubhouse – kitchen – fibreboard ceiling lining containing asbestos.

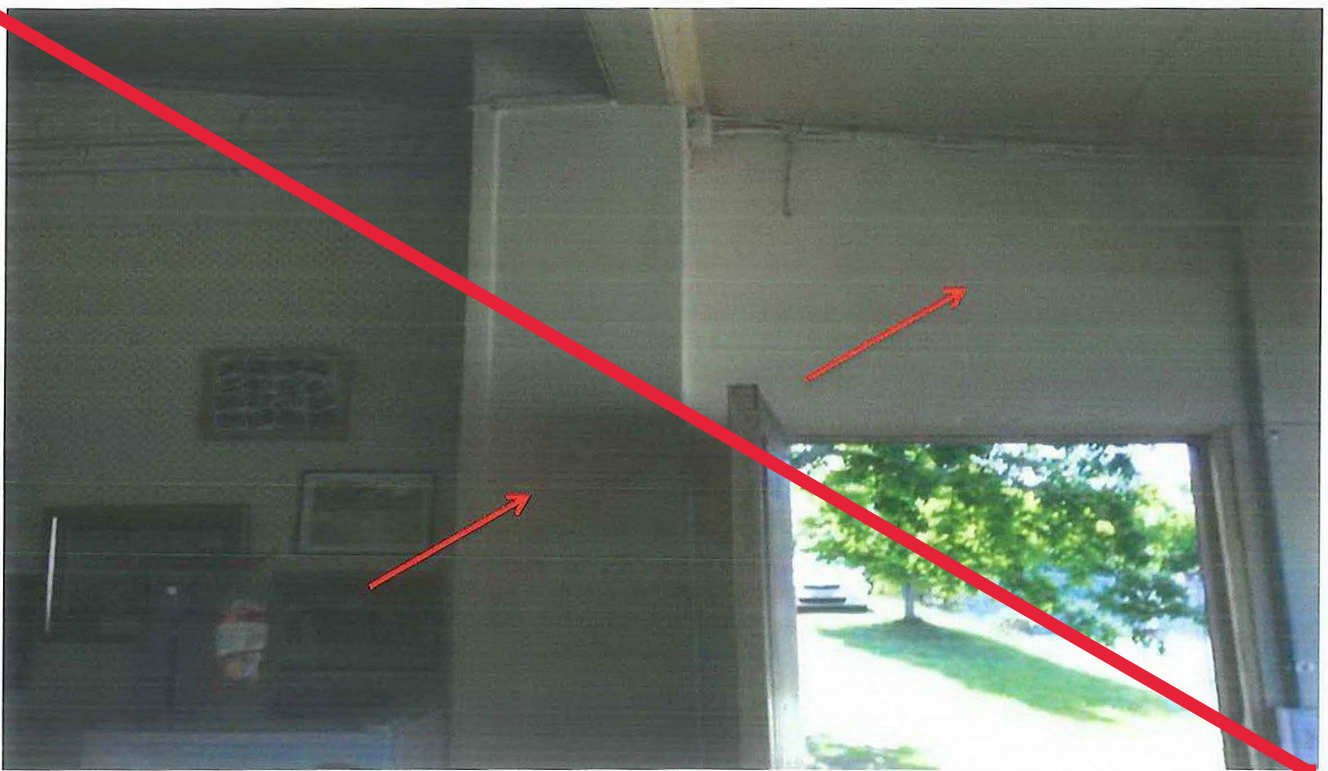
Photo 8: Asset D00153 – Jubilee Park, Blackheath – Tennis Clubhouse – kitchen and eastern entrance doorway – fibreboard containing asbestos riser covering and internal wall.

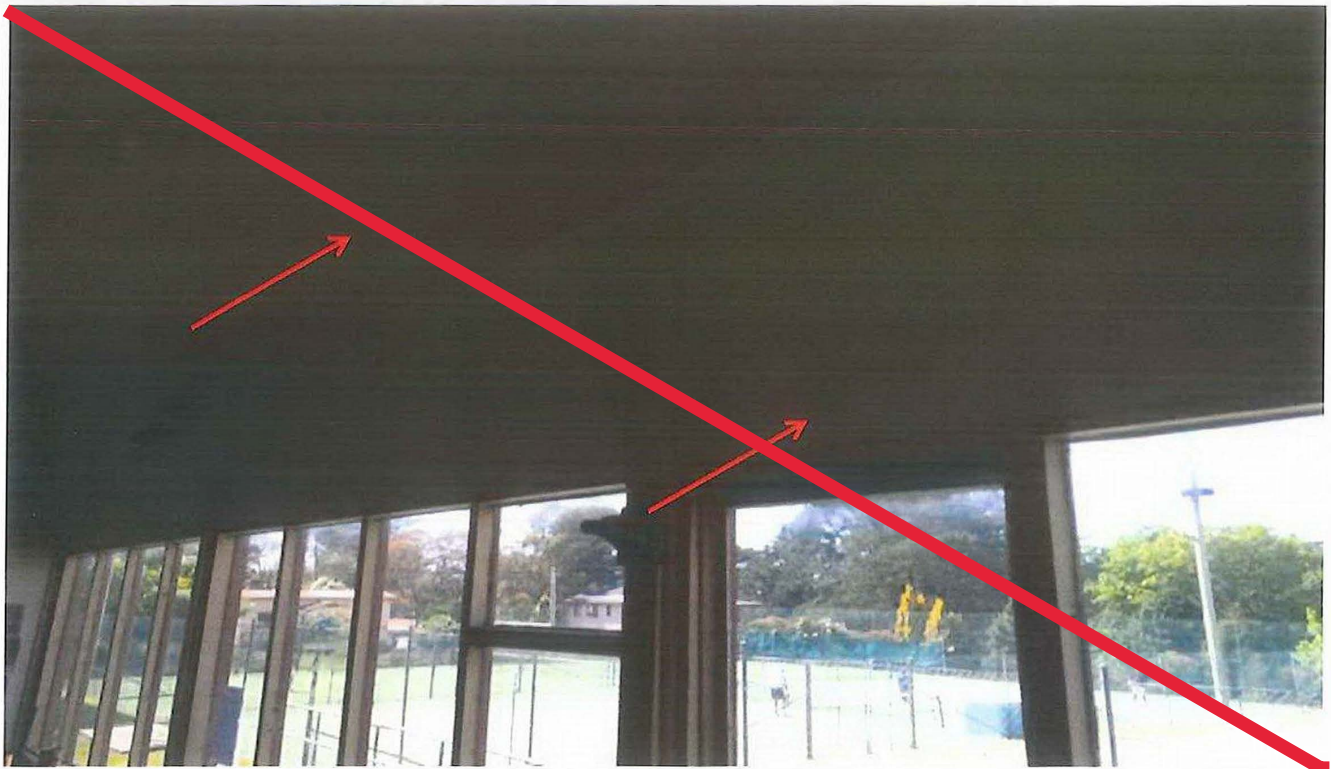
Location	Material	Sample ID	Sample Status	Photo No.	Asbestos Classification	Condition	Accessibility	Re-inspect	Current Label	Control Measure	Record of Works Undertaken
Main Room (sunroom) = ceiling lining 1061	Fibreboard	28781-1-8	Positive	9	Bonded	Stable	Low	November 2020	Not labeled	4	JMB CC 19/273232 Removed 26/11/2019
Main Room (sunroom) = eastern and western doorways = internal wall cladding 1062	Fibreboard	28781-1-9	Positive	8	Bonded	Stable	Medium	November 2020	Not labeled	4	JMB CC 19/273232 Removed 26/11/2019
Main Room (sunroom) = internal wall cladding above and below windows 1063	Fibreboard	28781-1-10	Positive	9	Bonded	Stable	Medium	November 2020	Not labeled	4	JMB CC 19/273232 Removed 26/11/2019
Storeroom = ceiling lining 1064	Fibreboard	28781-1-11	Negative		-	-	-	-	-	-	JMB CC 19/273232 Removed 26/11/2019

Photo 9: Asset D00153 – Jubilee Park, Blackheath – Tennis Clubhouse – main room (sunroom) – fibreboard containing asbestos ceiling lining and internal wall cladding above windows.

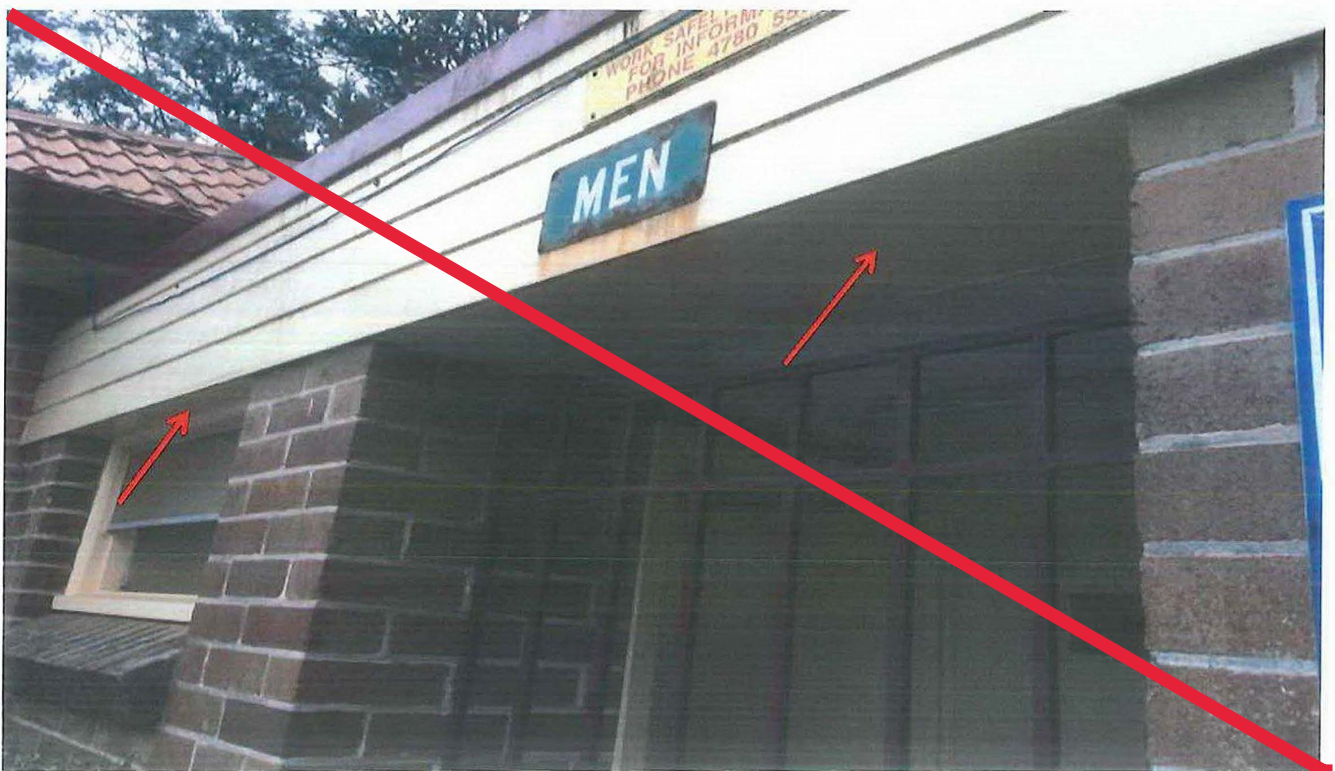
Photo 10: Asset E00544 – Blackheath Pool – Amenities Block – asbestos cement sheet eave linings and panels above the windows of the Male Changerooms and Toilets.
