ASBESTOS REGISTER

KATOOMBA TROTting PAVILION

6 ORIENT STREET, KATOOMBA

3.1.25 Asset D00099 – Trotting Pavilion – Katoomba Men’s Shed

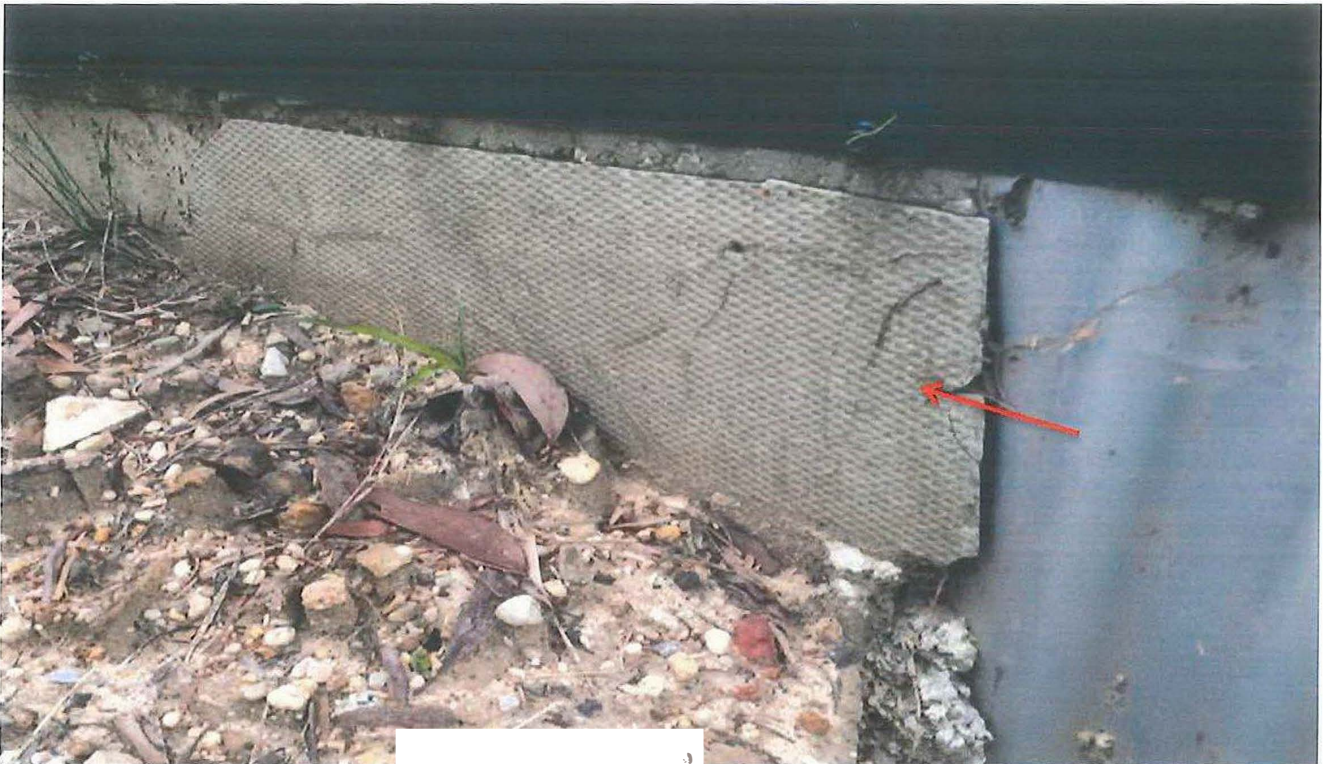
Location	Material	Sample ID	Sample Status	Photo No.	Asbestos Classification	Condition	Accessibility	Re-inspect	Current Label	Control Measure	Record of Works Undertaken
Asset D00099 – Trotting Pavilion – Katoomba Men’s Shed											
External											
Northern Perimeter – Garage Area – east – formwork on concrete slab 3301	Fibrous cement sheeting	28781-25-1	Positive	85	Bonded	Unstable	High	November 2020	Not labeled	3	Cleared 27/7/17-17/154687
Internal											
Western/Eastern – gable ends 3300	Fibreboard	28781-25-2	Negative	-	-	-	-	-	-	-	-

Photo 85: Asset D00099 – Trotting Pavilion – Katoomba Men's Shed– Garage Area asbestos cement sheeting on the eastern perimeter of the concrete slab.
