# Asbestos Register Resurvey Report

## Asbestos Register Condition Inspection

<b>Asset Name:</b>	Glenbrook Early Childhood Centre	<b>Date:</b>	13-3-19	<b>RAR No:</b>	RAR-14
<b>Asset Address:</b>	30 Park Street Glenbrook	<b>Inspection Carried Out By:</b>	Brian Ashton	<b>HPE No:</b>	19/84765
<b>Are Staff/PCBU aware that there is ACM onsite?</b>		Yes			
<b>Is there a copy of the Asbestos Register for this location onsite?</b>		Yes			
<b>Is there a copy of the Asbestos Management Plan for this location onsite?</b>		Yes

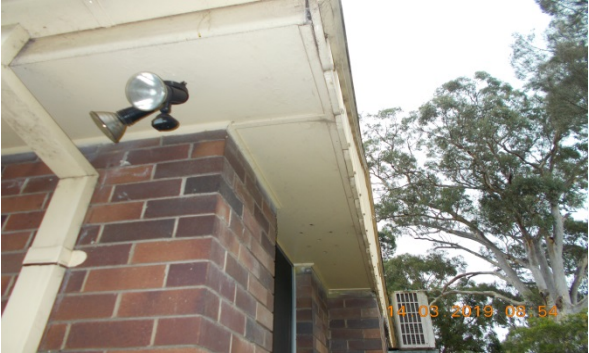
Reference Number Int / Ext Floor Specific Location	Photographs
1453 External Eave Lining

21880-46	Glenbrook Early Childhood Centre – External – eave linings	3x2x1mm fibrous cement sheet fragment	Chrysotile asbestos detected
21880-47	Glenbrook Early Childhood Centre – External – cloaked verges of roof – weather strips	12x5x2mm fibreboard fragment	No asbestos detected [Organic fibres detected]
21880-48	Glenbrook Early Childhood Centre – External – window frames – window putty	5x4x2mm mastic fragment	No asbestos detected
21880-49	Glenbrook Early Childhood Centre – Internal – linoleum throughout	25x14x4mm green vinyl sheet and fibrous underlay fragment	No asbestos detected [Organic fibres detected]
21880-50	Glenbrook Early Childhood Centre – Internal – Toilet – ceiling lining	5x4x2mm fibreboard fragment	No asbestos detected [Organic fibres detected]
21880-51	Glenbrook Early Childhood Centre – Internal – Wash Room adjacent Toilet – ceiling lining	5x2x1mm fibrous cement sheet fragment	Chrysotile asbestos detected

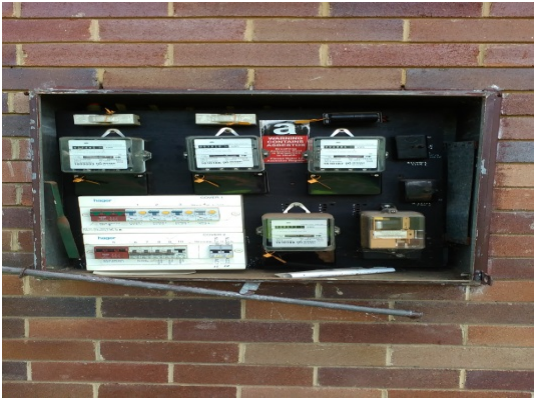
2870 External Western Electrical Box Backing Board

2870	Assumed positive	External Western Electrical Box Backing Board	Bituminous	0.5m2	Assumed Positive	1 Non- accessible	1 Good	1 Non- Friable	1 Sealed	4 Very Low	A4	Yes		12 Months
1458	21880-49	Internal Green Linoleum	Fibrous Backing		Negative						A5			
1460	No Sample Taken	Internal Kitchen, Blue Linoleum	Fibrous Backing		Not Suspect						A5			
1461	21880-50	Internal Toilet Ceiling Lining	Fibreboard		Negative						A5			
1815	21880-51	Internal Washroom Ceiling Lining	Fibrous Cement Sheeting	2m2	Positive	1 Non- accessible	1 Good	1 Non- Friable	1 Sealed	4 Very Low	A4	No		12 months
2871	No Sample Taken	Internal Ceiling Space			No Suspect Material sighted						A5			
2872	No Sample Taken	Internal Ceiling Throughout	Plasterboard		Not Suspect						A5			
2873	No Sample Taken	Internal Sub-Floor			No Suspect Material Sighted						A5
