# Asbestos Register

## **Resurvey Report**

<b>Asset Name:</b>	Winmalee Neighbourhood Centre	<b>Date:</b>	29/03/2019	<b>RAR No:</b>	RAR-62
<b>Asset Address:</b>	62 White Cross Road, Winmalee	<b>Inspection Carried Out By:</b>	Brian Ashton	<b>HPE No:</b>	19/84833
<b>Are Staff/PCBU aware that there is ACM onsite?</b>		Yes			
<b>Is there a copy of the Asbestos Register for this location onsite?</b>		Yes			
<b>Is there a copy of the Asbestos Management Plan for this location onsite?</b>		Yes

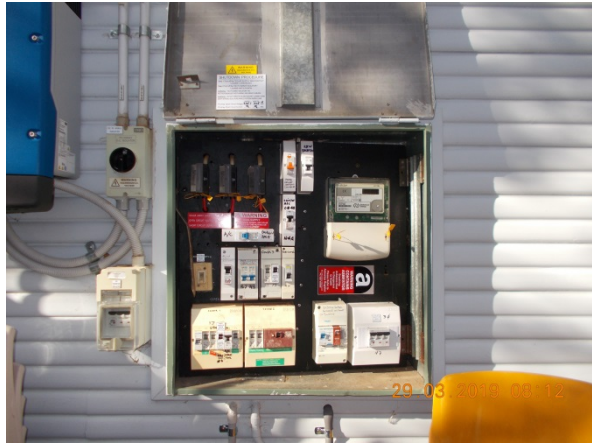
336	21880-188	External – Western Perimeter Electrical Box Electrical Backing Board	Bituminous	0.5m2	Positive	1 Non-Accessible	1 Good	1 Non-Friable	1 Sealed	4 Very Low	A4	Yes		12 Months
972	21880-189	External – Main Entrance Disabled Ramp Compressed Flooring	Fibreboard		Negative						A5			
973	21880-190	Internal – Ceiling Space Boiler Internal Insulation	Fibrous Insulation		Negative						A5			
337	21880-191	Internal – Kitchen Ceiling Lining (above Gyprock Lining)	Fibre Cement Sheeting	10m2	Positive	1 Non-Accessible	1 Good	1 Non-Friable	1 Sealed	4 Very Low	A4	Yes		12 Months
2987	Not Suspect	Internal – Kitchen Linoleum	Green Linoleum		Negative						A5			
2988	21880-192	Internal – Toilet Internal Wall Cladding	Fibreboard		Negative						A5			
2989	Similar to 21880-192	Internal – Wash Area Internal Wall Cladding	Fibreboard	16m2	Assumed Negative						A5			
2990	Similar to 21880-192	Internal – Disabled Toilet Internal Wall Cladding	Fibreboard	13m2	Assumed Negative						A5

336  
External  
Western Perimeter  
Electrical Box  
Electrical Backing Board

Sample No	Location/Reference	Sample Description	Asbestos ID - Material
21880-188	Winmalee Neighbourhood Centre – External – Western Perimeter – Electrical Box – electrical backing board	2x1x1mm bituminous backing board fragment	Chrysotile asbestos detected
21880-189	Winmalee Neighbourhood Centre – External – Main Entrance – disabled ramp – compressed flooring	17x13x1mm fibreboard fragment	No asbestos detected [Organic fibres detected]
21880-190	Winmalee Neighbourhood Centre – Internal – Ceiling Space – Boiler – internal insulation	8x4x1mm fibrous insulation fragment	No asbestos detected [Synthetic mineral fibres detected]
21880-191	Winmalee Neighbourhood Centre – Internal – Kitchen – ceiling lining (above Gyprock lining)	24x13x2mm fibrous cement sheet fragment	Chrysotile asbestos detected Crocidolite asbestos detected
21880-192	Winmalee Neighbourhood Centre – Internal – Toilet – internal wall cladding	14x7x2mm fibreboard fragment	No asbestos detected [Organic fibres detected]

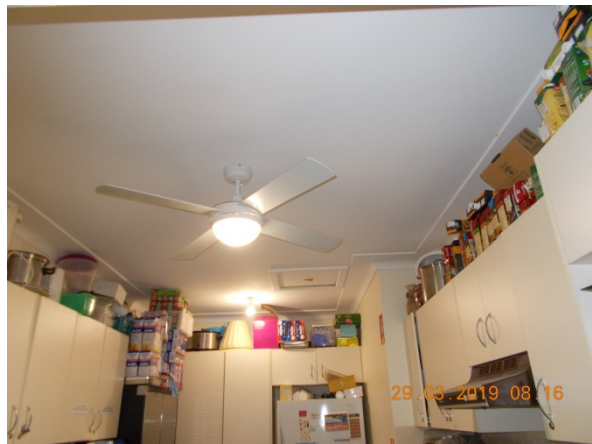
337  
Internal  
Kitchen  
Ceiling Lining  
(Above Gyprock Lining)
