Toilet Block - Reservoir Park

# **Asbestos/Lead Register & Management Plan**

Blue Mountains City Council conducted Hazardous Materials Management Register for the workplace located at 178 Rusden Road Mount Riverview NSW 2774.

The inspection was conducted on 21/09/2022, and the following items were identified:

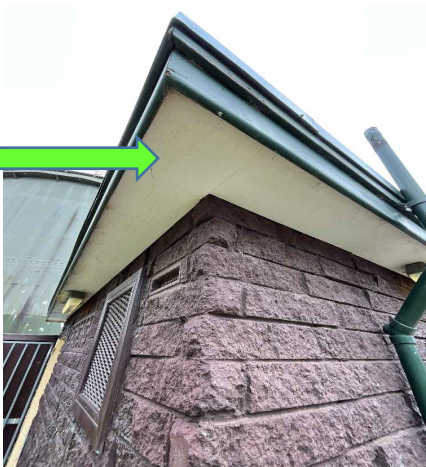
External, GF, Exterior, Eaves - Fibreboard, No Asbestos Detected, Similar to 37272-77 - Assumed negative

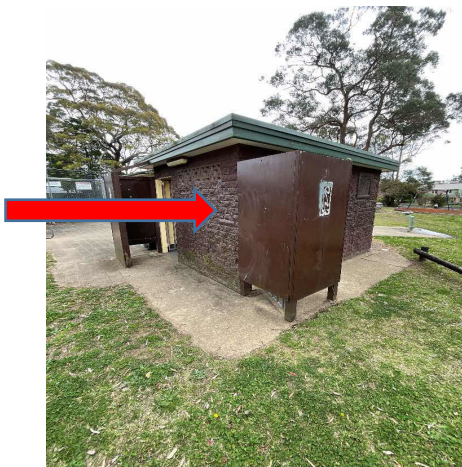
External / GF / Walls

Lead Paint - Brown Topcoat

Low

External, GF, Exterior, Walls - Brown - Topcoat, Lead Detected (1.0%w/w), 432937/LP02

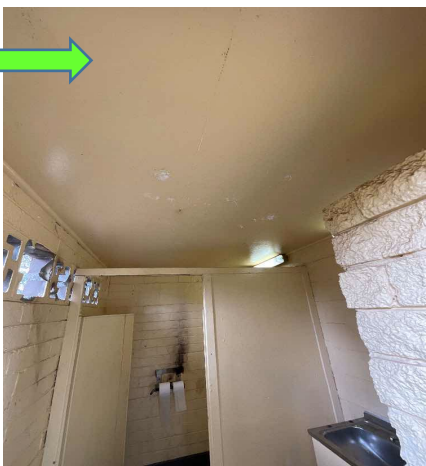
Internal, GF, Men's Bathroom, Ceiling Lining - Fibreboard, No Asbestos identified, 37272-77

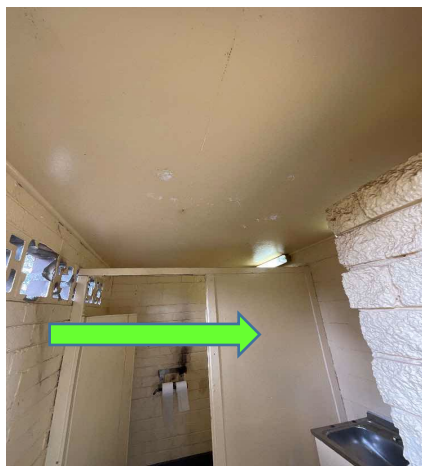
Internal, GF, Men's Bathroom, Wall Lining - Fibreboard, Assumed Negative, Similar to 37272-77 - Assumed Negative

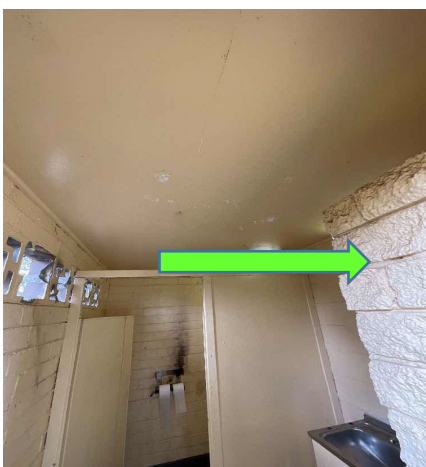
Internal, GF, Throughout, Walls throughout - Yellow - Topcoat, Lead Not Detected (<0.001%w/w), 432937/LP01

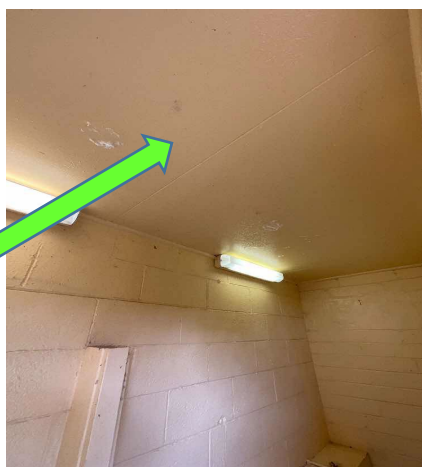
Internal, GF, Women's Bathroom, Ceiling Lining - Fibreboard, Assumed Negative, Similar to 37272-77 - Assumed Negative
