## ASBESTOS REGISTER

KATOOMBA FALLS CARAVAN PARK  
STORAGE SHED/BATHROOMS &  
CAMP KITCHEN

101 CLIFF DRIVE KATOOMBA

## **ASBESTOS REGISTER**

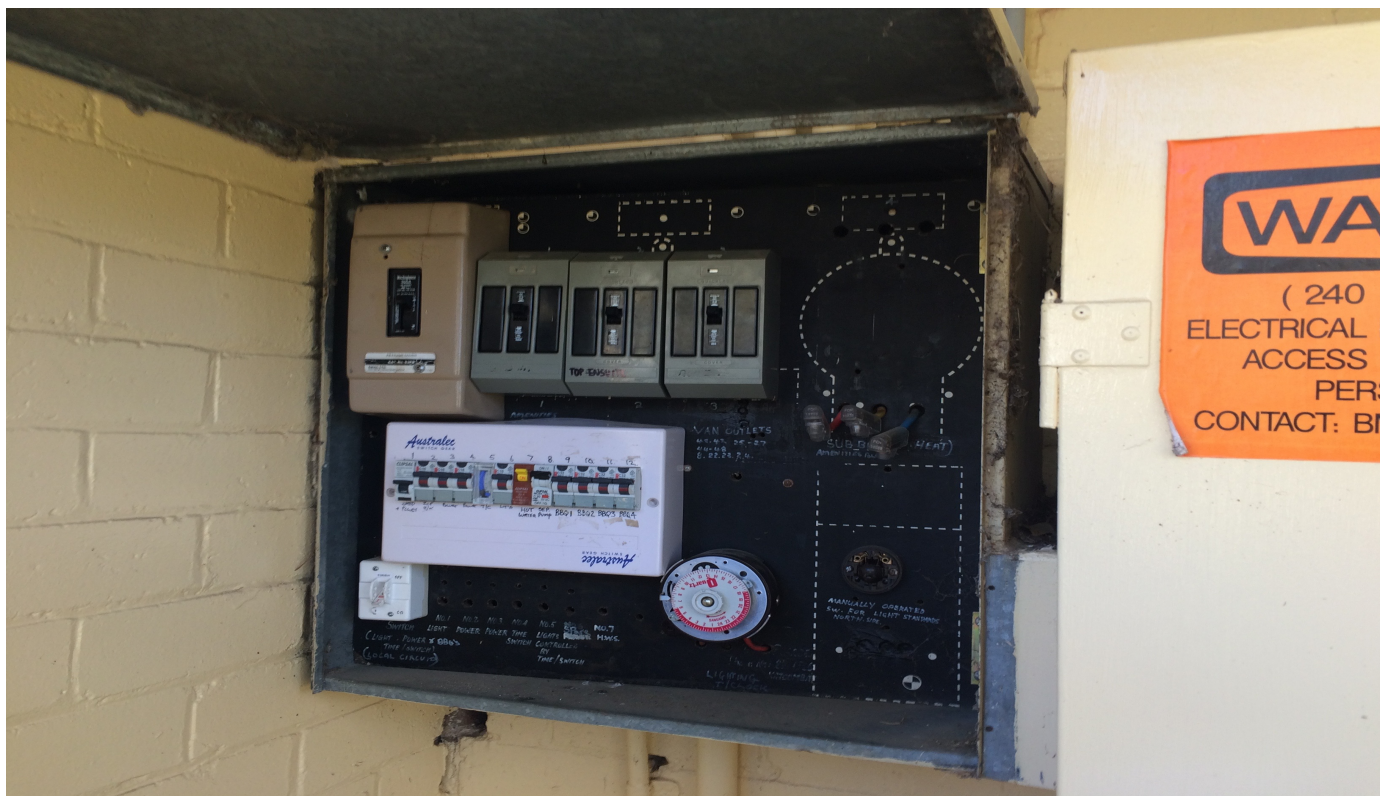
**Photo 13:** Asset E00479 – Camp Kitchen/ Recreation Room - Katoomba Falls Caravan Park – 101B Cliff Drive, Katoomba - Switchboard – Electrical backing board.
