# **Asbestos Register**

# **Management Plan**

The site is located: 36-38 Glenwattle Close Katoomba

## 5. Asbestos Register

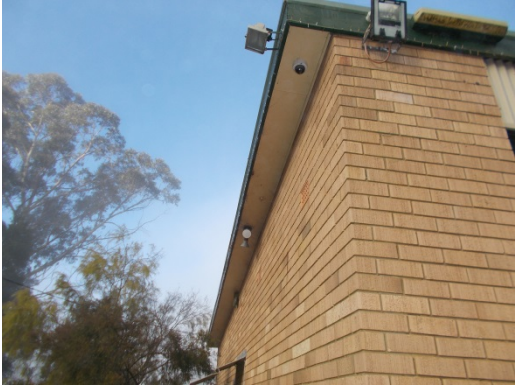
Reference Number Int / Ext Floor Specific Location	Photographs
1671 External Main Structure Eave Lining

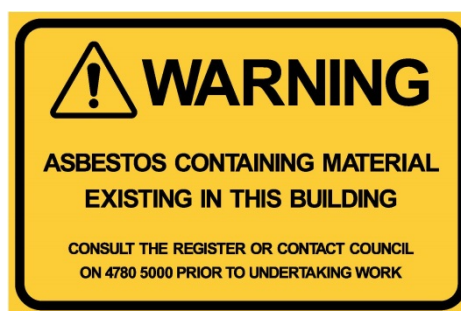
NSW Work Health and Safety Regulation 2017 R422, R424, R427 and R429 requires that the person with the management control of the workplace to identify asbestos containing materials and the asbestos material that has been identified to date must be labelled and ensure that it complies with the Australian Standard 1319: Safety Signs for the Occupational Environment; signage should be similar to the label detailed below.

Signage should also be placed at the entry points to the building/plant.

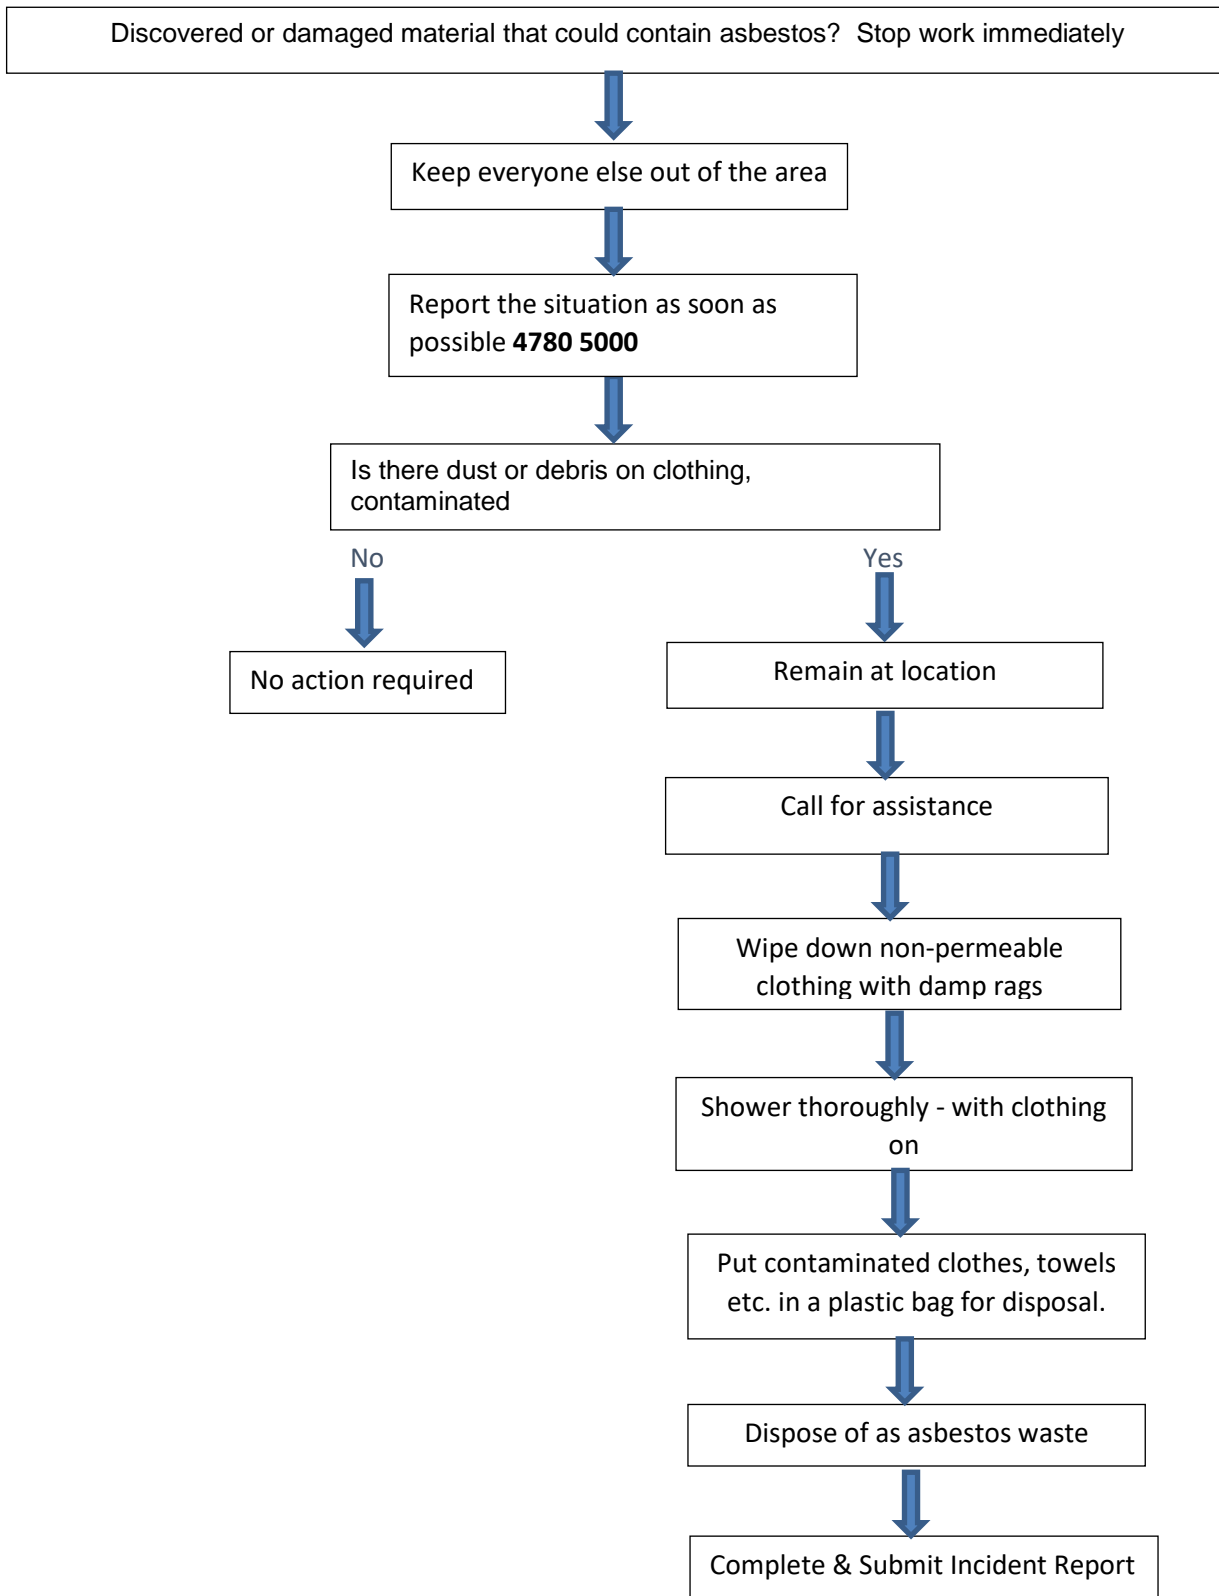
Figure 1 Emergency Procedures Chart

If known or suspected ACM is damaged or otherwise disturbed, the procedure in **Figure 1** (over the page) must be followed in full.

- stop work immediately,
- follow the chart,
- minimise the spread of contamination to other areas,
- keep risk of exposure as low as possible, and
- Immediately report incident to Council on 4780 5000.
