Prepared for:  
Blue Mountains City Council,  
2-6, Civic Place,  
Katoomba,  
NSW, 2780

Regional EnviroScience Pty Ltd was requested by Mr. Rick Harris of Blue Mountain City Council to undertake a Hazardous Building Materials Register and to prepare an Hazardous Materials Management Plan of the property known as Katoomba Neighbourhood Centre located at 8 Station Street, Katoomba, NSW, 2780. The purpose of the audit was to locate and identify asbestos based building materials and product within the building in accordance with the *NSW Work Health and Safety Act and Regulation 2017* and the *Code of Practice; How to Manage and Control Asbestos in the Workplace* [Safe Work Australia: 2016] and the *Code of Practice; How to Safely Remove Asbestos* [Safe Work Australia: 2016].

ASBESTOS MATERIALS REGISTER		ASSET: Katoomba Neighbourhood Centre, 8 Station Street, Katoomba, NSW, 2780			
DATE OF IDENTIFICATION	IMAGES	SPECIFIC LOCATION OF ASBESTOS/ APPROX M <sup>2</sup>	TYPE OF ASBESTOS/ FRIABLE OR NON-FRIABLE	RISK ACTION RATING	CONDITION & ACCESSIBILITY OF ASBESTOS
15 <sup>th</sup> December 2017

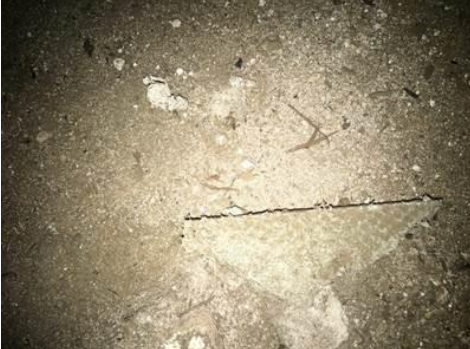
Scattered Debris in Subfloor Space on North Side of Cottage Approximately 1m <sup>2</sup>	Sample #B17466S01 Chrysotile Asbestos Detected Non-Friable <b>350</b>	A2	Poor Condition Accessible to Tradespeople Refer to Asbestos Management Plan
15 <sup>th</sup> December 2017

Note: It is recommended that the entire subfloor, where accessible, be hand-picked to remove the asbestos debris, as it appears to be broken bonded asbestos on the soils surface.

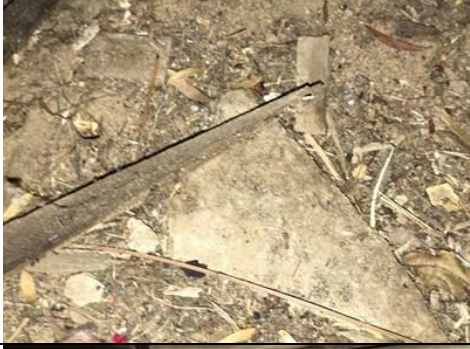
Scattered Debris in Subfloor Space on South Side of Cottage Approximately 1m <sup>2</sup>	Sample #B17466S02 Chrysotile Asbestos Detected Non-Friable <b>351</b>	A2	Poor Condition Accessible to Tradespeople Refer to Asbestos Management Plan
15 <sup>th</sup> December 2017

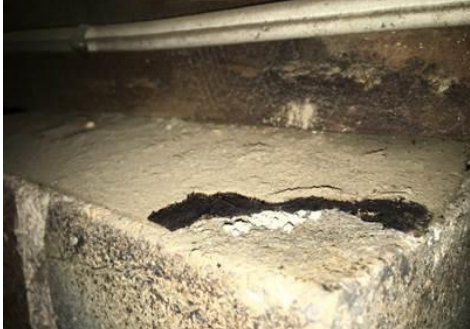
Waterproofing Membrane on Top of Brick Piers, Outer Brick walls & Under Bearers. Approximately 4m <sup>2</sup>	Sample #B17466S03 No Asbestos Detected <b>481</b>	A5	N/A

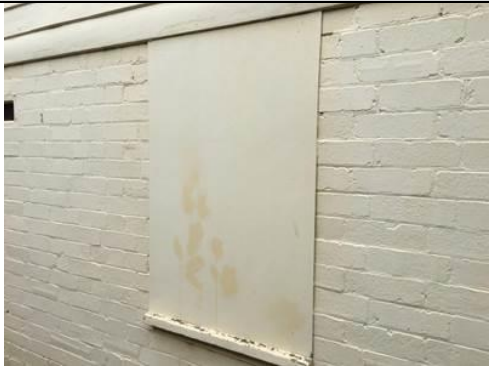
Infill Panel Redundant Window, North Side of Subfloor  Approximately 1m <sup>2</sup>	Sample #B17466S04 No Asbestos Detected  <b>482</b>	A5	N/A
15 <sup>th</sup> December 2017

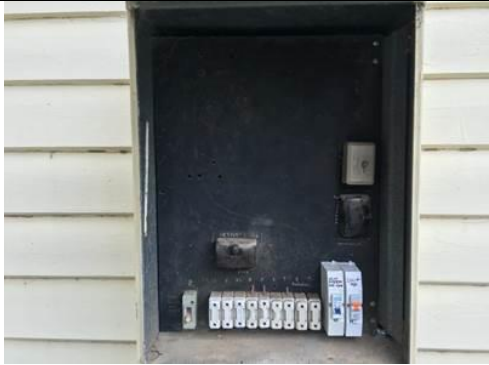
Electrical Backing Board on South Wall- Bakelite  Approximately 1m <sup>2</sup>	No Sample Taken. Assume Contains Asbestos Materials  <b>352</b>	A4	Good Condition Accessible to Tradespeople Refer to Asbestos Management Plan
15 <sup>th</sup> December 2017

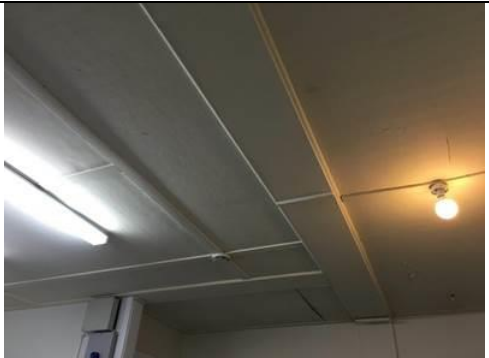
Ceiling Lining Throughout Cottage  Approximately 180m <sup>2</sup>	Sample #B17466S08 Chrysotile Asbestos Detected Non-Friable  <b>353</b>	A4	Good Condition Accessible to Tradespeople Refer to Asbestos Management Plan

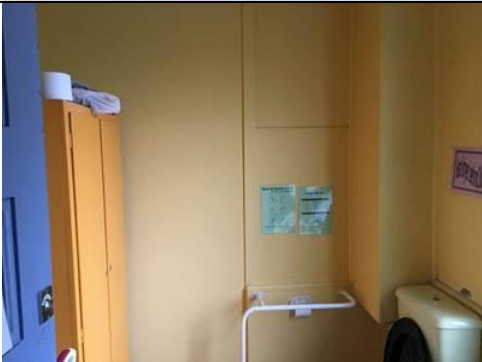
Wall Linings to Both Toilets, Kitchen. Approximately 70m <sup>2</sup> <b>354</b>	Similar to Sample #B17466S08 Chrysotile asbestos Detected Non-Friable	A4	Good Condition Accessible to Tradespeople Refer to Asbestos Management Plan
15 <sup>th</sup> December 2017

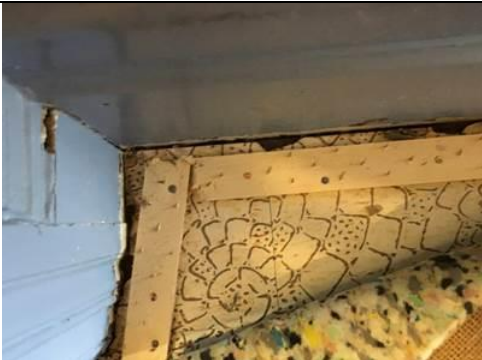
Vinyl Tile North Hall Under Carpet <b>Note:</b> Possibly Throughout Carpeted Areas <b>355</b>	Sample #B17466S10 Trace Chrysotile Asbestos Detected Non-Friable	A4	Good Condition Accessible to Tradespeople Refer to Asbestos Management Plan
15 <sup>th</sup> December 2017

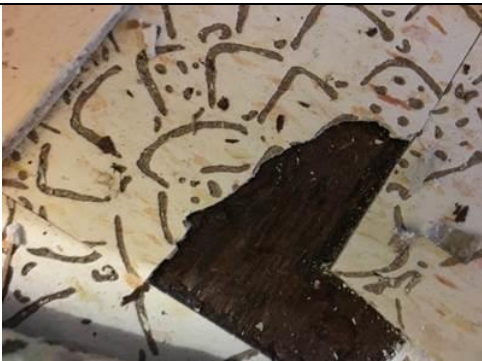
Vinyl Tile Adhesive Under Tile North Hall <b>483</b>	Sample #B17466S11 No Asbestos Detected	A5	N/A

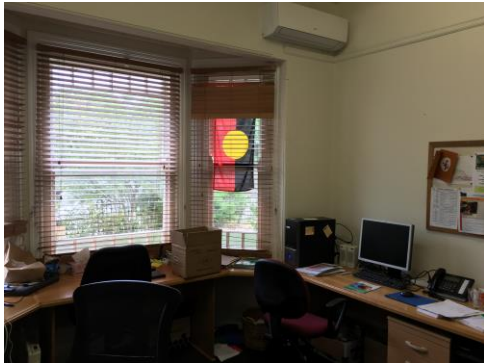
Service Support Office Wall Linings – Brick and Plaster, Fibre Board Ceiling. <b>356</b>	Similar to Sample #B17466S08 Chrysotile Asbestos Detected Non-Friable	A4	Good Condition Accessible to Tradespeople Refer to Asbestos Management Plan
15 <sup>th</sup> December 2017

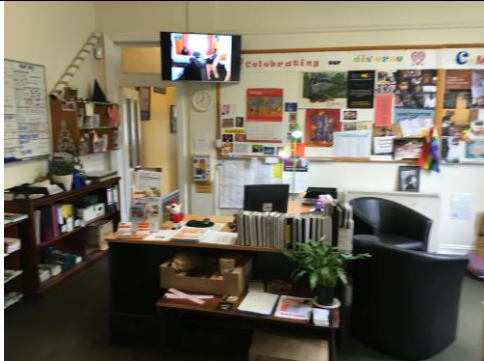
Reception Area Wall Linings – Brick and Plaster, Fibre Board Ceiling. <b>357</b>	Similar to Sample #B17466S08 Chrysotile Asbestos Detected Non-Friable	A4	Good Condition Accessible to Tradespeople Refer to Asbestos Management Plan
15 <sup>th</sup> December 2017

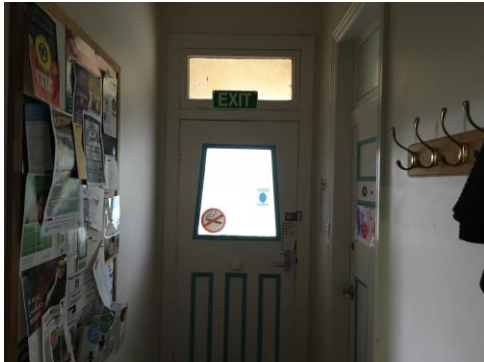
Hallway to East (Front) Wall Linings – Brick and Plaster, Fibre Board Ceiling. <b>358</b>	Similar to Sample #B17466S08 Chrysotile Asbestos Detected Non-Friable	A4	Good Condition Accessible to Tradespeople Refer to Asbestos Management Plan

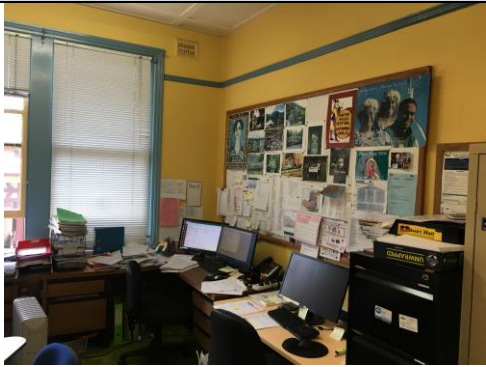
Finance Office Wall Linings – Brick and Plaster, Fibre Board Ceiling. <b>359</b>	Similar to Sample #B17466S08 Chrysotile Asbestos Detected Non-Friable	A4	Good Condition Accessible to Tradespeople Refer to Asbestos Management Plan
15 <sup>th</sup> December 2017

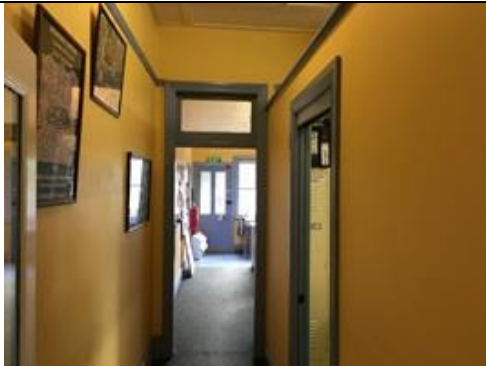
Reception and Staff Hallway. Brick and Plaster Walls, Timber & Gyproc Partition Wall, Fibre Board Ceiling. <b>360</b>	Similar to Sample #B17466S08 Chrysotile Asbestos Detected Non-Friable	A4	Good Condition Accessible to Tradespeople Refer to Asbestos Management Plan
15 <sup>th</sup> December 2017

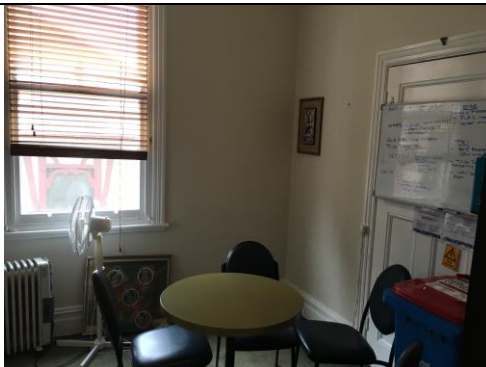
Manager's Office Wall Linings – Brick and Plaster, Fibre Board Ceiling. <b>361</b>	Similar to Sample #B17466S08 Chrysotile Asbestos Detected Non-Friable	A4	Good Condition Accessible to Tradespeople Refer to Asbestos Management Plan

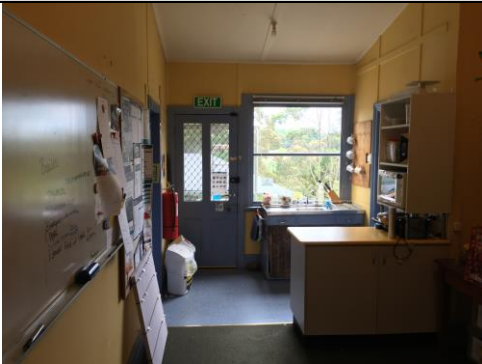
Staff Area Room Wall Linings – Brick and Plaster, Fibre Board Ceiling. <b>362</b>	Similar to Sample #B17466S08 Chrysotile Asbestos Detected Non-Friable	A4	Good Condition Accessible to Tradespeople Refer to Asbestos Management Plan
15 <sup>th</sup> December 2017

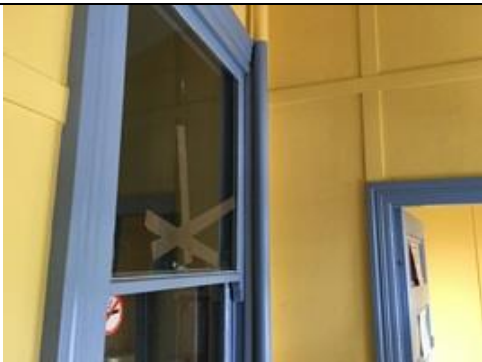
Rear Hallway. Fibre Board Walls and Ceiling. <b>363</b>	Similar to Sample #B17466S08 Chrysotile Asbestos Detected Non-Friable	A4	Good Condition Accessible to Tradespeople Refer to Asbestos Management Plan
15 <sup>th</sup> December 2017

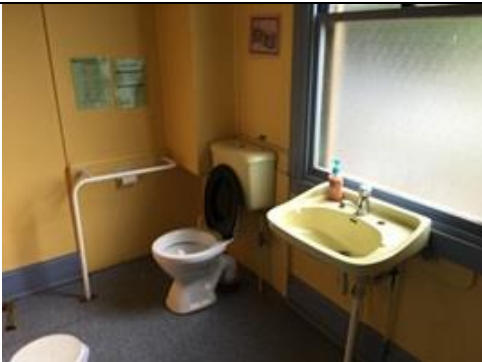
Public Bathroom. Fibre Board Walls and Ceiling. <b>364</b>	Similar to Sample #B17466S08 Chrysotile Asbestos Detected Non-Friable	A4	Good Condition Accessible to Tradespeople Refer to Asbestos Management Plan

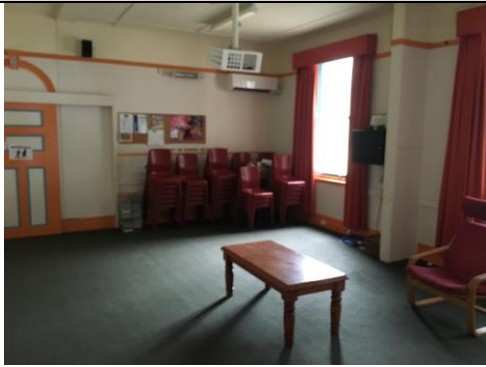
Community Room Wall Linings – Brick and Plaster, Fibre Board Ceiling. <b>365</b>	Similar to Sample #B17466S08 Chrysotile Asbestos Detected Non-Friable	A4	Good Condition Accessible to Tradespeople Refer to Asbestos Management Plan
15 <sup>th</sup> December 2017

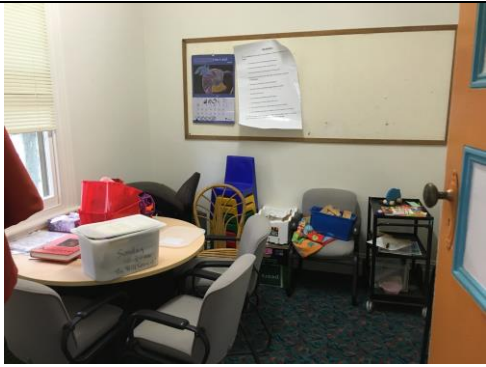
Playroom Wall Linings – Brick and Plaster <b>366</b>	Similar to Sample #B17466S08 Chrysotile Asbestos Detected Non-Friable	A4	Good Condition Accessible to Tradespeople Refer to Asbestos Management Plan
15 <sup>th</sup> December 2017

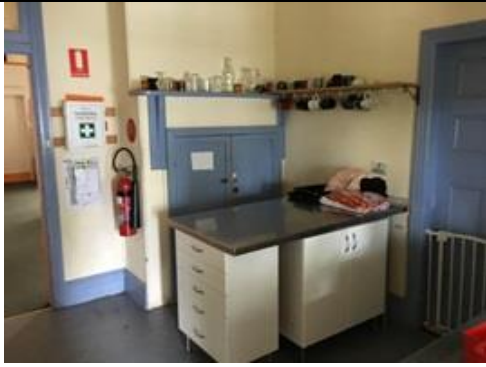
Kitchen. Wall Linings – Brick and Plaster, Fibre Board Ceiling. <b>367</b>	Similar to Sample #B17466S08 Chrysotile Asbestos Detected Non-Friable	A4	Good Condition Accessible to Tradespeople Refer to Asbestos Management Plan

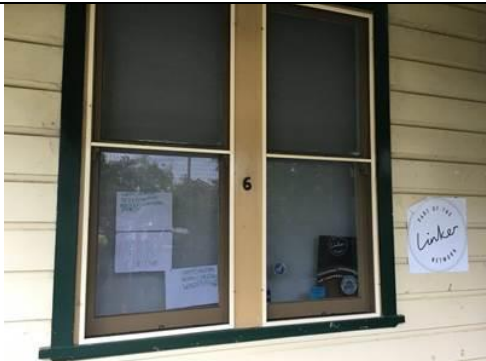
Putty External Window Frames Approximately 0.1m <sup>2</sup> <b>485</b>	Sample #B17466S12 No Asbestos Detected	A5	N/A
15 <sup>th</sup> December 2017

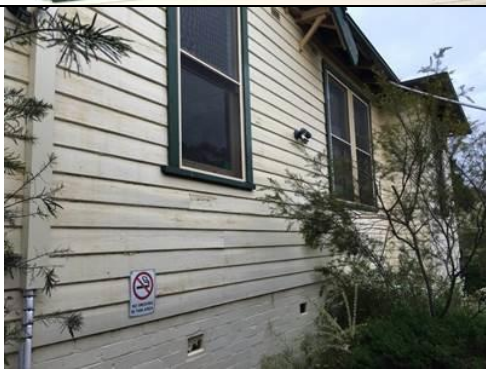
Exterior – Weatherboard and Brick.  Timber window frames. <b>487</b>	No Asbestos materials identified	A5	N/A

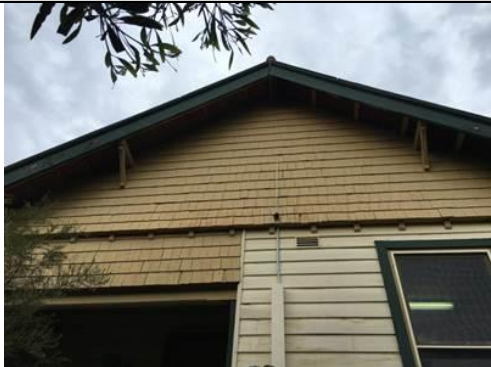
Exterior – Timber shingles, weatherboard and Brick. Timber window frames. <b>488</b>	No Asbestos materials identified	A5	N/A
15 <sup>th</sup> December 2017

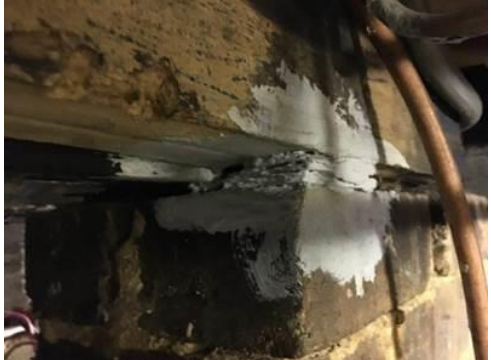
Packers to Piers in Subfloor Area <b>369</b>	Similar to Sample #B17466S01 Chrysotile Asbestos Detected Non-Friable	A3	Fair Condition Accessible to Tradespeople Refer to Asbestos Management Plan
15 <sup>th</sup> December 2017

- Provided the ACM remains in good condition and is not disturbed they pose minimal risk if left in situ.
- If the ACM is in fair condition it should be removed under controlled conditions and replaced, during routine maintenance works.
- If the ACM is in poor condition it should be removed under controlled conditions as soon as practicable.
- If renovation or demolition works are to occur the asbestos based materials which are likely to be disturbed should be removed prior to works commencing.

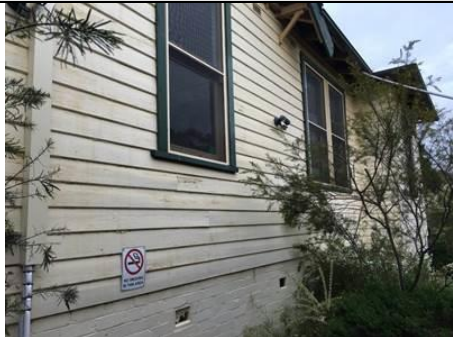
Yellow Paint to Weather Boards & External Surfaces	0.3% w/w	A5	Paint is not classified as lead based. Less than 1.0% w/w
Sample #B17466S06 (182641-2)

Good practice would dictate that existing paint, even though is below the recognised standard, should not be sanded and that dust minimisation techniques should be adopted, when undertaking renovation / repair works particularly in heritage period buildings. It would be good practice to wear a P1 dust mask during any paint removal even though it does not contain lead but small particles of paint can still be inhaled or ingested.

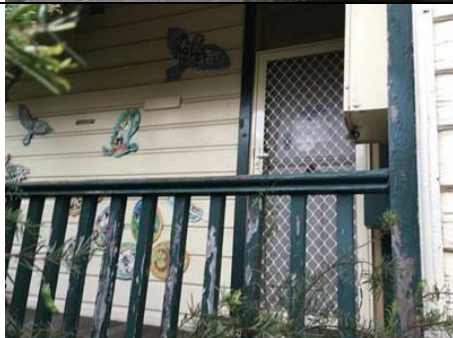
Green Paint to Posts, Rails & Architraves	0.2% w/w	A5	Paint is not classified as lead based. Less than 1.0% w/w

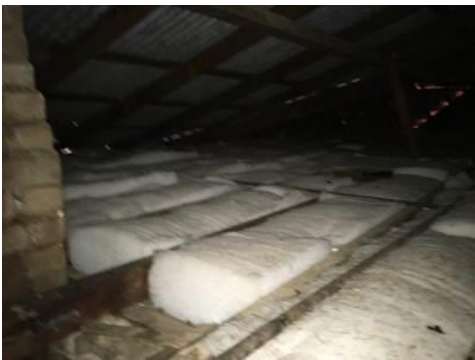
Ceiling Insulation	Visual Inspection	A4	Good Condition, Bonded, Not High Risk. Accessible to Tradespeople Refer to Asbestos Management Plan
15 <sup>th</sup> December 2017

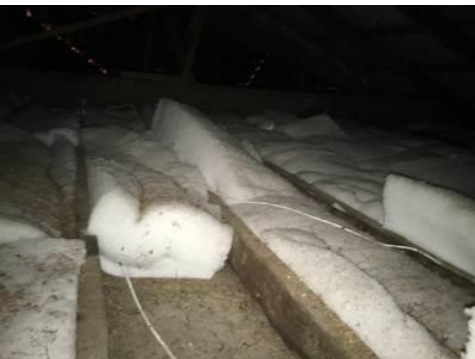
Ceiling Insulation	Visual Inspection	A4	Good Condition, Bonded, Not High Risk. Accessible to Tradespeople Refer to Asbestos Management Plan

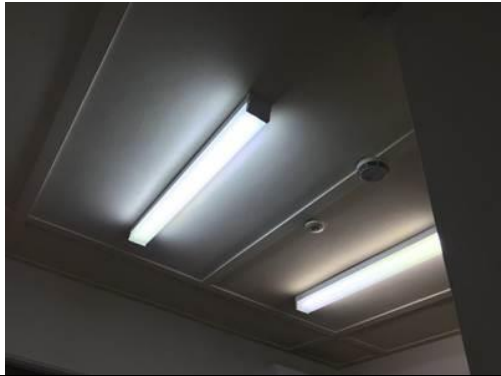
Kitchen Fluorescent Lights No PCB's Present	Visual Observation	A5	N/A
15 <sup>th</sup> December 2017

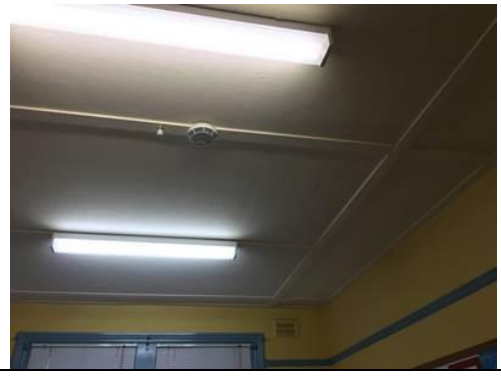
Fluorescent Lights No PCB's Present	Visual Observation	A5	N/A
15 <sup>th</sup> December 2017

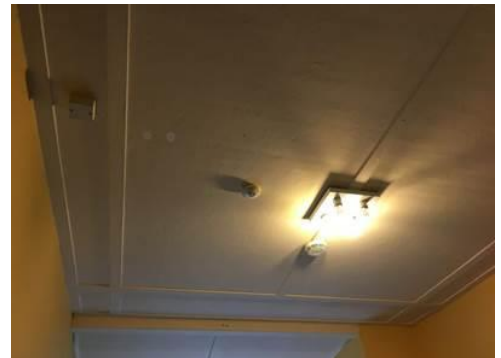
Fluorescent Lights No PCB's Present	Visual Observation	A5	N/A

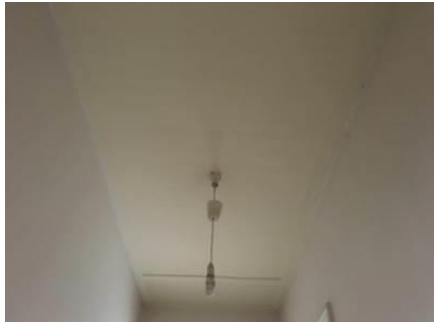
Hall Light Fitting Potential Phenol	Visual Inspection	A4	Good Condition Accessible to Tradespeople Refer to Phenols Management Plan
