Asbestos Register

Regional EnviroScience Pty Ltd was requested by Mr. Rick Harris of Blue Mountain City Council to undertake a Hazardous Building Materials Register and to prepare a Hazardous Materials Management Plan of the building known as Katoomba Falls Kiosk, located at the Blue Mountains Tourist Park, Katoomba, NSW, 2780. The purpose of the audit was to locate and identify asbestos based building materials and product within the building in accordance with the *NSW Work Health and Safety Act and Regulation 2017* and the *Code of Practice; How to Manage and Control Asbestos in the Workplace* [Safe Work Australia: 2016] and the *Code of Practice; How to Safely Remove Asbestos* [Safe Work Australia: 2016].

On the 5th December 2017, an Asbestos Audit was conducted at the Katoomba Falls Kiosk and asbestos containing materials were found to be present at the premises. Please refer Appendix I for results of products that were considered and consequently analysed but did not contain asbestos.

ASBESTOS MATERIALS REGISTER		ASSET: Katoomba Falls Kiosk, Blue Mountains Tourist Park, Katoomba NSW, 2780			
DATE OF IDENTIFICATION	IMAGES	SPECIFIC LOCATION OF ASBESTOS/ APPROX M ²	TYPE OF AS

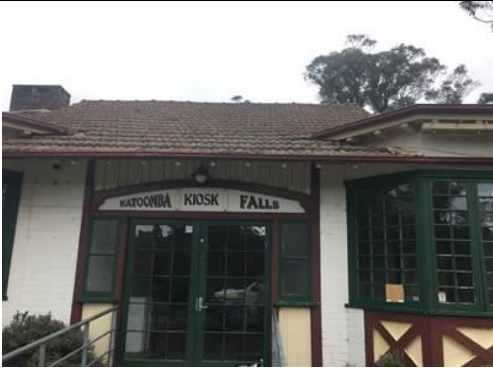
Katoomba Falls Kiosk South East Aspect Bonded Board Entry Sign, Timber Eaves, Tiled Roof, Brick Exterior Walls, Timber Window Frames with Mastic	N/A		N/A
5 th December 2017

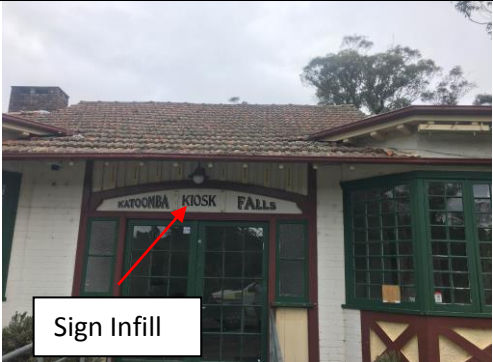
'Katoomba Falls Kiosk' Entrance Sign Bonded Board Approximately 2m ² 585	Similar to Sample # B17368S03 Chrysotile, Crocidolite, Amosite Asbestos Detected Non-Friable	A5	Clearance Certificate Tinitas 20/31682

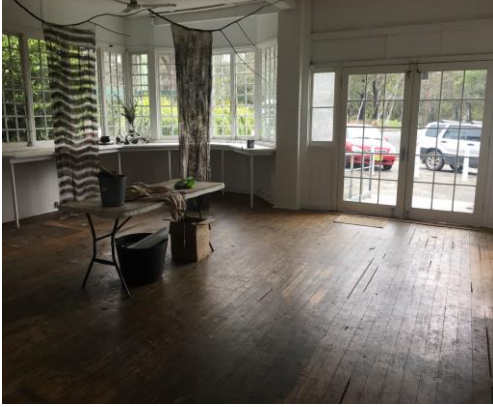
Dining Room. Timber Floors, Rendered Brick Walls to 2.2m, Masonite Infill on South East & South West Walls, Infills Around Bay Window, Fibre Cement Ceiling,	Sample #B17368S01 Chrysotile, Amosite, Crocidolite Asbestos Detected Non-Friable 586	A5	Clearance Certificate Tinitas 20/31682
5 th December 2017

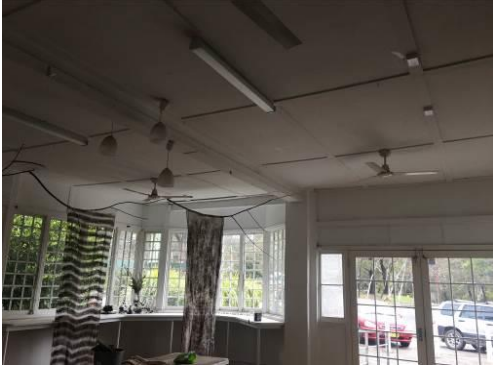
Dining Room. Ceiling Main Fibre Cement Approximately 50m²	Sample #B17368S01 Chrysotile, Amosite, Crocidolite Asbestos Detected Non-Friable 587	A5	Clearance Certificate Tinitas 20/31682
5 th December 2017

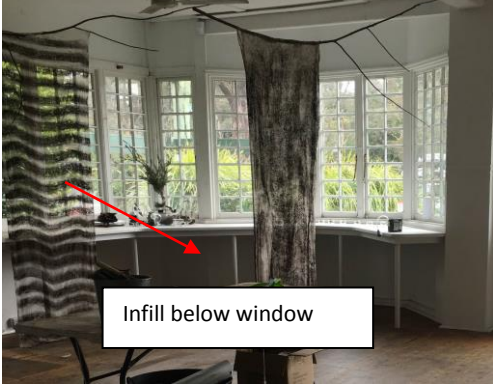
Dining Room. Bay Window Infill Below Window Fibre Cement	Sample #B17368S02 No Asbestos Detected 588	A5	N/A

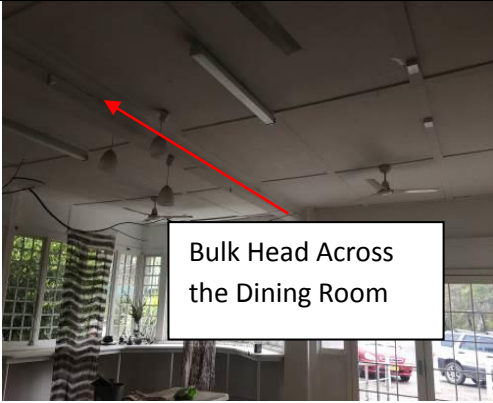
Dining Room. Bulkhead Across Centre of Dining Room Fibre Cement Approximately 3m ² 589	Sample #B17368S03 Chrysotile, Amosite, Crocidolite Asbestos Detected Non-Friable	A5	Clearance Certificate Tinitas 20/31682
5 th December 2017

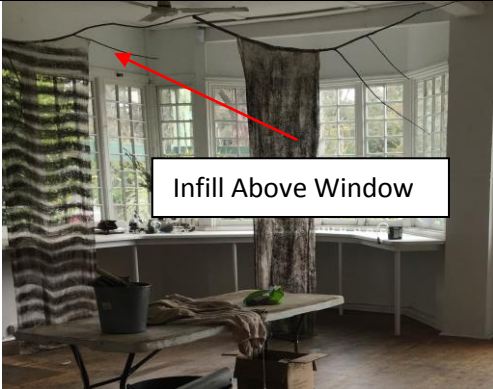
Dining Room. Infill Above Bay Window on North West Wall Fibre Cement Approximately 4m ² 590	Similar to Sample #B17368S01 Chrysotile, Amosite, Crocidolite Asbestos Detected Non-Friable	A5	Clearance Certificate Tinitas 20/31682
5 th December 2017

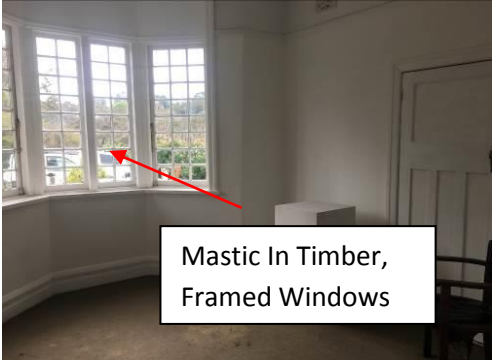
Bedroom 1. Timber Framed Windows Throughout, Mastic. 591	Sample #B17368S04 No Asbestos Detected	A5	N/A

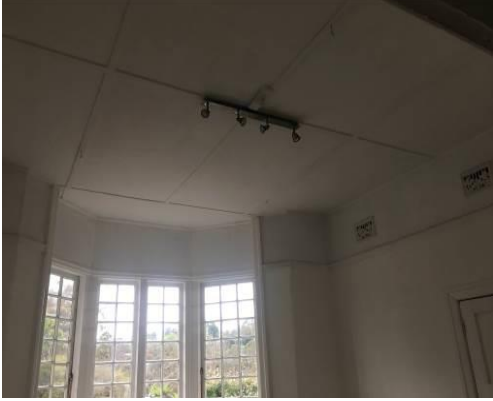
Bedroom 1. Fibre Cement Ceiling, Timber Architraves & Skirting, Rendered Cement Walls with Gyprock Infill – Approximately 10m ²	Sample #B17368S06 Chrysotile & Amosite Asbestos Detected Non-Friable 592	A5	Clearance Certificate Tinitas 20/31682
5 th December 2017

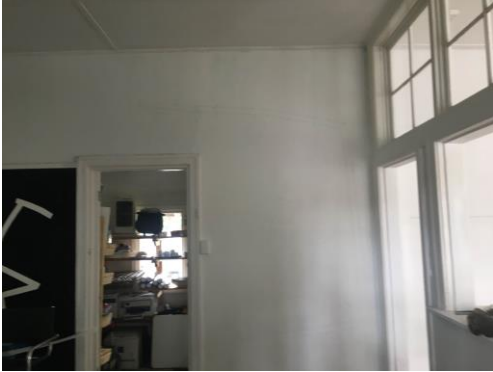
Lounge Room. Rendered Brick Walls & Fireplace, Gyprock Infills South East, South West & North West Walls, Fireplace Infill & Fibre Cement Ceiling	Similar to Sample # B17368S06 Chrysotile & Amosite Asbestos Detected 593	A5	Clearance Certificate Tinitas 20/31682
5 th December 2017	No Image Available	Fireplace Infill Lounge Room Above Old Stove Fibre Cement	Sample #B17368S05 No Asbestos Detected 594	A5	N/A

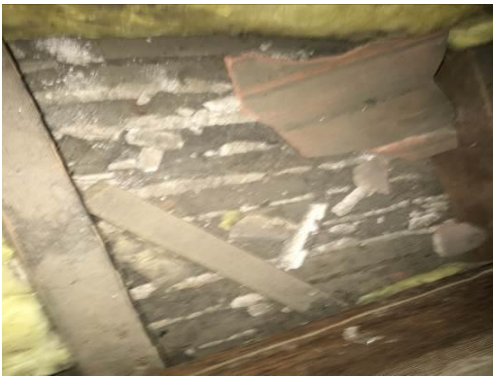
Bedroom 1 and Lounge Room. Above Ceiling in Dining Room, Fibre Cement	Sample # B17368S16 No Asbestos Detected 595	A5	N/A
5 th December 2017

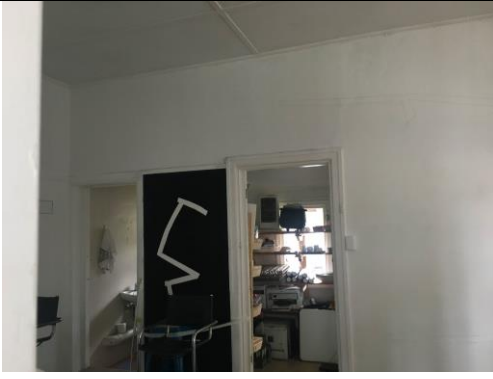
Lounge Room. Ceiling Fibre Cement Approximately 10m ²	Similar to Sample # B17368S06 Chrysotile & Amosite Asbestos Detected 596	A5	Clearance Certificate Tinitas 20/31682
5 th December 2017

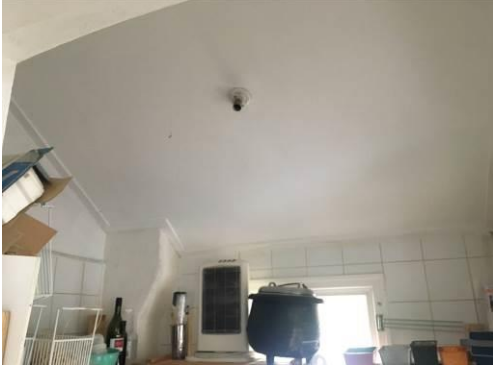
Kitchen/Pantry. Vinyl Tile Floor, Ceramic Tile Walls to 2.5m, Masonite Wall Infill to Roof – Kitchen/Pantry Ceiling & gable Infill Panels Fibre Cement Approximately 12m ²	Sample #B17368S07 Chrysotile Asbestos Detected Non-Friable 597	A5	Clearance Certificate Tinitas 20/31682

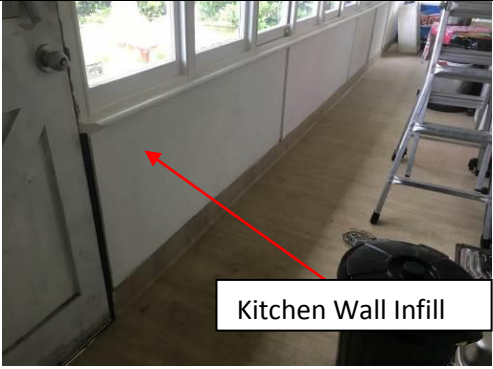
A photograph of a kitchen wall with a white infill panel. A red arrow points to the infill. A white box with the text 'Kitchen Wall Infill' is overlaid on the image.	Kitchen. Wall Infill & Gable Infill Fibre Cement Approximately 6m ²	Sample # B17368S08 Chrysotile Asbestos Detected Non-Friable 598	A5	Clearance Certificate Tinitas 20/31682
5 th December 2017

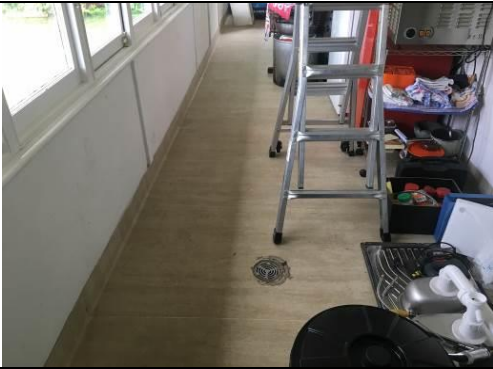
A photograph of a kitchen floor with light-colored vinyl tiles. A metal step ladder and various kitchen items are visible in the background.	Kitchen. Floor Vinyl Tile	Sample # B17368S09 No Asbestos Detected 600	A5	N/A
5 th December 2017

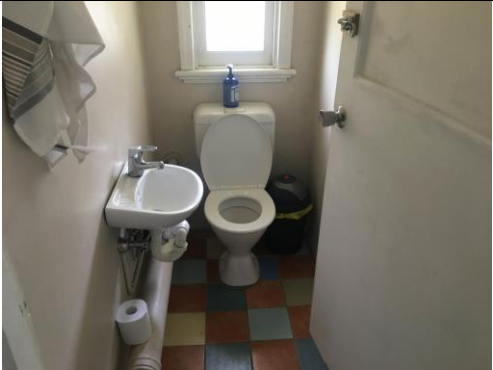
A photograph of a toilet room with a white sink, toilet, and tiled floor. The walls are rendered brick.	Toilet. Rendered Brick walls, Ceramic Tile Floor, Gyprock Infill Leading into Kitchen	No Asbestos Containing Material Identified 601	A5	N/A

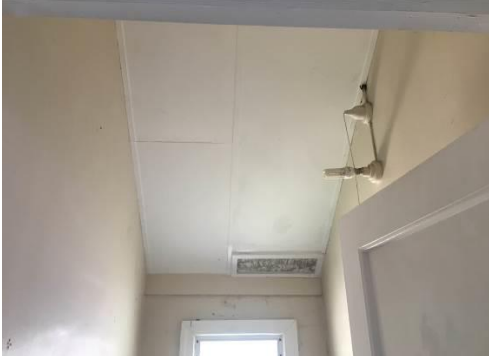
Toilet. Ceiling Fibre Cement Approximately 4m ²	Sample # B17368S10 Chrysotile Asbestos Detected Non-Friable 602	A5	Clearance Certificate Tinitas 20/31682
5 th December 2017

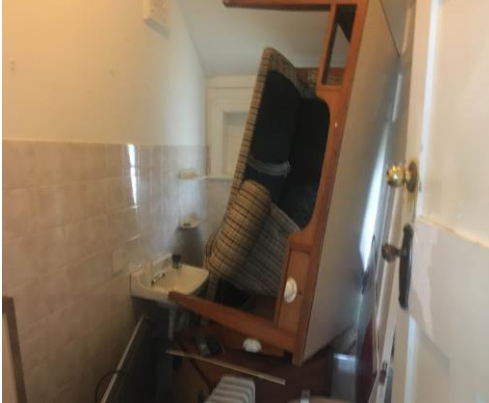
Bathroom Ceramic Tiles on Floor, Ceramic Wall Tile to 1.5m, Rendered Brick Walls – Fibre Cement Ceiling Approximately 3m ² * Limited Access Due to Items Stored Here	Similar to Sample # B17638S07 Chrysotile Asbestos Detected Non-Friable 603	A5	Clearance Certificate Tinitas 20/31682
5 th December 2017

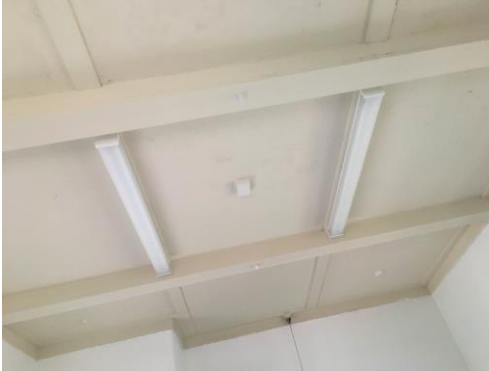
Bedroom 2. Rendered Brick Walls, Timber Floors, Timber Skirting & Architraves, Horse Hair Plaster Ceiling	No Asbestos Containing Material Identified 604	A5	N/A

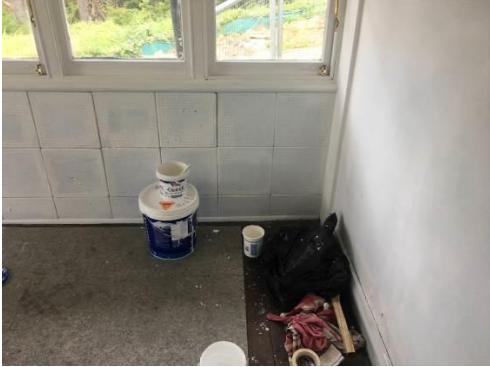
Sleepout. Rendered Brick Walls, Wood on Floor Overlaid by Vinyl Drop Sheet - Perforated Tiles of South West Wall Fibre Board	Sample # B17368S11 No Asbestos Detected 605	A5	N/A
5 th December 2017

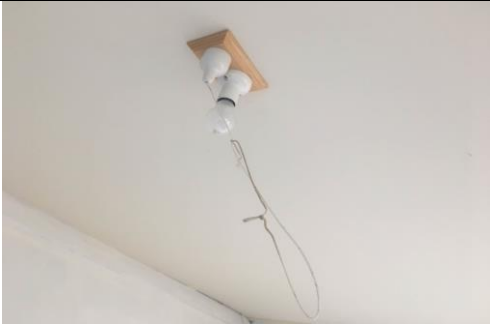
Sleepout. Ceiling Fibre Cement Approximately 5m²	Similar to Sample # B17638S07 Chrysotile Asbestos Detected Non-Friable 606	A5	Clearance Certificate Tinitas 20/31682
5 th December 2017

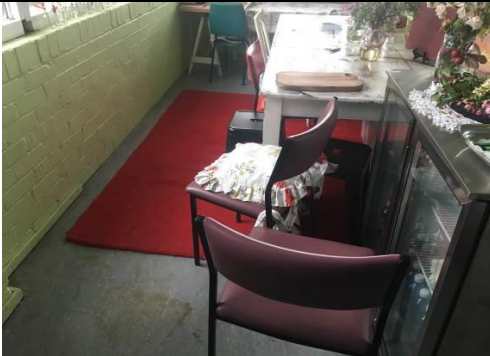
Enclosed Veranda. Brick Walls, Fibre Cement Ceiling - Linoleum Floor Vinyl Tile	Sample # B17368S12 No Asbestos Detected 607	A5	N/A

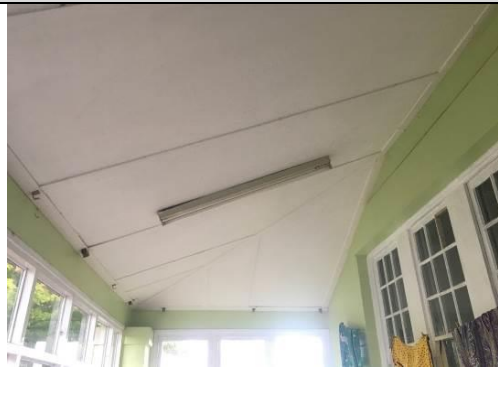
Enclosed Veranda. Ceiling Fibre Cement Approximately 10m ² *Note Damage to South-East Corner	Sample # B17368S13 Chrysotile & Amosite Asbestos Detected Non-Friable 608	A5	Clearance Certificate Tinitas 20/31682
5 th December 2017

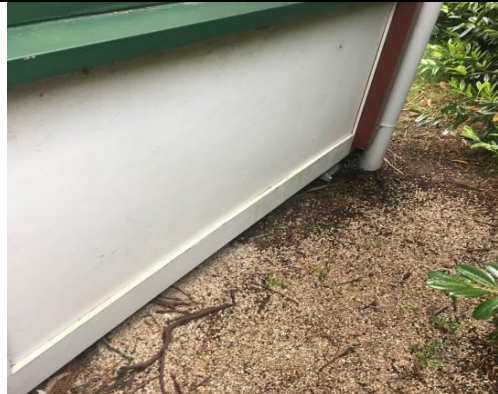
North Aspect External Wall Panels Fibre Cement Approximately 7m ²	Sample # B17368S14 Chrysotile Asbestos Detected Non-Friable 609	A5	Clearance Certificate Tinitas 20/31682
5 th December 2017

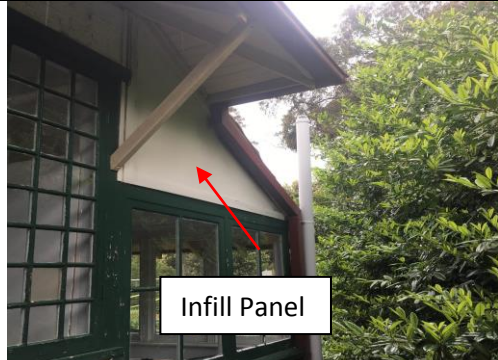
North External Infill Panel, Above Windows. Fibre Cement Approximately 1m ²	Similar to Sample # B17368S14 Chrysotile Asbestos Detected Non-Friable 610	A5	Clearance Certificate Tinitas 20/31682

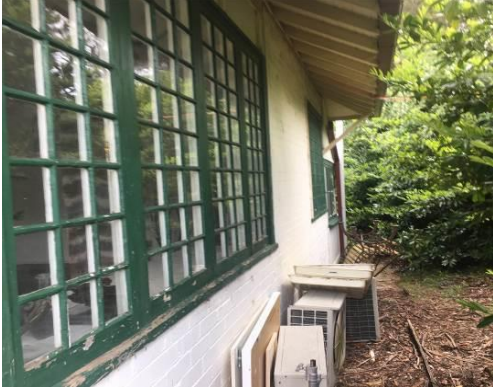
North Aspect. External Timber Windows Mastic	Sample # B17368S15 No Asbestos Detected 611	A5	N/A
5 th December 2017

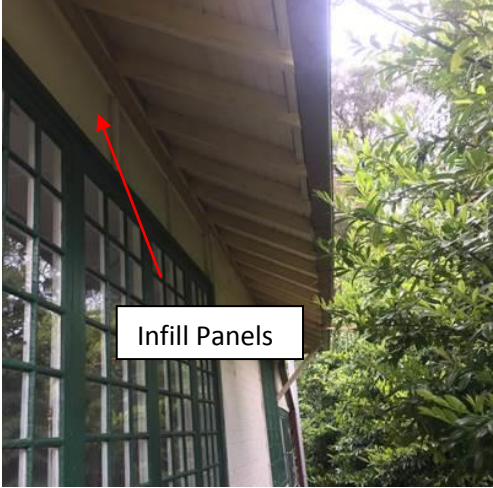
North Aspect. External Infills Above Windows. Fibre Cement.	Similar to Sample # B17368S14 Chrysotile Asbestos Detected Non-Friable 612	A5	Clearance Certificate Tinitas 20/31682
5 th December 2017

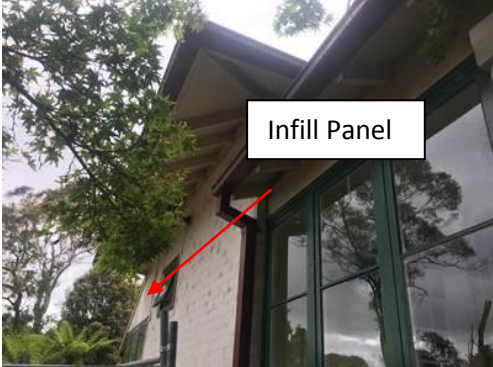
External Infill Panel. Fibre Cement	Similar to Sample # B17368S14 Chrysotile Asbestos Detected Non-Friable 613	A5	Clearance Certificate Tinitas 20/31682

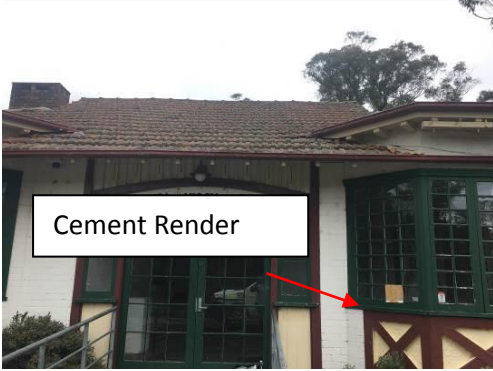
External Render Fibre Cement	Sample # B17368S17 No Asbestos Detected 614	A5	N/A
5 th December 2017

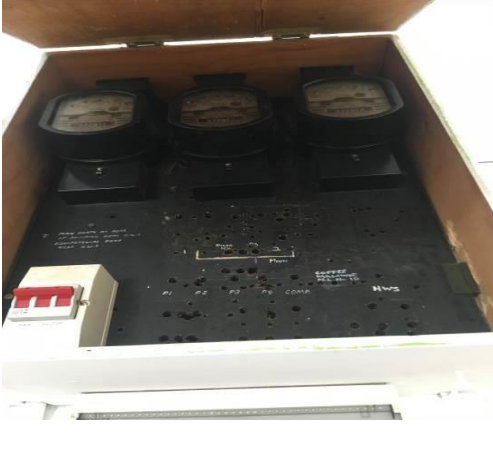
Electrical Meter Board Bakelite Backing Board 0.5m ²	No Sample Taken Assume Contains Asbestos 615	A5	Clearance Certificate Tinitas 20/31682
5 th December 2017

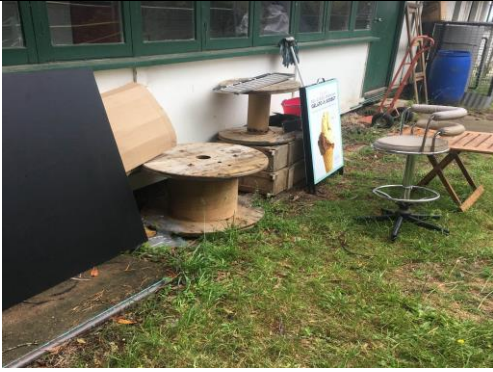
South Western External Kitchen Wall Infill Panels Fibre Cement Approximately 5m ²	Similar to Sample # B17368S14 Chrysotile Asbestos Detected Non-Friable 616	A5	Clearance Certificate Tinitas 20/31682

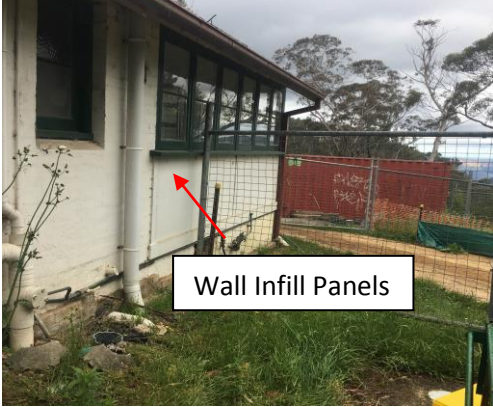
Eastern External Wall Panels Fibre Cement Approximately 3m ²	Similar to Sample # B17368S14 Chrysotile Asbestos Detected Non-Friable 617	A5	Clearance Certificate Tinitas 20/31682
5 th December 2017

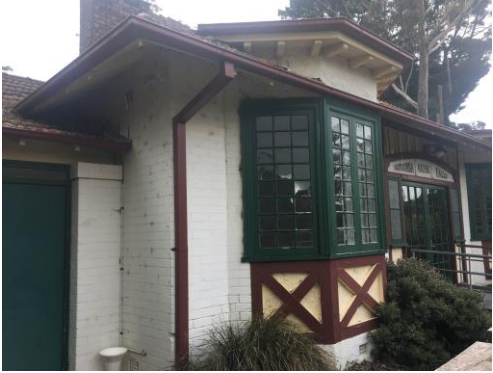
Exterior Brick Walls, Timber Eaves, Tiled Roof, Steel Guttering & Downpipes.	No Asbestos Containing Material Identified 618	A5	N/A
5 th December 2017

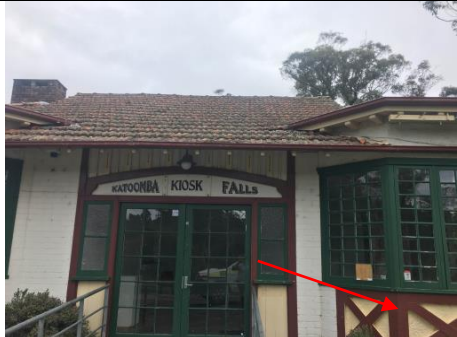
External Maroon Paint	0.1 % w/w	A5	Paint is not classified as lead based. Less than 1.0% w/w
Sample No 2 (181776-2)

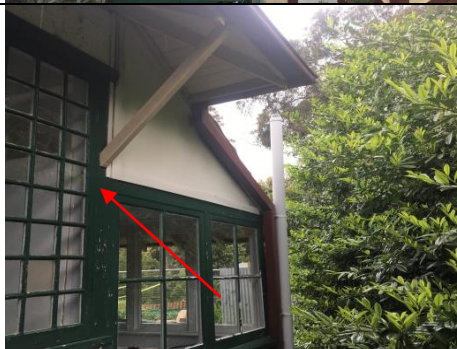
External Green Paint	2.1 % w/w	A4	Paint is classified as lead based. Greater than 1.0% w/w

The two (2) samples of exterior green paint (181776-2) and interior skirting and wall paint (181776-4) obtained from the property, has recorded a result of 2.1% w/w and 3.4% respectively, for lead in paint, which is above the classification criteria of 1% w/w, and therefore remedial action is required. However good practice would dictate that existing paint, even if it is below the recognised standard, should not be sanded and that dust minimisation techniques should be adopted, when undertaking renovation / repair works particularly in heritage period buildings. It would be good practice to wear a P1 dust mask during any paint removal even though it does not contain lead but small particles of paint can still be inhaled or ingested.

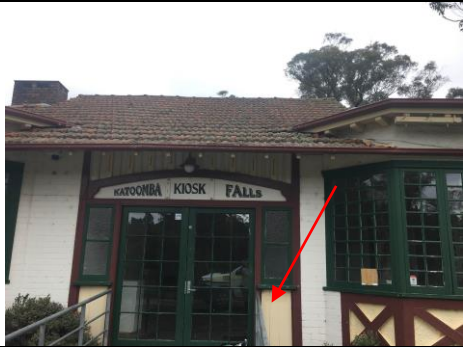
Cream Exterior Paint	0.2 % w/w	A5	Paint is not classified as lead based. Less than 1.0% w/w
Sample No 4 (181776-4)

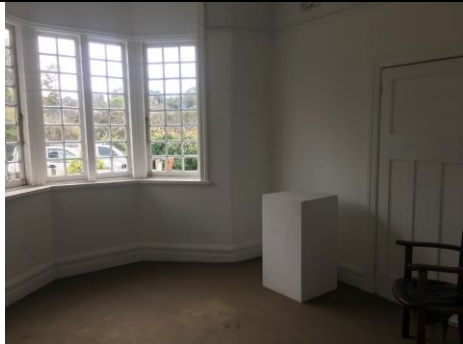
Interior Skirting and Wall White Paint	3.4 % w/w	A4	Paint is classified as lead based. Greater than 1.0% w/w

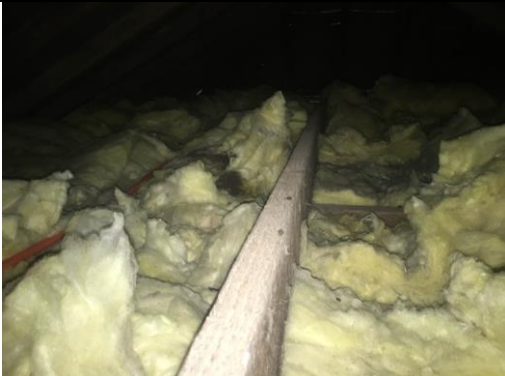
Ceiling Space Throughout	Visual Identification	A4	Good Condition, Bonded Accessible to Tradespeople

No high-risk synthetic mineral fibre was identified during the on-site inspection. The material identified on-site was in a bonded format or was encapsulated, and in this structure and condition does not present a significant risk in its current condition and state.

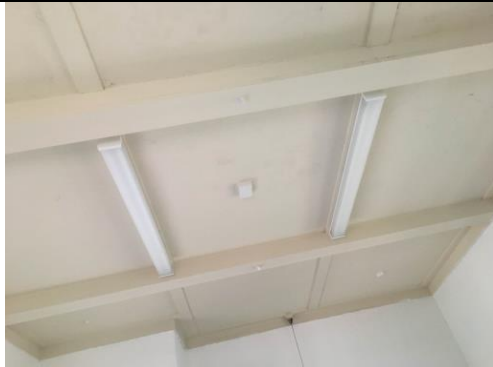
Lights in Bedroom 2, Fluorescent Lights No PCB Present	Visual Inspection	A5	N/A
5 th December 2017

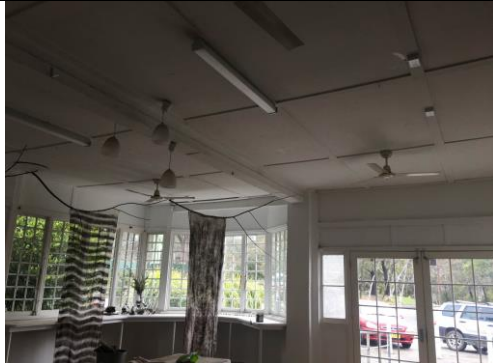
Lights in Main Dining Room Fluorescent Lights No PCB Present	Visual Inspection	A5	N/A

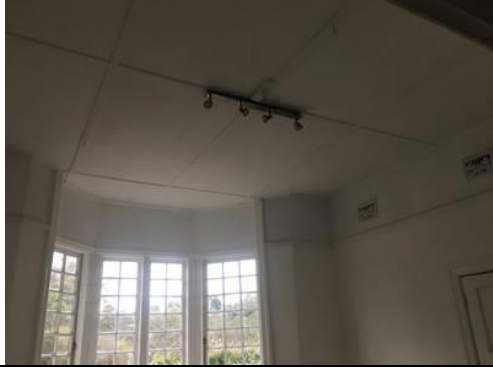
Lights in Bedroom 1 Fluorescent Lights No PCB's Observed	Visual Inspection	A5	N/A
5 th December 2017

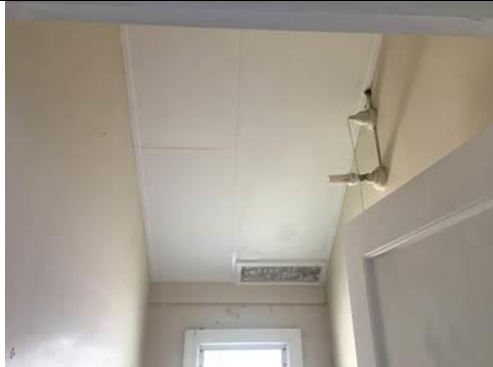
Toilet Light Fluorescent Light No PCB's Observed	Visual Inspection	A5	N/A
5 th December 2017

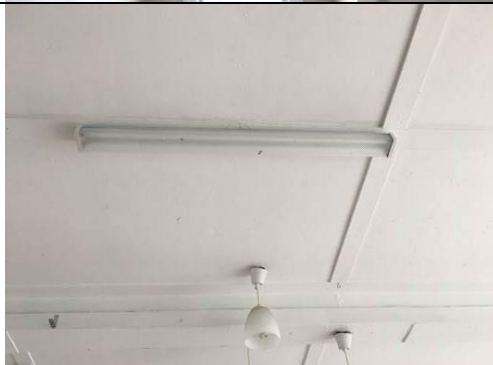
Kitchen Fluorescent Lights No PCB's Observed	Visual Inspection	A5	N/A

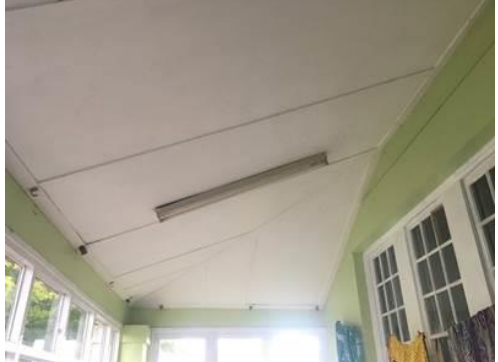
Enclosed Verandah Fluorescent Lights No PCB's Observed	Visual Inspection	A5	N/A

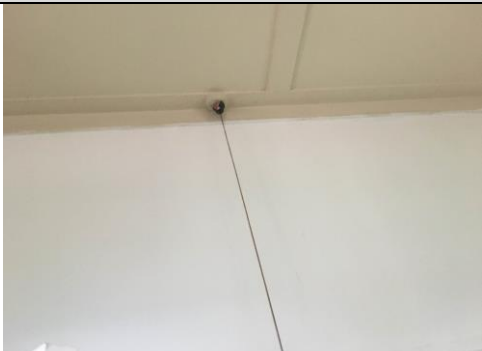
Light Fitting & Associated Light Switch in Bedroom 2	Potential Phenol Containing Material Visual Identification Only	A4	Good Condition Accessible to Tradespeople Refer to Management Plan

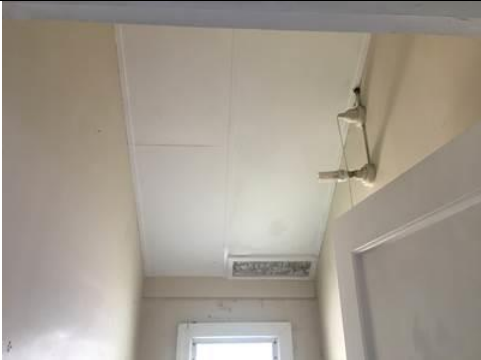
Toilet Light Fitting & Associated Switch	Potential Phenol Containing Material Visual Identification Only	A4	Good Condition Accessible to Tradespeople Refer to Management Plan
5 th December 2017

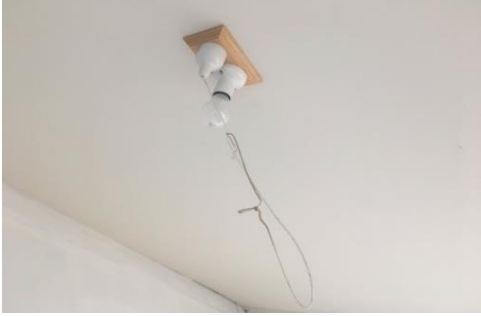
Light Fitting in Sleepout Potential Bakelite	Potential Phenol Containing Material Visual Identification Only	A4	Good Condition Accessible to Tradespeople Refer to Management Plan
5 th December 2017

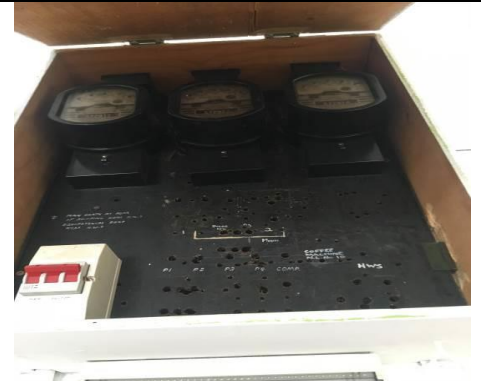
Meter Board Electrical Bakelite Backing Board	Assume Phenol Positive	A4	Good Condition Accessible to Tradespeople Refer to Management Plan
