# Asbestos Register

Regional EnviroScience Pty Ltd was requested by Mr. Rick Harris of Blue Mountain City Council to undertake a Hazardous Building Materials Register and to prepare a Hazardous Materials Management Plan of the Amenities Block at the property known as Lawson Oval located at Ferris Lane, Lawson, NSW, 2783. The purpose of the audit was to locate and identify asbestos based building materials and product within the building in accordance with the *NSW Work Health and Safety Act and Regulation 2017* and the *Code of Practice; How to Manage and Control Asbestos in the Workplace* [Safe Work Australia: 2016] and the *Code of Practice; How to Safely Remove Asbestos* [Safe Work Australia: 2016].

ASBESTOS MATERIALS REGISTER		ASSET: Lawson Oval Amenities, Ferris Lane, Lawson, NSW, 2783			
DATE OF IDENTIFICATION	IMAGES	SPECIFIC LOCATION OF ASBESTOS/ APPROX M <sup>2</sup>	TYPE OF ASBESTOS/ FRIABLE OR NON-FRIABLE	RISK ACTION RATING	CONDITION & ACCESSIBILITY OF ASBESTOS
1 <sup>st</sup> December 2017

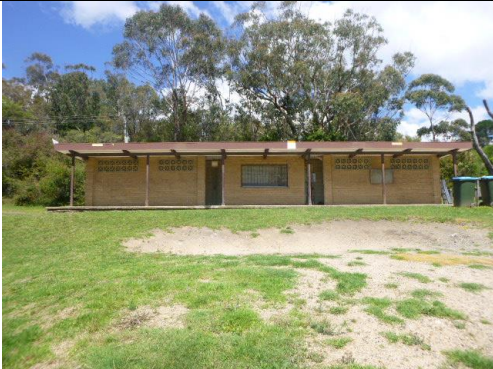
Lawson Oval Amenities Block Eastern Aspect Aluminium Roof/Fascia Cover, Brick Walls, Soffit Linings, Timber Top Plate, Concrete Floor, Steel Pour Pipes, PVC Downpipes, Aluminium Gutter	N/A		N/A
1 <sup>st</sup> December 2017

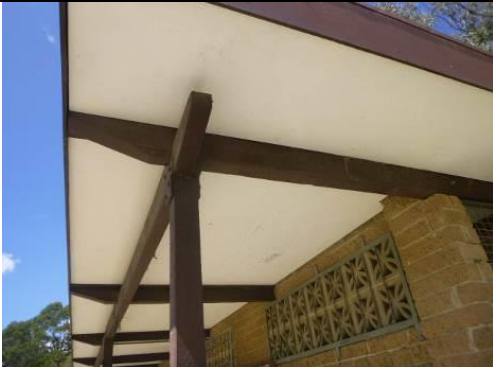
External – Eastern Aspect Soffit Lining Fibre Cement <b>159</b>	Sample #B17355S01 No Asbestos Detected	A5	N/A

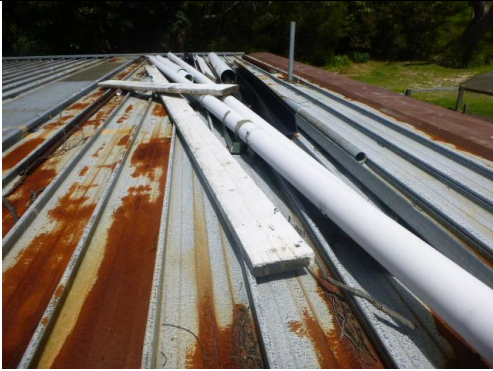
Roof Aspect Iron Roofing Rusted <b>163</b>	No Asbestos Material Identified	A5	N/A
1 <sup>st</sup> December 2017

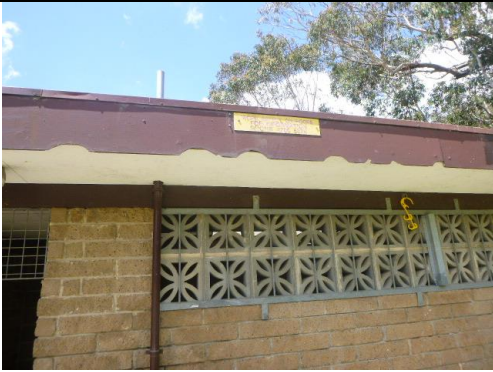
External – Northern Aspect Maroon Fascia Panel Fibre Cement <b>164</b>	Sample #B17355S02 No Asbestos Detected	A5	N/A
1 <sup>st</sup> December 2017

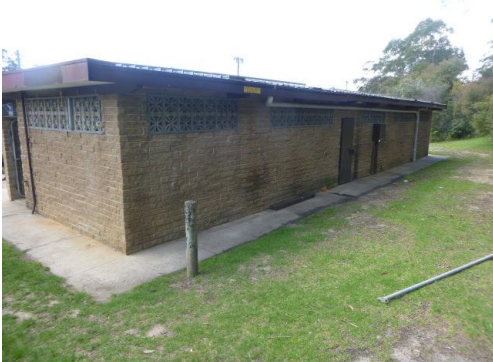
West Aspect Maroon Fascia Panel Fibre Cement <b>165</b>	Same as Sample #B17355S02 No Asbestos Detected	A5	N/A

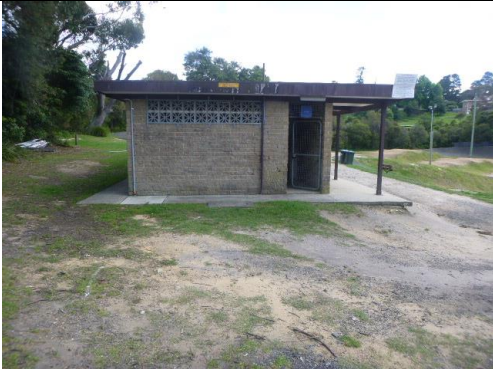
South Aspect Maroon Fascia Panel Fibre Cement <b>166</b>	Same as Sample #B17355S02 No Asbestos Detected	A5	N/A
1 <sup>st</sup> December 2017

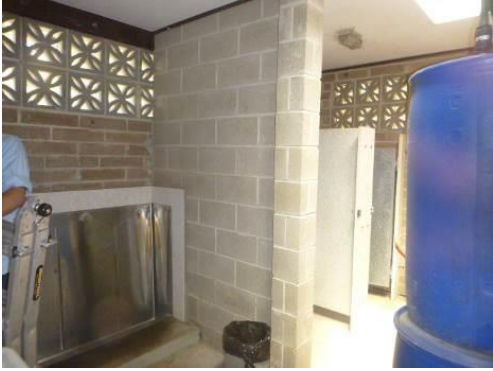
Internal Male Toilet Timber Battens, Brick/Block Walls, Stainless Steel Cistern, Ceramic Toilet, Wash Bowl & Splashback, Reconstituted Rock Partitions, Stainless Steel Urinal, Concrete Floor – Bonded Board Ceiling Approximately 30m <sup>2</sup>	Sample #B17355S03 Chrysotile Asbestos Detected Non-Friable <b>167</b>	A3	Fair Condition Accessible to Tradespeople Refer to Asbestos Management Plan
1 <sup>st</sup> December 2017

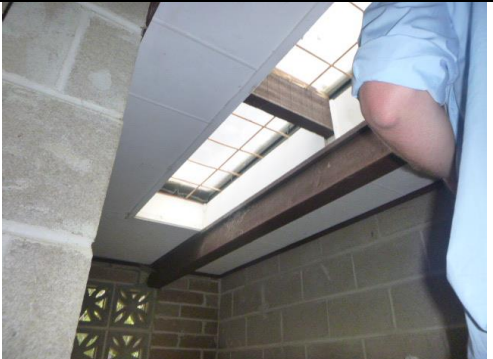
Cement Board Inserts Around Skylight Bonded Board Approximately 1.5m <sup>2</sup> <b>168</b>	Similar to Sample #B17355S03 Chrysotile Asbestos Detected Non-Friable	A3	Good Condition Accessible to Tradespeople Refer to Asbestos Management Plan

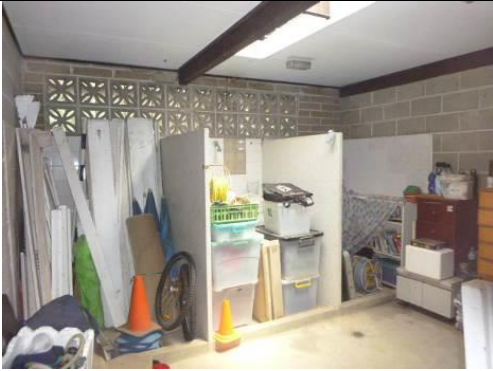
Visiting Team Room Timber Battens, Brick/Block Walls, Stainless Steel Cistern, Ceramic Toilet & Sink, Tile Splashback, Reconstituted Rock Partitions, Concrete Floor - Ceiling Lining Bonded Board Approximately 30m <sup>2</sup>	Similar to Sample #B17355S03 Chrysotile Asbestos Detected Non-Friable <b>169</b>	A3	Good Condition Accessible to Tradespeople Refer to Asbestos Management Plan
1 <sup>st</sup> December 2017

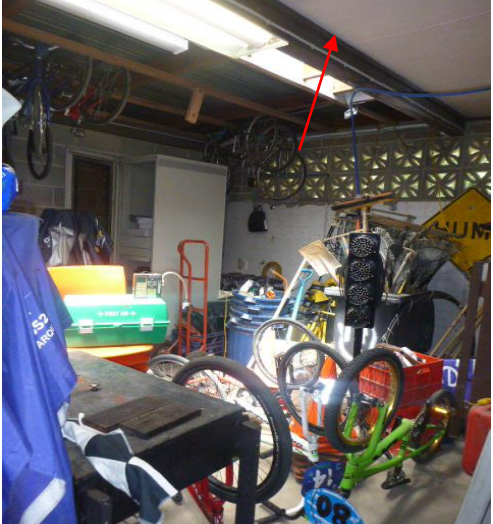
BMX Storage Area Brick/Block Walls, Timber Battens, Concrete Floor - Ceiling Lining Bonded Board Approximately 20m <sup>2</sup> Note: Segments of the Ceiling Have Already Been Removed	Similar to Sample #B17355S03 Chrysotile Asbestos Detected Non-Friable <b>170</b>	A3	Good Condition Accessible to Tradespeople Refer to Asbestos Management Plan

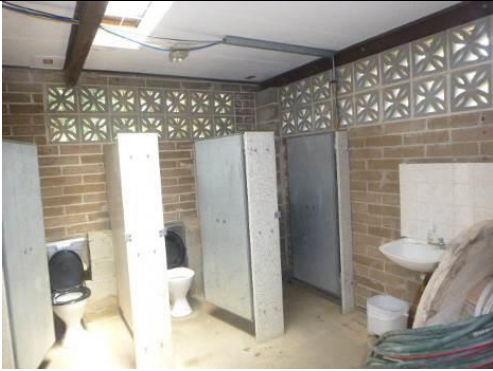
Female Toilet Timber Battens, Brick/Block Walls, Stainless Steel Cistern, Ceramic Toilet & Sink, Tile Splashback, Reconstituted Rock Partitions, Concrete Floor - Ceiling Bonded Board Approximately 30m <sup>2</sup>	Similar to Sample #B17355S03 Chrysotile Asbestos Detected Non-Friable <b>171</b>	A3	Good Condition Accessible to Tradespeople Refer to Asbestos Management Plan
1 <sup>st</sup> December 2017

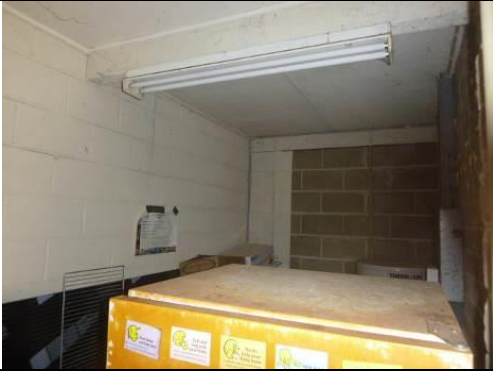
Canteen Store Room Brick/Block Walls, Timber Battens & Concrete Floor - Ceiling Lining Bonded Board Approximately 6m <sup>2</sup>	Similar to Sample #B17355S03 Chrysotile Asbestos Detected Non-Friable <b>172</b>	A3	Good Condition Accessible to Tradespeople Refer to Asbestos Management Plan

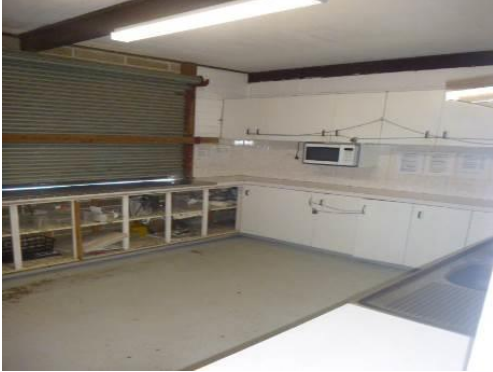
Canteen Brick/Block Walls, Timber Battens, Roller Door, Concrete Floor, Timber & Laminate Cupboards - Ceiling Lining Bonded Board Approximately 12m <sup>2</sup>	Similar to Sample #B17355S03 Chrysotile Asbestos Detected Non-Friable <b>173</b>	A3	Good Condition Accessible to Tradespeople Refer to Asbestos Management Plan

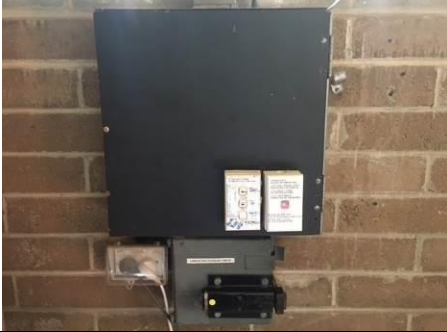
Internal – Canteen Store Room Electrical Back Board Approximately 0.5m <sup>2</sup> <b>174</b>	No Sample Taken Assume Asbestos Containing Material Non-Friable	A3	Good Condition Accessible to Tradespeople Refer to Asbestos Management Plan
1 <sup>st</sup> December 2017

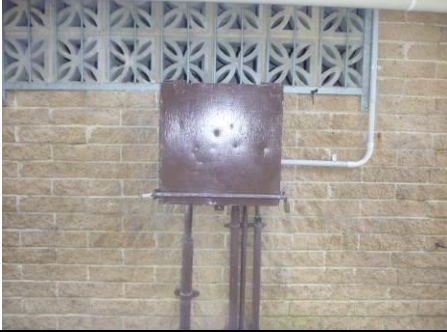
External – Western Aspect Electrical Cabinet Approximately 0.5m <sup>2</sup> Note: Electrical Cabinet Was Locked at Time of Inspection <b>175</b>	No Sample Taken Assume Asbestos Containing Material Unknown Type	A3	Unknown Condition Accessible to Tradespeople Refer to Asbestos Management Plan
1 <sup>st</sup> December 2017

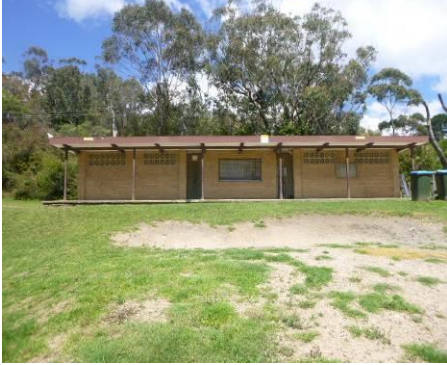
External – Eastern Aspect Aluminium Gutter/ Fascia Cover, Fibre Cement Fascia Board / Soffit Lining, Brick, Timber Top Plate, Steel Odour Pipe, Concrete Pad	No Asbestos Materials Identified <b>2844</b>	A5	N/A

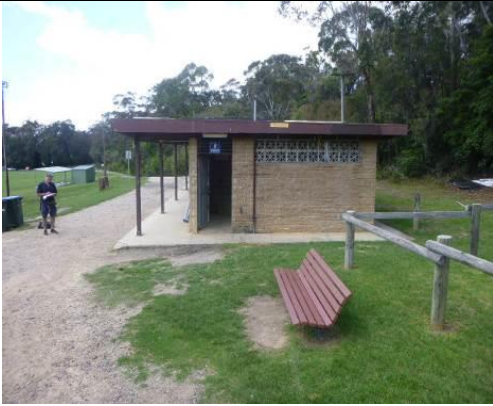
External – Northern Aspect Aluminium Gutter/ Fascia Cover, Fibre Cement Fascia Board / Soffit Lining, Brick, Timber Top Plate, Steel Odour Pipe, Concrete Pad	No Asbestos Materials Identified <b>723</b>	A5	N/A
1st December 2017

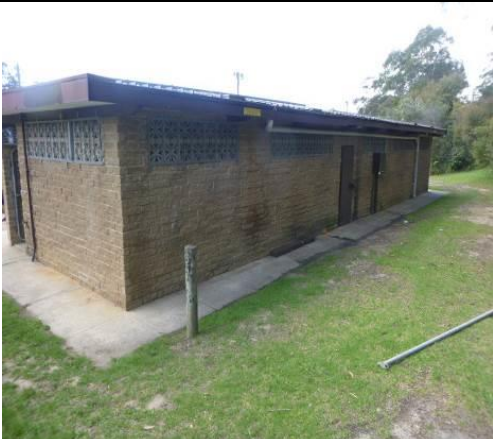
External – Western Aspect Aluminium Gutter/ Fascia Cover, PVC Downpipe, Fibre Cement Fascia Board / Soffit Lining, Brick, Timber Top Plate, Concrete Pad	No Asbestos Material Identified <b>723</b>	A5	N/A
1st December 2017

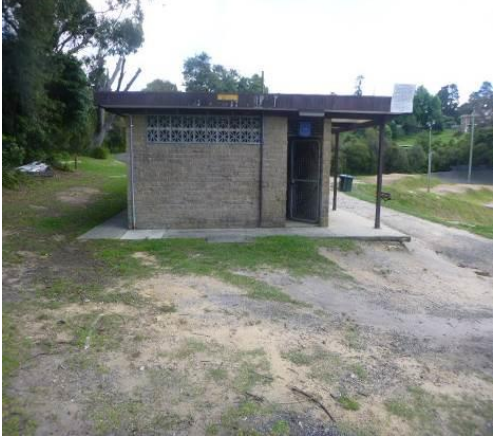
External – Southern Aspect Aluminium Gutter/ Fascia Cover, PVC Downpipe, Fibre Cement Fascia Board / Soffit Lining, Brick, Timber Top Plate, Steel Odour Pipe, Concrete Pad	No Asbestos Material Identified <b>723</b>	A5	N/A

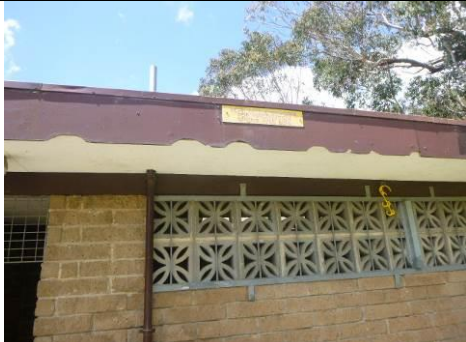
Maroon Paint to Internal & External Surfaces	<0.05 w/w	A4	Paint is not classified as lead based. Less than 1.0% w/w

No lead based paints were detected at Lawson Oval Amenities Block, however good practice would dictate that existing paint, even though is below the recognised standard, should not be sanded and that dust minimisation techniques should be adopted, when undertaking renovation / repair works particularly in heritage period buildings. It would be good practice to wear a P1 dust mask during any paint removal even though it does not contain lead but small particles of paint can still be inhaled or ingested.

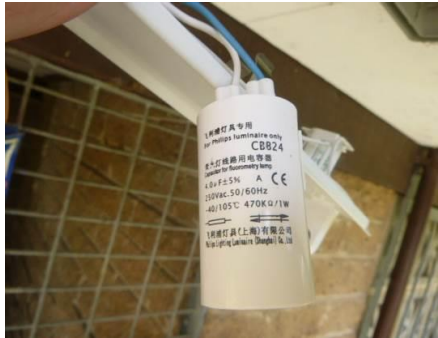
North West Aspect Fluorescent Light Phillips CBB24 Type Capacitor	No PCB's Present  Visual Observation	A5	N/A
1 <sup>st</sup> December 2017

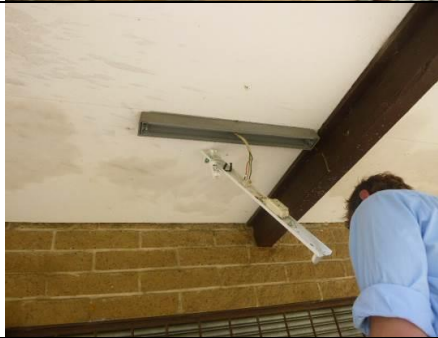
Eastern Aspect Fluorescent Light ATCO 48/03 Type Capacitor	No PCB's Present  Visual Observation	A5	N/A
1 <sup>st</sup> December 2017

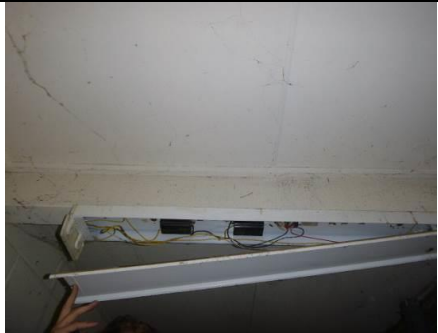
Internal – Canteen Store Fluorescent Light Soltra SK40 Type Capacitor	No PCB's Present  Visual Observation	A5	N/A

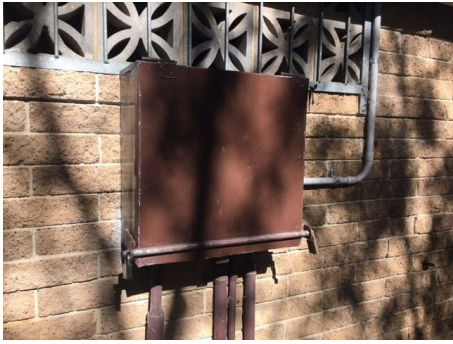
External – Western Aspect Electrical Cabinet Potential Bakelite Approximately 0.5m <sup>2</sup>  Note: Electrical Cabinet Was Locked at Time of Inspection	Assume Phenol Positive Non-Friable	A3	Unknown Condition Accessible to Tradespeople Refer to Management Plan
1 <sup>st</sup> December 2017

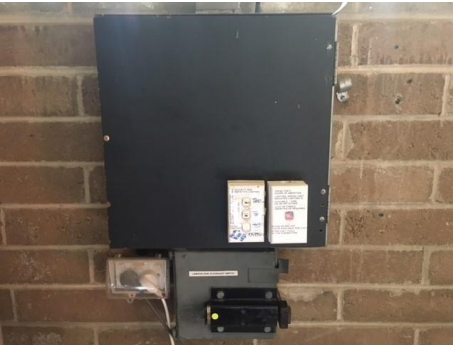
Internal – Canteen Store Room Electrical Back Board Potential Bakelite Approximately 0.5m <sup>2</sup>	Assume Phenol Positive Non-Friable	A3	Good Condition Accessible to Tradespeople Refer to Management Plan
