# Asbestos Register

Regional EnviroScience Pty Ltd was requested by Mr. Rick Harris of Blue Mountain City Council to undertake a Hazardous Building Materials Register and to prepare a Hazardous Materials Management Plan of the Amenities, Pump House and Cottage of the property known as Blackheath Memorial Pool, located at Prince Edward Street, Blackheath, NSW, 2785. The purpose of the audit was to locate and identify asbestos based building materials and product within the building in accordance with the *NSW Work Health and Safety Act and Regulation 2017* and the *Code of Practice; How to Manage and Control Asbestos in the Workplace* [Safe Work Australia: 2016] and the *Code of Practice; How to Safely Remove Asbestos* [Safe Work Australia: 2016].

On the 6<sup>th</sup> December 2017, an Asbestos Audit was conducted at the Blackheath Memorial Pool and asbestos containing materials were found to be present at the premises. Please refer Appendix I for results of products that were considered and consequently analysed but did not contain asbestos.

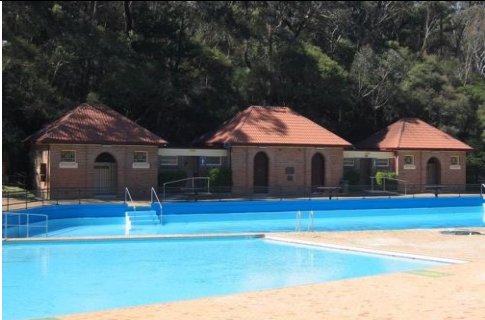
Male and Female Amenities.	N/A		N/A
6 <sup>th</sup> December 2017

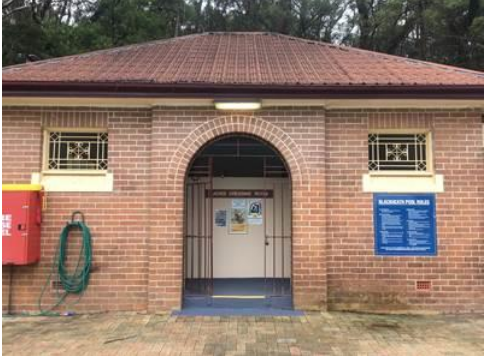
Exterior to Male & Female Amenities & Changerooms. Brick Exterior, Timber Fascia, Bonded Board Eaves, Metal Door & Window Grill, Aluminium Guttering & Downpipes	Sample #B17371S02 Chrysotile Asbestos Detected Non-Friable <b>1155</b>	A4	Good Condition Accessible to Tradespeople Refer to Asbestos Management Plan

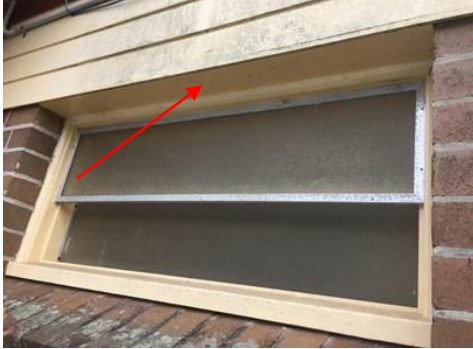
Male & Female Amenities External- Windows Infill Panel Fibre Cement  Approximately 0.5m <sup>2</sup> <b>1156</b>	Sample #B17371S01 Chrysotile Asbestos Detected Non-Friable	A4	Good Condition Accessible to Tradespeople Refer to Asbestos Management Plan
6 <sup>th</sup> December 2017

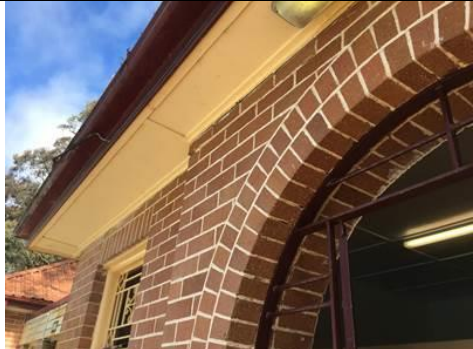
Male Amenities External- Eaves. Fibre Cement  Approximately 10m <sup>2</sup> <b>1157</b>	Sample #B17371S02 Chrysotile Asbestos Detected Non-Friable	A4	Good Condition Accessible to Tradespeople Refer to Asbestos Management Plan
6 <sup>th</sup> December 2017

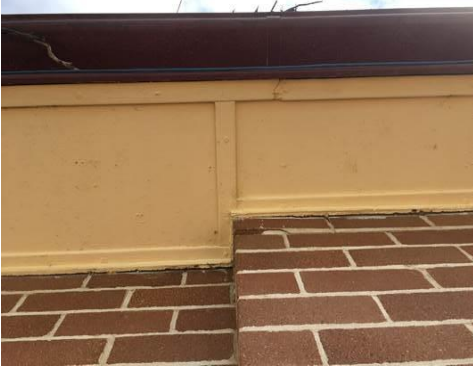
Male Amenities External- Eave Lining Edge & Cover Strips. Fibre Cement  <b>1158</b>	Sample #B17371S03 Chrysotile Asbestos Detected Non-Friable	A4	Good Condition Accessible to Tradespeople Refer to Asbestos Management Plan

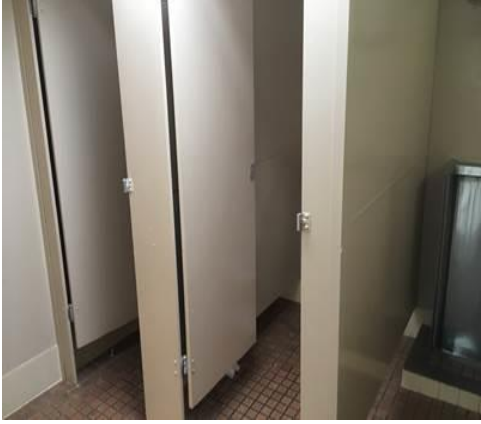
Male Amenities. Ceramic Tile Floor, Rendered Brick Walls, Timber Doors, Bonded Ceiling, Skylight Infill, Aluminium Windows.  Fibre Cement Partitions  Approximately 7m <sup>2</sup>	Sample #B17371S07 Chrysotile Asbestos Detected Non-Friable <b>1159</b>	A4	Good Condition Accessible to Tradespeople Refer to Asbestos Management Plan
6 <sup>th</sup> December 2017

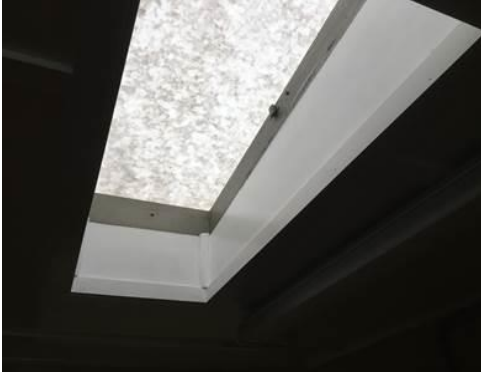
Male Wheelchair Access Amenities.  Skylight Infill Fibre Cement <b>1160</b>	Sample #B17371S04 No Asbestos Detected	A5	N/A
6 <sup>th</sup> December 2017

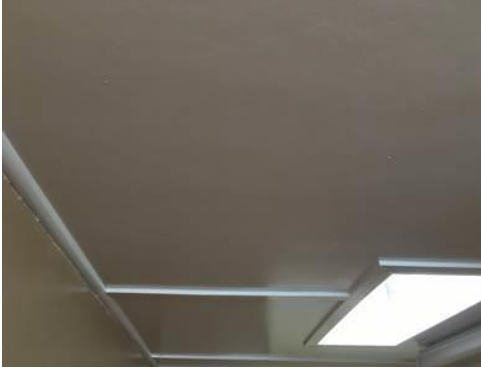
Male Wheelchair Access Amenities Internal- Ceiling.  Fibre Cement <b>1161</b>	Sample #B17371S05 No Asbestos Detected	A5	N/A

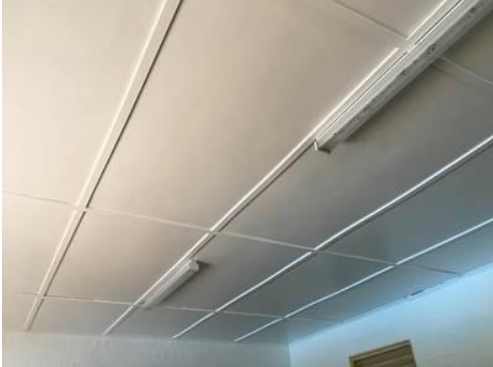
Males Amenities Changeroom Ceiling. Fibre Cement <b>1162</b>	Sample #B17371S06 No Asbestos Detected	A5	N/A
6 <sup>th</sup> December 2017

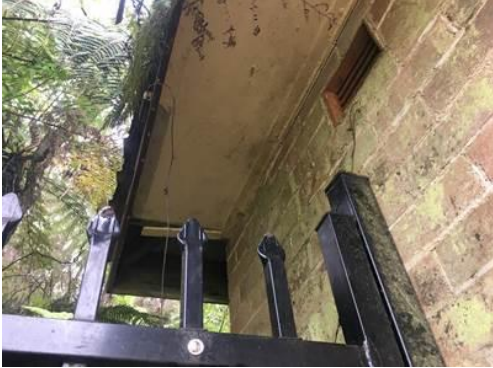
Female Amenities Eaves. Fibre Cement Approximately 12m <sup>2</sup> <b>1163</b>	Sample #B17371S08 Chrysotile Asbestos Detected Non-Friable	A3	Fair Condition Accessible to Tradespeople Refer to Asbestos Management Plan
6 <sup>th</sup> December 2017

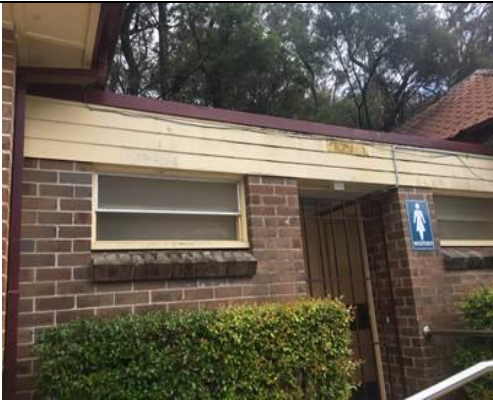
Male & Female Amenities Between Changerooms and Old Kiosk. Brick Walls, Tiled Roof, Fibre Board Window Infills. <b>1164</b>	Similar to Sample #B17371S01 Chrysotile Asbestos Detected Non-Friable	A4	Good Condition Accessible to Tradespeople Refer to Asbestos Management Plan

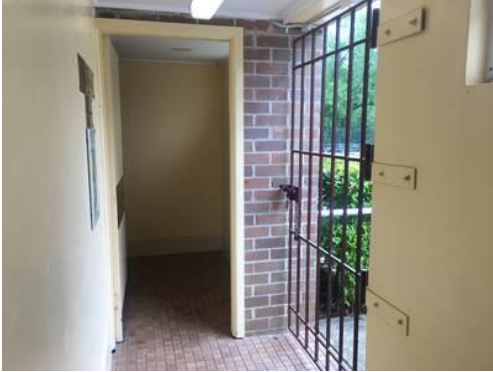
Male and Female Amenities Entries. Brick & Rendered Brick Walls, Ceramic Tiled Floor. <b>1165</b>	No Asbestos Materials Identified.	A5	N/A
6 <sup>th</sup> December 2017

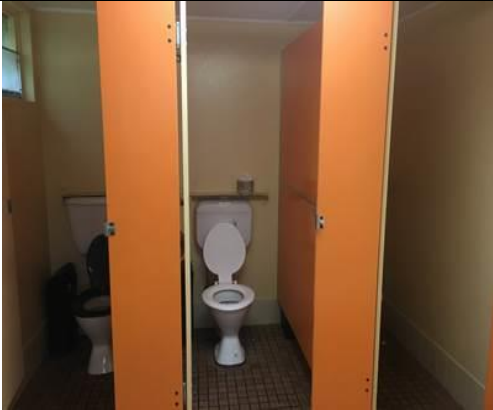
Female Amenities. Fibre Cement Toilet Partitions. Ceramic Tile Floor, Rendered Brick Walls, Timber Doors, Aluminium Windows. Approximately 6m <sup>2</sup>	Sample #B17371S10 Chrysotile Asbestos Detected Non-Friable <b>1166</b>	A4	Good Condition Accessible to Tradespeople Refer to Asbestos Management Plan
6 <sup>th</sup> December 2017

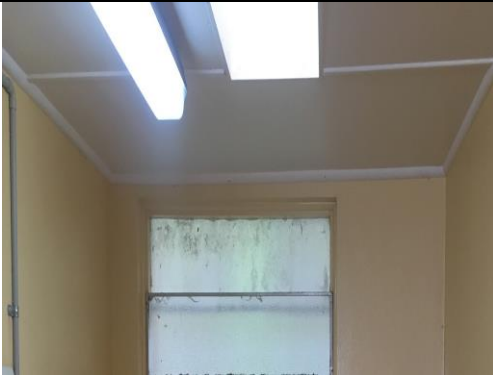
Female Amenities. Ceramic Tiled Floor, Rendered Brick Walls. Toilet Ceiling & Infill Below Skylight. Approximately 9m <sup>2</sup>	Sample #B17371S09 Chrysotile Asbestos Detected Non-Friable <b>1167</b>	A4	Good Condition Accessible to Tradespeople Refer to Asbestos Management Plan

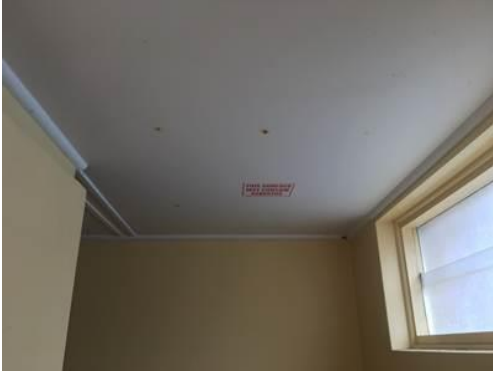
Female Wheelchair Access Toilet Entry. Ceiling Fibre Cement Approximately 4m <sup>2</sup> <b>1168</b>	Similar to Sample #B17371S09 Chrysotile Asbestos Detected Non-Friable	A4	Good Condition Accessible to Tradespeople Refer to Asbestos Management Plan
6 <sup>th</sup> December 2017

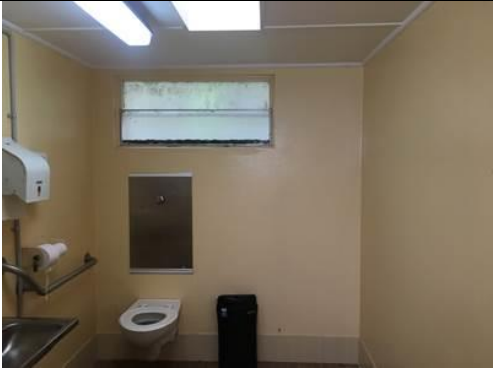
Female Wheelchair Access Toilet. Ceiling & Skylight Infills. Fibre Cement Ceiling. Approximately 9m <sup>2</sup>	Similar to Sample #B17371S09 Chrysotile Asbestos Detected Non-Friable <b>1169</b>	A4	Good Condition Accessible to Tradespeople Refer to Asbestos Management Plan
6 <sup>th</sup> December 2017

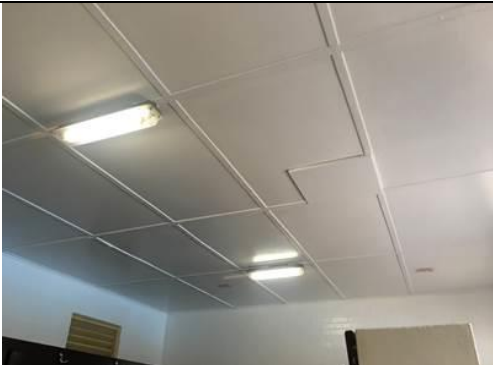
Female Amenities Changeroom. Internal Ceiling Fibre Cement Approximately 25m <sup>2</sup>	Sample #B17371S11 Chrysotile Asbestos Detected Non-Friable <b>1170</b>	A4	Good Condition Accessible to Tradespeople Refer to Asbestos Management Plan

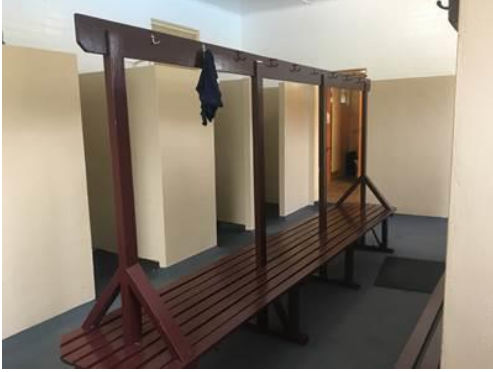
Female Amenities Changeroom. Rendered Brick Walls & Shower Partitions, Concrete Floor, Timber Seating, Fibre Cement Ceiling. <b>1171</b>	Sample #B17371S11 Chrysotile Asbestos Detected Non-Friable	A4	Good Condition Accessible to Tradespeople Refer to Asbestos Management Plan
6 <sup>th</sup> December 2017

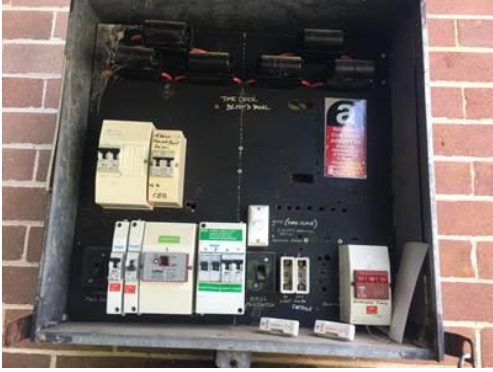
Electrical Meter Board. External Wall of Female Amenities. Identified as Containing ACM. <b>1172</b>	Assume Contains Asbestos Materials.	A4	Good Condition Accessible to Tradespeople Refer to Asbestos Management Plan
6 <sup>th</sup> December 2017

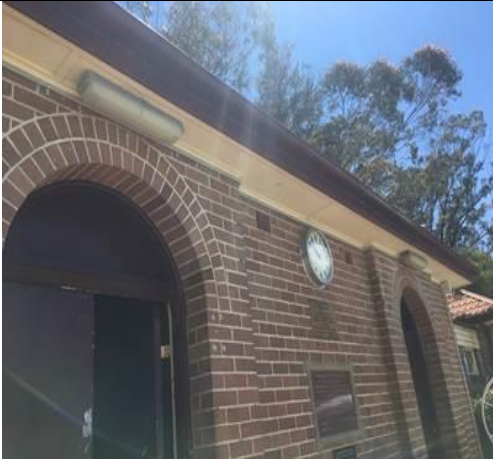
Old Kiosk & Storeroom. Brick external Walls, Timber Fascia, Steel Gutters and Downpipes, Tiled Roof. Fibre Cement Eaves Approximately 15m <sup>2</sup>	Similar to Sample #B17371S08 Chrysotile Asbestos Eaves Detected Non-Friable <b>1173</b>	A3	Fair Condition Accessible to Tradespeople Refer to Asbestos Management Plan

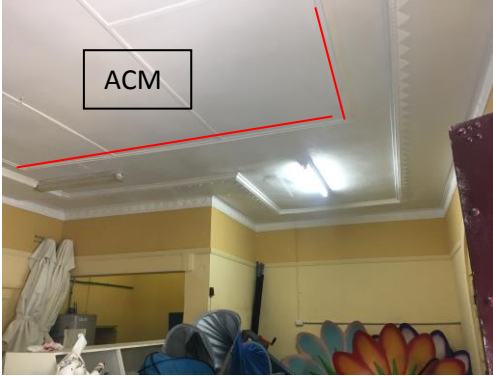
Old Kiosk/Storeroom. Rendered Brick Walls, Concrete Floor. MDF, Plaster & Fibre Cement Ceiling. Approximately 4m <sup>2</sup> <b>1175</b>	Sample #B17371S13 Chrysotile Asbestos Detected Non-Friable	A4	Good Condition Accessible to Tradespeople Refer to Asbestos Management Plan
6 <sup>th</sup> December 2017

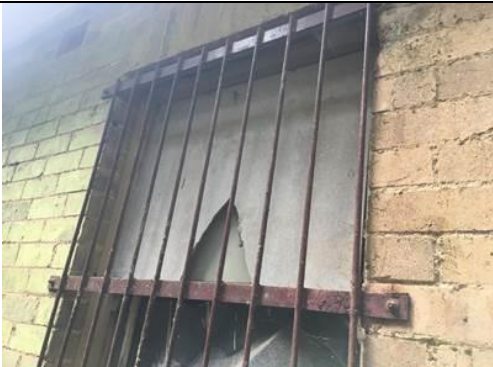
North Storeroom Rear of Kiosk Window External Fibre Cement Approximately 1m <sup>2</sup> <b>1176</b>	Sample #B17371S14 Chrysotile Asbestos Detected Non-Friable	A2	Poor Condition Accessible to Tradespeople Refer to Asbestos Management Plan

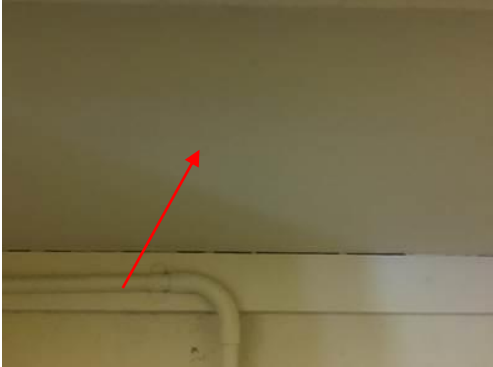
Infill Above Oven Old Kiosk/ Storeroom.  Fibre Cement Approximately 1m <sup>2</sup> <b>1177</b>	Sample #B17371S15 Chrysotile Asbestos Detected Non-Friable	A4	Good Condition Accessible to Tradespeople Refer to Asbestos Management Plan
6 <sup>th</sup> December 2017

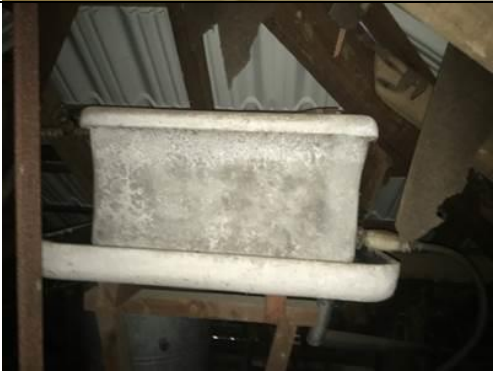
Old Kiosk/Storeroom.  Water Heater Base Fibre Cement  Approximately 3m <sup>2</sup> <b>1178</b>	Sample #B17371S22 Chrysotile Asbestos Detected Non-Friable	A2	Good Condition Accessible to Tradespeople Refer to Asbestos Management Plan
6 <sup>th</sup> December 2017

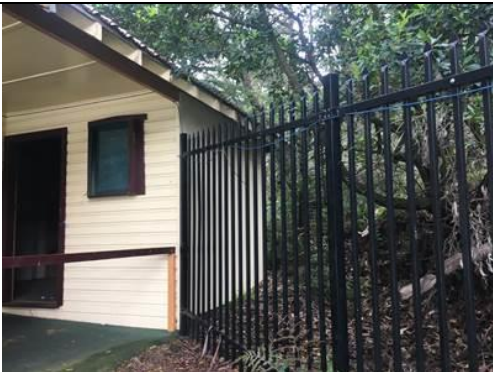
Cottage.  Containing Office & First Aid Room South Wall Timber Cladding, Remainder Bonded Sheeting, Tiled Roof with Metal Capping, No Eaves, Soffit	N/A		N/A

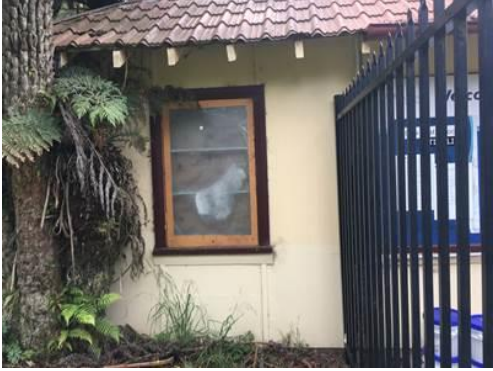
External North, West and East Wall Cladding. Fibre Cement. Approximately 35m <sup>2</sup> <b>1179</b>	No Asbestos Found	A5	Clearance Certificate JMB 10/09/2020 HPE 20/200752

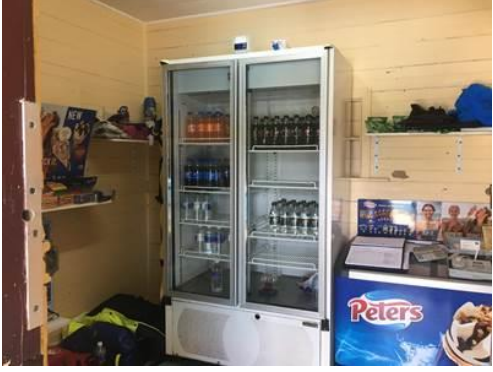
Cottage Office. Timber Clad Walls, Ceiling, skirting and Architraves, Vinyl Floor Covering. <b>1180</b>	No Asbestos Materials Identified.	A5	N/A
6 <sup>th</sup> December 2017

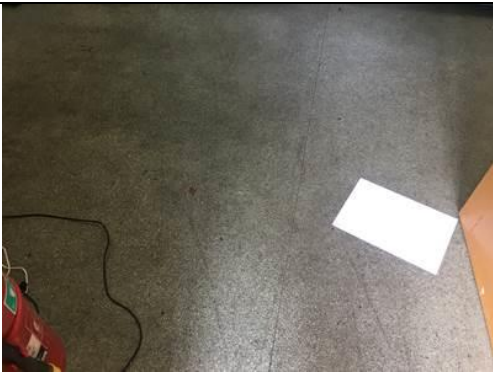
Office Area Floor Linoleum Approximately 6m <sup>2</sup> <b>1181</b>	Sample #B17371S16 No Asbestos Detected	A5	N/A

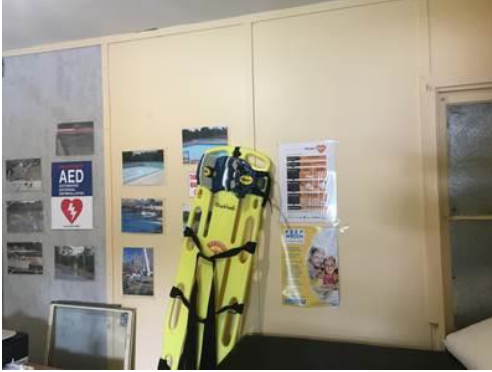
Cottage First Aid Room.  Timber & Concrete Floor, Fibre Cement Northern, Western & Southern Walls & Ceiling. <b>1182</b>	No Asbestos Found	A5	Clearance Certificate JMB 10/09/2020 HPE 20/200752
6 <sup>th</sup> December 2017

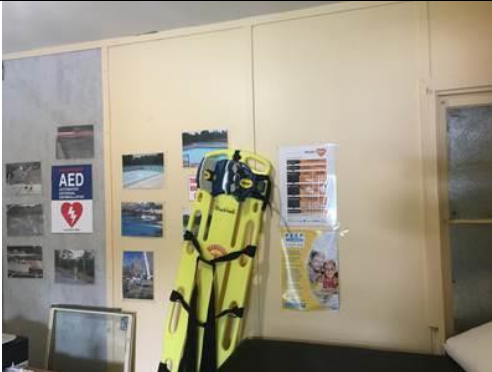
Cottage First Aid Room.  Three (3) Eastern Wall Sheets, Fibre Cement <b>1183</b>	Sample #B17371S20 No Asbestos Detected	A5	N/A
6 <sup>th</sup> December 2017

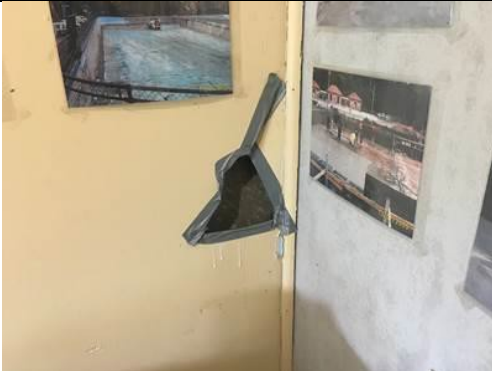
Cottage First Aid Room.  Walls Fibre Cement  Approximately 15m <sup>2</sup> <b>1184</b>	No Asbestos Found	A5	Clearance Certificate JMB 10/09/2020 HPE 20/200752

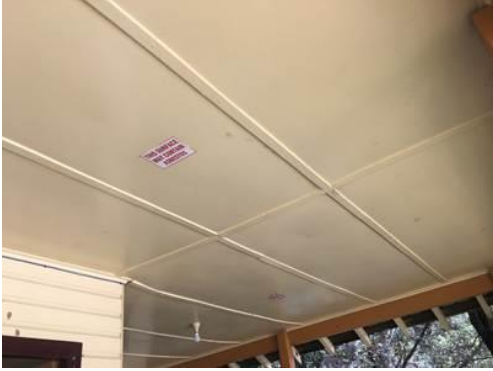
Cottage. External Soffit Fibre Cement Approximately 12m <sup>2</sup>  <b>1186</b>	No Asbestos Found	A5	Clearance Certificate JMB 10/09/2020 HPE 20/200752
6 <sup>th</sup> December 2017

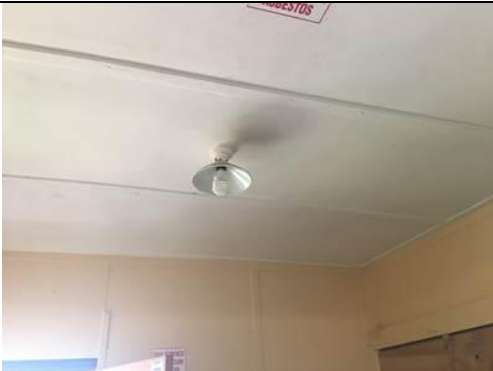
Cottage. First Aid Room Ceiling Lining Fibre Cement Approximately 11m <sup>2</sup>  <b>1185</b>	No Asbestos Found	A5	Clearance Certificate JMB 10/09/2020 HPE 20/200752
6 <sup>th</sup> December 2017

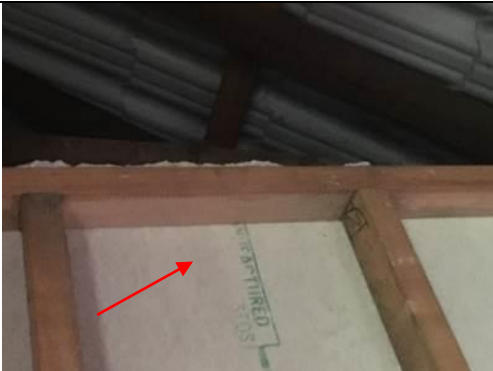
Cottage. 3 Panels East Wall First Aid Room Fibre Cement  <b>1187</b>	No Asbestos Found	A5	N/A

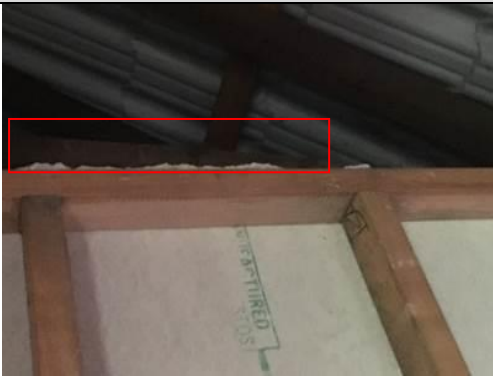
Cottage. Overhang ceiling from First Aid Room into Empty Room Approximately 1m <sup>2</sup>  <b>1188</b>	No Asbestos Found	A5	N/A  Cleared ART 18/7/2019
6 <sup>th</sup> December 2017

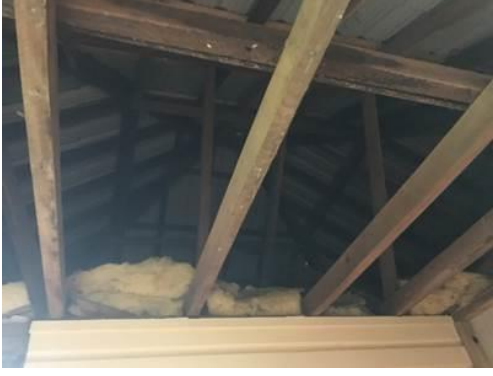
Cottage Vacant Storeroom. Ceiling Removed, Timber Flooring. Note: Exposed Asbestos & Poorly Removed Ceiling Sheeting to Adjacent Room.  <b>1189</b>		A4	Clearance Certificate JMB 10/09/2020 HPE 20/200752
6 <sup>th</sup> December 2017

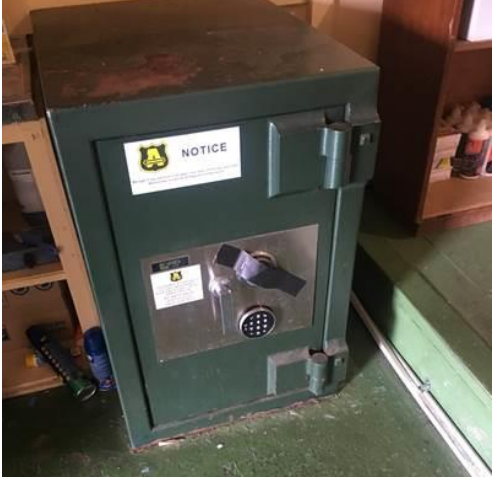
Safe in First Aid Room  <b>1190</b>	Nil Access Potential Asbestos in Door Lining Non-Friable	A4	Sealed & Bonded. Accessible to Tradespeople Refer to Asbestos Management Plan

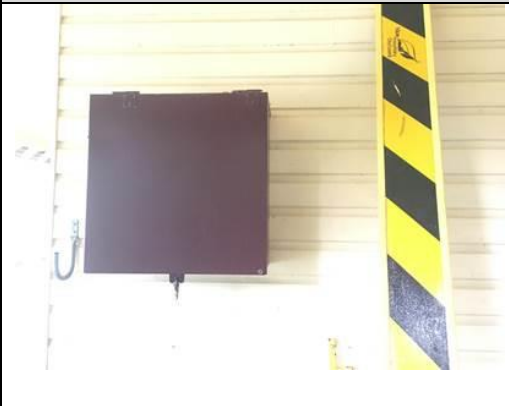
Meter Box External Cottage Electrical Bakelite Backing Board <b>1191</b>	No Access Available, Assume Contains Asbestos Non-Friable	A4	Presume in Good Condition Accessible to Tradespeople Refer to Asbestos Management Plan
6 <sup>th</sup> December 2017

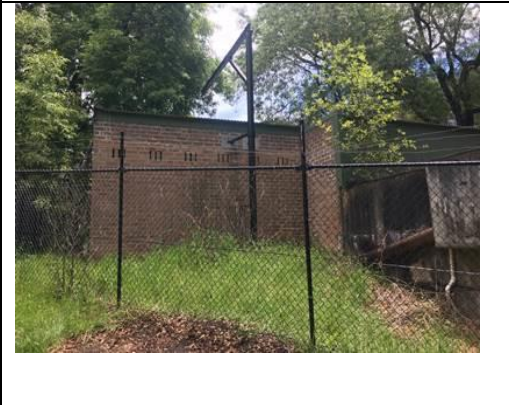
Plant Room. Exterior External Brick Walls, Concrete & Steel Roof, Steel Guttering. <b>1192</b>	No Asbestos Materials Identified	A5	N/A
6 <sup>th</sup> December 2017

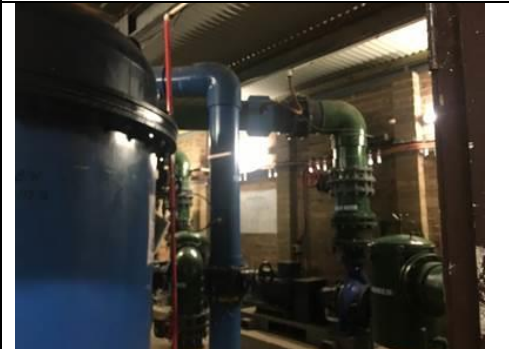
Plant Room. Interior Brick walls, Concrete Floor, Steel Piping & Roof <b>1193</b>	No Asbestos Materials Identified	A5	N/A

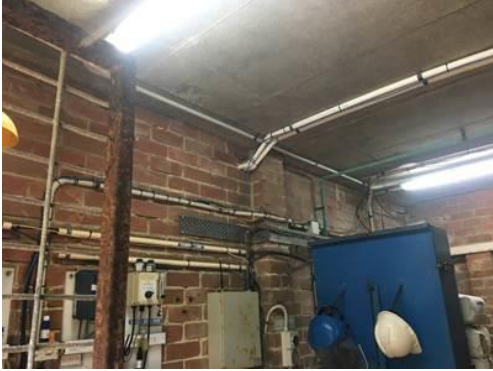
Plant Room. Interior Brick walls, Concrete Floor & Roof, Steel Piping & Roof.  <b>1194</b>	No Asbestos Materials Identified	A5	N/A
6 <sup>th</sup> December 2017

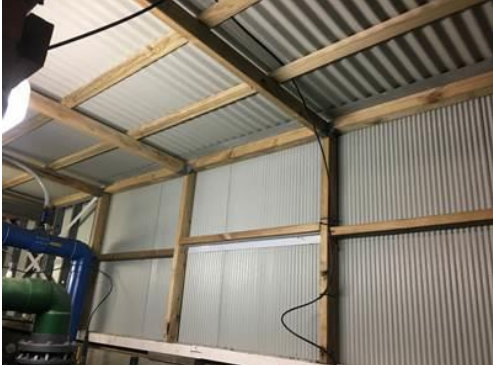
Plant Room. Room Attached the Main Plant Room. Concrete and Corrugated Iron Clad Walls and Roof, Concrete Floor.  <b>1195</b>	No Asbestos Materials Identified	A5	N/A

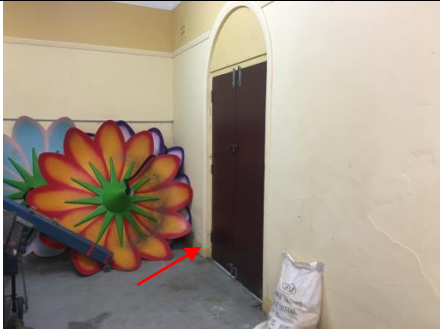
Cream Paint Old Skirting in Kiosk/ Storeroom	<0.05% w/w	A5	Paint is not classified as lead based. Less than 1.0% w/w
17371- S02 (181888-2)

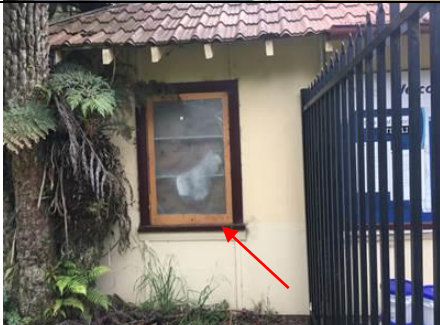
Orange Paint External Cottage	0.2% w/w	A5	Paint is not classified as lead based. Less than 1.0% w/w

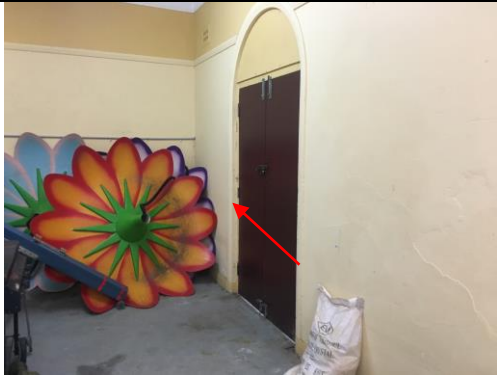
Paint on Storeroom/ Old Kiosk Doors External	0.2% w/w	A5	Paint is not classified as lead based. Less than 1.0% w/w

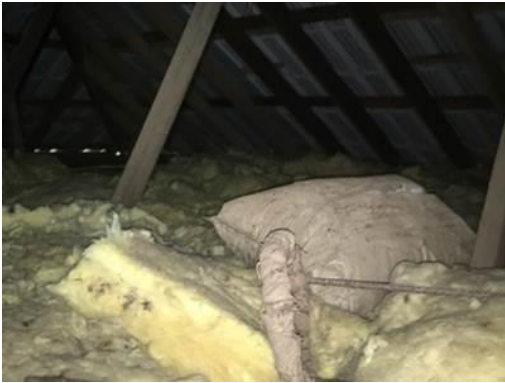
Cottage Ceiling SMF Insulation	Visual Inspection	A5	Bonded & In Good Condition. Not High Risk.
6 <sup>th</sup> December 2017

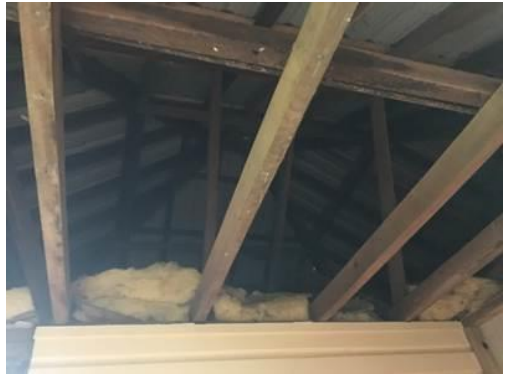
First Aid Room Ceiling SMF Insulation	Visual Inspection	A5	Bonded & In Good Condition. Not High Risk.

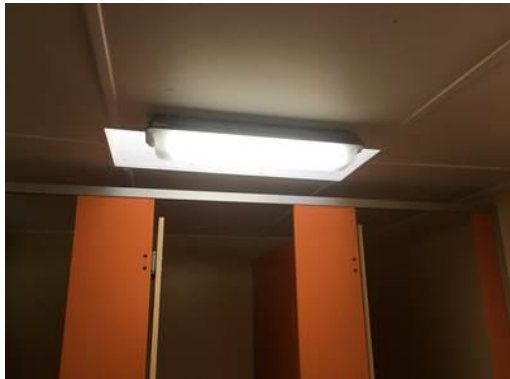
Male & Female Amenities.  Toilet & Changeroom Fluorescent Lights No PCB's Present	Visual Inspection	A5	N/A

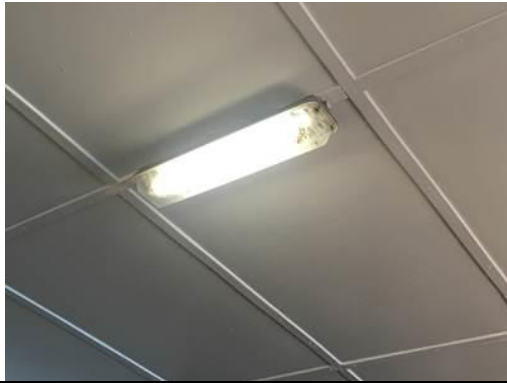
Male & Female Amenities. Toilet Fluorescent Lights No PCB's Present	Visual Inspection	A5	N/A
6 <sup>th</sup> December 2017

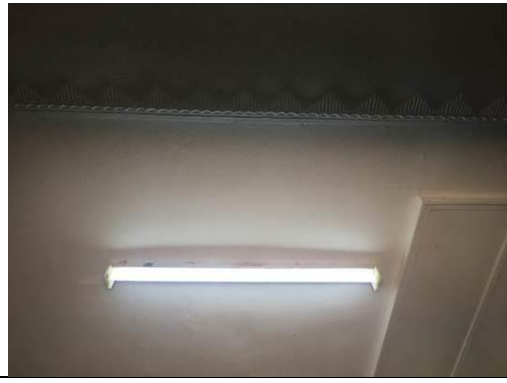
Old Kiosk & Storeroom. Fluorescent Lights No PCB's Present	Visual Inspection	A5	N/A
6 <sup>th</sup> December 2017

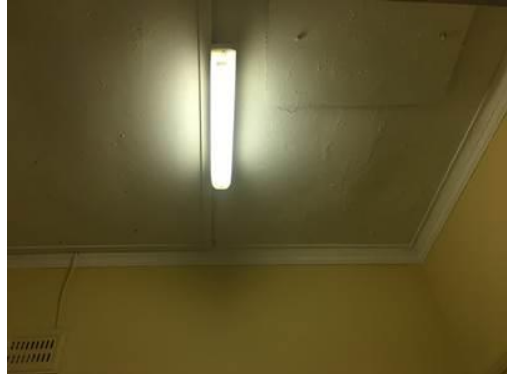
Old Kiosk & Storeroom. Room Adjacent Kiosk, Fluorescent Light. No PCB's Present

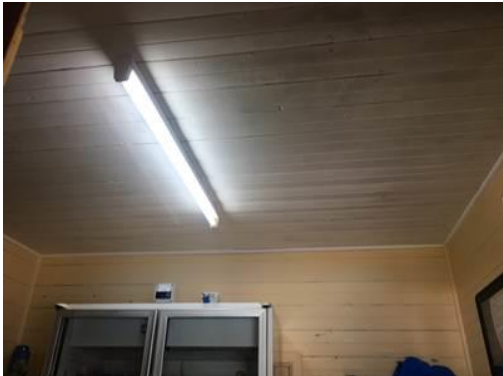
Cottage. Office Fluorescent Lights No PCB's Present	Visual Inspection	A5	N/A

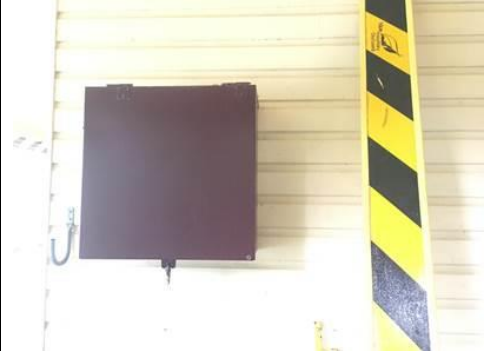
Meter Box External Cottage Electrical Bakelite Backing Board	No Access Assume Phenol Positive	A4	Presume in Good Condition Accessible to Tradespeople Refer to Management Plan
6 <sup>th</sup> December 2017

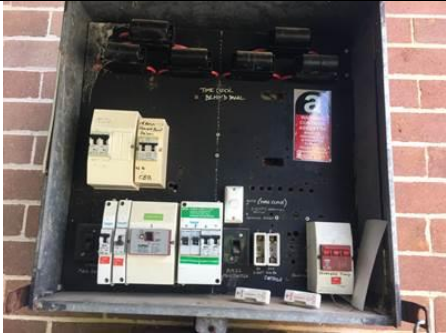
External Electrical Bakelite Backing Board	Visual Inspection Assume Phenol Positive	A4	Good Condition Accessible to Tradespeople Refer to Management Plan

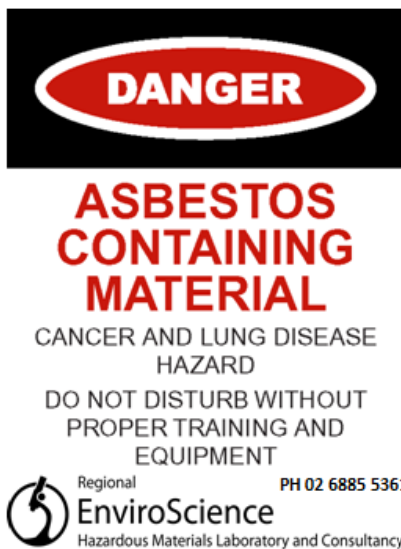
Work Health and Safety Regulation 2017 R422, R424, R427 and R429 requires that the person with the management control of the workplace to identify asbestos containing materials and the asbestos material that has been identified to date should be labelled and ensured that it complies with the *Australian Standard 1319: Safety Signs for the Occupational Environment*; signage should be similar to the label detailed below.

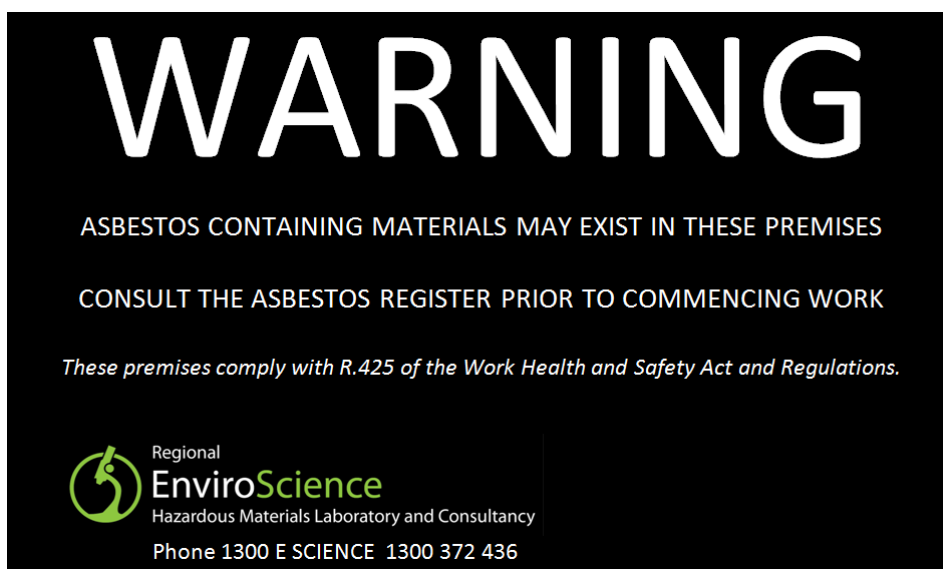
Signage should also be placed at the entry points to the building/plant similar to the one detailed below

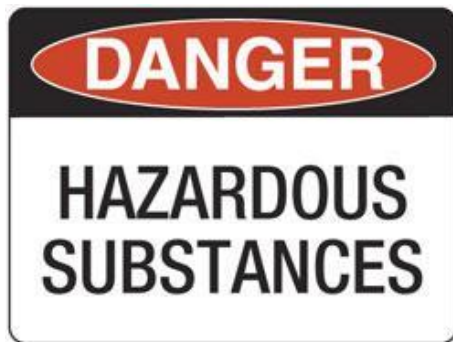
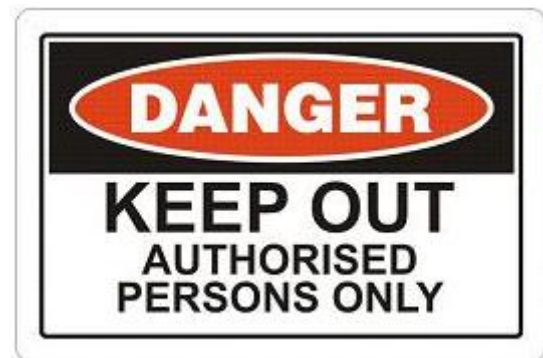
It is recommended that signage be placed around the perimeter of the site, together with barriers constructed of barrier tape and or trestles. Signage should be similar to the ones detailed below.
