Asbestos Register

Regional EnviroScience Pty Ltd was requested by Mr. Rick Harris of Blue Mountain City Council to undertake a Hazardous Building Materials Register and to prepare a Hazardous Materials Management Plan of the Clubhouse and Amenities buildings, for the site known as Knapsack Park, located at Barnet Street, Glenbrook, NSW, 2773. The purpose of the audit was to locate and identify asbestos based building materials and product within the building in accordance with the *NSW Work Health and Safety Act and Regulation 2017* and the *Code of Practice; How to Manage and Control Asbestos in the Workplace* [Safe Work Australia: 2016] and the *Code of Practice; How to Safely Remove Asbestos* [Safe Work Australia: 2016].

On the 5th December 2017, an Asbestos Audit was conducted at the Knapsack Park on the Clubhouse and Amenities buildings and asbestos containing materials were found to be present at the premises. Please refer Appendix I for results of products that were considered and consequently analysed but did not contain asbestos.

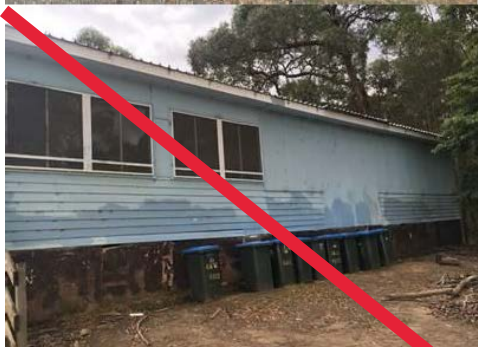
Clubhouse Exterior East, Fibre Cement. Lower section of the Wall is Timber Weatherboard. Approximately 20m ²	Sample #B17365S01 Chrysotile Asbestos Detected Non-Friable 752	A3	Fair Condition Accessible to Tradespeople Refer to Asbestos Management Plan

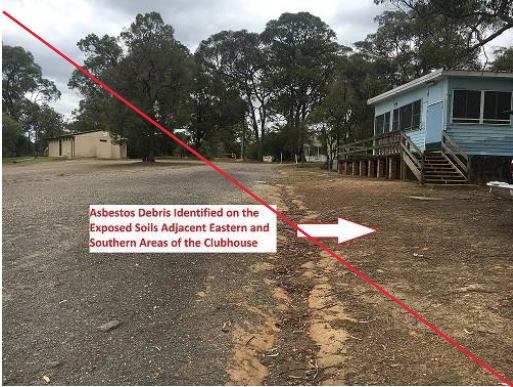
Asbestos Debris Identified on the Soils Surface Adjacent the Eastern and Southern Sides of the Clubhouse.	Sample #B17365S09 Chrysotile-Asbestos Detected Non-Friable 753	A1	Poor Condition- Accessible to Tradespeople Refer to Asbestos- Management Plan SLR CC #610.17816.00000.0300-V01-CLR - 18/263586
5 th December 2017

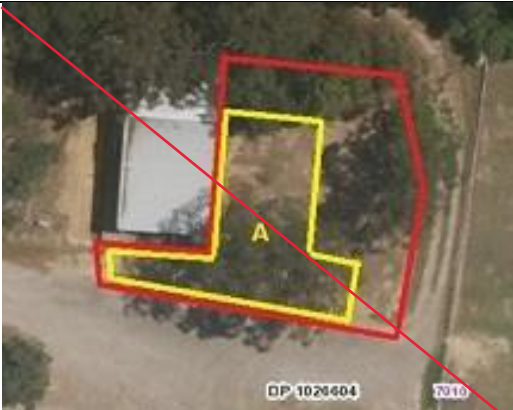
Barricade-Fencing 'Red', Surrounding the Exposed-Asbestos-Debris.	Sample #B17365S09 Chrysotile-Asbestos- Detected- Non-Friable 755	A1	Poor Condition- Accessible to Tradespeople Refer to Asbestos- Management Plan SLR CC #610.17816.00000.0300-V01-CLR - 18/263586
5 th December 2017

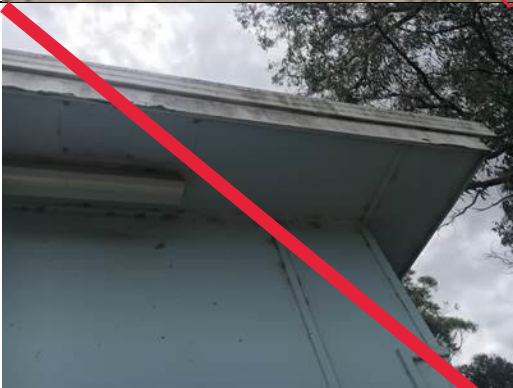
Clubhouse Southern, Eastern, Northern & North-western Eaves, Fibre Cement Approximately 23m ²	Sample #B17365S02 Chrysotile Asbestos Detected Non-Friable 756 Asbestos removed - Clearance Certificate 22/06/20 TRIM ref. 21/11398	A3	Fair Condition Accessible to Tradespeople Refer to Asbestos Management Plan

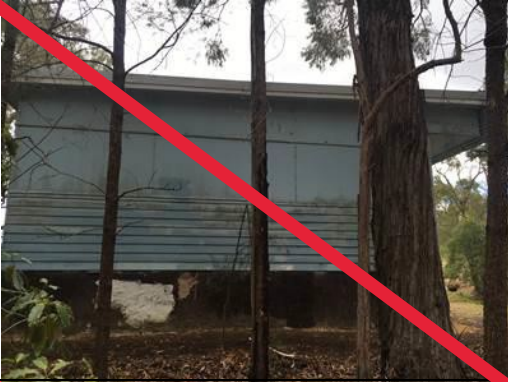
Northern Aspect Fibre Cement. Lower section of the Wall is Timber Weatherboard. 757	Same as Sample #B17365S01 Chrysotile Asbestos Detected Non-Friable	A3	Fair Condition Accessible to Tradespeople Refer to Asbestos Management Plan
5 th December 2017

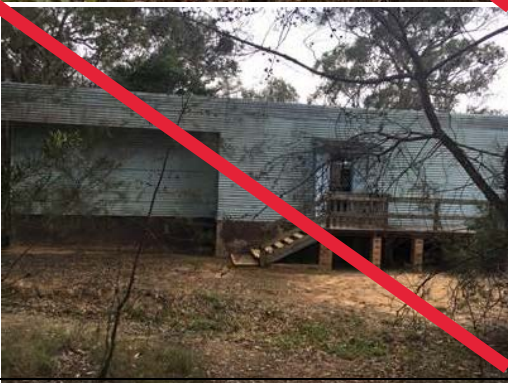
Western Aspect Corrugated Iron Wall Cladding, Rendered Brick Footings, Timber and Brick Verandah. 758	No Asbestos Materials Identified.	A5	N/A
5 th December 2017

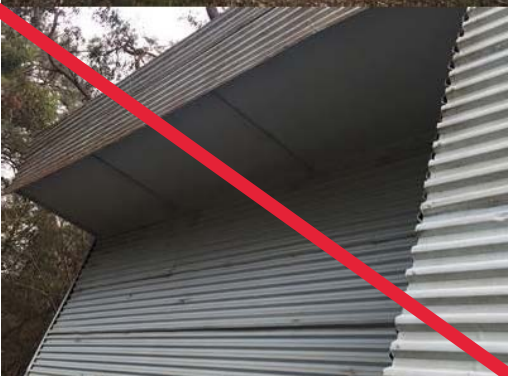
Western Aspect Eaves Fibre Cement Approximately 3m² 759	Same as Sample #B17365S02 Chrysotile Asbestos Detected Non-Friable	A3	Fair Condition Accessible to Tradespeople Refer to Asbestos Management Plan

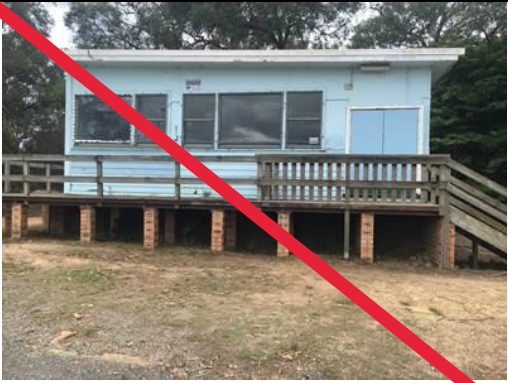
Southern Aspect. Fibre Cement Board and Timber Weatherboard Wall Cladding. Aluminium Framed Windows, Timber and Brick Verandah.	Same as Sample #B17365S01 Chrysotile Asbestos Detected Non-Friable 760 Asbestos removed - Clearance Certificate 22/06/20 TRIM ref. 21/11398	A3	Fair Condition Accessible to Tradespeople Refer to Asbestos Management Plan
5 th December 2017

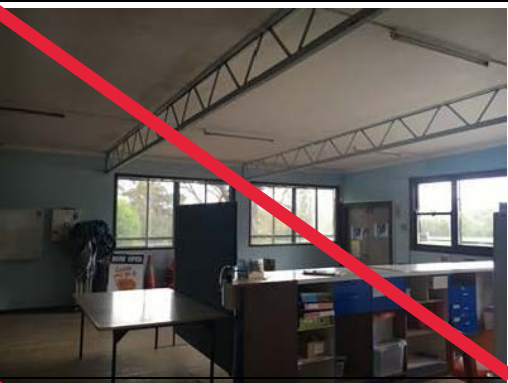
Internal Southeast Aspect. Plaster Board Ceiling & Walls, Timber Flooring, Steel Exposed Roof Support Beams.	No Asbestos Materials Identified. 761 Asbestos removed - Clearance Certificate 22/06/20 TRIM ref. 21/11398	A5	N/A
5 th December 2017

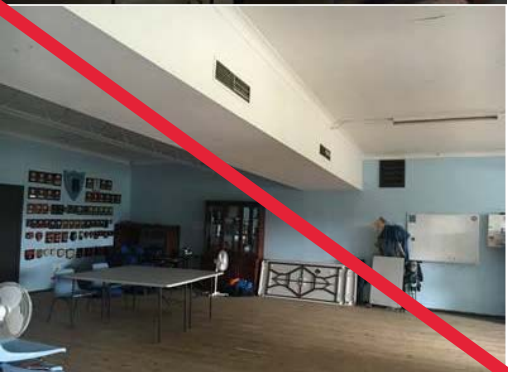
Clubhouse Internal Northeast Aspect. Plaster Board Ceiling, Air Conditioning Cover & Walls, Timber Flooring.	No Asbestos Materials Identified. 762 Asbestos removed - Clearance Certificate 22/06/20 TRIM ref. 21/11398	A5	N/A

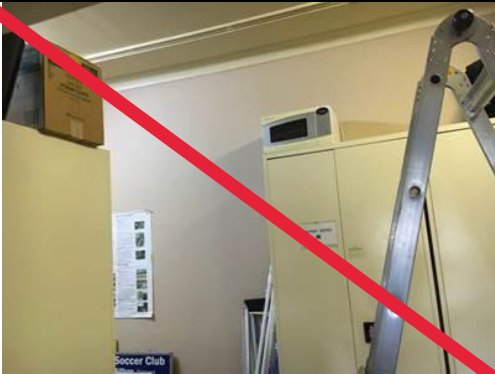
Clubhouse Storeroom and Office. Plaster Board Ceiling & Walls, Timber Flooring. 763	No Asbestos Materials Identified	A5	N/A
5 th December 2017

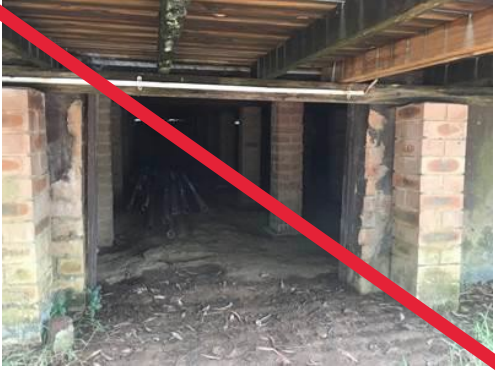
Clubhouse Sub Floor Brick Supports, Timber Flooring Above & No Packers Identified 764	No Asbestos Materials Identified	A5	N/A
5 th December 2017

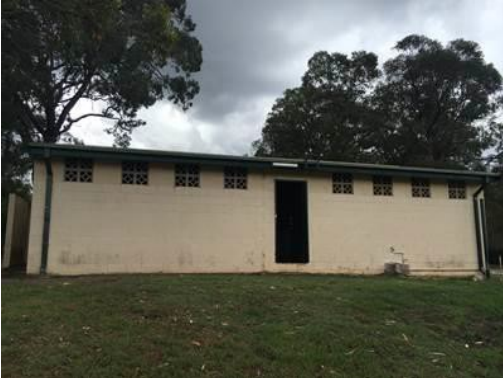
Amenities East Aspect. Concrete Block Walls, Timber fascia and Steel gutters and Downpipes. 765	No Asbestos Materials Identified	A5	N/A
5 th December 2017

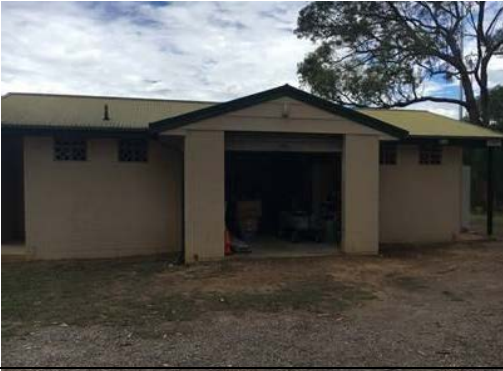
Amenities West Aspect. Roller Door to Store, Concrete Block Walls, Timber Fascia, Corrugated Iron Roof. 766	No Asbestos Materials Identified	A5	N/A
5 th December 2017

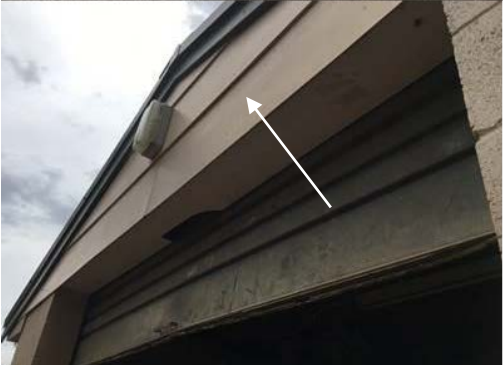
Amenities West Aspect Gable. Fibre Cement 767	Sample #B17365S03 No Asbestos Detected	A5	N/A

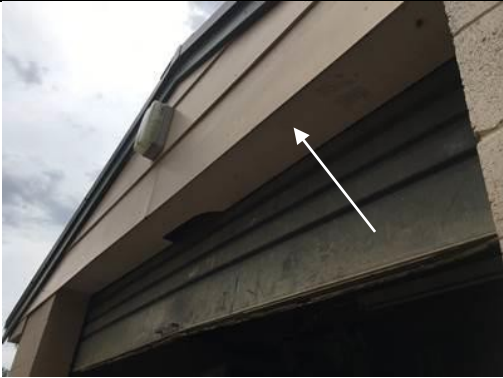
Amenities West Infill above the Roller Door Entry. Fibre Cement. 768	Sample #B17365S12 No Asbestos Detected	A5	N/A
5 th December 2017

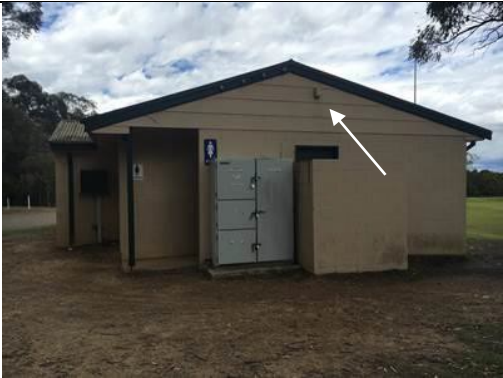
Southern Aspect. Gabel Fibre Cement, Concrete Block Walls, Timber Fascia. 770	Same as Sample #B17365S03 No Asbestos Detected	A5	N/A
5 th December 2017

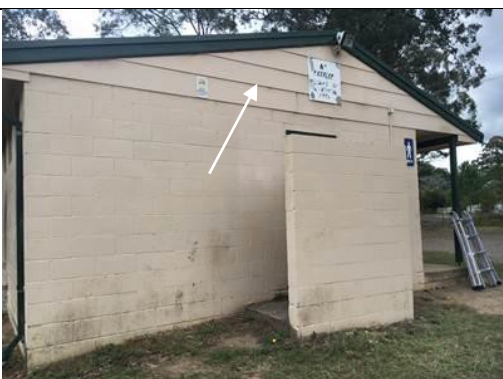
Amenities North Aspect. Brick Walls, Timber Facia, Corrugated Iron Roof. Gabel Fibre Cement 771	Same as Sample #B17365S03 No Asbestos Detected	A5	N/A

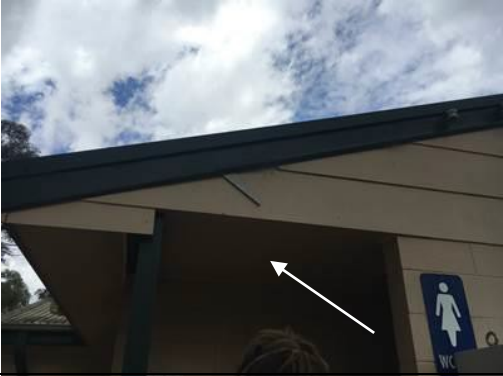
Amenities Eaves South Fibre Cement Approximately 10m ² 772	Sample #B17365S04 Chrysotile Asbestos Detected Non-Friable	A4	Good Condition Accessible to Tradespeople Refer to Asbestos Management Plan
5 th December 2017

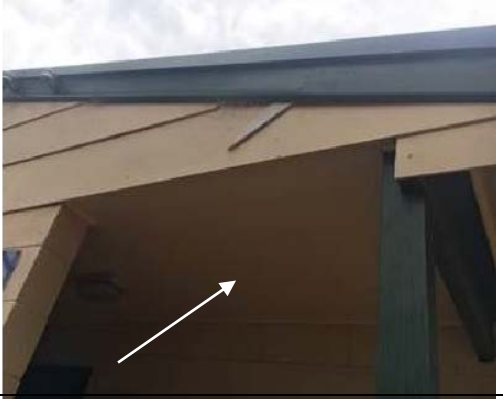
Amenities Eaves North Fibre Cement Approximately 12m ² 773	Same as Sample #B17365S04 Chrysotile Asbestos Detected Non-Friable	A4	Good Condition Accessible to Tradespeople Refer to Asbestos Management Plan
5 th December 2017

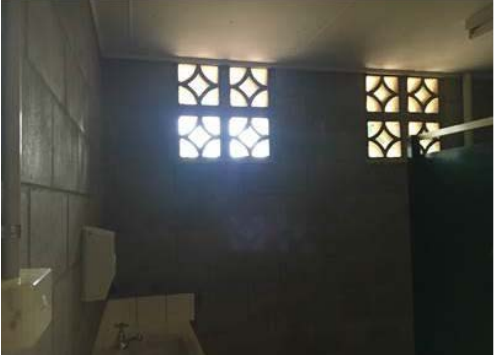
Amenities Male Toilets Ceiling Sheeting Fibre Cement Approximately 9m ² 774	Sample #B17365S05 Chrysotile Asbestos Detected Non-Friable	A4	Good Condition Accessible to Tradespeople Refer to Asbestos Management Plan

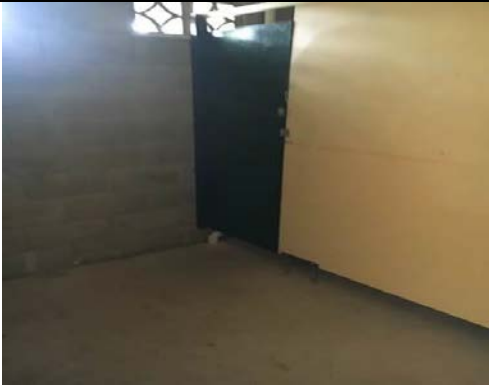
Amenities Male Toilets Cubical Partitions Fibre Cement Approximately 5m ² 775	Sample #B17365S06 Chrysotile Asbestos Detected Non-Friable	A4	Good Condition Accessible to Tradespeople Refer to Asbestos Management Plan
5 th December 2017

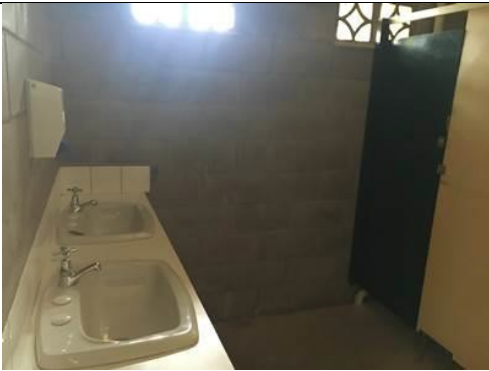
Amenities Male Toilets Brick Walls, Concrete Slab Floor, Timber Doors & Aluminium Door Frames 776	No Asbestos Material Identified	A5	N/A
5 th December 2017

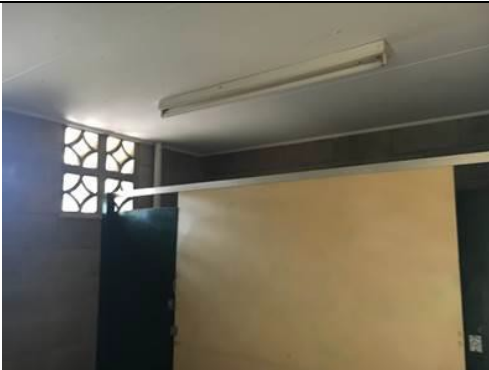
Amenities Female Toilet Ceiling Sheeting Fibre Cement Approximately 9m ² 777	Same as Sample #B17365S05 Chrysotile Asbestos Detected Non-Friable	A4	Good Condition Accessible to Tradespeople Refer to Asbestos Management Plan

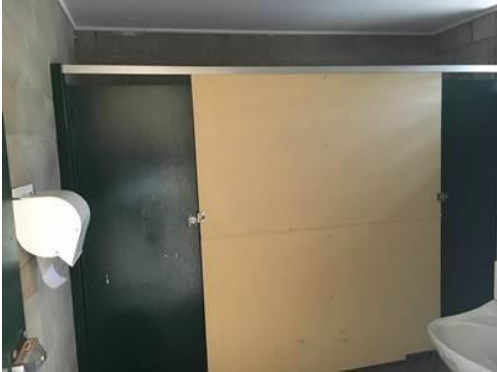
Amenities Female Toilets Cubical Partitions Fibre Cement Approximately 5m ² 778	Same as Sample #B17365S06 Chrysotile Asbestos Detected Non-Friable	A4	Good Condition Accessible to Tradespeople Refer to Asbestos Management Plan
5 th December 2017

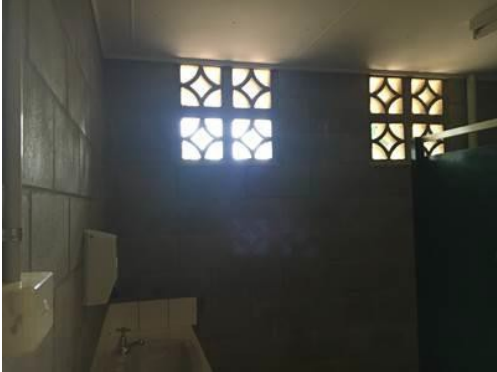
Amenities Female Toilets Brick Walls, Concrete Slab Floor, Timber Doors & Aluminium Door Frames 779	No Asbestos Material Identified	A5	N/A
5 th December 2017

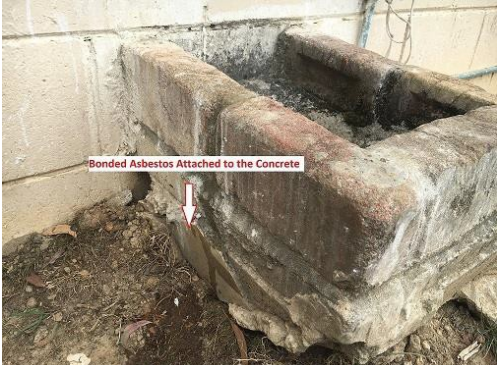
Amenities External South Drain Fibre Cement 780	Sample #B17365S07 Chrysotile Asbestos Detected Non-Friable	A3	Fair Condition Accessible to Tradespeople Refer to Asbestos Management Plan

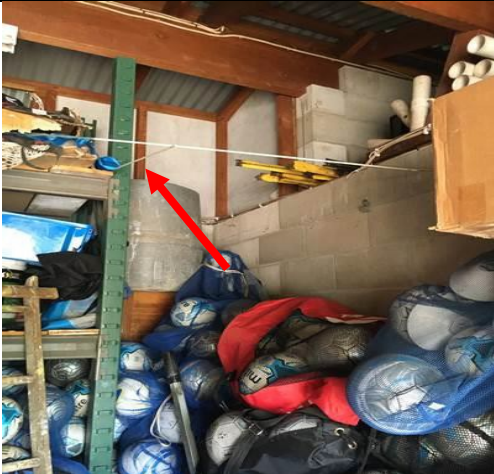
Amenities Storeroom Wall Sheeting Above Brick Walls Fibre Cement Approximately 5m ² 781	Same as Sample #B17365S05 Chrysotile Asbestos Detected Non-Friable	A4	Good Condition Accessible to Tradespeople Refer to Asbestos Management Plan
5 th December 2017

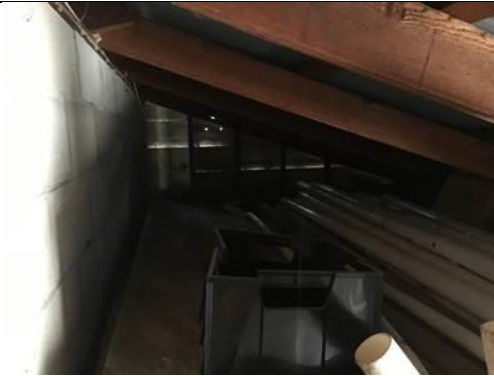
Amenities Storeroom Ceiling Space Brick Walls, Exposed Beams, No Ceiling Sheet, Cement Pad & Roller Door 782	No Asbestos Material Identified	A5	N/A
5 th December 2017

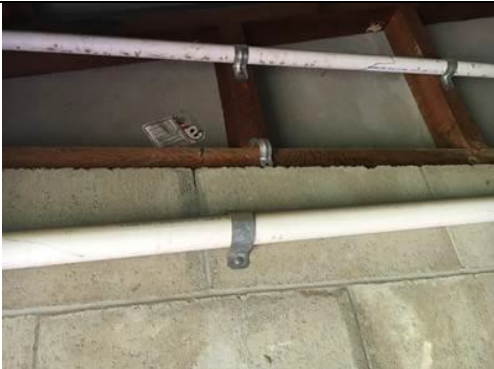
Amenities South Storeroom Wall Above Brick Walls Fibre Cement Approximately 5m ² 783	Same as Sample #B17365S05 Chrysotile Asbestos Detected Non-Friable	A4	Good Condition Accessible to Tradespeople Refer to Asbestos Management Plan

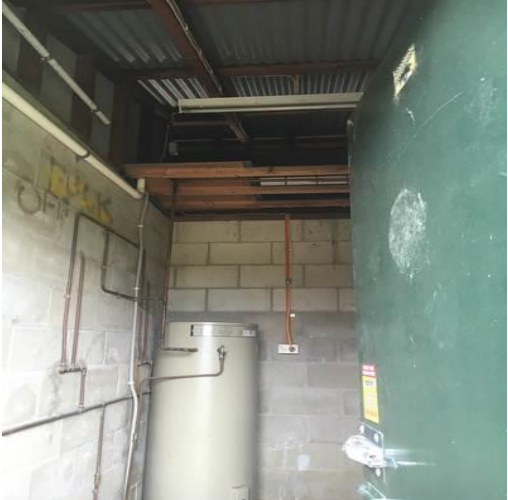
Amenities South Storeroom Brick Walls, Timber Trusses, No Ceiling Sheeting, Wood Door & Aluminium Door Frames 784	No Asbestos Materials Identified	A5	N/A
5 th December 2017

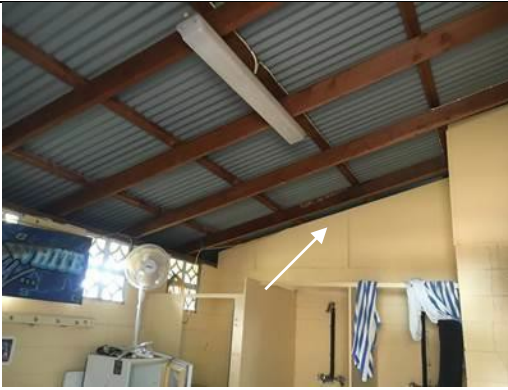
Amenities Change Room Wall Sheeting Above Brick Approximately 5m ² 785	Sample #B17365S08 Chrysotile Asbestos Detected Non-Friable	A4	Good Condition Accessible to Tradespeople Refer to Asbestos Management Plan
5 th December 2017

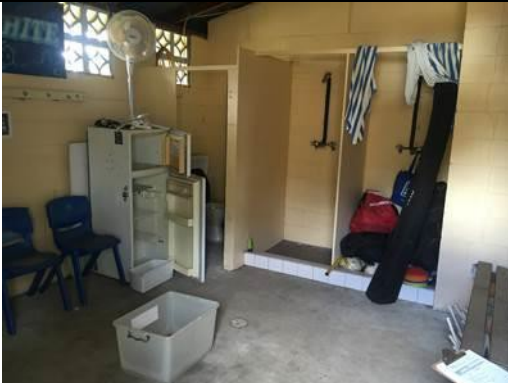
Amenities Change Room Cubical Partitions Approximately 4m ² 786	Same as Sample #B17365S06 Chrysotile Asbestos Detected Non-Friable	A4	Good Condition Accessible to Tradespeople Refer to Asbestos Management Plan

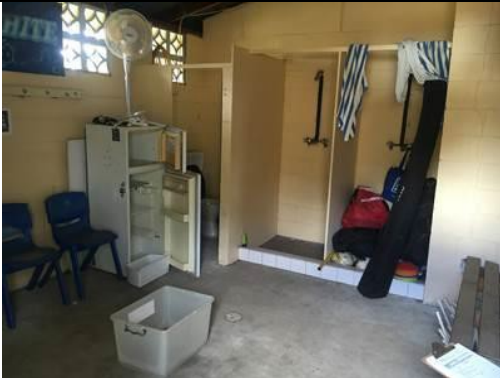
Amenities Change Room Ceramic Tile Floor in Showers, Besser Block Walls, Timber Door & Metal Door Frame 787	No Asbestos Materials Identified	A5	N/A
5 th December 2017

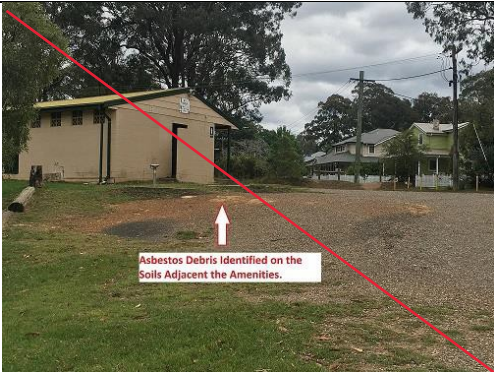
North West Pipe Amenities Fibre Cement 788	Sample #B17365S10 Chrysotile-Asbestos- Detected- Non-Friable	A2 SLR CC #610.17816.00000.0300-V01- CLR - 18/263586	Poor Condition- Accessible to Tradespeople Refer to Asbestos- Management Plan
5 th December 2017

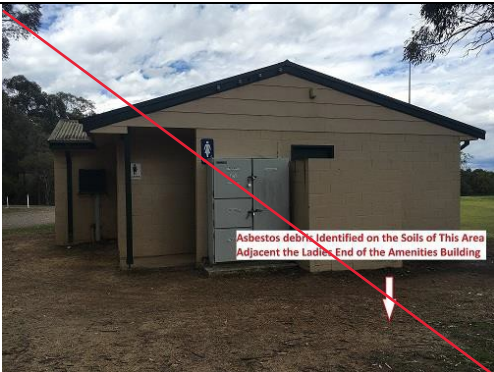
Asbestos pipe Debris on Soil Identified South East Amenities Fibre Cement 789	Sample #B17365S11 Chrysotile- and Crocidolite- Asbestos- Detected- Non-Friable	A2 SLR CC #610.17816.00000.0300-V01- CLR - 18/263586	Poor Condition- Accessible to Tradespeople Refer to Asbestos- Management Plan

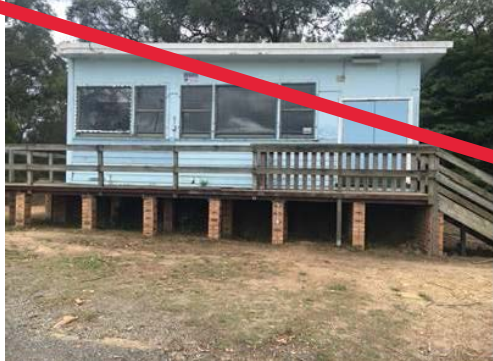
External Blue Paint on Clubhouse	<0.05% w/w Lead in Paint	A5	Building demolished July 2020 Paint is not classified as lead based. Less than 1.0% w/w
5 th December 2017 17365- S02

No lead based paints were detected at either the Clubhouse or the Amenities Block at Knapsack Park, however good practice would dictate that existing paint, even though is below the recognised standard, should not be sanded and that dust minimisation techniques should be adopted, when undertaking renovation / repair works particularly in heritage period buildings. It would be good practice to wear a P1 dust mask during any paint removal even though it does not contain lead but small particles of paint can still be inhaled or ingested.

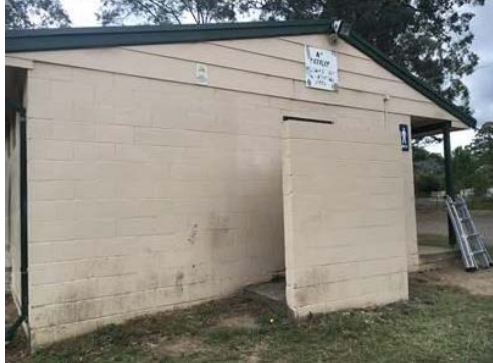
Green Paint on Amenities Fascia	<0.05% w/w Lead in Paint	A5	Paint is not classified as lead based. Less than 1.0% w/w

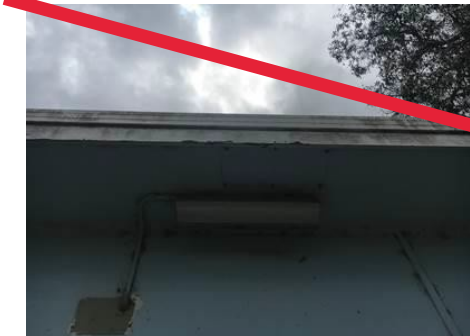
Exterior Light Above Clubhouse Entry Fluorescent Light No PCBs Present	Visual Inspection	A5	N/A Building demolished July 2020

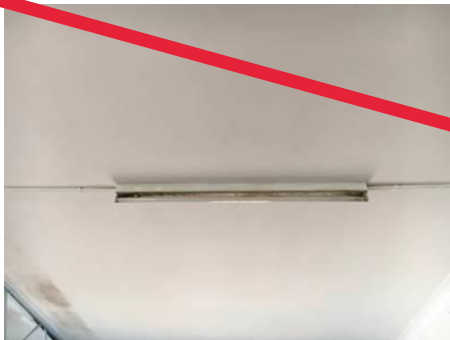
Interior Hall Lights in Clubhouse Fluorescent Lights No PCB's Present	Visual Inspection	A5	N/A Building demolished July 2020
5 th December 2017

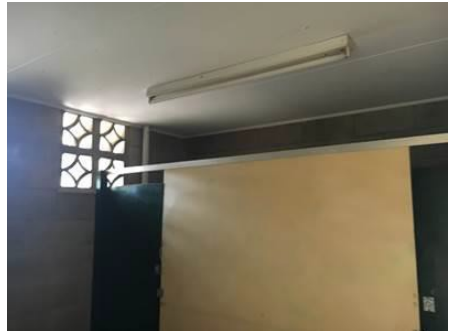
Amenities Both Male and Female Toilets Fluorescent Lights No PCB's Present	Visual Inspection	A5	N/A
5 th December 2017

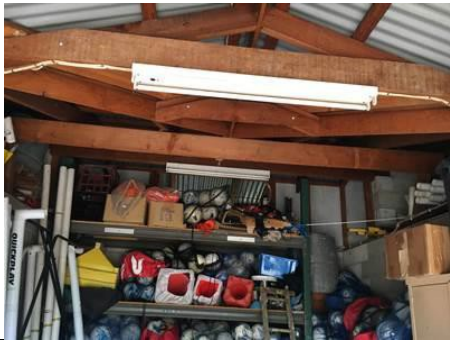
Amenities Store Room Fluorescent Lights No PCB's Present	Visual Inspection	A5	N/A
5 th December 2017

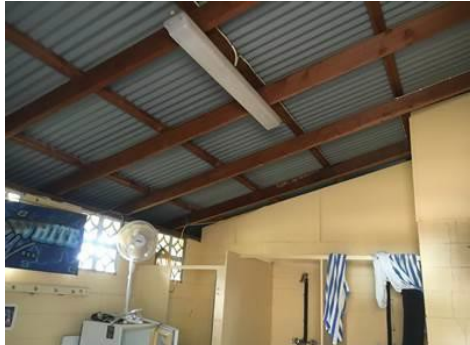
Amenities Changeroom Fluorescent Lights No PCB's Present	Visual Inspection	A5	N/A
