Asbestos Register

Regional EnviroScience Pty Ltd was requested by Mr. Rick Harris of Blue Mountain City Council to undertake a Hazardous Building Materials Register and to prepare an Asbestos Materials Management Plan of the property known as Warrimoo Senior Citizens Hall located on Eley Hawkins Drive, Warrimoo, NSW, 2774. The purpose of the audit was to locate and identify asbestos based building materials and product within the building in accordance with the *NSW Work Health and Safety Act and Regulation 2017* and the *Code of Practice; How to Manage and Control Asbestos in the Workplace* [Safe Work Australia: 2016] and the *Code of Practice; How to Safely Remove Asbestos* [Safe Work Australia: 2016].

ASBESTOS MATERIALS REGISTER		ASSET: Warrimoo Senior Citizens Hall, Eley Hawkins Dr, Warrimoo, NSW, 2774			
DATE OF IDENTIFICATION	IMAGES	SPECIFIC LOCATION OF ASBESTOS/ APPROX M ²	TYPE OF ASBESTOS/ FRIABLE OR NON-FRIABLE	RISK ACTION RATING	CONDITION & ACCESSIBILITY OF ASBESTOS
5 th December 2017

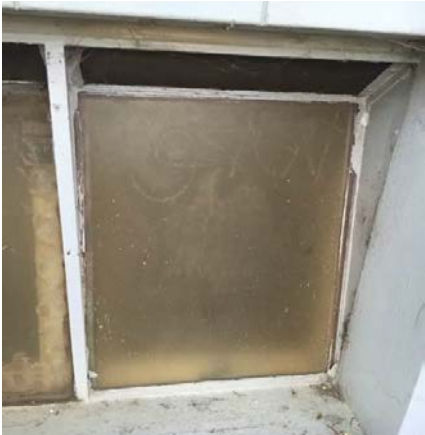
North and West Elevation Window putty 150	Sample #B17358S01 No Asbestos Detected	N/A	N/A
5 th December 2017

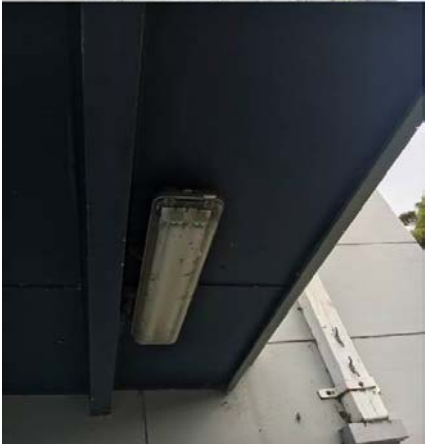
Eaves Fibre cement Approximately 8m ² 152	Sample #B17358S02 Chrysotile, Amosite Asbestos Detected Non-Friable	A5	N/A CC 20/59107 JMB

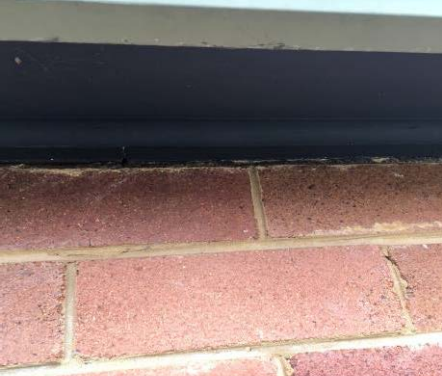
Level Two Eaves Surrounding Building 154	Similar to Sample #B17358S02 Chrysotile, Amosite Asbestos Detected Non-Friable	A5	N/A CC 20/59107 JMB
5 th December 2017

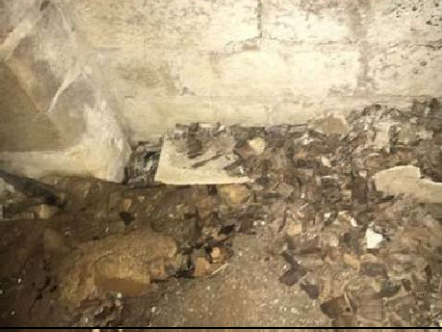
Bonded Sheeting Debris – Sub-floor. Fibre board 155	Sample #B17358S03 No Asbestos Detected	A5	N/A
5 th December 2017

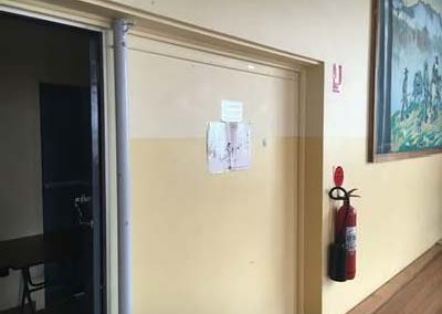
East & West Walls to Foyer Fibre cement 338	Sample #B17358S05 No Asbestos Detected	A5	N/A

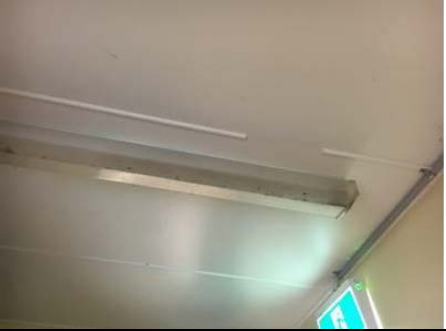
Ceiling to Foyer Fibre cement 10m ² 339	Sample #B17358-S06 Chrysotile & Amosite Asbestos Detected Non-Friable	A5	N/A CC 20/59107 JMB
5 th December 2017

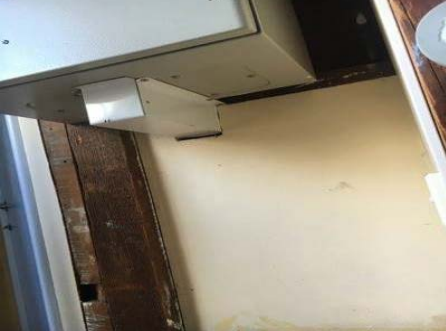
Entry Stairwell to Ladies Toilet Fibre Cement 345	Sample B#17358-S08 No Asbestos Detected Encapsulated SLR 18/260897	N/A	N/A
5 th December 2017

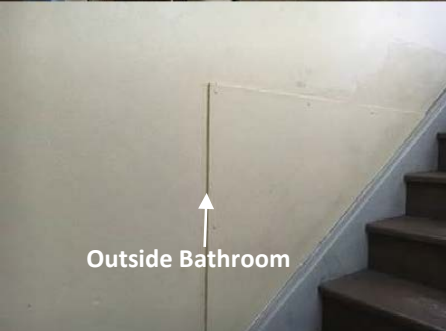
↑ Outside Bathroom	Stairwell to Ladies Toilet Fibre Cement 346	Sample B#17358-S09 No Asbestos Detected	N/A	N/A

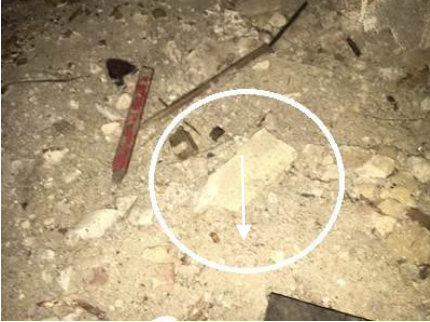
North/East Under Floor. Debris in a Number of Areas. 340	Sample- B#17358-S10 Chrysotile-Asbestos- Detected Non-Friable	A5	N/A ART CC – 19/23684
5 th December 2017

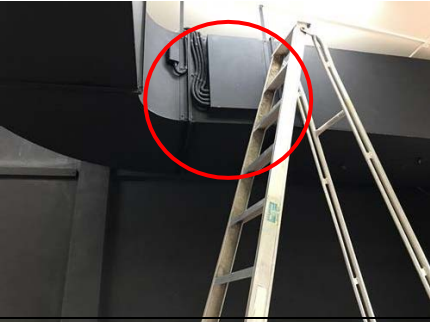
Front Stage Air Conditioning & Heating Bank. Approx. 3m ² . 2053	Sample B#17358-S11 No Asbestos Detected	A5	N/A
5 th December 2017

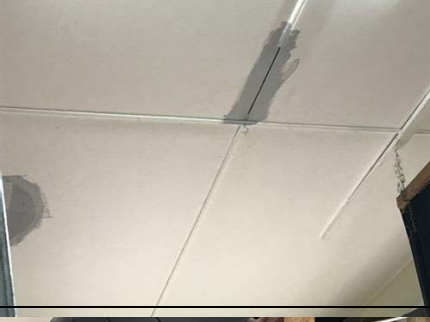
Front Stage Ceiling. Approx. 60m ² . 2054	Sample B#17358-S12 Chrysotile & Amosite Asbestos Detected Non-Friable	A5	N/A CC 20/59104 JMB
5 th December 2017

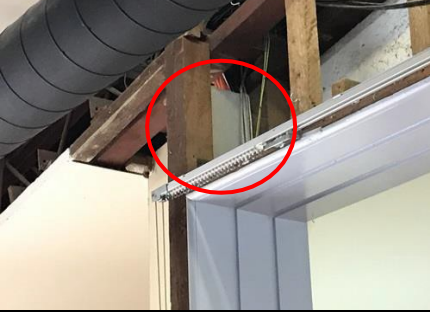
Front stage Unpainted Board. 2056	Sample B#17358-S13 No Asbestos Detected	A5	N/A

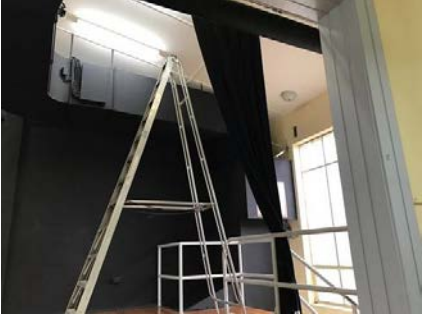
Front Stage Black Curtains. 2057	Sample B#17358-S14 No Asbestos Detected	A5	N/A
5th December 2017

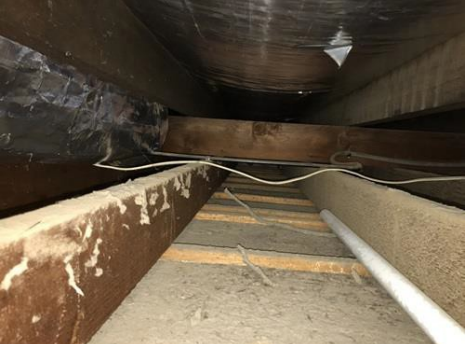
Main Ceiling Plenum. Timber Beams Covered in General Dust. Limited Access 2058	Sample B#17358-S15 No Asbestos Detected	A5	N/A
5th December 2017

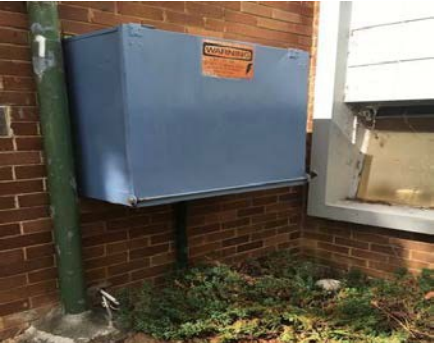
External Electrical Meter Board. Nil Access, Locked Cabinet, Northeast Building.	No Sample Taken. Assume Contains Asbestos Materials. 342	A4	Refer to Asbestos Management Plan. Pacific HazMat CC #S04033 - 18/46757
5 th December 2017

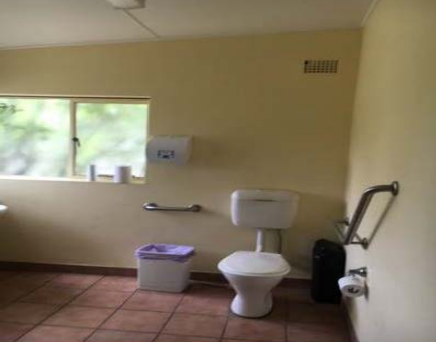
Wheelchair Accessible Amenities. Bonded Board Ceiling, Rendered Brick walls, ceramic tiled floor.	Similar to Sample #B17358-S06 Chrysotile & Amosite Asbestos Detected Non Friable	A5	N/A CC 20/59107 JMB 471
5 th December 2017

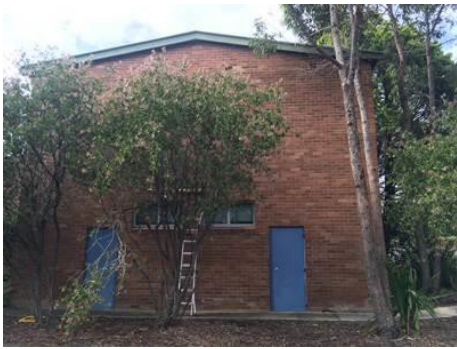
External Blue/Grey Paint	<0.05	N/A	Paint not classified as lead based as less than 1.0% w/w
5 th December 2017 Sample 17358- LS02 (181777-2)

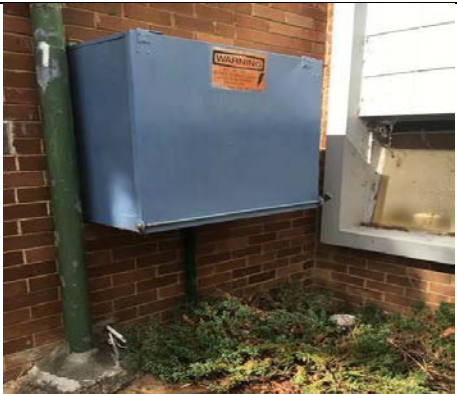
External Down Pipe Green Paint	0.4	N/A	Paint not classified as lead based as less than 1.0% w/w

One (1) sample of green coloured paint obtained from the exterior cladding of the property has recorded a result of 0.4% w/w for lead in paint which is below the classification for lead in paint and therefore no remedial action is required. It would be considered to be good practice to wear a P1 dust mask during any paint removal even though it does not contain lead but small particles of paint can still be inhaled or ingested.

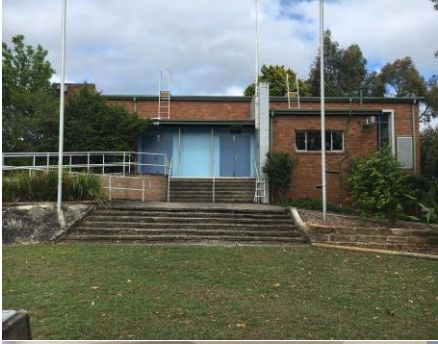
External Blue Paint	<0.05	N/A	Paint not classified as lead based as less than 1.0% w/w
5 th December 2017 Sample 17358- LS04 (181777-4)

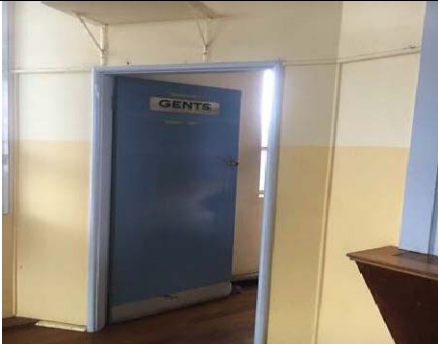
Internal Door Frames Blue Paint	0.06	N/A	Paint not classified as lead based as less than 1.0% w/w

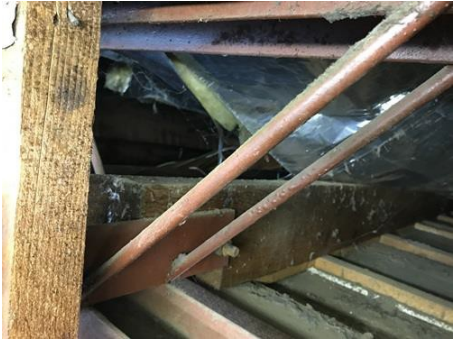
Synthetic Mineral Fibre Products Were Identified Within the Ceiling Insulation	Visual Inspection	N/A	N/A
5 th December 2017

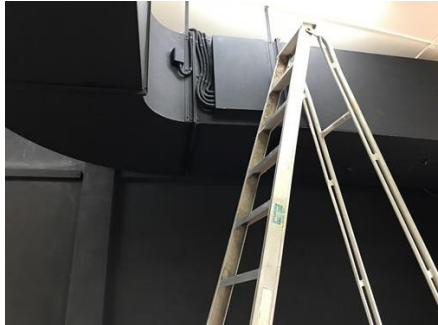
Synthetic Mineral Fibre Products Were Identified Within the Front Stage Air Conditioning & Heating Bank.	Visual Inspection	N/A	N/A

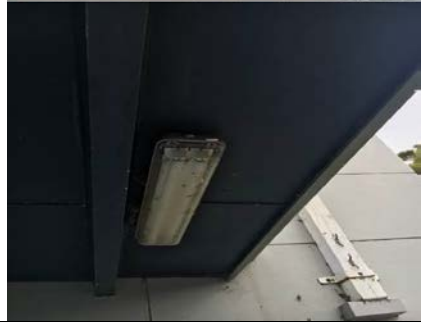
Light Exterior Entry Way Fluorescent Light ATCO 36/40 Type Capacitor	No PCB's Present Visual Observation	N/A	N/A
5 th December 2017

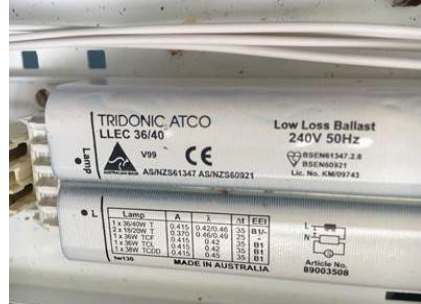
Light 500mm Double Fluorescent Light Tridonic ATCO LLEC 36/40 Type Capacitor	No PCB's Present Visual Observation	N/A	N/A

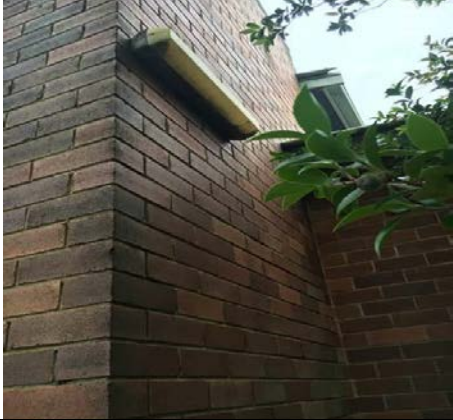
Exterior Light Fixture Southern Aspect Fluorescent Light ATCO 32/40 Type Capacitor	No PCB's Present Visual Observation	N/A	N/A
5 th December 2017

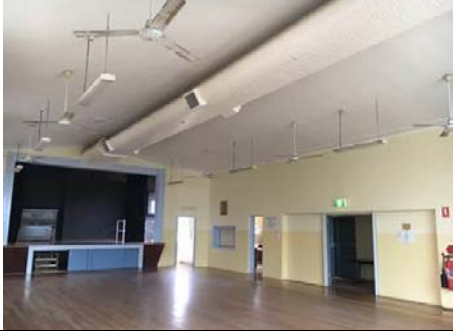
Interior Light Fixtures in Main Hall Area x 8 lights Fluorescent Light Phillips BTA 36/40 Type Capacitor	No PCB's Present Visual Observation	N/A	N/A
5 th December 2017

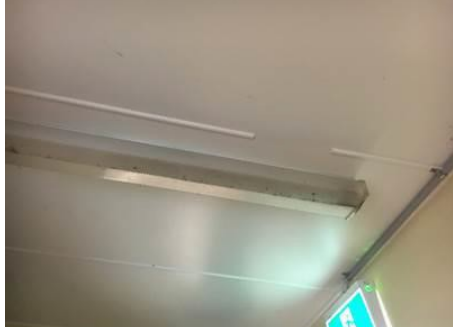
Foyer Lights Fluorescent Light Clipsal 766/36 Type Capacitor	No PCB's Present Visual Observation	N/A	N/A

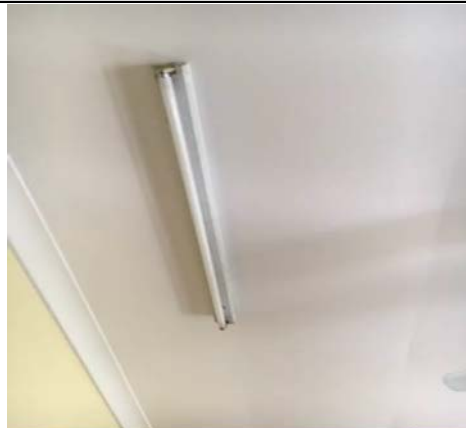
Kitchen Lights 2x Fluorescent Lights A 140 Type Capacitor	No PCB's Present Visual Observation	N/A	N/A
5 th December 2017

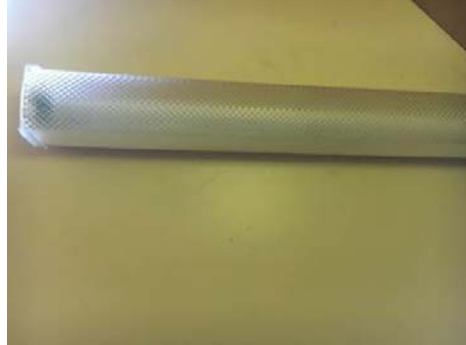
Light Fixture in Stairwell and Ladies Toilets Fluorescent Light Clipsal 36/40 Type Capacitor	No PCB's Present Visual Observation	N/A	N/A
5 th December 2017

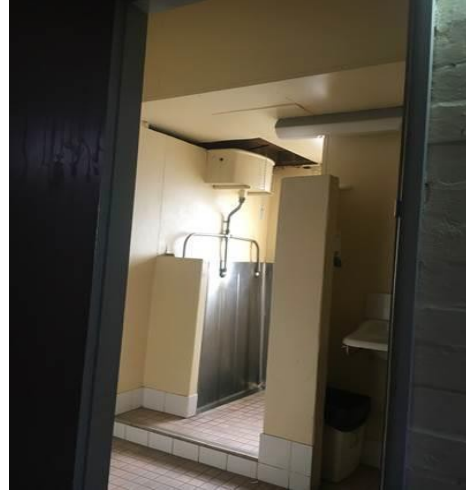
Light in Male Toilets Fluorescent Light EC36/40 Type Capacitor	No PCB's Present Visual Observation	N/A	N/A
