Asbestos Register

1.3 ASBESTOS MATERIALS REGISTER

ASBESTOS MATERIALS REGISTER PAGE 1		ASSET: Wentworth Falls Preschool, 2 Day Street, Wentworth Falls, NSW, 2872			
DATE OF IDENTIFICATION	IMAGES	SPECIFIC LOCATION OF ASBESTOS LABORATORY SAMPLE	LABORATORY SAMPLE NUMBER and RESULTS, FRIABLE OR NON-FRIABLE	RISK ACTION RANKING	OBSERVATIONS AND COMMENTS
30 th November 2017

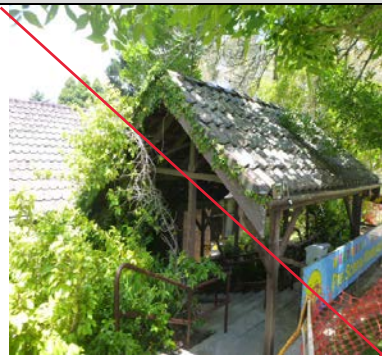
Day Street Front Entrance Gazebo Asbestos-Sheeting Attached to the Gable Timbers and Beneath the Edge Roof Tiles, Both Gables Approximately 1m ² 1196	Sample B17335S01 Chrysotile Asbestos Detected Non-Friable	A5	High Risk Weathered Edges/ Loose Material, Easily Disturbed Potential for Airborne Asbestos Asbestos Sheeting was Removed as Per Clearance Report CLR17335R02 9 th December 2017
30 th November 2017

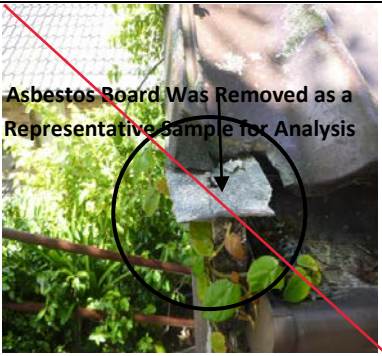
Asbestos Board Was Removed as a Representative Sample for Analysis	Image of the Asbestos Sheet Sandwiched Between the Gable Timber & Roof Tile. Bonded Sheeting Approximately 1m ² 1197	Same as Sample B17335S01 Chrysotile Asbestos Detected Non-Friable	A5	High Risk Poor Condition, Potential for Airborne Asbestos Asbestos Sheeting was Removed as Per Clearance Report CLR17335R02 9 th December 2017

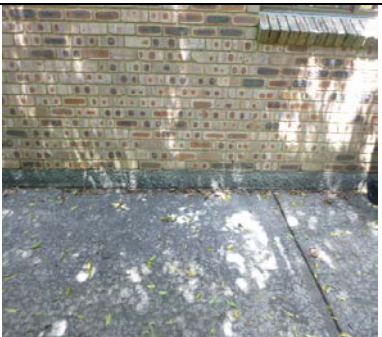
Concrete Paths Bituminous Expansion Jointing. 1198	Sample B17335S02 No Asbestos Detected	A5	N/A

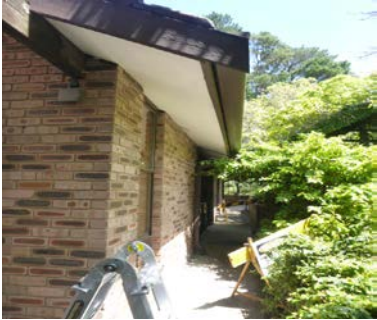
Soffit/Eave Surrounding the Building, West Aspect & Site Entry. Bonded Sheeting. Approximately 10m ²	Sample B17335S03 Chrysotile Asbestos Detected Non-Friable 1199	A4	Good Condition, No Damage No Action Required Accessible to Trades People Refer to Asbestos Management Plan
30 th November 2017

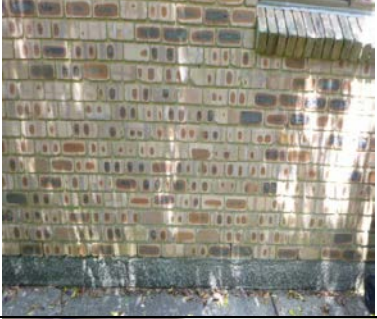
Shotcrete Type Coating to the Bottom of the Brickwork Adjacent the Concrete Pathways.	Sample B17335S04 No Asbestos Detected 1200	A5	N/A
30 th November 2017

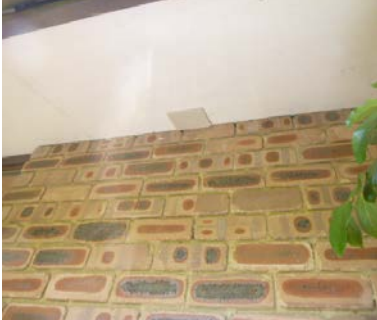
Cement Sheet Cover Over the Damaged Soffit/Eave.	Sample B17335S05 No Asbestos Detected 1201	A5	N/A

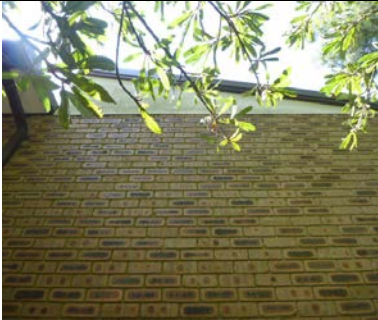
South Extension Wall Infill Bonded Sheet Approximately 5m ² 1202	Sample B17335S06 No Asbestos Detected	A5	N/A
30 th November 2017

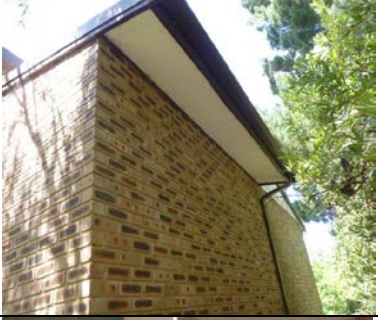
South Extension Eave. Bonded Sheet. Approximately 3m ² 1203	Sample B17335S07 No Asbestos Detected	A5	N/A
30 th November 2017

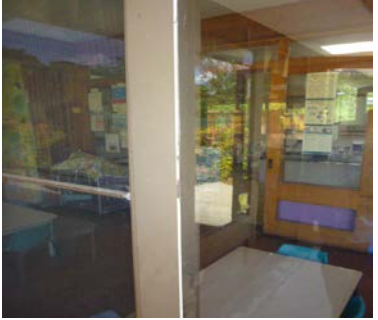
Grey Window Putty Damaged & Breaking Away in Many Places. 1204	Sample B17335S08 No Asbestos Detected	A5	N/A

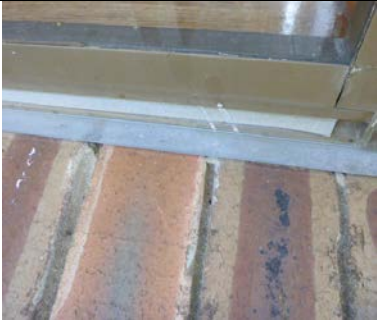
Aluminum Window Frame Seal All Windows 1205	Sample B17335S09 No Asbestos Detected	A5	N/A
30 th November 2017

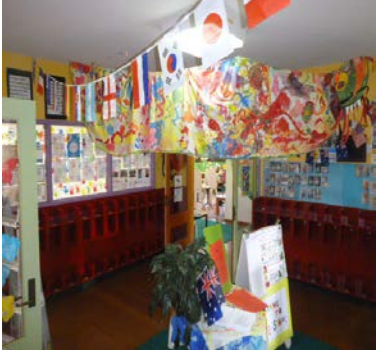
Entry Foyer Pink Vinyl Floor Tile Approximately 25m ² 1206	Sample B17335S10 Trace Chrysotile Asbestos Detected Non-Friable	A3	Fair Condition, Slightly Worn Surface Remove During Scheduled Building Maintenance Accessible to Trades People Refer to Asbestos Management Plan
30 th November 2017

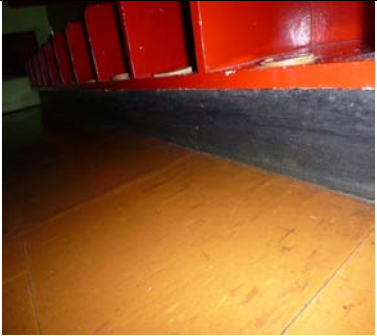
Entry Foyer, Bituminous Skirting. Approximately 20 Lineal Meters 1207	Sample B17335S11 No Asbestos Detected	A5	N/A

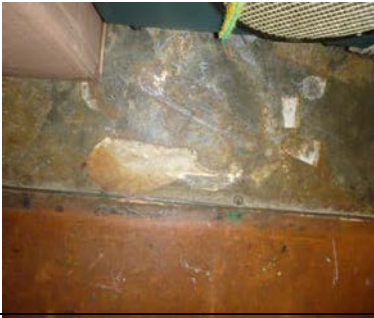
Wattle Room Cupboard. Adhesive Vinyl Tile Backing Remnant. Approximately 1m ² 1208	Sample B17335S12 No Asbestos Detected	A5	N/A
30 th November 2017

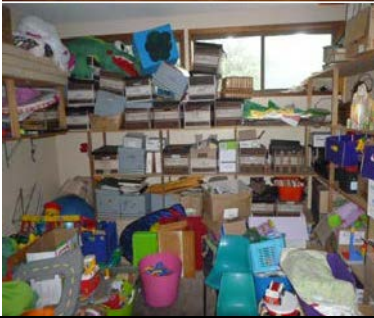
Wattle & Piano Rooms Walls Bonded Sheet. Approximately 54m ² 1209	Sample B17335S13 Chrysotile Asbestos Detected Non-Friable	A4	Good Condition, No, Damage. No Action Required, Accessible to Trades People. Refer to Asbestos Management Plan
30 th November 2017

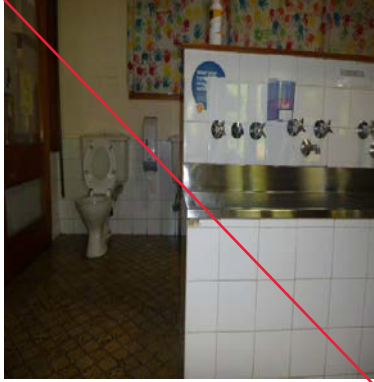
Children's Toilet Ceramic Tile-Covered Bonded Sheet Including West Wall. Approximately 30m ² 1210	Sample- B17335S14 Chrysotile- Asbestos- Detected Non-Friable	A4	Fair Condition, Minimal Damage. Exposed Asbestos Substrate Where a Tile Has Been Dislodged. Tile was Covered and Sealed Off as Per Clearance Report CLR17335R02 9 th December 2017

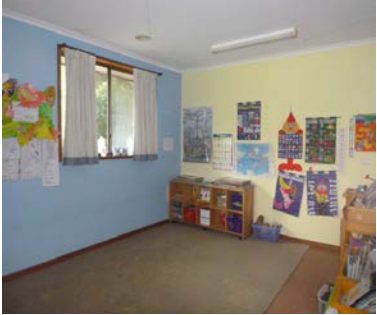
Rainbow Room 2 Vinyl Floor Tile. Approximately 20m ² 1211	Sample B17335S15 No Asbestos Detected	A5	N/A
30 th November 2017

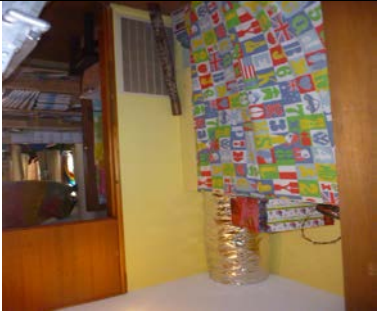
Void to Rainbow Room 2 Walls Bonded Sheet. Approximately 15m ² 1212	Sample B17335S16 Chrysotile Asbestos Detected Non-Friable	A4	Good Condition, No Damage No Action Required, Accessible to Trades People. Refer to Asbestos Management Plan
30 th November 2017

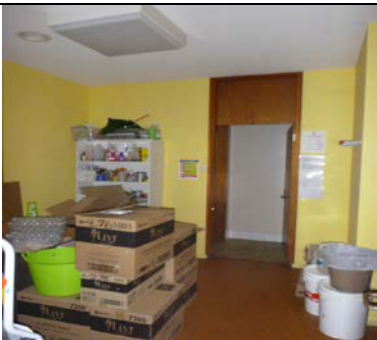
Paint Room West Area Walls &, Half of Northern Wall Bonded Sheet. Approximately 18m ² 1213	Sample B17335S17 Chrysotile Asbestos Detected	A4	Good Condition, No Damage No Action Required, Accessible to Trades People. Refer to Asbestos Management Plan

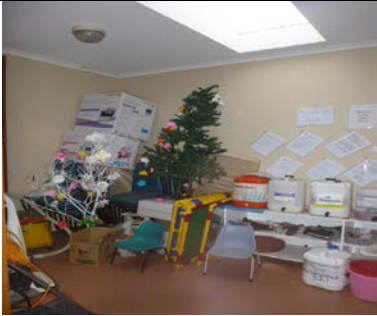
Store Room Vinyl Floor Tile Approximately 12m ² 1214	Same as Sample B17335S15 No Asbestos Detected	A5	N/A
30 th November 2017

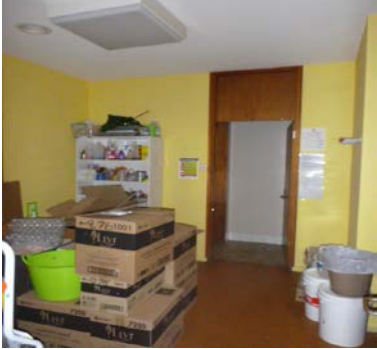
Paint Room Vinyl Floor Tile Approximately 16m ² 1215	Sample B17335S10 Trace Chrysotile Asbestos Detected Non-Friable	A3	Fair Condition, Slightly Worn Surface Remove During Scheduled Building Maintenance Accessible to Trades People Refer to Asbestos Management Plan
30 th November 2017

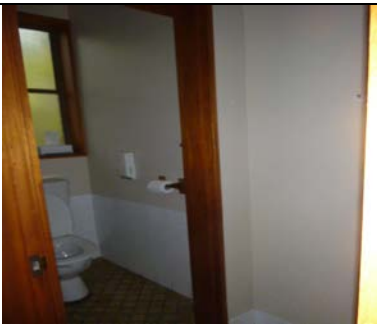
Paint Room Toilet & Entry Area Walls Bonded Sheet. Approximately 16m ² 1216	Sample B17335S17 Chrysotile Asbestos Detected	A4	Good Condition, No Damage No Action Required, Accessible to Trades People. Refer to Asbestos Management Plan

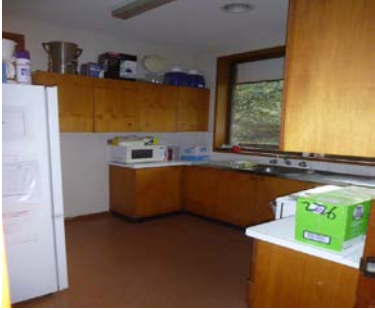
Kitchen Walls Bonded Sheet Approximately 27m ² 1217	Same as Sample B17335S17 Chrysotile Asbestos Detected Non-Friable	A4	Good Condition, No Damage No Action Required Accessible to Trades People. Refer to Asbestos Management Plan
30 th November 2017

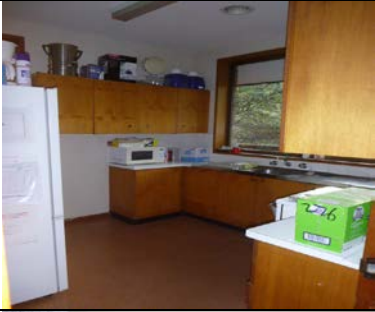
Kitchen Vinyl Tile Floor Approximately 9m ² 1218	Same as Sample B17335S15 No Asbestos Detected	A5	N/A
30 th November 2017

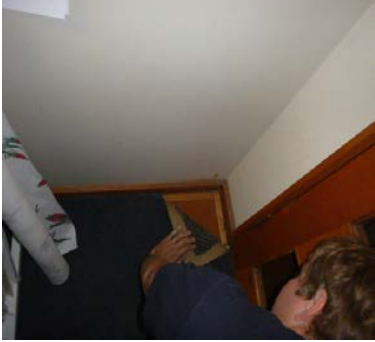
Staff Room Vinyl Floor Tile Below Carpet Approximately 20m ² 1219	Sample B17335S10 Trace Chrysotile Asbestos Detected Non-Friable	A3	Good Condition Below Carpet Remove During Scheduled Building Maintenance Accessible to Trades People Refer to Asbestos Management Plan

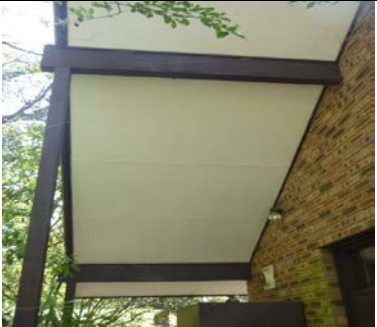
Southwest Aspect Soffit/Eave Lining Bonded Sheet. Approximately 8m ² 1220	Same as Sample B17335S03 Chrysotile Asbestos Detected Non-Friable	A4	Good Condition, No Damage No Action Required Accessible to Trades People. Refer to Asbestos Management Plan
30 th November 2017

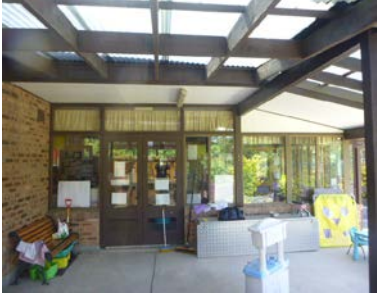
Southeast Aspect Adjacent the Rainbow Room, Including Infill. Bonded Sheet. Approximately 11m ² 1221	Same as Sample B17335S03 Chrysotile Asbestos Detected Non-Friable	A4	Good Condition, No Damage No Action Required Accessible to Trades People. Refer to Asbestos Management Plan
30 th November 2017

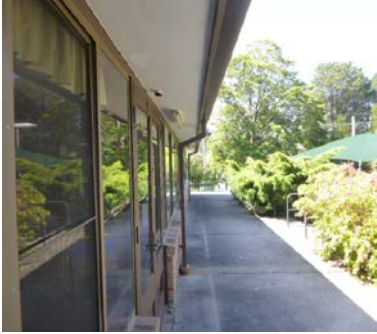
Northeast Aspect Soffit/Eave Lining Bonded Sheet. Approximately 10m ² 1222	Sample B17335S03 Chrysotile Asbestos Detected Non-Friable	A4	Good Condition, No Damage No Action Required Accessible to Trades People. Refer to Asbestos Management Plan

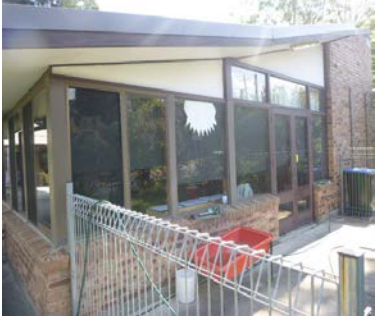
Southeast Aspect Adjacent Rainbow Room 1 Soffit/Eave Lining & Infills Above Door & Windows Bonded Sheet Approximately 5m ²	Same as Sample B17335S03 Chrysotile Asbestos Detected Non-Friable 1223	A4	Good Condition, No Damage No Action Required Accessible to Trades People. Refer to Asbestos Management Plan
30 th November 2017

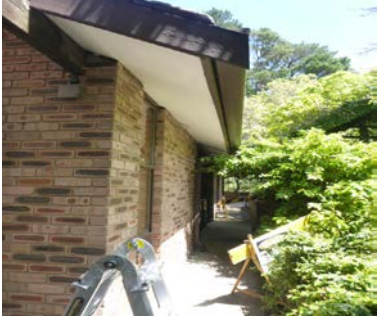
Asbestos Sheeting Attached to the Timbers and Beneath the Edge Roof Tiles to North & South of Main Building Approximately 3m ²	Same as Sample B17335S01 Chrysotile Asbestos Detected Non-Friable 1224	A3	Good Condition, Slight Weathering to Edges No Action Required Accessible to Trades People. Refer to Asbestos Management Plan

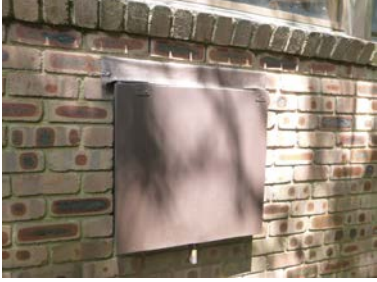
Locked electrical meter board cabinet. Nil access.	No Sample taken. Assumed Containing Asbestos Materials. 1225	A4	Condition of the Meter Board and Cabinet Needs to be Assessed When Access is Available.

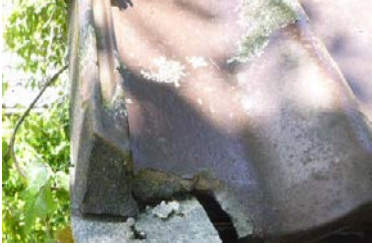
Wunderlich Brown Roof Tile to Main Building & Entry Gazebo 1226	Sample B17335S18 No Asbestos Detected	A5	N/A

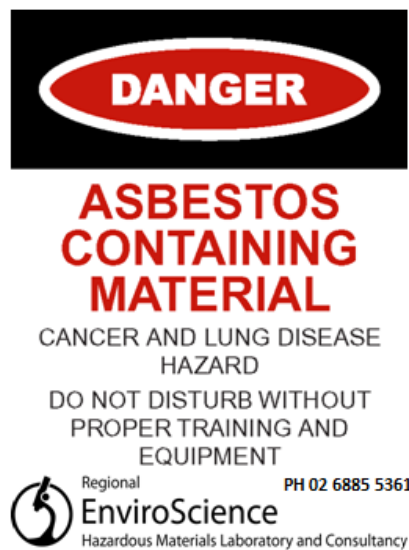
Work Health and Safety Regulation 2017 R424, R427 and R429 requires that the person with the management control of the workplace to identify asbestos containing materials and the asbestos material that has been identified to date should be labelled and ensured that it complies with the *Australian Standard 1319: Safety Signs for the Occupational Environment*; signage should be similar to the label detailed below.
