# Asbestos Register

Regional EnviroScience Pty Ltd was requested by Mr. Rick Harris of Blue Mountain City Council to undertake a Hazardous Building Materials Register and to prepare a Hazardous Materials Management Plan of the property known as Glenbrook Cinema and Hall located on the Corner of Great Western Highway and Ross Street, Glenbrook, NSW, 2773. The purpose of the audit was to locate and identify asbestos based building materials and product within the building in accordance with the *NSW Work Health and Safety Act and Regulation 2017* and the *Code of Practice; How to Manage and Control Asbestos in the Workplace* [Safe Work Australia: 2016] and the *Code of Practice; How to Safely Remove Asbestos* [Safe Work Australia: 2016].

On the 12<sup>th</sup> and 14<sup>th</sup> of December 2017, an Asbestos Audit was conducted at the Glenbrook Cinema and Hall and asbestos containing materials were found to be present at the premises. Please refer Appendix I for results of products that were sampled and analysed but did not contain asbestos.

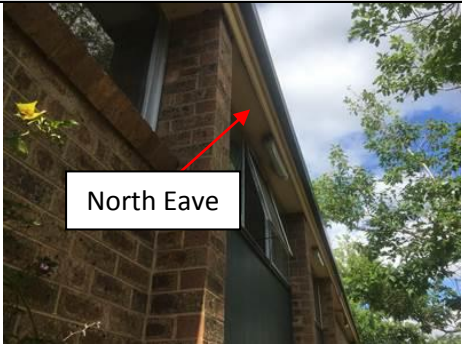
| ASBESTOS MATERIALS REGISTER | | ASSET: Glenbrook Cinema and Hall, Corner of Great Western Highway and Ross Street, Glenbrook, NSW, 2773 | | | |
|---|---|---|---|---|---|
| 12 <sup>th</sup> December 2017 | | Exterior North Eave.<br><br>Fibre Cement<br>Approximately 10m <sup>2</sup><br><b>2747</b> | Sample #B17440S01<br><br>Chrysotile Asbestos Detected<br>Non-Friable | A4 | Good Condition<br>Accessible to Tradespeople<br>Refer to Asbestos Management Plan |

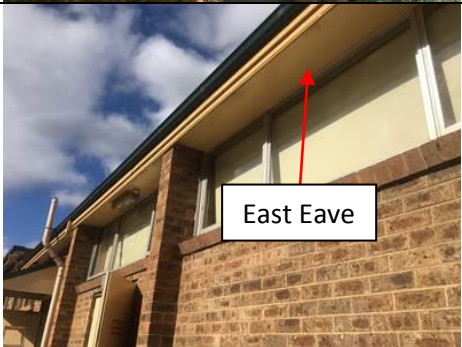
| ASBESTOS MATERIALS REGISTER | | ASSET: Glenbrook Cinema and Hall, Corner of Great Western Highway and Ross Street, Glenbrook, NSW, 2773 | | | |
|---|---|---|---|---|---|
| 12 <sup>th</sup> December 2017 | | Exterior East Eave.<br><br>Fibre Cement<br>Approximately 15m <sup>2</sup><br><b>2748</b> | Similar to Sample #B17440S01<br><br>Chrysotile Asbestos Detected<br>Non-Friable | A4 | Good Condition<br>Accessible to Tradespeople<br>Refer to Asbestos Management Plan |

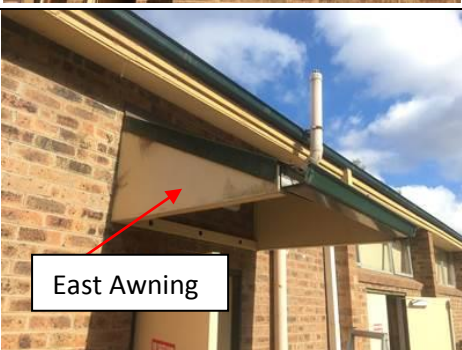
| ASBESTOS MATERIALS REGISTER | | ASSET: Glenbrook Cinema and Hall, Corner of Great Western Highway and Ross Street, Glenbrook, NSW, 2773 | | | |
|---|---|---|---|---|---|
| 12 <sup>th</sup> December 2017 | | Exterior Awning Above Door to East.<br><br>Fibre Cement<br><b>2749</b> | Sample #B17440S02<br><br>No Asbestos Detected | A5 | N/A |

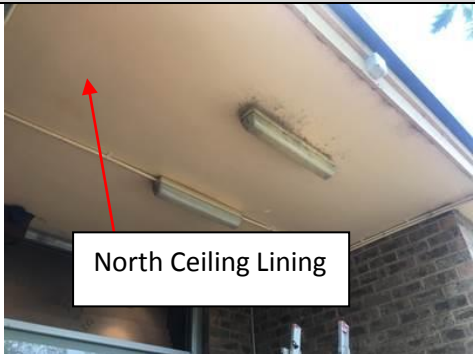
| ASBESTOS MATERIALS REGISTER | | ASSET: Glenbrook Cinema and Hall, Corner of Great Western Highway and Ross Street, Glenbrook, NSW, 2773 | | | |
|---|---|---|---|---|---|
| 12 <sup>th</sup> December 2017 | | Exterior North.<br>Ceiling Lining for Veranda.<br>Fibre Cement<br>Approximately 6m <sup>2</sup><br><b>2750</b> | Sample #B17440S03<br>Chrysotile Asbestos Detected<br>Non-Friable | A4 | Good Condition<br>Accessible to Tradespeople<br>Refer to Asbestos Management Plan |

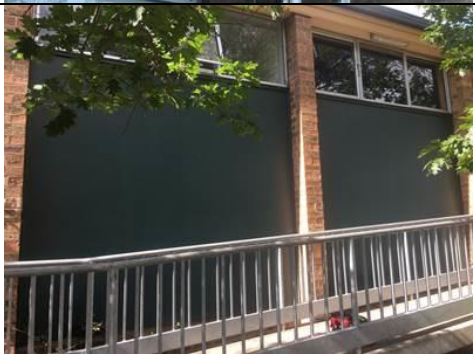
| ASBESTOS MATERIALS REGISTER | | ASSET: Glenbrook Cinema and Hall, Corner of Great Western Highway and Ross Street, Glenbrook, NSW, 2773 | | | |
|---|---|---|---|---|---|
| 12 <sup>th</sup> December 2017 | | Exterior Wall Cladding to North.<br>Fibre Cement<br><b>2751</b> | Sample #B17440S04<br>No Asbestos Detected | A5 | N/A |

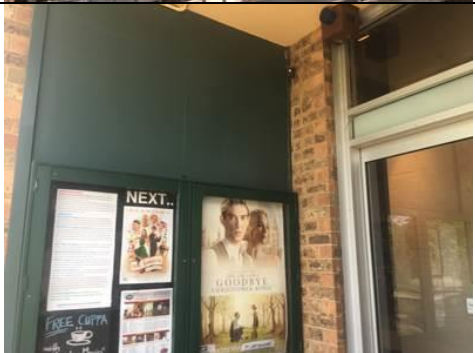
| ASBESTOS MATERIALS REGISTER | | ASSET: Glenbrook Cinema and Hall, Corner of Great Western Highway and Ross Street, Glenbrook, NSW, 2773 | | | |
|---|---|---|---|---|---|
| 12 <sup>th</sup> December 2017 | | Exterior Wall Cladding Infill to North<br>Fibre Cement.<br><b>2752</b> | Similar to Sample #B17440S04<br>No Asbestos Detected | A5 | N/A |

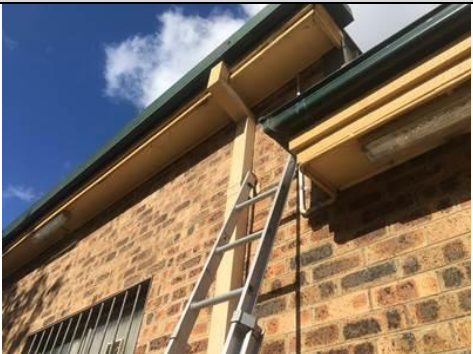
| ASBESTOS MATERIALS REGISTER | | ASSET: Glenbrook Cinema and Hall, Corner of Great Western Highway and Ross Street, Glenbrook, NSW, 2773 | | | |
|---|---|---|---|---|---|
| 12 <sup>th</sup> December 2017 | | Eaves to South West.<br>Fibre Cement<br><b>2754</b> | Sample #B17440S05<br>No Asbestos Detected | A5 | N/A |

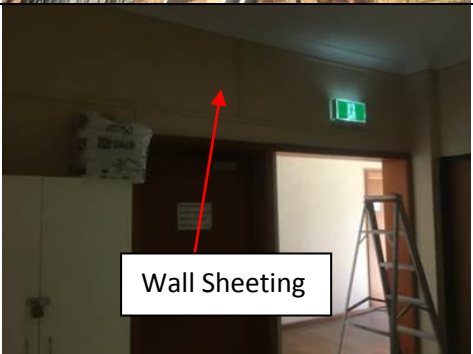
| ASBESTOS MATERIALS REGISTER | | ASSET: Glenbrook Cinema and Hall, Corner of Great Western Highway and Ross Street, Glenbrook, NSW, 2773 | | | |
|---|---|---|---|---|---|
| 12 <sup>th</sup> December 2017 | <br>Wall Sheetting | Interior.<br>Kitchen, Toilets<br>Foyer Wall<br>Sheeting to North.<br>Fibre Cement<br>Approximately 8m <sup>2</sup> | Sample #B17440S06<br>Chrysotile Asbestos Detected<br>Non-Friable<br><b>2755</b> | A4 | Good Condition<br>Accessible to Tradespeople<br>Refer to Asbestos Management Plan |

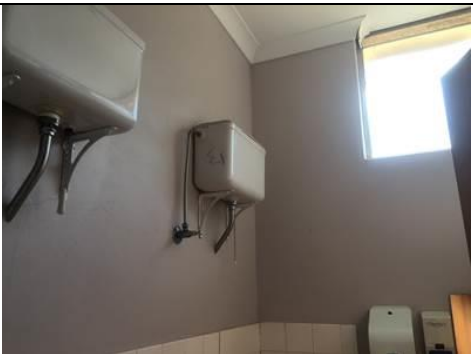
| ASBESTOS MATERIALS REGISTER | | ASSET: Glenbrook Cinema and Hall, Corner of Great Western Highway and Ross Street, Glenbrook, NSW, 2773 | | | |
|---|---|---|---|---|---|
| 12 <sup>th</sup> December 2017 | | Male Toilets.<br>Plaster Board Walls and Ceiling<br>Sheeting, Ceramic Tile on Concrete Floor. | No Asbestos Materials Sighted.<br><b>2756</b> | A5 | N/A |

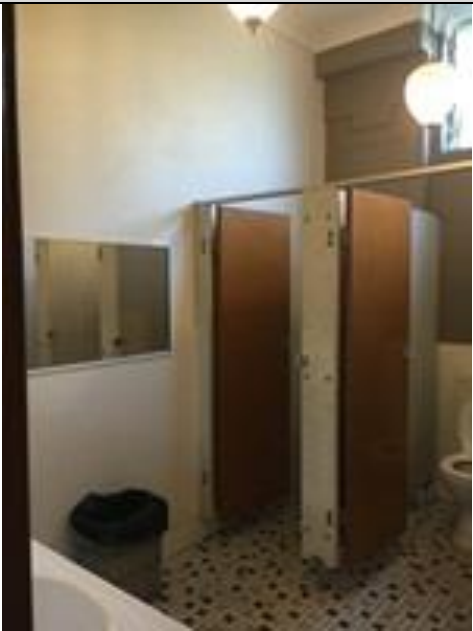
| ASBESTOS MATERIALS REGISTER | | ASSET: Glenbrook Cinema and Hall, Corner of Great Western Highway and Ross Street, Glenbrook, NSW, 2773 | | | |
|---|---|---|---|---|---|
| 12 <sup>th</sup> December 2017 | | Female Toilets.<br>Plaster Board Wall and Ceiling Sheeting, Ceramic tiles on Concrete Floor.<br><b>2757</b> | No Asbestos Materials Sighted. | A5 | N/A |

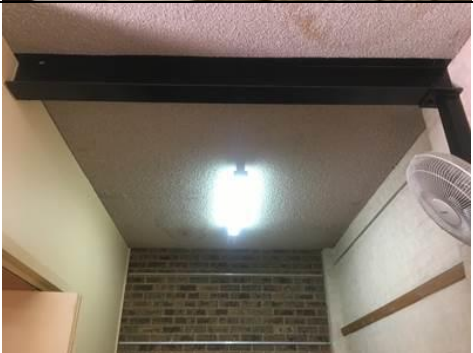
| ASBESTOS MATERIALS REGISTER | | ASSET: Glenbrook Cinema and Hall, Corner of Great Western Highway and Ross Street, Glenbrook, NSW, 2773 | | | |
|---|---|---|---|---|---|
| 12 <sup>th</sup> December 2017 | | Interior.<br>Vermiculite Hall Ceiling<br><b>2758</b> | Sample #B17440S07<br>No Asbestos Detected | A5 | N/A |

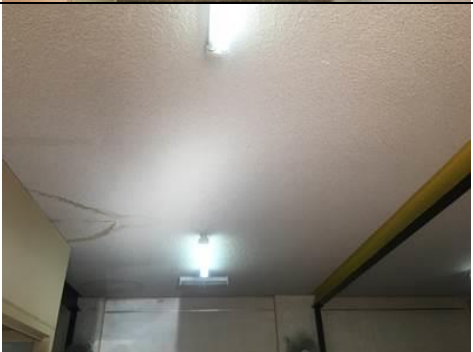
| ASBESTOS MATERIALS REGISTER | | ASSET: Glenbrook Cinema and Hall, Corner of Great Western Highway and Ross Street, Glenbrook, NSW, 2773 | | | |
|---|---|---|---|---|---|
| 12 <sup>th</sup> December 2017 | | Interior.<br>Vermiculite Hall Ceiling 2 <sup>nd</sup> Section to South<br><b>2759</b> | Sample #B17440S08<br>No Asbestos Detected | A5 | N/A |

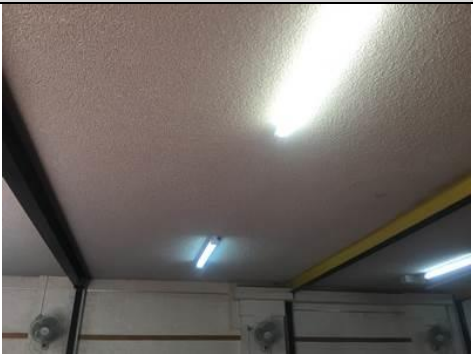
| ASBESTOS MATERIALS REGISTER | | ASSET: Glenbrook Cinema and Hall, Corner of Great Western Highway and Ross Street, Glenbrook, NSW, 2773 | | | |
|---|---|---|---|---|---|
| 12 <sup>th</sup> December 2017 | | Interior.<br>Vermiculite Hall Ceiling Middle Section to North<br><b>2760</b> | Sample #B17440S09<br>No Asbestos Detected | A5 | N/A |

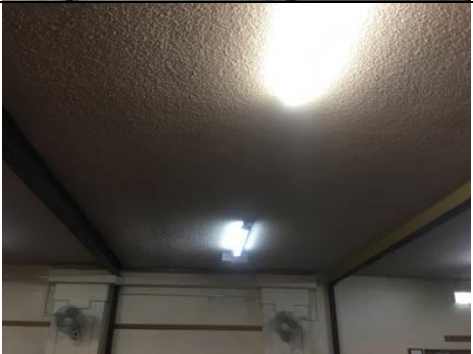
| ASBESTOS MATERIALS REGISTER | | ASSET: Glenbrook Cinema and Hall, Corner of Great Western Highway and Ross Street, Glenbrook, NSW, 2773 | | | |
|---|---|---|---|---|---|
| 12 <sup>th</sup> December 2017 | | Interior.<br>Vermiculite Hall Ceiling 1 <sup>st</sup> & 2 <sup>nd</sup> Section to North<br><b>2761</b> | Sample #B17440S10 & Sample #B17440S11<br>No Asbestos Detected | A5 | N/A |

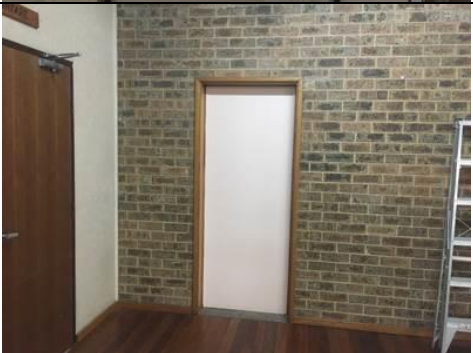
| ASBESTOS MATERIALS REGISTER | | ASSET: Glenbrook Cinema and Hall, Corner of Great Western Highway and Ross Street, Glenbrook, NSW, 2773 | | | |
|---|---|---|---|---|---|
| 12 <sup>th</sup> December 2017 | | Interior.<br>Fibre Cement Wall to North.<br><b>2762</b> | Sample #B17440S12<br>No Asbestos Detected | A5 | N/A |

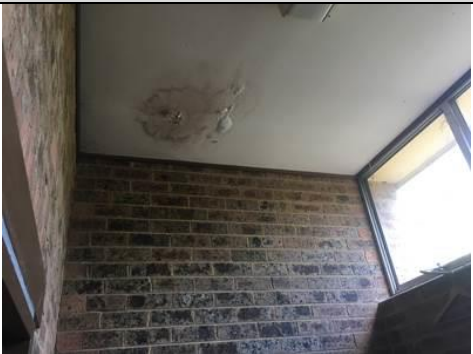
| ASBESTOS MATERIALS REGISTER | | ASSET: Glenbrook Cinema and Hall, Corner of Great Western Highway and Ross Street, Glenbrook, NSW, 2773 | | | |
|---|---|---|---|---|---|
| 12 December 2017 | | Interior.<br>Storeroom to North Hall<br>Plasterboard Ceiling, Brick Walls, Wooden Floor & Aluminium Framed Windows. | No Asbestos Materials Observed<br><b>2763</b> | A5 | N/A |

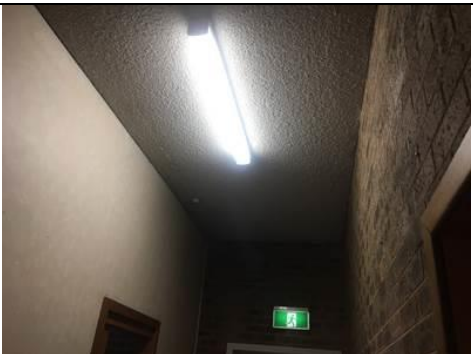
| ASBESTOS MATERIALS REGISTER | | ASSET: Glenbrook Cinema and Hall, Corner of Great Western Highway and Ross Street, Glenbrook, NSW, 2773 | | | |
|---|---|---|---|---|---|
| 12 <sup>th</sup> December 2017 | | Toilet.<br>Vermiculite Ceiling to Southern Entrance/Exit.<br>Brick and Fibre Cement Sheet Walls. | Similar to Sample #B17440S08 & Sample #B17440S12<br>No Asbestos Detected<br><b>2764</b> | A5 | N/A |

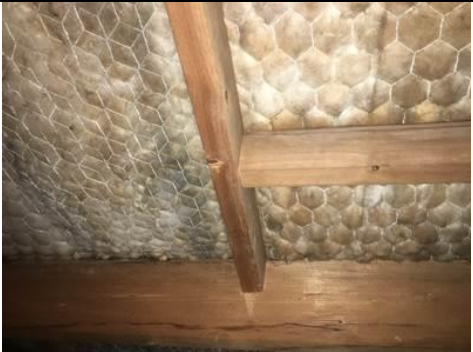
| ASBESTOS MATERIALS REGISTER | | ASSET: Glenbrook Cinema and Hall, Corner of Great Western Highway and Ross Street, Glenbrook, NSW, 2773 | | | |
|---|---|---|---|---|---|
| 12 <sup>th</sup> December 2017 | | Interior.<br>Ceiling Insulation Above Kitchen | Sample #B17440S13<br>No Asbestos Detected<br><b>2765</b> | A5 | N/A |

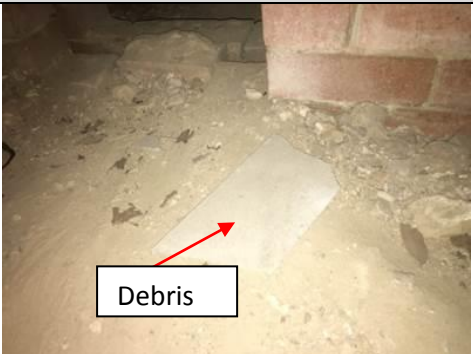
| ASBESTOS MATERIALS REGISTER | | ASSET: Glenbrook Cinema and Hall, Corner of Great Western Highway and Ross Street, Glenbrook, NSW, 2773 | | | |
|---|---|---|---|---|---|
| 12 <sup>th</sup> December 2017 | | Sub Floor.<br>Northern End.<br><br>Debris Throughout Sub Floor.<br><b>2766</b> | Sample #B17440S14<br><br>Chrysotile Asbestos Detected | A3 | Poor Condition<br>Accessible to Tradespeople<br>Refer to Asbestos Management Plan |

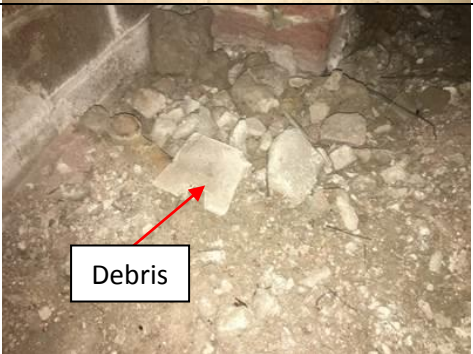
| ASBESTOS MATERIALS REGISTER | | ASSET: Glenbrook Cinema and Hall, Corner of Great Western Highway and Ross Street, Glenbrook, NSW, 2773 | | | |
|---|---|---|---|---|---|
| 12 <sup>th</sup> December 2017 | | Sub Floor.<br>Southern End.<br><br>Debris Throughout Sub Floor.<br><b>2767</b> | Sample #B17440S15<br><br>Chrysotile Asbestos Detected | A3 | Poor Condition<br>Accessible to Tradespeople<br>Refer to Asbestos Management Plan |

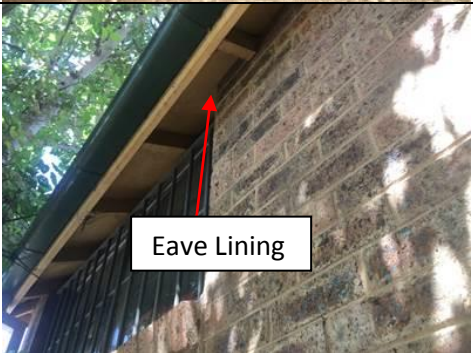
| ASBESTOS MATERIALS REGISTER | | ASSET: Glenbrook Cinema and Hall, Corner of Great Western Highway and Ross Street, Glenbrook, NSW, 2773 | | | |
|---|---|---|---|---|---|
| 12 <sup>th</sup> December 2017 | | Eave Lining.<br>External to South Dressing Room.<br><br>Approximately 12m <sup>2</sup><br><b>2768</b> | Sample #B17440S16<br><br>Chrysotile Asbestos Detected | A4 | Good Condition<br>Accessible to Tradespeople<br>Refer to Asbestos Management Plan |

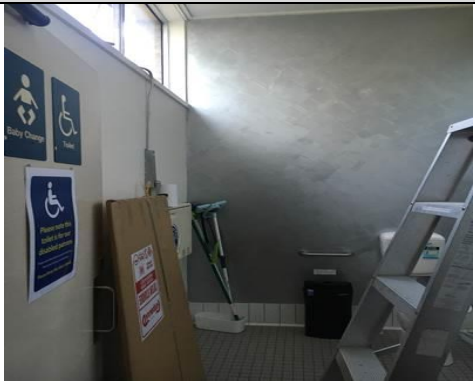
| ASBESTOS MATERIALS REGISTER | | ASSET: Glenbrook Cinema and Hall, Corner of Great Western Highway and Ross Street, Glenbrook, NSW, 2773 | | | |
|---|---|---|---|---|---|
| 14 <sup>th</sup> December 2017 | | Wheelchair Accessible Toilet.<br><br>Internal North West & North-East Walls.<br><br>Fibre Cement<br><b>2769</b> | Sample #B17440S17<br><br>No Asbestos Detected | A5 | N/A |

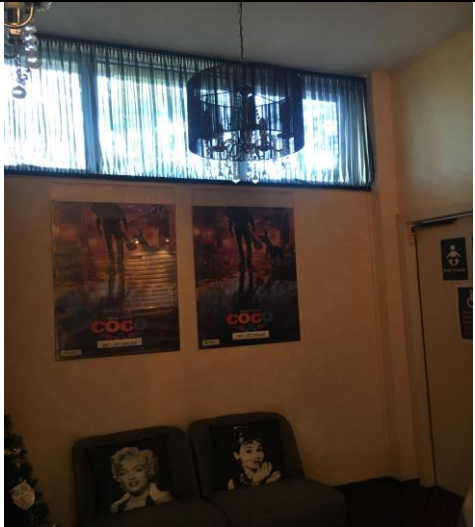
| ASBESTOS MATERIALS REGISTER | | ASSET: Glenbrook Cinema and Hall, Corner of Great Western Highway and Ross Street, Glenbrook, NSW, 2773 | | | |
|---|---|---|---|---|---|
| 14 <sup>th</sup> December 2017 | | Foyer to Disabled Toilet.<br><br>Wall and Ceiling Sheeting.<br><br>Fibre Cement<br><b>2770</b> | Similar to Sample #B17440S17<br><br>No Asbestos Detected | A5 | N/A |

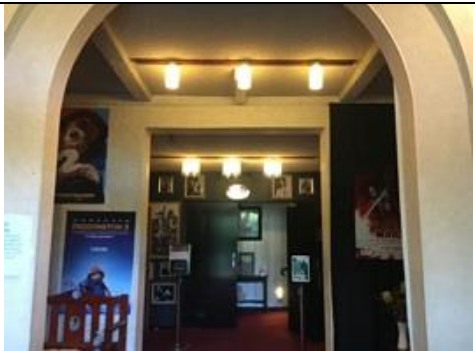
| ASBESTOS MATERIALS REGISTER | | ASSET: Glenbrook Cinema and Hall, Corner of Great Western Highway and Ross Street, Glenbrook, NSW, 2773 | | | |
|---|---|---|---|---|---|
| 14 <sup>th</sup> December 2017 | | Foyer.<br><br>Vermiculite Ceiling<br><br><b>2771</b> | Sample #B17440S18 & Sample #B17440S19<br><br>No Asbestos Detected | A5 | N/A |

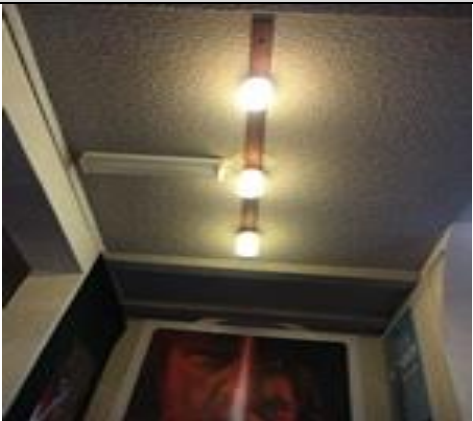
| ASBESTOS MATERIALS REGISTER | | ASSET: Glenbrook Cinema and Hall, Corner of Great Western Highway and Ross Street, Glenbrook, NSW, 2773 | | | |
|---|---|---|---|---|---|
| 14 <sup>th</sup> December 2017 | | Foyer.<br>Vermiculite Ceiling<br><b>2772</b> | Sample #B17440S20 & Sample #B17440S21<br><br>No Asbestos Detected | A5 | N/A |

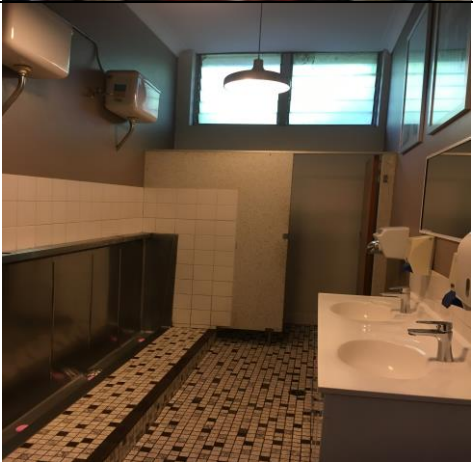
| ASBESTOS MATERIALS REGISTER | | ASSET: Glenbrook Cinema and Hall, Corner of Great Western Highway and Ross Street, Glenbrook, NSW, 2773 | | | |
|---|---|---|---|---|---|
| 14 <sup>th</sup> December 2017 | | Men's Toilet.<br>Plaster Board Ceiling, Rendered Brick Walls, Terrazzo Partitions, Ceramic Tiles on Concrete Floor.<br><b>2773</b> | No Asbestos Materials Observed | A5 | N/A |

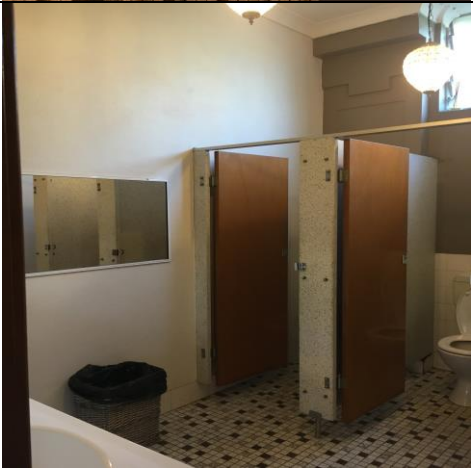
| ASBESTOS MATERIALS REGISTER | | ASSET: Glenbrook Cinema and Hall, Corner of Great Western Highway and Ross Street, Glenbrook, NSW, 2773 | | | |
|---|---|---|---|---|---|
| 14 <sup>th</sup> December 2017 | | Plaster Board Ceiling, Rendered Brick Walls, Terrazzo Partitions, Ceramic Tiles on Concrete Floor.<br><b>2774</b> | No Asbestos Materials Observed | A5 | N/A |

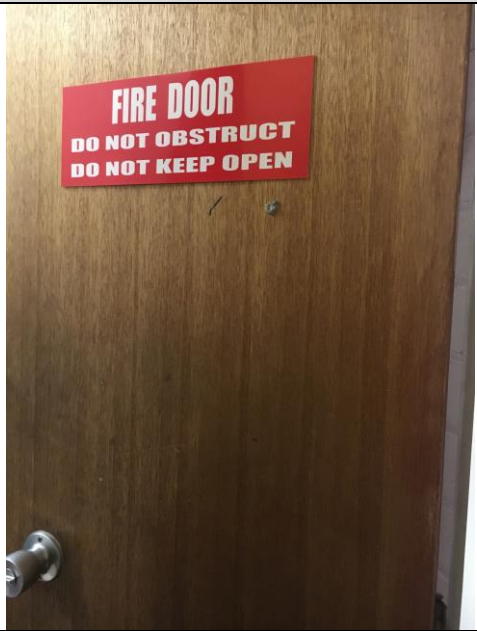
| ASBESTOS MATERIALS REGISTER | | ASSET: Glenbrook Cinema and Hall, Corner of Great Western Highway and Ross Street, Glenbrook, NSW, 2773 | | | |
|---|---|---|---|---|---|
| 14 <sup>th</sup> December 2017 | | Projector Room.<br><br>Fire Door.<br><b>2776</b> | Potential Asbestos Containing Insulation –<br><br>No Sample Taken. Nil Access. | A4 | Good Condition<br>Accessible to Tradespeople<br>Refer to Asbestos Management Plan |

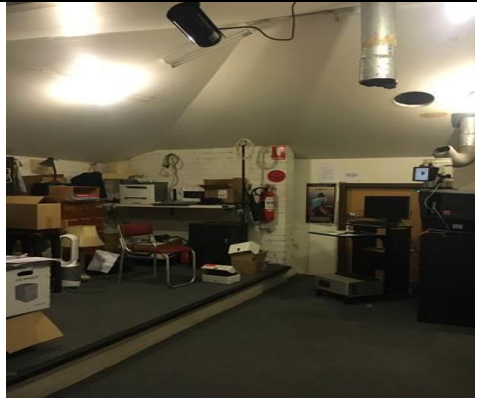
| ASBESTOS MATERIALS REGISTER | | ASSET: Glenbrook Cinema and Hall, Corner of Great Western Highway and Ross Street, Glenbrook, NSW, 2773 | | | |
|---|---|---|---|---|---|
| 14 <sup>th</sup> December 2017 | | Projector Room.<br><br>Plaster Board Ceiling, Brick Walls, Carpet on Concrete Floor.<br><b>2776</b> | No Asbestos Materials Observed | A5 | N/A |

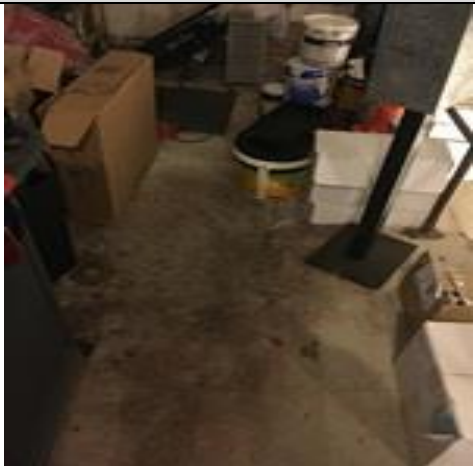
| ASBESTOS MATERIALS REGISTER | | ASSET: Glenbrook Cinema and Hall, Corner of Great Western Highway and Ross Street, Glenbrook, NSW, 2773 | | | |
|---|---|---|---|---|---|
| 14 <sup>th</sup> December 2017 | | Projector Room.<br>Vinyl Tile Backing<br>Adhesive Tape<br>Samples.<br><b>2777</b> | Sample<br>#B17440S22<br>& Sample<br>#B17440S23<br>No Asbestos<br>Detected | A5 | N/A |

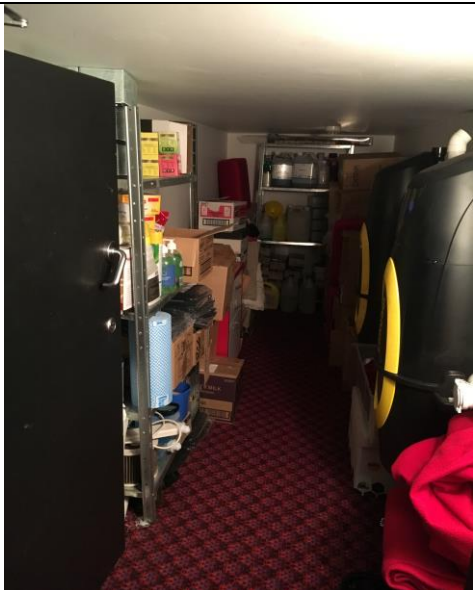
| ASBESTOS MATERIALS REGISTER | | ASSET: Glenbrook Cinema and Hall, Corner of Great Western Highway and Ross Street, Glenbrook, NSW, 2773 | | | |
|---|---|---|---|---|---|
| 14 <sup>th</sup> December 2017 | | Store Room Left<br>of Theatre Entry.<br><br>Plaster Board<br>Ceiling & Walls,<br>Carpet on<br>Concrete. | No Asbestos<br>Materials<br>Observed<br><b>2779</b> | A5 | N/A |

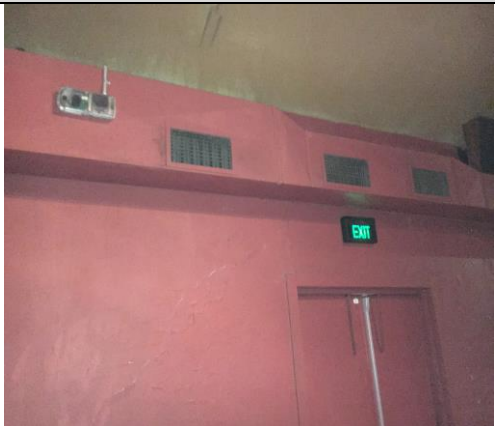
| ASBESTOS MATERIALS REGISTER | | ASSET: Glenbrook Cinema and Hall, Corner of Great Western Highway and Ross Street, Glenbrook, NSW, 2773 | | | |
|---|---|---|---|---|---|
| 14 <sup>th</sup> December 2017 | | Main Seating Area.<br>Air Conditioner Ducting to North and West Walls.<br><b>2780</b> | Potential to Harbour Heater Banks. No External Indicators. No Sample Taken. Nil Access. | A4 | Good Condition<br>Accessible to Tradespeople<br>Refer to Asbestos Management Plan |

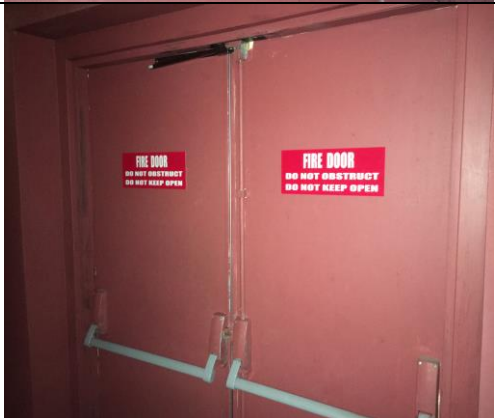
| ASBESTOS MATERIALS REGISTER | | ASSET: Glenbrook Cinema and Hall, Corner of Great Western Highway and Ross Street, Glenbrook, NSW, 2773 | | | |
|---|---|---|---|---|---|
| 14 <sup>th</sup> December 2017 | | Main Seating Area.<br>Fire Doors to East and West.<br><b>2781</b> | Potential Asbestos Containing Insulation –<br>No Sample Taken. Nil Access. | A4 | Good Condition<br>Accessible to Tradespeople<br>Refer to Asbestos Management Plan |

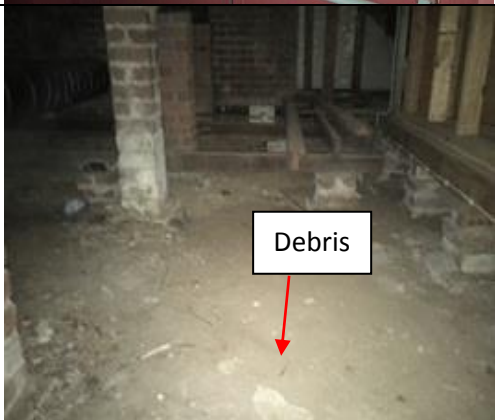
| ASBESTOS MATERIALS REGISTER | | ASSET: Glenbrook Cinema and Hall, Corner of Great Western Highway and Ross Street, Glenbrook, NSW, 2773 | | | |
|---|---|---|---|---|---|
| 14 <sup>th</sup> December 2017 | | Sub Floor.<br>Stage Debris Throughout Sub Floor.<br>Fibre Cement<br><b>2782</b> | Sample #B17440S24<br>Chrysotile Asbestos Detected<br>Non-Friable | A3 | Poor Condition<br>Accessible to Tradespeople<br>Refer to Asbestos Management Plan |

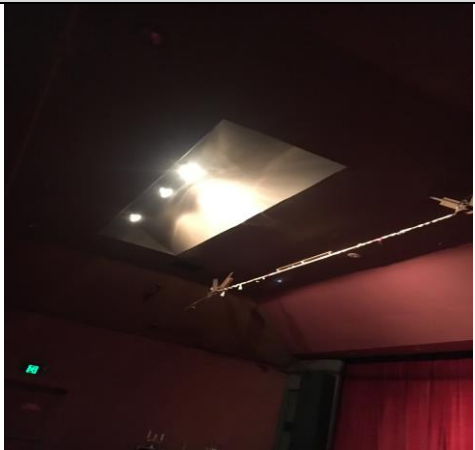
| ASBESTOS MATERIALS REGISTER | | ASSET: Glenbrook Cinema and Hall, Corner of Great Western Highway and Ross Street, Glenbrook, NSW, 2773 | | | |
|---|---|---|---|---|---|
| 14 <sup>th</sup> December 2017 | | Main Seating Area.<br>Plaster Board and Vermiculite Ceiling, Rendered Brick Walls, Carpet on Concrete Floor.<br><b>2783</b> | Sample #B17440S29 and #B17440S30<br>No Asbestos Detected | A5 | N/A |

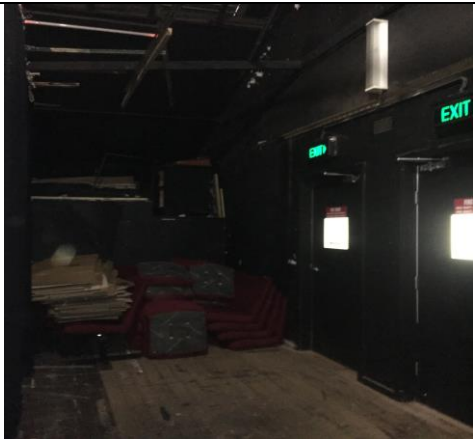
| ASBESTOS MATERIALS REGISTER | | ASSET: Glenbrook Cinema and Hall, Corner of Great Western Highway and Ross Street, Glenbrook, NSW, 2773 | | | |
|---|---|---|---|---|---|
| 14 <sup>th</sup> December 2017 | | Stage.<br>Fire Doors.<br><b>2785</b> | Potential Asbestos Containing Insulation –<br>No Sample Taken. Nil Access. | A4 | Good Condition Accessible to Tradespeople Refer to Asbestos Management Plan |

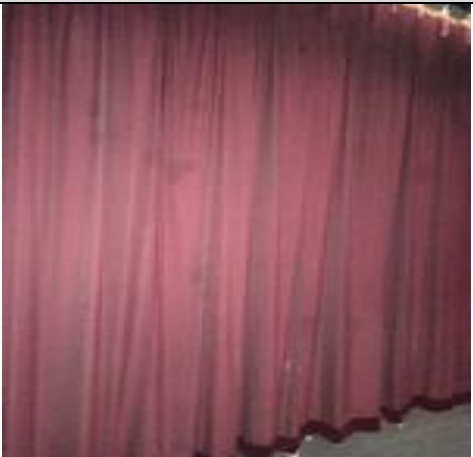
| ASBESTOS MATERIALS REGISTER | | ASSET: Glenbrook Cinema and Hall, Corner of Great Western Highway and Ross Street, Glenbrook, NSW, 2773 | | | |
|---|---|---|---|---|---|
| 14 <sup>th</sup> December 2017 | | Stage.<br>Red Stage Curtain<br><b>2786</b> | Sample #B17440S26<br>No Asbestos Detected | A5 | N/A |

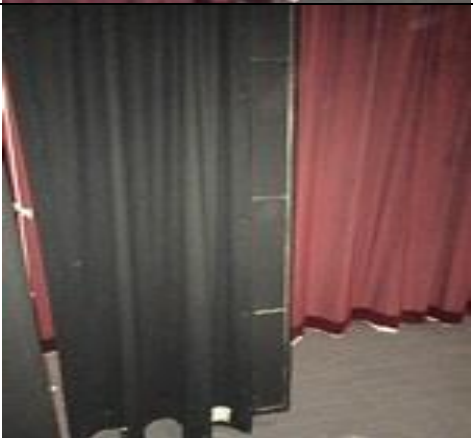
| ASBESTOS MATERIALS REGISTER | | ASSET: Glenbrook Cinema and Hall, Corner of Great Western Highway and Ross Street, Glenbrook, NSW, 2773 | | | |
|---|---|---|---|---|---|
| 14 <sup>th</sup> December 2017 | | Stage.<br>Black Stage Curtain<br><b>2787</b> | Sample #B17440S27<br>No Asbestos Detected | A5 | N/A |

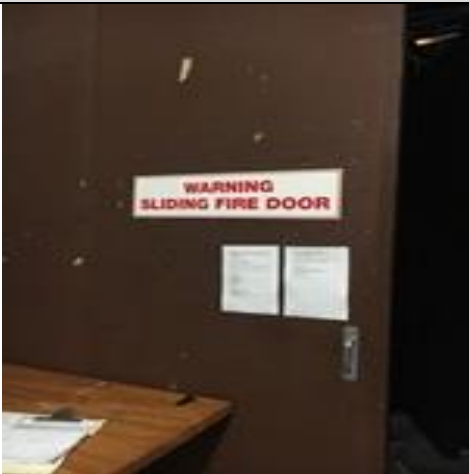
| ASBESTOS MATERIALS REGISTER | | ASSET: Glenbrook Cinema and Hall, Corner of Great Western Highway and Ross Street, Glenbrook, NSW, 2773 | | | |
|---|---|---|---|---|---|
| 14 <sup>th</sup> December 2017 | | Sliding Fire Door to Back of Stage Store.<br><b>2789</b> | Possible Asbestos Containing Insulation – No Sample Taken | A4 | Good Condition<br>Accessible to Tradespeople<br>Refer to Asbestos Management Plan |

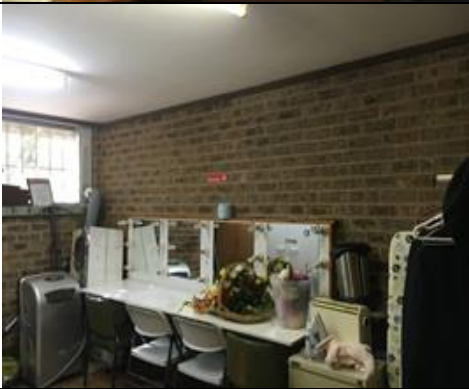
| ASBESTOS MATERIALS REGISTER | | ASSET: Glenbrook Cinema and Hall, Corner of Great Western Highway and Ross Street, Glenbrook, NSW, 2773 | | | |
|---|---|---|---|---|---|
| 14 <sup>th</sup> December 2017 | | Dressing Room.<br>Brick Walls, Timber Floors, Cement Stairs, Plaster Board Ceiling Sheeting.<br><b>2790</b> | No Asbestos Materials Observed | A5 | N/A |

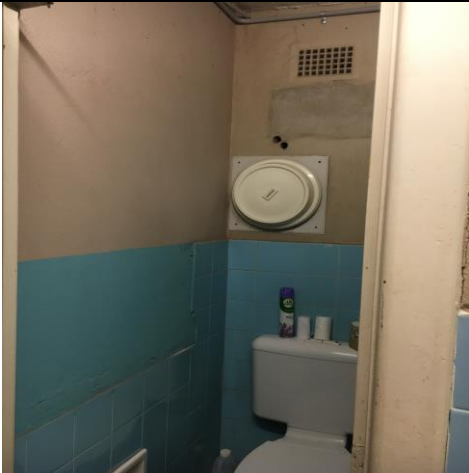
| ASBESTOS MATERIALS REGISTER | | ASSET: Glenbrook Cinema and Hall, Corner of Great Western Highway and Ross Street, Glenbrook, NSW, 2773 | | | |
|---|---|---|---|---|---|
| 14 <sup>th</sup> December 2017 | | Ladies Toilet to Dressing Room.<br>Concrete Ceiling and Floors, Brick Walls, Ceramic Tiled Walls & Floor.<br><b>2791</b> | No Asbestos Materials Observed | A5 | N/A |

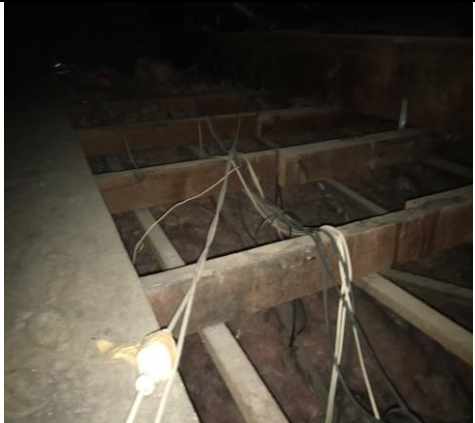
| ASBESTOS MATERIALS REGISTER | | ASSET: Glenbrook Cinema and Hall, Corner of Great Western Highway and Ross Street, Glenbrook, NSW, 2773 | | | |
|---|---|---|---|---|---|
| 14 <sup>th</sup> December 2017 | | Ceiling Space.<br>Pink Insulation Batts Throughout Ceiling Space.<br><b>2793</b> | No Asbestos Materials Observed | A5 | Insulation removed<br>Trinitas<br>17/09/2020 HPE<br>20/205943 |

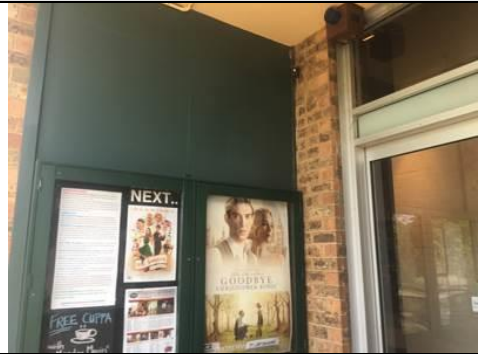
| LEAD BASED PAINTS REGISTER<br>Sample Date: 12 <sup>th</sup> December 2017 | | ASSET: Glenbrook Cinema and Hall, Corner of Great Western Highway and Ross Street, Glenbrook, NSW, 2773 | | | |
|---|---|---|---|---|---|
| 17440- S01 | | External to East Green Paint | 0.08% | A5 | Paint not classified as lead based as less than or Equal to 0.1% w/w |

Lead based paint samples obtained from the Glenbrook Cinema and Hall returned results below classification for Lead Paint 0.1% W/W. However, good practice would dictate that existing paint, even if it is below the recognised standard, should not be sanded and that dust minimisation techniques should be adopted, when undertaking renovation / repair works particularly in heritage period buildings. It would be good practice to wear a P1 dust mask during any paint removal even though it does not contain lead but small particles of paint can still be inhaled or ingested.

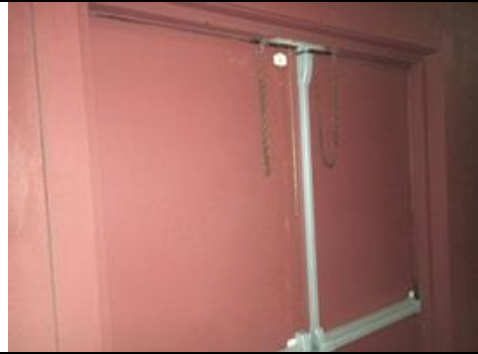
| LEAD BASED PAINTS REGISTER<br>Sample Date: 12 <sup>th</sup> December 2017 | | ASSET: Glenbrook Cinema and Hall, Corner of Great Western Highway and Ross Street, Glenbrook, NSW, 2773 | | | |
|---|---|---|---|---|---|
| 17440- S02 | | Red Painted Surfaces Throughout | 0.07% | | Paint not classified as lead based as less than or Equal to 0.1% w/w |

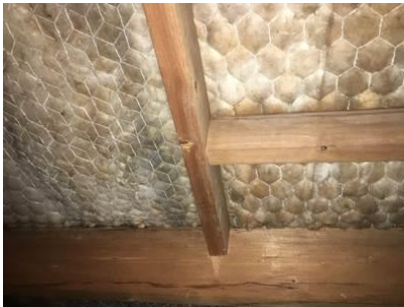
| SYNTHETIC MINERAL FIBRE REGISTER | | ASSET: Glenbrook Cinema and Hall, Corner of Great Western Highway and Ross Street, Glenbrook, NSW, 2773 | | | |
|---|---|---|---|---|---|
| 12 <sup>th</sup> December 2017 | | Synthetic Mineral Fibre Products Were Identified Above Kitchen. | Sample #B17440S13 | A5 | Bonded and Secure. Not High Risk |

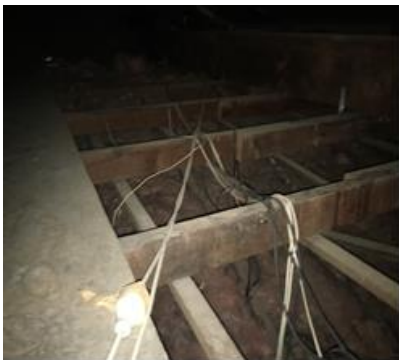
| SYNTHETIC MINERAL FIBRE REGISTER | | ASSET: Glenbrook Cinema and Hall, Corner of Great Western Highway and Ross Street, Glenbrook, NSW, 2773 | | | |
|---|---|---|---|---|---|
| 14 <sup>th</sup> December 2017 | | Synthetic Mineral Fibre Products Were Identified Above Stage. | No Sample Taken | A5 | Bonded and Secure. Not High Risk |

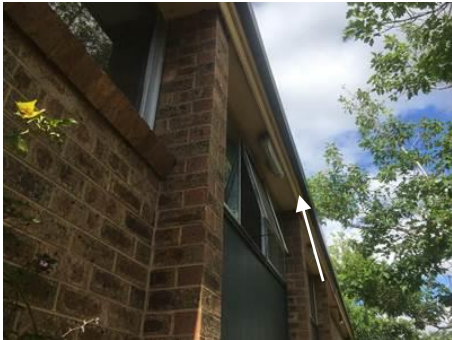
| POLYCHLORINATED BIPHENYLS REGISTER | | ASSET: Glenbrook Cinema and Hall, Corner of Great Western Highway and Ross Street, Glenbrook, NSW, 2773 | | | |
|---|---|---|---|---|---|
| 12 <sup>th</sup> December 2017 | | Exterior Lights Around Building Fluorescent Lights No PCB's Present | Visual Inspection | A5 | N/A |

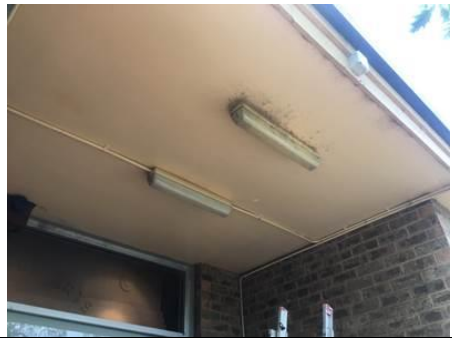
| POLYCHLORINATED BIPHENYLS REGISTER | | ASSET: Glenbrook Cinema and Hall, Corner of Great Western Highway and Ross Street, Glenbrook, NSW, 2773 | | | |
|---|---|---|---|---|---|
| 12 <sup>th</sup> December 2017 | | Exterior Lights Above Entry Fluorescent Lights No PCB's Present | Visual Inspection | A5 | N/A |

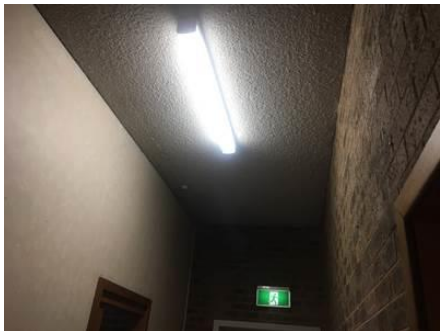
| POLYCHLORINATED BIPHENYLS REGISTER | | ASSET: Glenbrook Cinema and Hall, Corner of Great Western Highway and Ross Street, Glenbrook, NSW, 2773 | | | |
|---|---|---|---|---|---|
| 12 December 2017 | | Hallway Light Fluorescent Lights No PCB's Present | Visual Inspection | A5 | N/A |
