# Asbestos Register

**HAZARDOUS MATERIALS REGISTER &  
MANAGEMENT PLAN**

Regional EnviroScience Pty Ltd was requested by Mr. Rick Harris of Blue Mountain City Council to undertake a Hazardous Building Materials Register and to prepare a Hazardous Materials Management Plan of the property known as 'Katoomba Out of School Hours', located at 10 Station Street, Katoomba, NSW, 2780. The purpose of the audit was to locate and identify asbestos based building materials and product within the building in accordance with the *NSW Work Health and Safety Act and Regulation 2017* and the *Code of Practice; How to Manage and Control Asbestos in the Workplace* [Safe Work Australia: 2016] and the *Code of Practice; How to Safely Remove Asbestos* [Safe Work Australia: 2016].

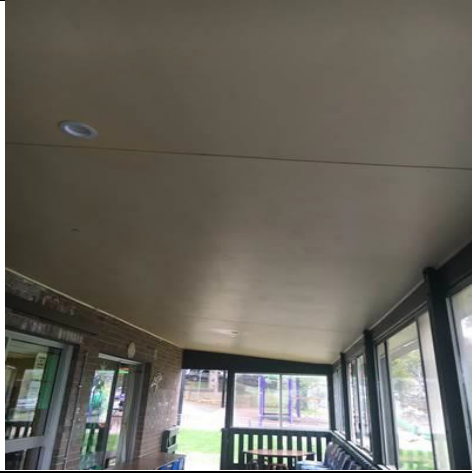
Lower Ground Floor. External Veranda North Elevation. Brick West Wall, Aluminium Framed Windows, Timber Floor Fibre Cement Ceiling Sheet <b>371</b>	Sample #B17467S02 Chrysotile Asbestos Detected Non-Friable	A5	N/A Clearance Certificate JMB 19/143810
15 <sup>th</sup> December 2017

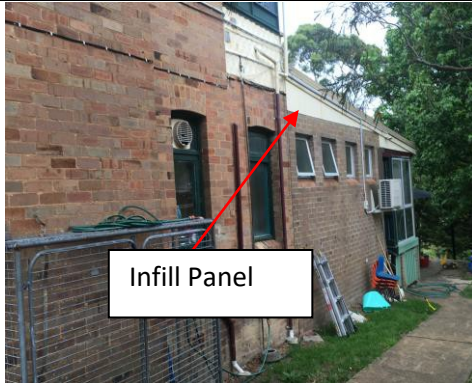
Infill Panel	North Elevation External Infill Sheet. Fibre Cement Approximately 2m <sup>2</sup> <b>372</b>	Sample #B17467S03 Chrysotile Asbestos Detected Non-Friable	A5	N/A Clearance Certificate JMB 19/143810
15 <sup>th</sup> December 2017

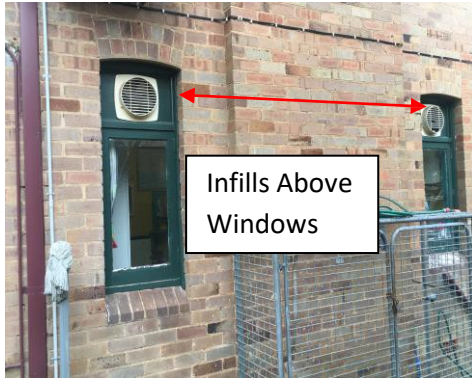
Infills Above Windows	Infills Above Windows North Elevation. Fibre Cement <b>373</b>	Sample #B17467S04 Chrysotile Asbestos Detected Non-Friable	A5	N/A Clearance Certificate JMB 19/143810

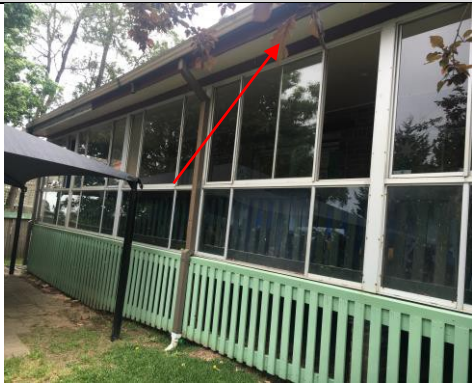
West Elevation Eaves & Veranda Sheeting. Fibre Cement  <b>374</b>	Sample #B17467S05 Chrysotile Asbestos Detected Non-Friable	A5	N/A Clearance Certificate JMB 19/143810
15 <sup>th</sup> December 2017

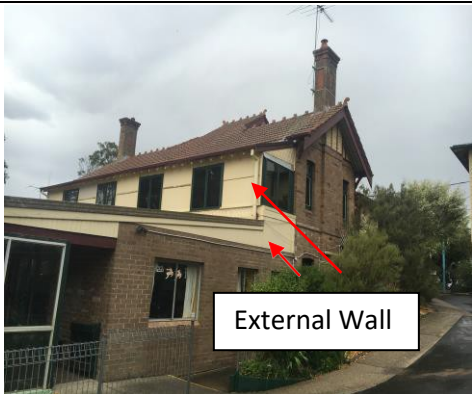
Southern Elevation. 1 <sup>st</sup> Story Enclosed Veranda. External Wall Fibre Cement  <b>375</b>	Sample #B17467S06 Chrysotile Asbestos Detected Non-Friable	A5	N/A Clearance Certificate JMB 19/143810
15 <sup>th</sup> December 2017

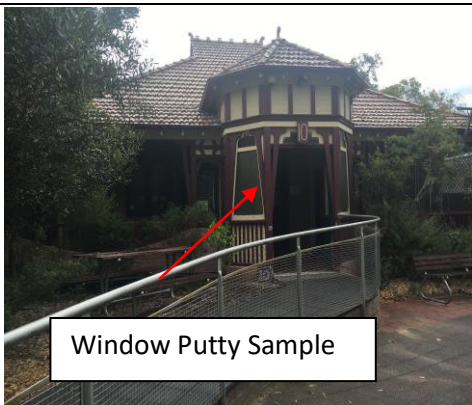
East Elevation Window Putty  <b>494</b>	Sample #B17467S07 No Asbestos Detected	A5	N/A

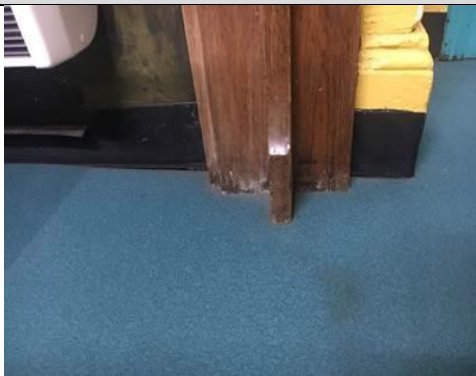
Bottom of Fire Place Quiet Room Linoleum Floor Covering.  <b>495</b>	Sample #B17467S08  No Asbestos Detected	A5	N/A
15 <sup>th</sup> December 2017

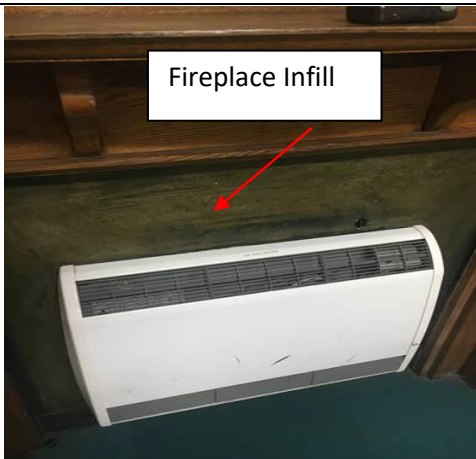
Over Fire Place Quiet Area.  Fibre Cement  <b>376</b>	Sample #B17467S09 Chrysotile Asbestos Detected Non-Friable	A5	N/A Clearance Certificate JMB 19/143810
15 <sup>th</sup> December 2017

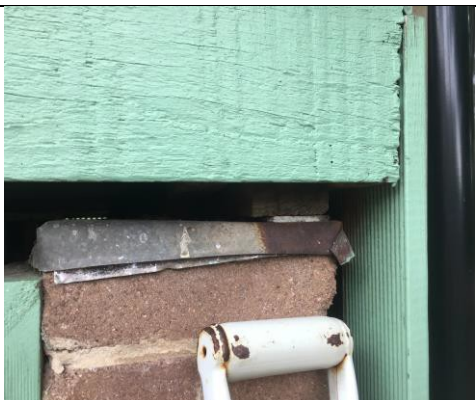
Packing to Bearer Timbers, Sub Floor Space. Fibre Cement Approximately 1m <sup>2</sup>  <b>377</b>	Sample #B17467S10 Chrysotile Asbestos Detected Non-Friable	A4	Fair Condition, Minimal, Damage.  Encapsulated Emaclad 22/06/2019 19/143810

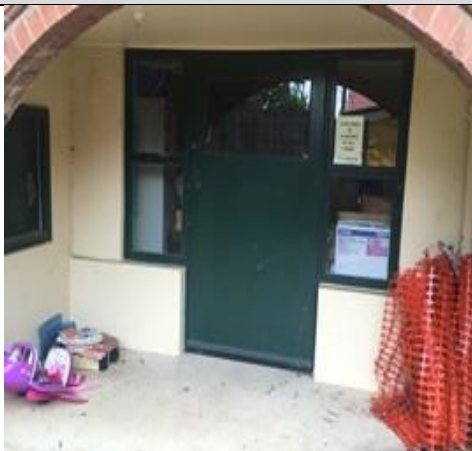
Lower Ground Floor Northern Entrance. Fibre Cement Ceiling Sheeting. Timber door. Timber Door and Window Frames. Rendered Brick Walls. <b>379</b>	Sample #B17467S02 Chrysotile Asbestos Detected Non-Friable	A5	N/A Clearance Certificate JMB 19/143810
15 <sup>th</sup> December 2017

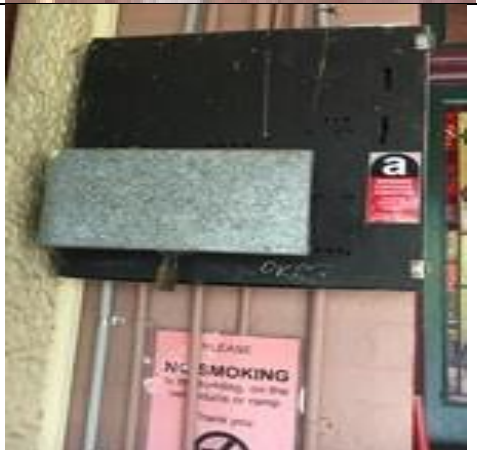
Electrical Meter Backing Board Adjacent the Front Entry. <b>382</b>	No Sample Taken, Assume Contains Asbestos Materials.	A4	Good Condition Accessible to Tradespeople Refer to Asbestos Management Plan
15 <sup>th</sup> December 2017		Ground Floor Front Veranda Southern Elevation. Timber Ceiling/Rendered Brick Walls/Timber Door/Timber Door and Window Frames/Tile on Concrete Slab Floor <b>522</b>	No Asbestos Containing Material Identified	A5	N/A

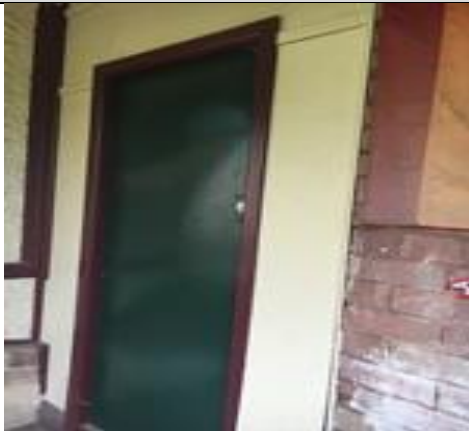
Ground Floor Front Veranda Southern Elevation.  Fibre Cement Sheet Surrounding door to Internal Store Room.  <b>381</b>	<del>No Sample Taken. Similar to Sample #B17467S02</del> Chrysotile Asbestos Detected  Non-Friable	A5	N/A  Clearance Certificate JMB 19/143810
15 <sup>th</sup> December 2017

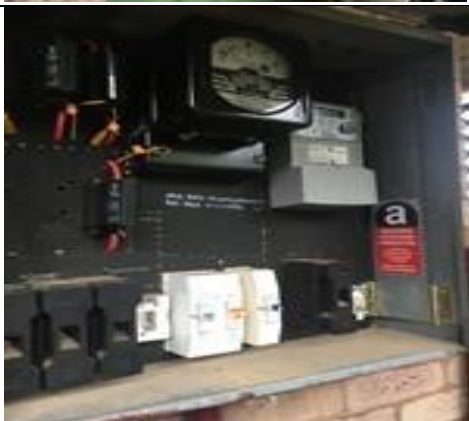
Electrical Meter Backing Board. South West of Front Entry.  <b>380</b>	No Sample Taken, Assume Contains Asbestos Materials.	A4	Good Condition Accessible to Tradespeople Refer to Asbestos Management Plan

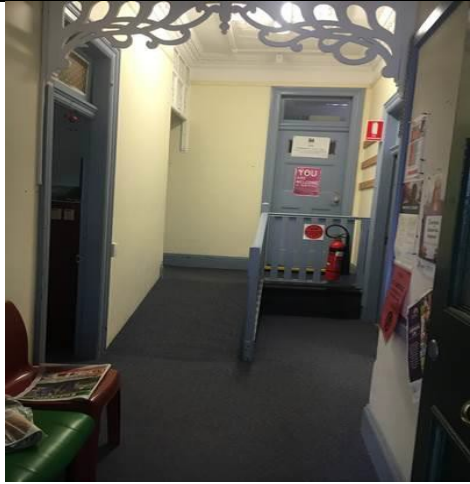
Blue Paint - Internal Throughout	1.7% w/w	A4	Paint is classified as lead based. Greater than 1.0% w/w
Sample S02 (182541-2)

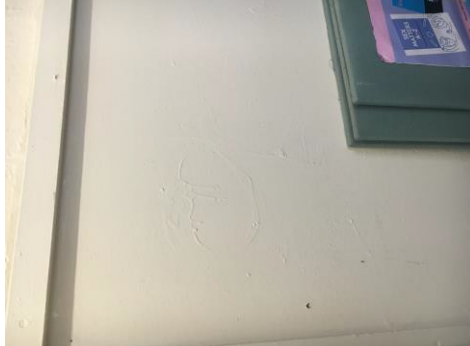
Cream Paint - Internal Throughout	<0.05% w/w	A5	Paint is not classified as lead based. Less than 1.0% w/w

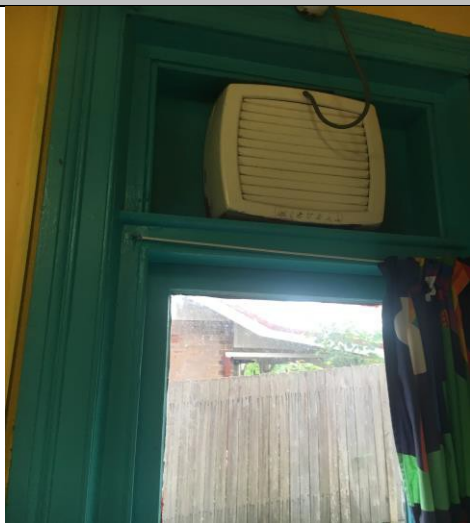
Green/Blue Paint - Internal Throughout	0.05% w/w	A5	Paint is not classified as lead based. Less than 1.0% w/w
Sample S04 (182541-4)

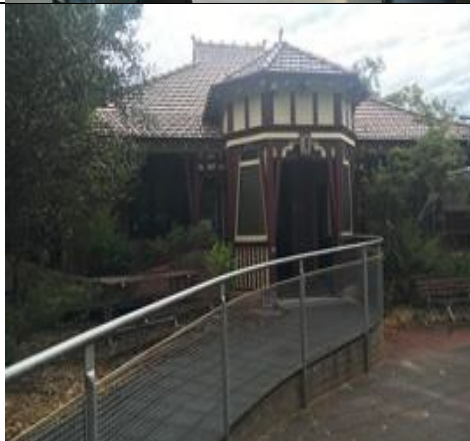
External Red Paint.	0.09% w/w	A5	Paint is not classified as lead based. Less than 1.0% w/w

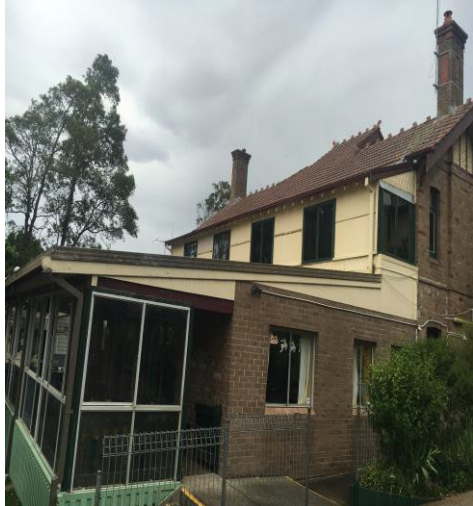
Cream Paint- External Entire Building	41% w/w	A4	Paint is classified as lead based. Greater than 1.0% w/w

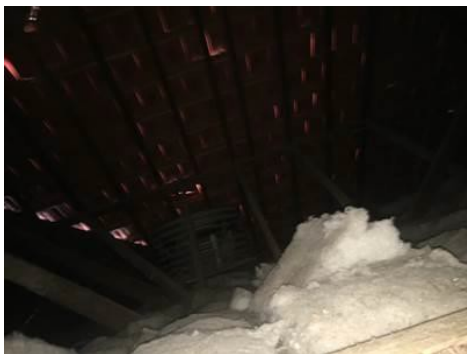
Roof Space Insulation Batt's	Visual Inspection No SMF Detected	A5	N/A
