Asbestos Register

Regional EnviroScience Pty Ltd was requested by Mr. Rick Harris of Blue Mountain City Council to undertake a Hazardous Building Materials Register and to prepare a Hazardous Materials Management Plan of the property known as Summerhayes Park Club House and Amenities buildings, located at 358-360 Hawkesbury Road, Winmalee, NSW, 2777. The purpose of the audit was to locate and identify asbestos based building materials and product within the building in accordance with the *NSW Work Health and Safety Act and Regulation 2017* and the *Code of Practice; How to Manage and Control Asbestos in the Workplace* [Safe Work Australia: 2016] and the *Code of Practice; How to Safely Remove Asbestos* [Safe Work Australia: 2016].

ASBESTOS MATERIALS REGISTER		ASSET: Summerhayes Park, 358-360 Hawkesbury Road, Winmalee, NSW, 2777			
DATE OF IDENTIFICATION	IMAGES	SPECIFIC LOCATION OF ASBESTOS/ APPROX M ²	TYPE OF ASBESTOS/ FRIABLE OR NON-FRIABLE	RISK ACTION RATING	CONDITION & ACCESSIBILITY OF ASBESTOS
7 th December 2017

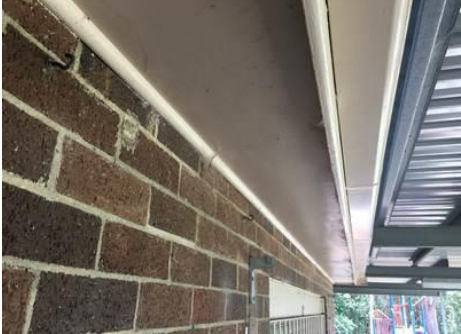
Soffit East and West Aspect Adjacent Roller Door, Bonded Board Approximately 3m ² 525	Sample #B17394S01 Chrysotile Asbestos Detected Non-Friable	A4	Good Condition Accessible to Tradespeople Refer to Asbestos Management Plan
7 th December 2017

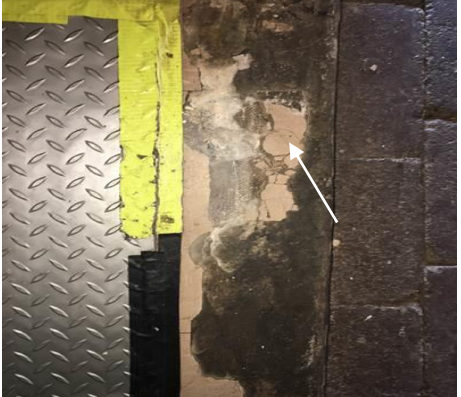
Kiosk Floor Vinyl Tile Cream 526	Sample #B17394S02 No Asbestos Detected	A5	N/A

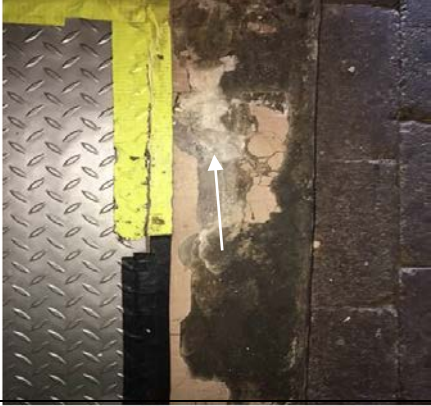
Kiosk Floor Tile Adhesive 527	Sample #B17394S03 No Asbestos Detected	A5	N/A
7 th December 2017

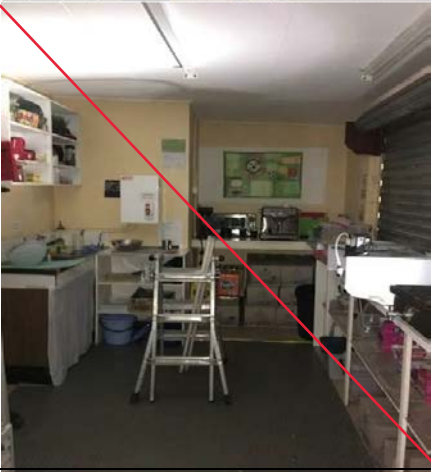
Kiosk Ceiling- Sheet Fibre-Cement. Rendered Brick-Walls, Vinyl Floor Tiles. Approximately 14m ² 528	Sample #B17394S04 Chrysotile-Asbestos- Detected Non-Friable	A4	Good Condition Accessible to Tradespeople Refer to Asbestos-Management-Plan SLR CC #610.17816.00000.02-10-R01-v1.0 CLR - 18/22273
7 th December 2017

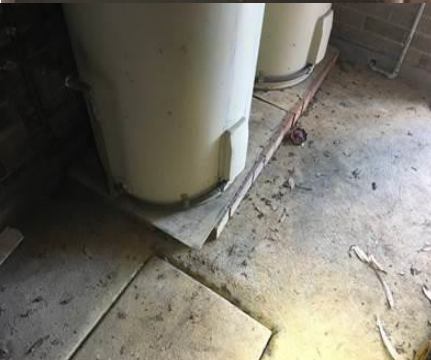
Water Heater Room Bonded Sheet Under Water Heater Fibre Cement 529	Sample #B17394S05 No Asbestos Detected	A5	N/A

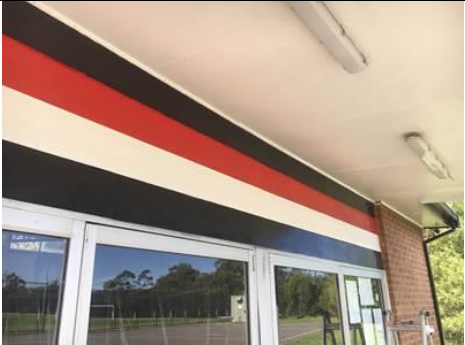
North Aspect. Infill Above Doors. Fibre Cement Approximately 8m ² 542	Sample #B17394S06 Chrysotile Asbestos Detected Non-Friable	A4	Good Condition Accessible to Tradespeople Refer to Asbestos Management Plan
7 th December 2017

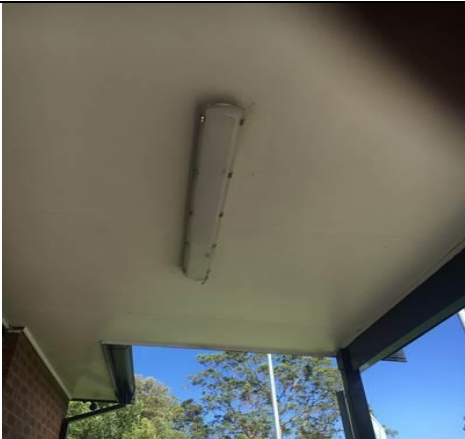
Eaves and Veranda Ceiling, Fibre Cement Approximately 23m ² 543	Sample #B17394S07 Chrysotile Asbestos Detected Non-Friable	A4	Good Condition Accessible to Tradespeople Refer to Asbestos Management Plan

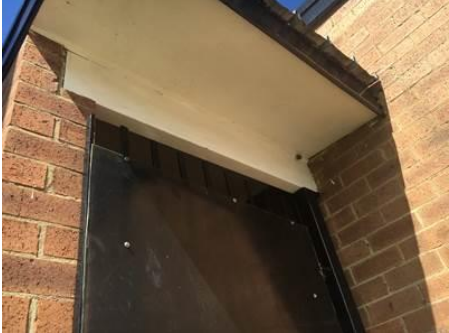
East Elevation Eave, Fibre Cement. Aluminium Framed Window, Timber Fascia, Brick Walls. 544	Similar to Sample #B17394S08 Chrysotile Asbestos Detected Non-Friable	A4	Good Condition Accessible to Tradespeople Refer to Asbestos Management Plan
7 th December 2017

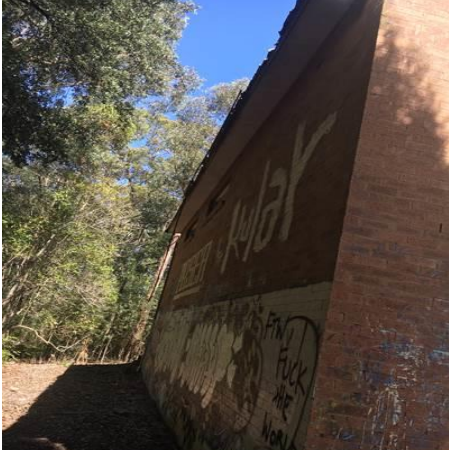
South Elevation Eave, Fibre Cement. Brick Walls. Approximately 5m ² 545	Sample #B17394S08 Chrysotile Asbestos Detected Non-Friable	A4	Good Condition Accessible to Tradespeople Refer to Asbestos Management Plan
7 th December 2017

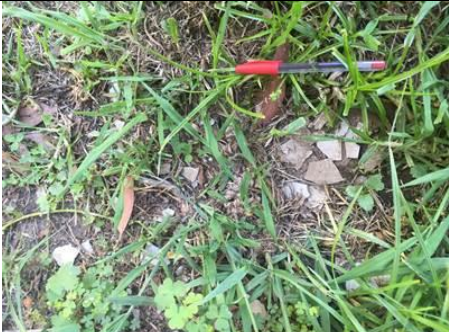
Debris West Elevation Vinyl Tile 546	Sample #B17394S09 No Asbestos Detected	A5	N/A

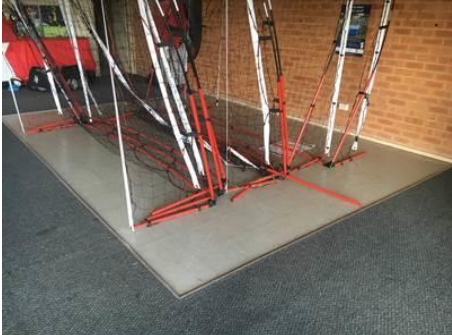
Main Dance Floor Vinyl Tile Grey 547	Sample #B17394S10 No Asbestos Detected	A5	N/A
7 th December 2017

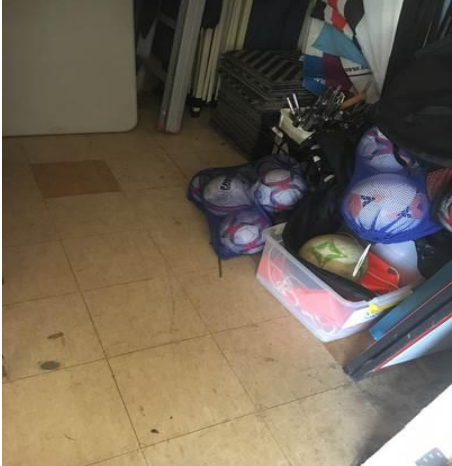
Store Room Vinyl Tile Cream 548	Sample #B17394S11 No Asbestos Detected	A5	N/A
7 th December 2017

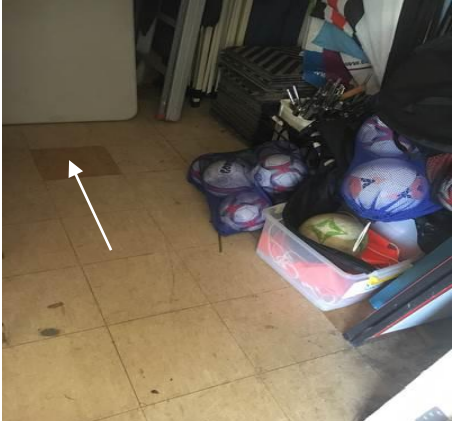
Store Room Vinyl Tile Orange 549	Sample #B17394S12 No Asbestos Detected	A5	N/A

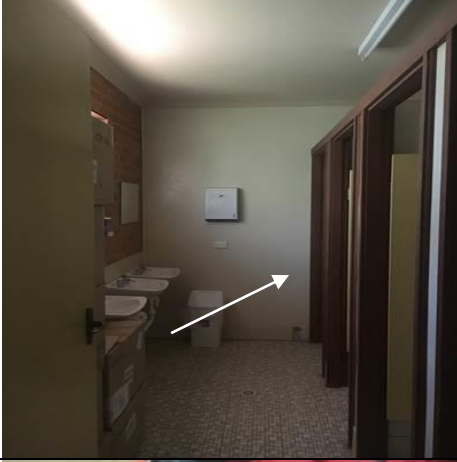
Ladies Toilet Cubicle Walls Fibre Cement Approximately 30m ² 550	Sample #B17394S13 Chrysotile Asbestos Detected Non-Friable	A4	Good Condition Accessible to Tradespeople Refer to Asbestos Management Plan
7 th December 2017

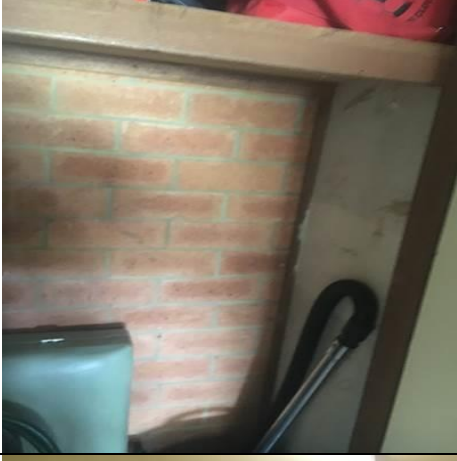
Ladies Toilet Wall Sheeting on Cupboard Approximately 2m ² 551	Similar to Sample #B17394S13 Chrysotile Asbestos Detected Non-Friable	A4	Good Condition Accessible to Tradespeople Refer to Asbestos Management Plan
7 th December 2017

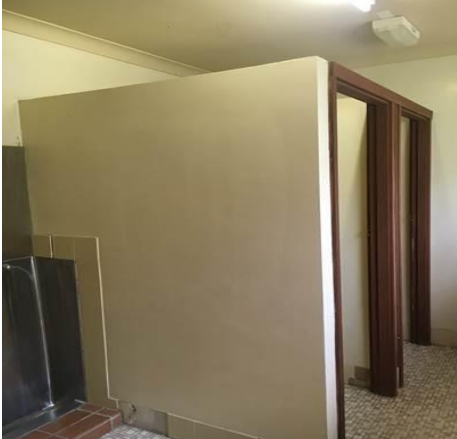
Men's Toilet Cubicle Walls & Wall Sheet Approximately 40m ² 552	Similar to Sample #B17394S13 Chrysotile Asbestos Detected Non-Friable	A4	Good Condition Accessible to Tradespeople Refer to Asbestos Management Plan

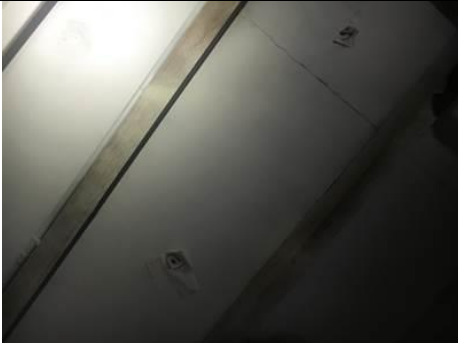
Subfloor of Building, Fibre Cement Approximately 40m ² 554	Sample #B17394S15 Chrysotile Asbestos Detected Non-Friable	A4	Good Condition Accessible to Tradespeople Refer to Asbestos Management Plan
7 th December 2017

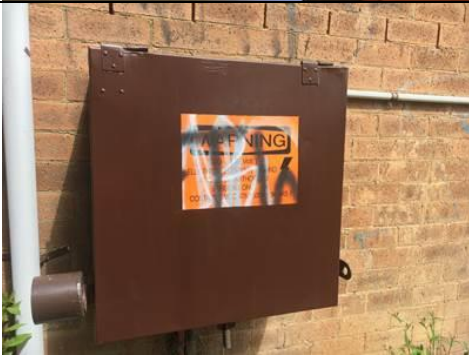
Electrical Meter Box. Nil Access. 557	Assume Contains Asbestos Materials.	A4	Presume to be in Good Condition Accessible to Tradespeople Refer to Asbestos Management Plan
7 th December 2017

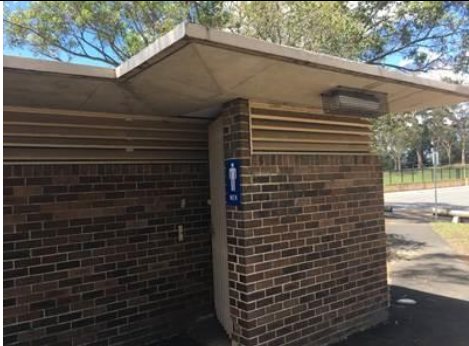
Exterior Timber Vents Cream Paint	0.08% w/w	A5	Paint is not classified as lead based. Less than 1.0% w/w

There were no lead based paints detected at Summerhayes Park, however good practice would dictate that existing paint, even though is below the recognised standard, should not be sanded and that dust minimisation techniques should be adopted, when undertaking renovation / repair works particularly in heritage period buildings. It would be good practice to wear a P1 dust mask during any paint removal even though it does not contain lead but small particles of paint can still be inhaled or ingested.

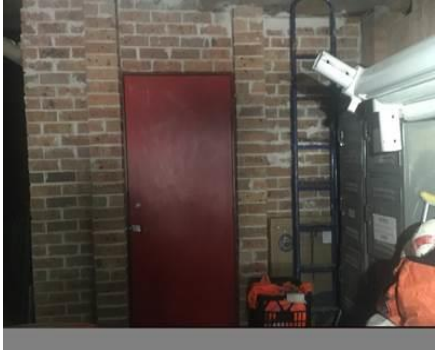
Red Door Beneath Building Red Paint	<0.05% w/w	A5	Paint is not classified as lead based. Less than 1.0% w/w
Sample - S02 (182110-2)

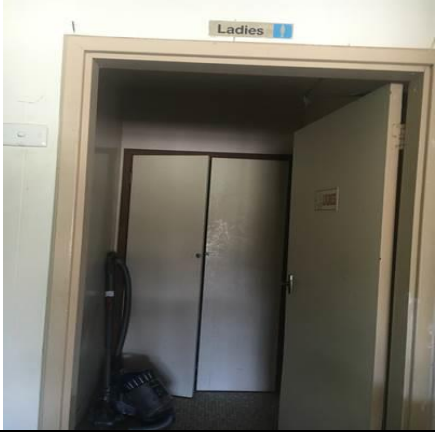
Internal Architrave Door Frame Cream Paint	<0.05% w/w	A5	Paint is not classified as lead based. Less than 1.0% w/w
Sample - S03 (182110-1)

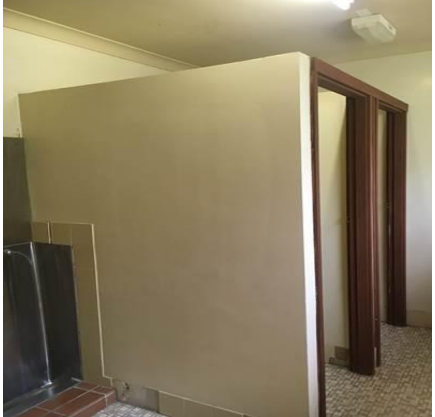
Ladies and Men's Toilets Yellow Cubicle Door Paint	0.1% w/w	A5	Paint is not classified as lead based. Less than 1.0% w/w

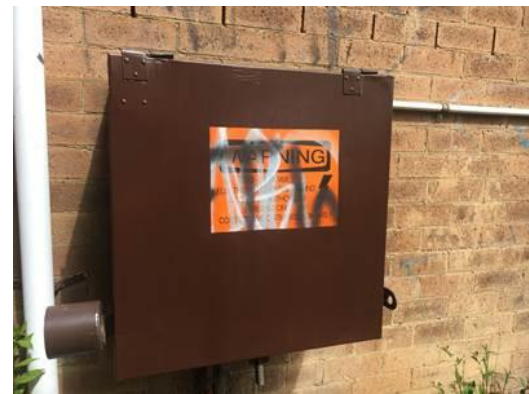
External Electrical Backing Board Potential Bakelite Materials.	Assume Phenol Positive	A4	Presume to be in Good Condition. Accessible to Tradespeople Refer to Management Plan
