# Asbestos Register

Regional EnviroScience Pty Ltd was requested by Mr. Rick Harris of Blue Mountain City Council to undertake a Hazardous Building Materials Register and to prepare an Hazardous Materials Management Plan of the property known as Tom Hunter Oval Amenities located at Hunter Way, Faulconbridge, NSW, 2776. The purpose of the audit was to locate and identify asbestos based building materials and product within the building in accordance with the *NSW Work Health and Safety Act and Regulation 2017* and the *Code of Practice; How to Manage and Control Asbestos in the Workplace* [Safe Work Australia: 2016] and the *Code of Practice; How to Safely Remove Asbestos* [Safe Work Australia: 2016].

ASBESTOS MATERIALS REGISTER		ASSET: Tom Hunter Oval, Hunter Way, Faulconbridge, NSW, 2776			
DATE OF IDENTIFICATION	IMAGES	SPECIFIC LOCATION OF ASBESTOS/ APPROX M <sup>2</sup>	TYPE OF ASBESTOS/ FRIABLE OR NON-FRIABLE	RISK ACTION RATING	CONDITION & ACCESSIBILITY OF ASBESTOS
12 <sup>th</sup> December 2017

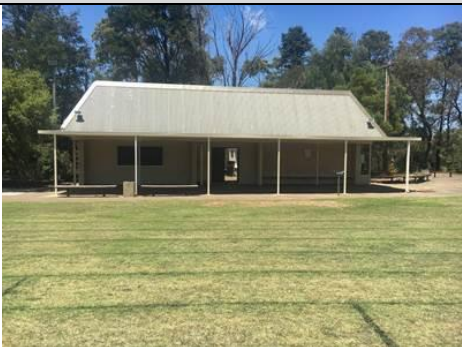
North Elevation Amenities Building. Brick External Walls Timber Facia, Corrugated Iron Roof	N/A		N/A
12 <sup>th</sup> December 2017

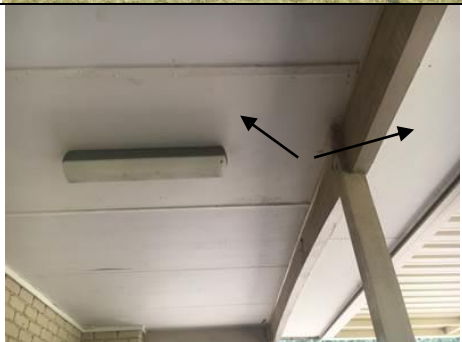
Amenities External North Elevation Eaves and Verandah Sheeting Fibre Cement <b>386</b>	Sample #B17447S01 No Asbestos Detected	A5	N/A
12 <sup>th</sup> December 2017

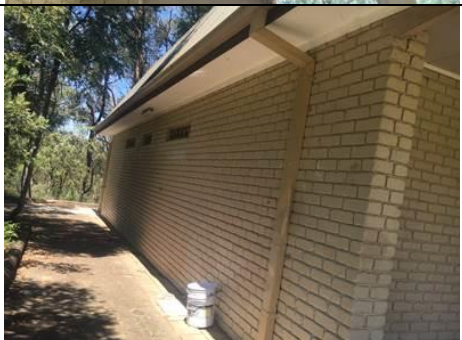
Amenities External Eaves East Elevation Fibre Cement <b>387</b>	Same as Sample #B17447S01 No Asbestos Detected	A5	N/A

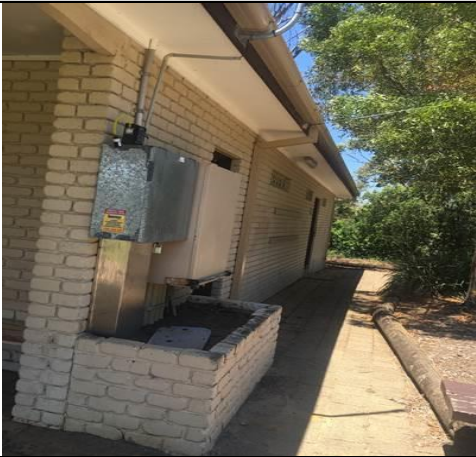
Amenities West Elevation Eaves. Fibre Cement <b>388</b>	Same as Sample #B17447S01 No Asbestos Detected	A5	N/A
12 <sup>th</sup> December 2017

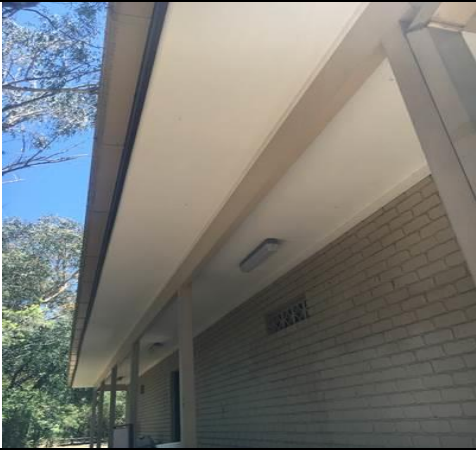
Amenities South Elevation Eaves. Fibre Cement <b>389</b>	Same as Sample #B17447S01 No Asbestos Detected	A5	N/A
12 <sup>th</sup> December 2017

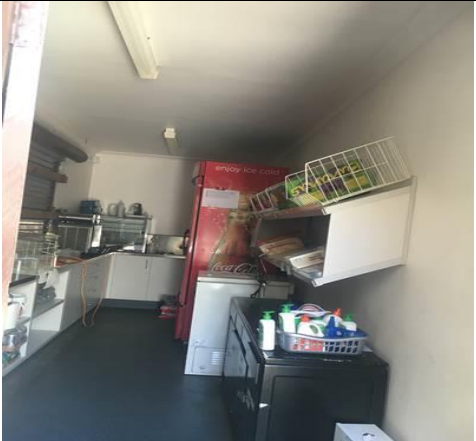
Canteen Plasterboard Ceiling, Rendered Brick Walls & Linoleum on Concrete. <b>390</b>	No Asbestos Materials Identified	A5	N/A

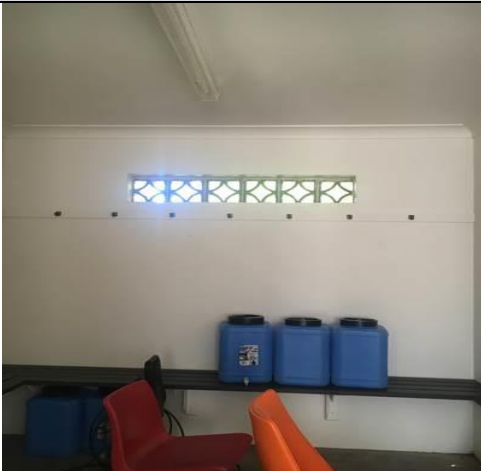
Men's Changeroom. Plasterboard Ceiling, Ceramic Tile in Toilet Floor, Rendered Brick Walls, Cement, Aluminium Frame Windows & Terrazzo Partitions	No Asbestos Materials Identified <b>391</b>	A5	N/A
12 <sup>th</sup> December 2017

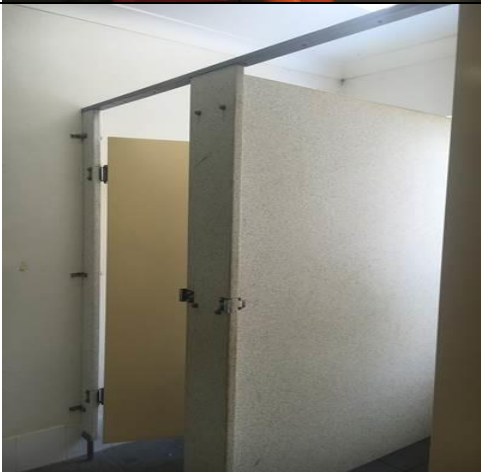
Men's Toilet. Plasterboard Ceiling, Rendered Brick Walls, Cement Flooring, Ceramic Tile in Toilet Aluminium Frame Windows & Terrazzo Partitions	No Asbestos Materials Identified <b>392</b>	A5	N/A
12 <sup>th</sup> December 2017

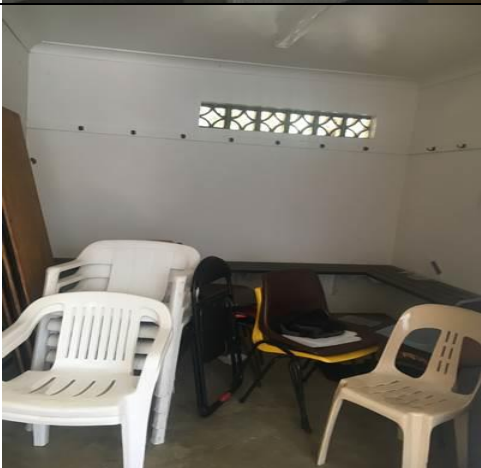
Ladies Changeroom. Plasterboard Ceiling, Ceramic Tile in Toilet Floor, Rendered Brick Walls, Cement, Aluminium Frame Windows & Terrazzo Partitions	No Asbestos Materials Identified <b>393</b>	A5	N/A

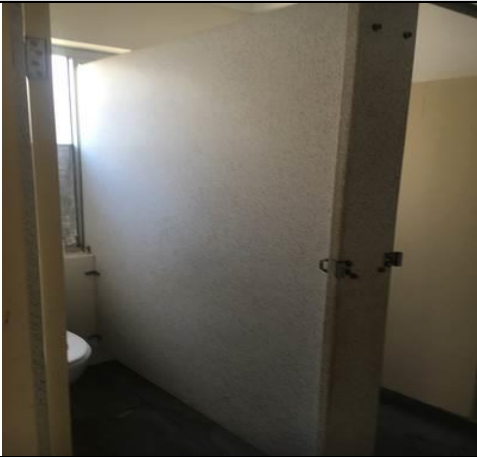
Ladies Toilet. Plasterboard Ceiling, Rendered Brick Walls, Cement Flooring, Ceramic Tile in Toilet Aluminium Frame Windows & Terrazzo Partitions <b>394</b>	No Asbestos Materials Identified	A5	N/A
12 <sup>th</sup> December 2017

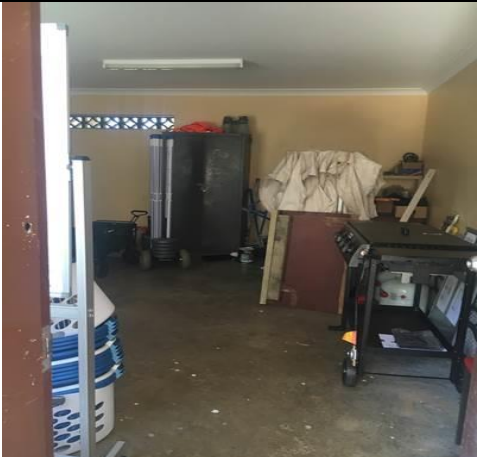
Storeroom. Plasterboard Ceiling, Brick Walls, Concrete Floor & Aluminium Window Frames & Sliding Door <b>395</b>	No Asbestos Materials Identified	A5	N/A
12 <sup>th</sup> December 2017

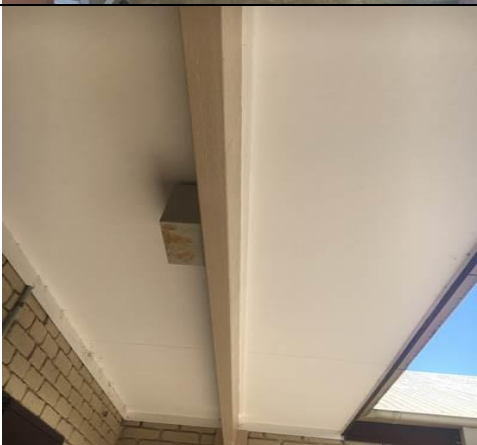
South Elevation Eaves. Fibre Cement <b>396</b>	Same as Sample #B17447S01 No Asbestos Detected	A5	N/A

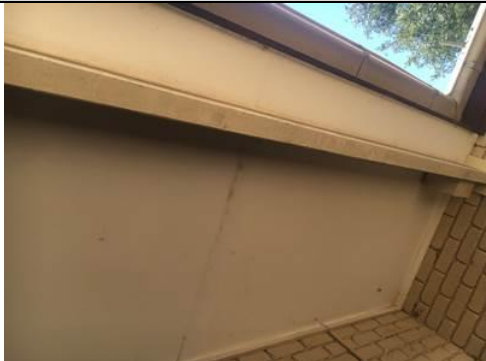
North Elevation Eaves. Fibre Cement  <b>397</b>	Same as Sample #B17447S01 No Asbestos Detected	A5	N/A
12 <sup>th</sup> December 2017

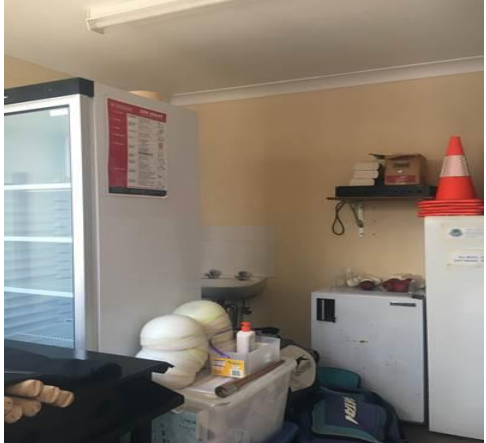
West Storeroom. Plasterboard Ceiling, Rendered Brick Rendered Walls & Cement Floor  <b>398</b>	No Asbestos Material Identified	A5	N/A
12 <sup>th</sup> December 2017

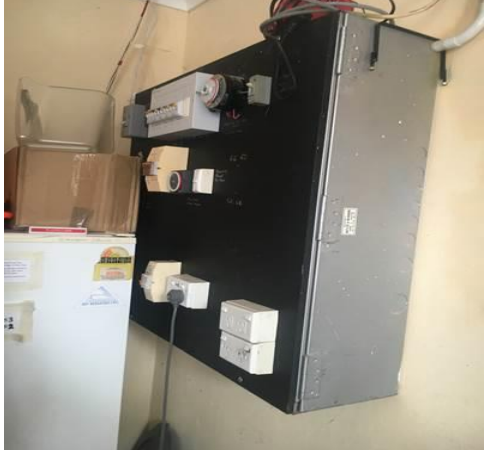
West Storeroom. Electrical Board Potential Bakelite  <b>399</b>	Assumes Contains Asbestos	A4	Good Condition Accessible to Tradespeople Refer to Asbestos Management Plan

The materials identified in this report were in good condition and can be managed effectively according to the Asbestos Management Plan. Provided they remain in this condition and are not disturbed they pose minimal risk if left in situ. If renovation or demolition works are to occur the asbestos based materials which are likely to be disturbed should be removed prior to works commencing.

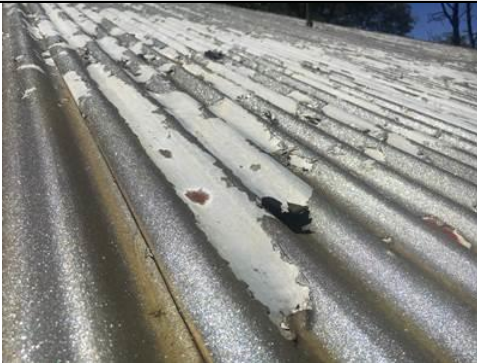
Entire Corrugated Iron Roof Coating.  <b>400</b>	Sample #B17447S02  No Asbestos Detected	A5	N/A
12 <sup>th</sup> December 2017

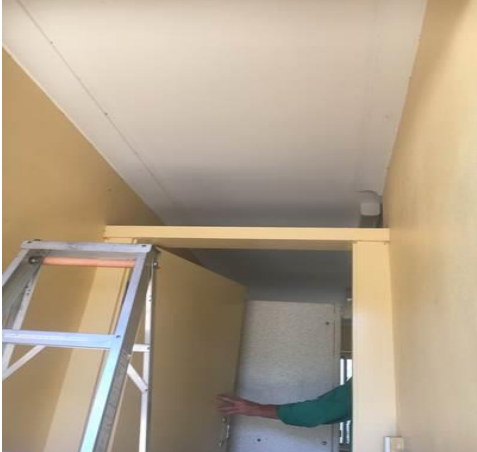
Exterior Male Toilets Ceiling Sheeting. Fibre Cement. Rendered Brick Walls, Cement Floor & Terrazzo Partitions  <b>401</b>	Sample #B17447S03  No Asbestos Detected	A5	N/A
12 <sup>th</sup> December 2017

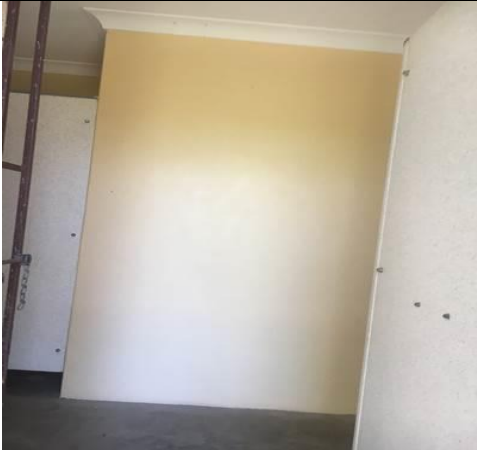
Exterior Female Toilet Ceiling Sheeting. Fibre Cement. Render Brick Walls, Cement Floor & Terrazzo Partitions  <b>402</b>	Same as Sample #B17447S03 No Asbestos Detected	A5	N/A

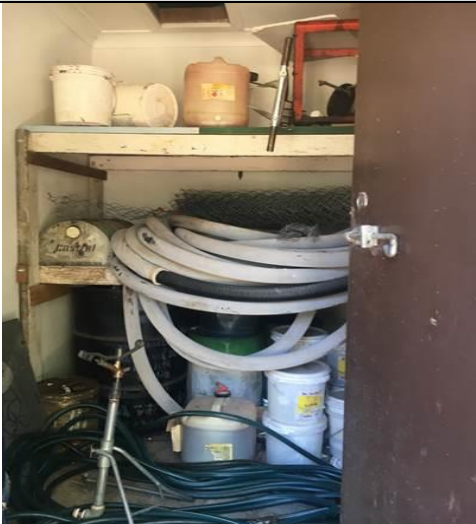
Chemical Store. Plasterboard Ceiling, Rendered Brick Walls & Concrete Floor <b>403</b>	No Asbestos Material Identified	A5	N/A
12 <sup>th</sup> December 2017

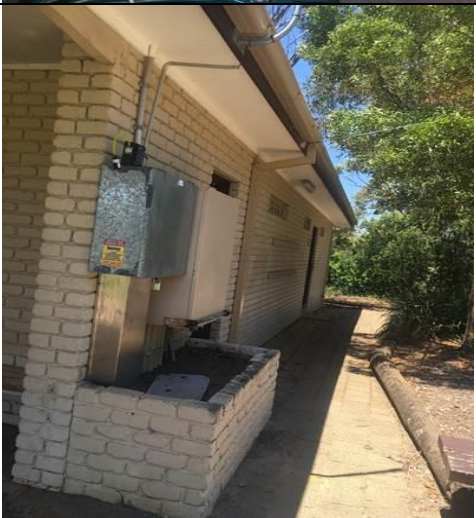
External Electrical Cabinets. Nil Access. <b>404</b>	Assume the Electrical Meter Backing Boards Contain Asbestos materials.	A4	Presume to be in Good Condition. Accessible to Tradespeople Refer to Asbestos Management Plan

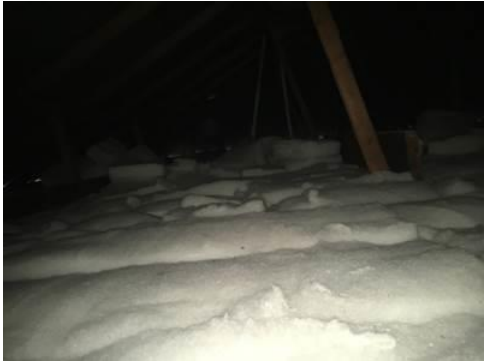
Synthetic Mineral Fibre Identified Ceiling Space Throughout	Visual Inspection	A4	Bonded Condition, Non-Friable, Low Risk, Accessible to Tradespeople

No high-risk synthetic mineral fibre was identified during the on-site inspection. The material identified on-site was in a bonded format or was encapsulated, and in this structure and condition does not present a significant risk in its current condition and state. If works do need to be undertaken which will disturb this material, safety goggles, disposable coveralls, gloves and a class P2 respirator should be adopted. This will avoid any skin irritation and inhalation of airborne fibres.

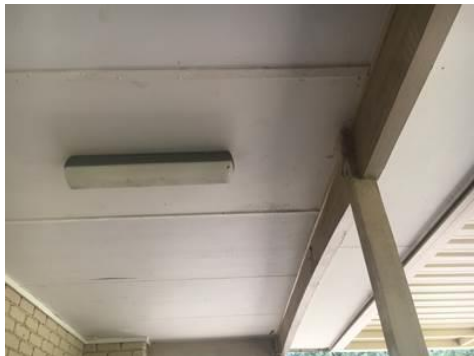
External Fluorescent Lights No PCB's Present	Visual Inspection	A5	N/A
12 <sup>th</sup> December 2017

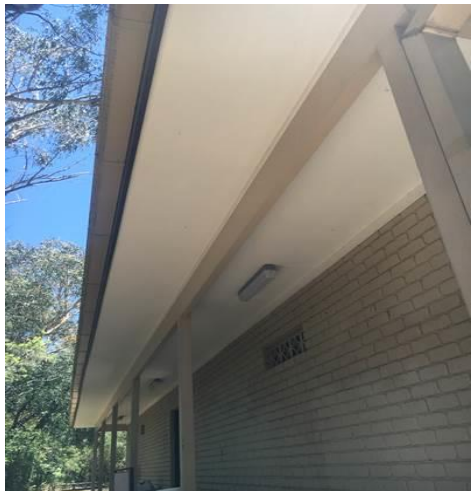
Lights Around Exterior of Building Fluorescent Lights No PCB's Present	Visual Inspection	A5	N/A

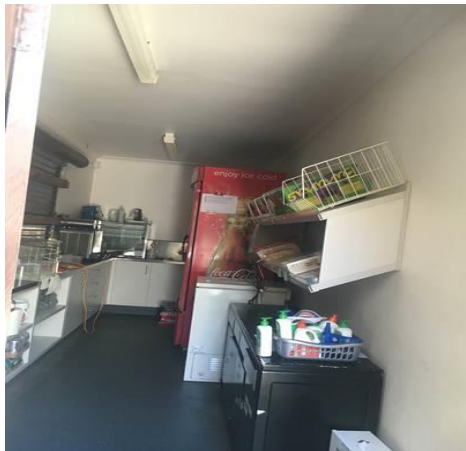
Canteen Fluorescent Lights No PCB's Present	Visual Inspection	A5	N/A
12 <sup>th</sup> December 2017

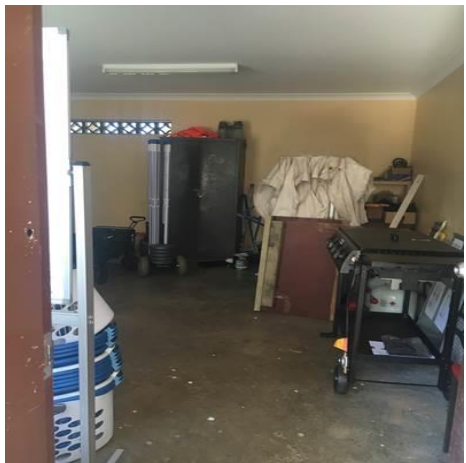
Storeroom Fluorescent Lights No PCB's Present	Visual Inspection	A5	N/A

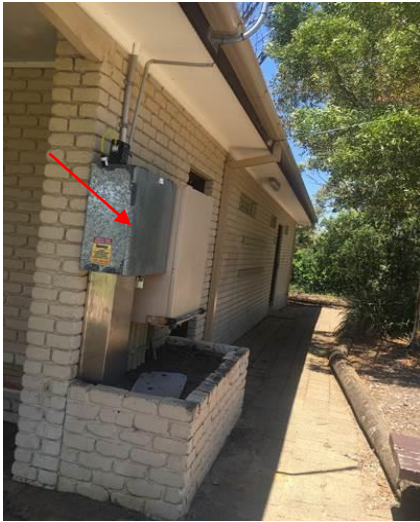
External Power Board (Left) Electrical Backing Board Potential Bakelite	Visual Inspection. Assume Positive for Phenol Materials.	A5	N/A
12 <sup>th</sup> December 2017

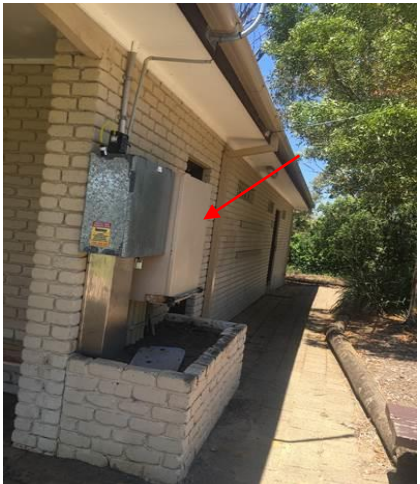
External Power Board (Right) Electrical Backing Board Potential Bakelite	Visual Inspection. Assume Positive for Phenol Materials.	A5	N/A

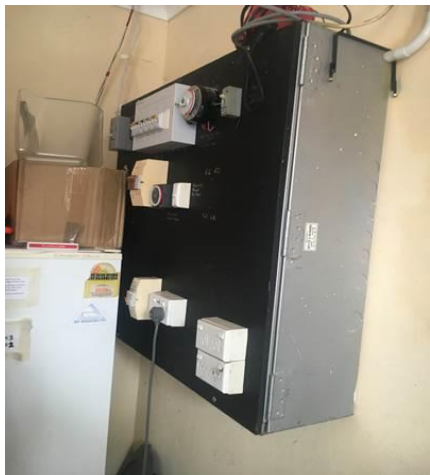
Internal Power Board Electrical Backing Board Potential Bakelite	Visual Inspection. Assume Positive for Phenol Materials.	A5	N/A
