Asbestos Register

Regional EnviroScience Pty Ltd was requested by Mr. Rick Harris of Blue Mountain City Council to undertake a Hazardous Building Materials Register and to prepare a Hazardous Materials Management Plan of the Amenities Block at the property known as Katoomba Falls Tourist Park, located at 101 Katoomba Falls Road, Katoomba, NSW, 2780. The purpose of the audit was to locate and identify asbestos based building materials and product within the building in accordance with the *NSW Work Health and Safety Act and Regulation 2017* and the *Code of Practice; How to Manage and Control Asbestos in the Workplace* [Safe Work Australia: 2016] and the *Code of Practice; How to Safely Remove Asbestos* [Safe Work Australia: 2016].

ASBESTOS MATERIALS REGISTER		ASSET: Katoomba Falls Tourist Park, 101 Katoomba Falls Road, Katoomba, NSW, 2780			
DATE OF IDENTIFICATION	IMAGES	SPECIFIC LOCATION OF ASBESTOS/ APPROX M ²	TYPE OF ASBESTOS/ FRIABLE OR NON-FRIABLE	RISK ACTION RATING	CONDITION & ACCESSIBILITY OF ASBESTOS
6 th December 2017

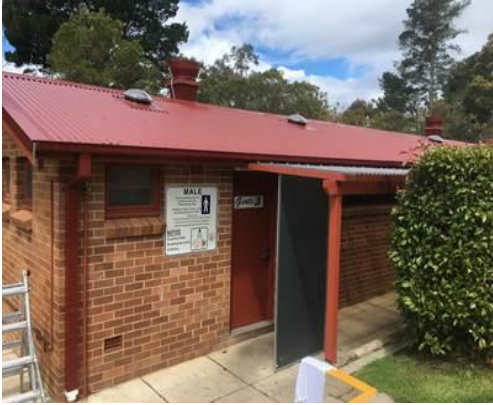
Katoomba Falls Tourist Park Amenities Block. Brick Exterior, Corrugated Iron Roof, Steel Gutters & Downpipes, Bonded Board Eaves	No Asbestos Material Sighted 577	A5	N/A
6 th December 2017

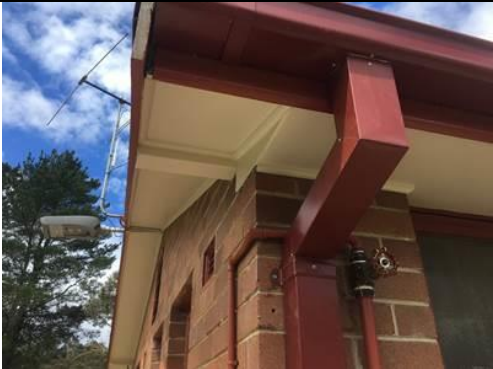
Amenities Block. External Eaves on All Sides of Amenities Block Fibre Cement Board	Sample #B17379S01 No Asbestos Detected 578	A5	N/A

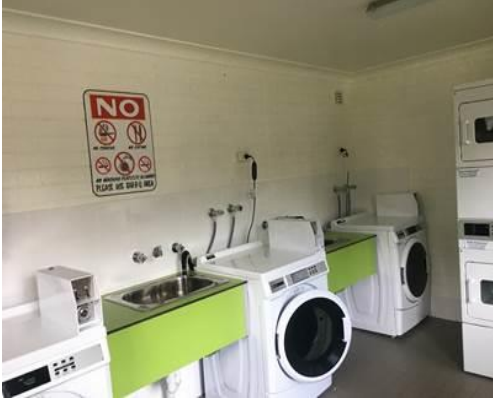
Laundry. Ceramic Tile Floor & Splashback, Brick Walls, Laminate Benches & Plasterboard Ceiling	No Asbestos Material Sighted 579	A5	N/A
6 th December 2017

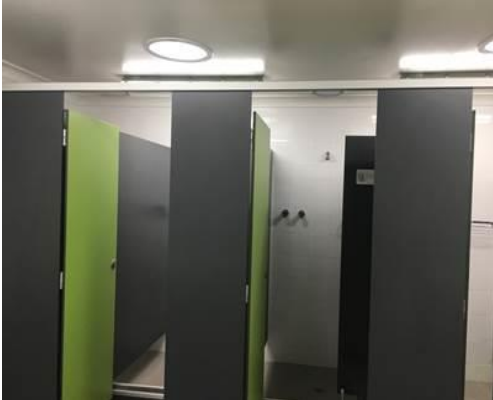
Ladies Toilets/Showers. Ceramic Tile Floors & Walls, Plasterboard Ceiling, Laminate Partitions, Aluminium & Wood Windows	No Asbestos Material Sighted 580	A5	N/A
6 th December 2017	No Image Available	Internal Wooden Window Sash (Rope) in Disabled Toilets	Sample #B17379S02 No Asbestos Detected 581	A5	N/A

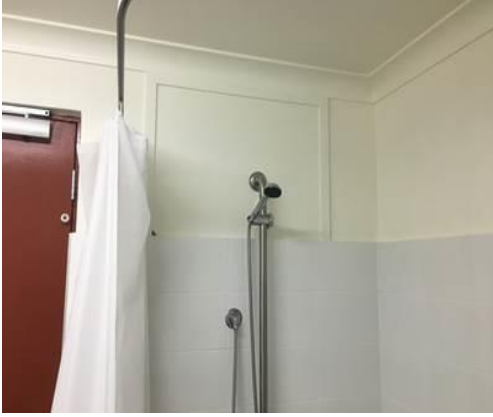
Wheelchair Accessible Toilet/Shower. Ceramic Tile Floor & Wall to 1.5m, Rendered Brick Walls, Laminate & Timber Bench, Polypipe, Timber Doors & Windows – Shower Infill Fibre Cement	Sample #B17379S03 No Asbestos Detected 582	A5	N/A
6 th December 2017

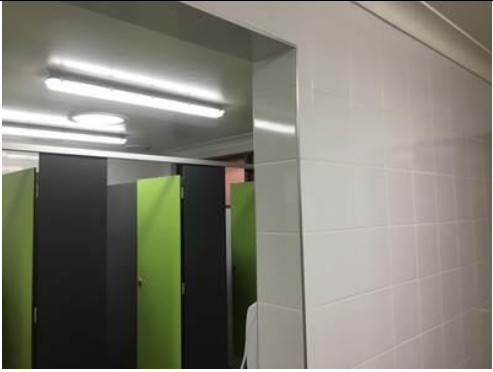
Male Toilets/showers. Ceramic Tile Floors & Walls, Plasterboard Ceiling, Laminate Partitions, Aluminium & Wood Windows	No Asbestos Material Sighted 583	A5	N/A
6 th December 2017

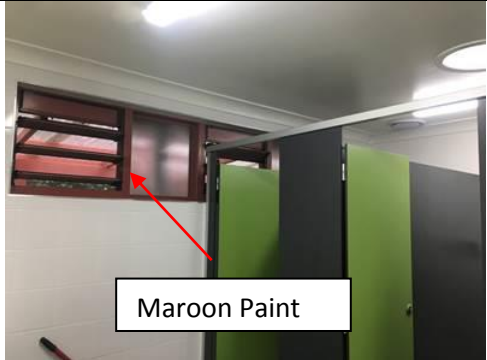
Internal Windows Ladies Bathroom. Maroon Paint	<0.05% w/w	A5	Paint is not classified as lead based. Less than 0.1% w/w
17379- S02 (181889-2)

No Lead based paints were detected at Katoomba Falls Tourist Park Amenities Block, however good practice would dictate that existing paint, even though is below the recognised standard, should not be sanded and that dust minimisation techniques should be adopted, when undertaking renovation/ repair works particularly in heritage period buildings. It would be good practice to wear a P1 dust mask during any paint removal even though it does not contain lead but small particles of paint can still be inhaled or ingested

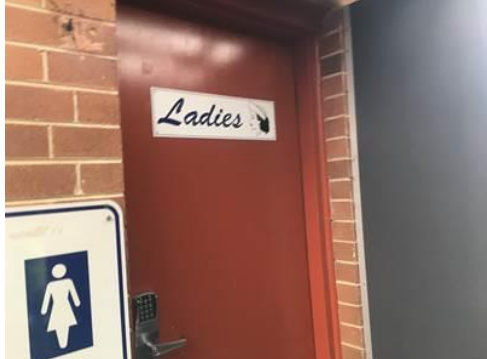
External Maroon Paint	<0.05% w/w	A5	Paint is not classified as lead based. Less than 0.1% w/w

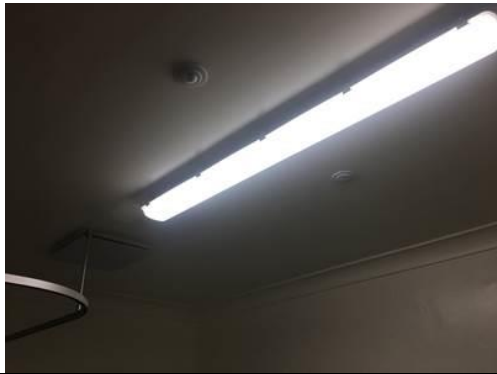
Light in Disabled Toilet Fluorescent Light No PCB's Present	Visual Inspection	A5	N/A
6 th December 2017

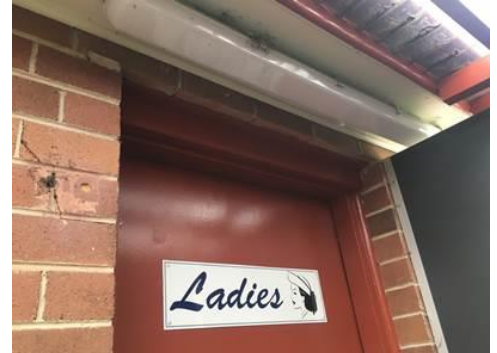
External Light Female Toilet Fluorescent Light No PCB's Present	Visual Inspection	A5	N/A

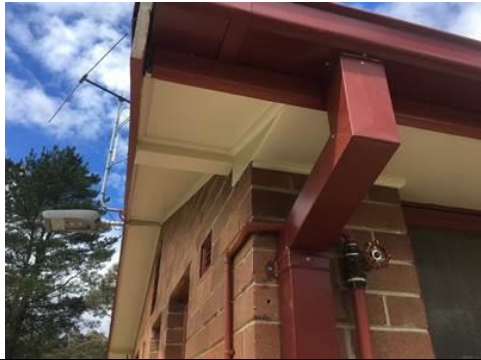
Exterior Amenities Lights Fluorescent Lights No PCB's Present	Visual Inspection	A5	N/A
6 th December 2017

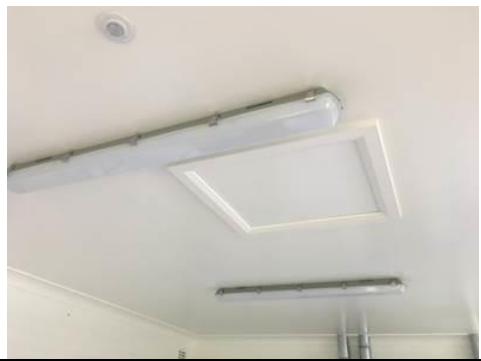
Lights in Laundry Fluorescent Lights No PCB's Present	Visual Inspection	A5	N/A
6 th December 2017

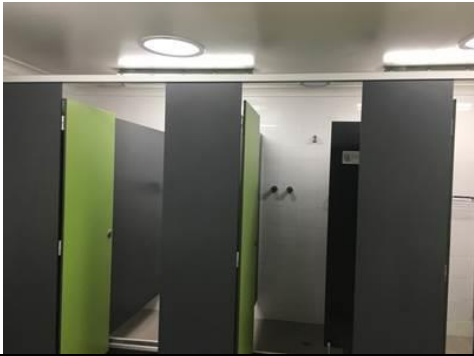
Ladies Toilets/Showers Fluorescent Lights No PCB's Present	Visual Inspection	A5	N/A
6 th December 2017

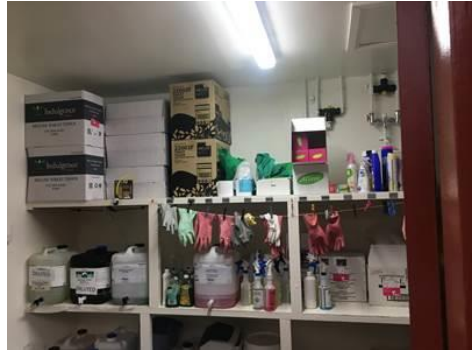
Internal Storeroom Fluorescent Light No PCB's Present	Visual Inspection	A5	N/A
