# Asbestos Register

Regional EnviroScience Pty Ltd was requested by Mr. Rick Harris of Blue Mountain City Council to undertake a Hazardous Building Materials Survey and to prepare a Hazardous Materials Register and Management Plan of the subfloor areas only, for the property known as Blue Mountains Theatre and Community Hub, located at 106-108 Macquarie Road, Springwood, NSW, 2777. The purpose of the audit was to locate and identify asbestos based building materials and product within the building in accordance with the *NSW Work Health and Safety Act and Regulation 2017* and the *Code of Practice; How to Manage and Control Asbestos in the Workplace* [Safe Work Australia: 2016] and the *Code of Practice; How to Safely Remove Asbestos* [Safe Work Australia: 2016].

ASBESTOS MATERIALS REGISTER		ASSET: Blue Mountains Theatre and Community Hub, 106-108 Macquarie Road, Springwood, NSW, 2777			
DATE OF IDENTIFICATION	IMAGES	SPECIFIC LOCATION OF ASBESTOS/ APPROX M <sup>2</sup>	TYPE OF ASBESTOS/ FRIABLE OR NON-FRIABLE	RISK ACTION RATING	CONDITION & ACCESSIBILITY OF ASBESTOS
3 <sup>rd</sup> April 2018

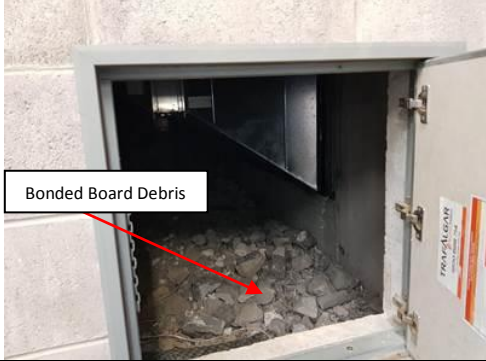
Theatre Plant Room Subfloor Entrance Bonded Board Debris.	Sample #B18168S01 No Asbestos Detected.	A5	N/A
3 <sup>rd</sup> April 2018

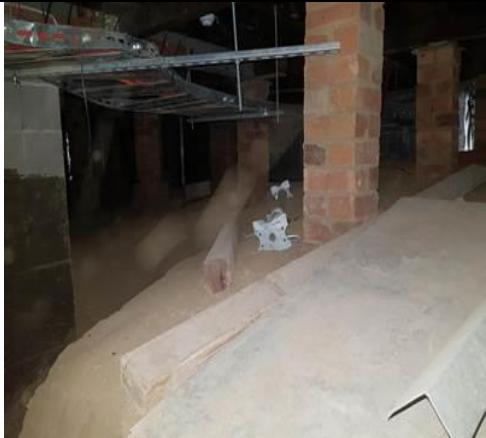
Theatre Plant Room Subfloor. Timber Ceiling, Cement Walls & Rubble, Brick Piers, Dirt Floor, Suspended Electrical Cabling, Air Conditioning Ducts & Building Debris.	No Sample Taken. No Asbestos Containing Materials Sighted.	A5	N/A

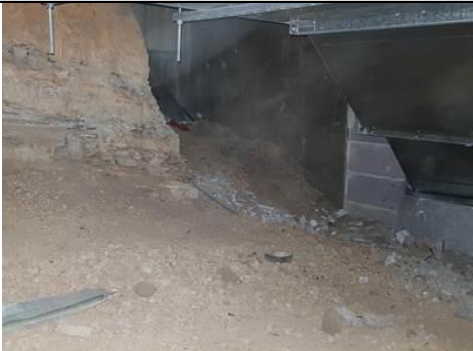
Theatre Plant Room Subfloor. South Entrance Bonded Board Debris.	Sample #B18168S02 No Asbestos Detected.	A5	N/A
3 <sup>rd</sup> April 2018

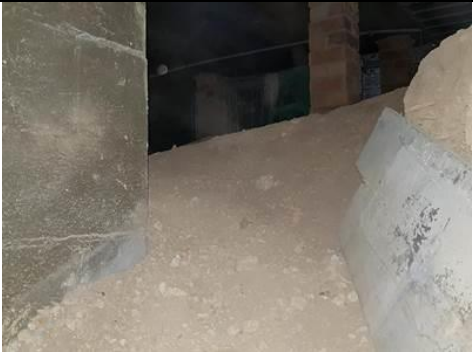
Theatre Plant Room Subfloor. South East Corner Fibre Cement.	Sample #B18168S03 No Asbestos Detected.	A5	N/A
3 <sup>rd</sup> April 2018

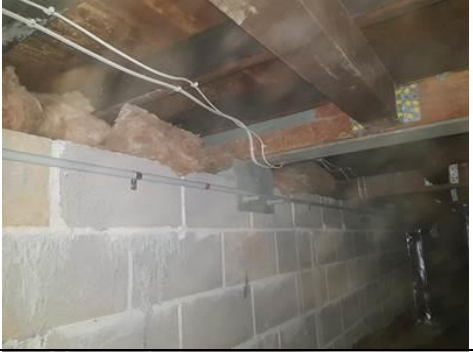
Theatre Plant Room Subfloor. Ceiling to Theatre Plant Room Insulation Batts.	Sample #B18168S04 No Asbestos Detected.	A5	N/A
3 <sup>rd</sup> April 2018

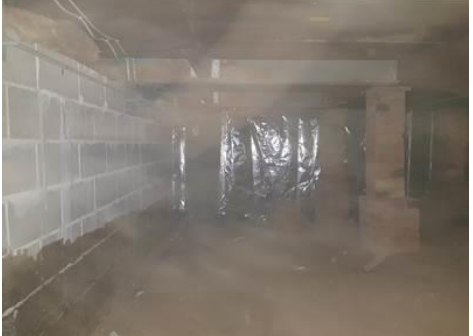
Theatre Plant Room Subfloor. Southern Wall. Insulated Air Conditioning Vents.	Similar to Sample #B18168S04 No Asbestos Detected.	A5	N/A

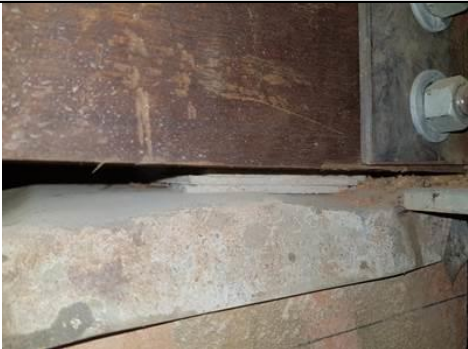
Theatre Plant Room Subfloor. Fibre Cement Sheet Packers on Brick Piers. Approximately 1.5m <sup>2</sup>	No Sample Taken. Assume Contains Asbestos. Non-Friable.	A4	Good Condition Accessible to Tradespeople Refer to Asbestos Management Plan.
3 <sup>rd</sup> April 2018

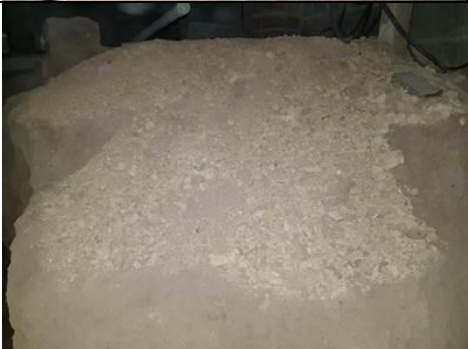
Theatre Plant Room Subfloor. North Wall Vinyl Tile Debris on Ground.	Sample #B18168S05 No Asbestos Detected.	A5	N/A
3 <sup>rd</sup> April 2018

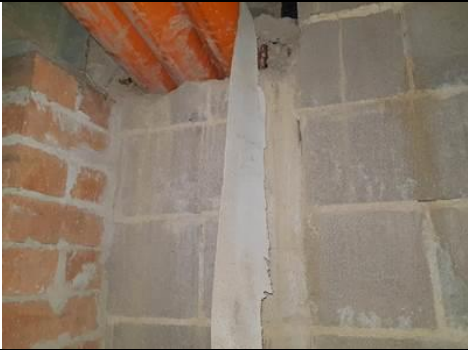
Theatre Plant Room Subfloor. North Wall Vinyl Tile Piping Wrap.	Sample #B18168S06 No Asbestos Detected.	A5	N/A
3 <sup>rd</sup> April 2018

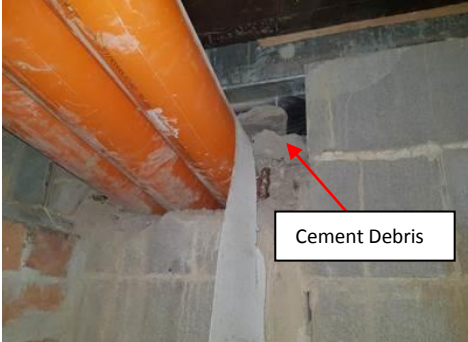
Theatre Plant Room Subfloor. North Wall Penetration, Cement Debris.	Sample #B18168S07 No Asbestos Detected.	A5	N/A

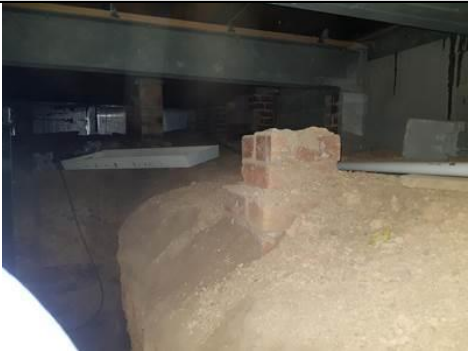
Theatre Plant Room Subfloor.  North Aspect. Timber Ceiling, Cement Brick Wall, Brick Piers, Steel Bearers, Dirt Floor & Building Debris.	No Sample Taken.  No Asbestos Containing Material Sighted.	A5	N/A
3 <sup>rd</sup> April 2018

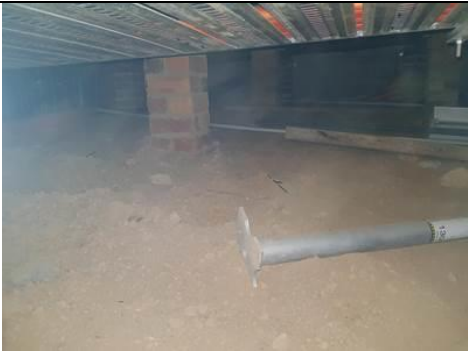
Theatre Plant Room Subfloor.  Western Aspect. Cement Brick Wall, Brick Piers, Suspended Electrical Cabling, Dirt Floor, Timber & Screwjacks.	No Sample Taken.  No Asbestos Containing Material Sighted.	A5	N/A
3 <sup>rd</sup> April 2018

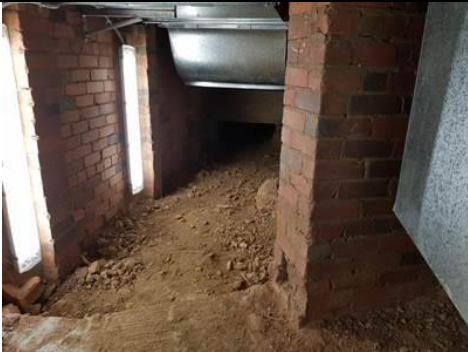
South Green Room Subfloor.  South Entrance. Dirt Floor, Brick & Cement Walls, Brick Piers, Air Conditioning Vents, Steel Bearers & Timber Ceiling.	No Sample Taken.  No Asbestos Containing Material Sighted.	A5	N/A

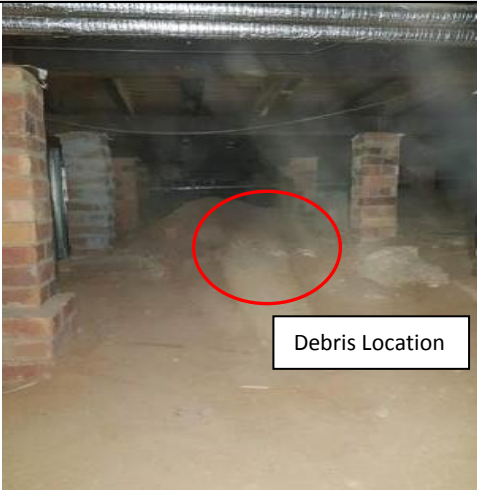
South Green Room Subfloor.  North West Corner Fibre Cement Debris.	Sample #B18168S08  No Asbestos Detected.	A5	N/A
3 <sup>rd</sup> April 2018

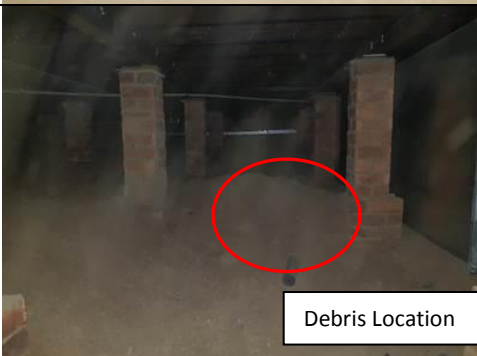
South Green Room Subfloor.  North East Side Fibre Cement Debris.	Sample #B18168S09  No Asbestos Detected.	A5	N/A
3 <sup>rd</sup> April 2018

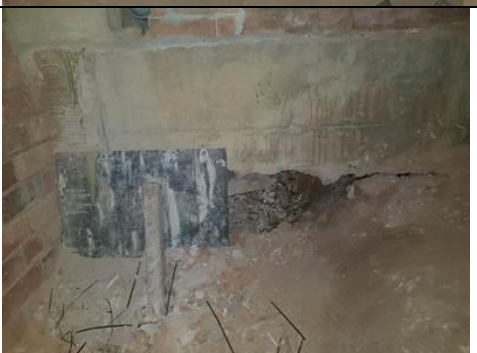
South Green Room Subfloor.  South West Corner Dust.	Sample #B18168S10  No Asbestos Detected.	A5	N/A

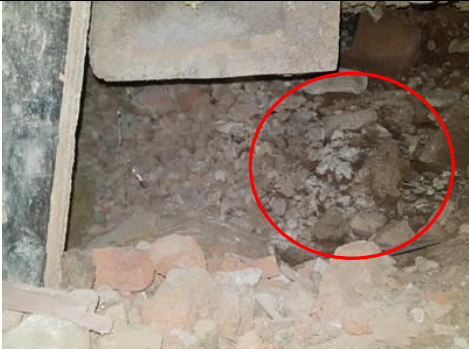
South Green Room Subfloor.  South West Corner White Dust on Rubble.	Sample #B18168S11  No Asbestos Detected.	A5	N/A
3 <sup>rd</sup> April 2018

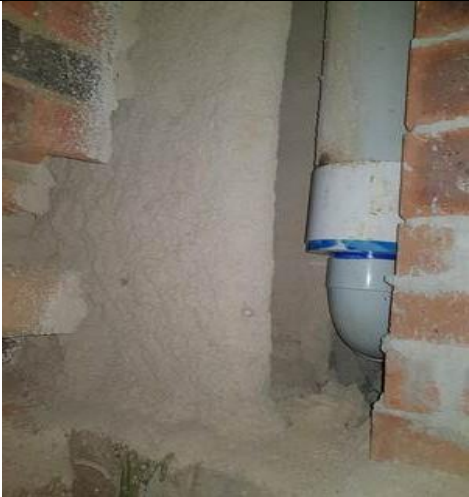
South Green Room Subfloor.  South West Corner Sprayed Insulation.	Sample #B18168S12  No Asbestos Detected.	A5	N/A
3 <sup>rd</sup> April 2018

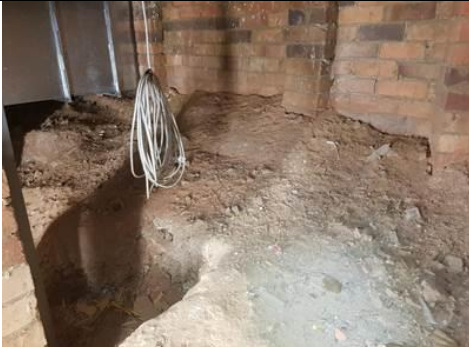
South Green Room Subfloor.  Southern Entrance Area Bonded Board Debris.  Approximately 0.5m <sup>2</sup>	Sample #B18168S13  Chrysotile Asbestos Detected.  Non-Friable.	A3	Fair Condition Accessible to Tradespeople Refer to Asbestos Management Plan.

- Provided the ACM remains in good condition and is not disturbed they pose minimal risk if left in situ.
- If the ACM is in fair condition it should be removed under controlled conditions and replaced, during routine maintenance works.
- If the ACM is in poor condition it should be removed under controlled conditions as soon as practicable.
- If renovation or demolition works are to occur the asbestos based materials which are likely to be disturbed should be removed prior to works commencing.

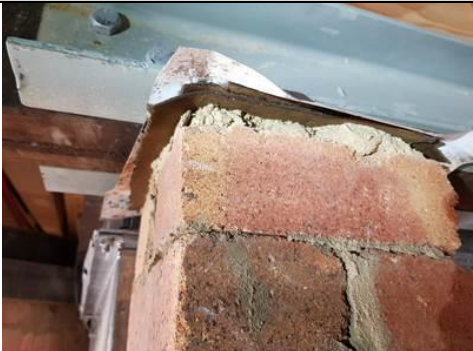
South Green Room Subfloor. Vinyl Tile Packers on Some Brick Piers.	Sample #B18168S14 No Asbestos Detected.	A5	N/A
3 <sup>rd</sup> April 2018

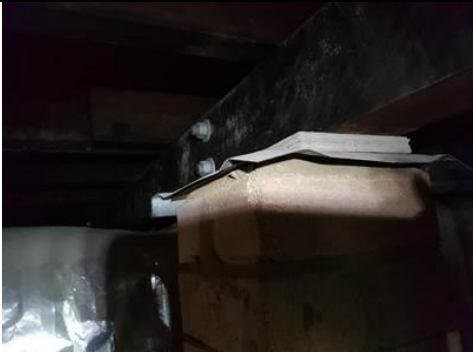
South Green Room Subfloor. Bonded Board Packers to Some Brick Piers. Approximately 1m <sup>2</sup>	No Sample Taken. Assume Contains Asbestos. Non-Friable.	A4	Good Condition Accessible to Tradespeople Refer to Asbestos Management Plan.
3 <sup>rd</sup> April 2018

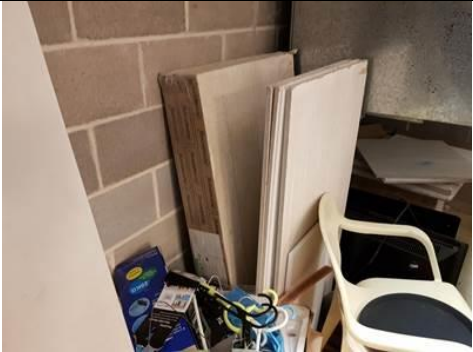
South Green Room Subfloor. Acoustic Panels at Entrance of Subfloor Space.	Sample #B18168S15 No Asbestos Detected.	A5	N/A
3 <sup>rd</sup> April 2018

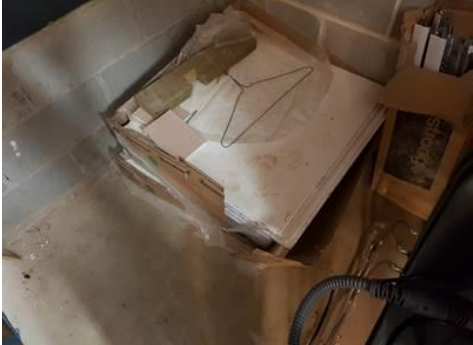
South Green Room Subfloor. Acoustic Panels at Entrance of Subfloor Space.	Similar to Sample #B18168S15 No Asbestos Detected.	A5	N/A

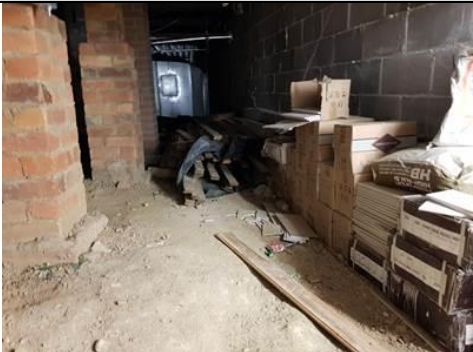
South Green Room Subfloor.  Southern Wall. Building Materials Stockpile. Timber & Tiles.	No Sample Taken.  No Asbestos Containing Material Sighted.	A5	N/A
3 <sup>rd</sup> April 2018

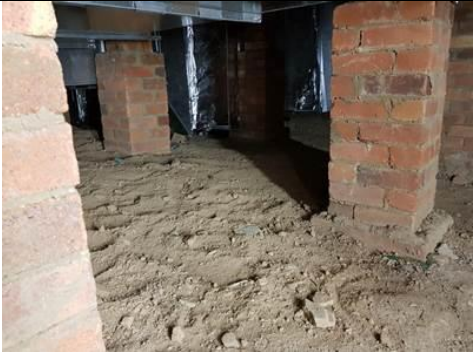
South Green Room Subfloor.  South East Aspect. Timber Ceiling, Steel Bearers, Brick Piers, Brick & Cement Walls, PVC Piping, Air Conditioning Vents & Dirt Floor.	No Sample Taken.  No Asbestos Containing Material Sighted.	A5	N/A
3 <sup>rd</sup> April 2018

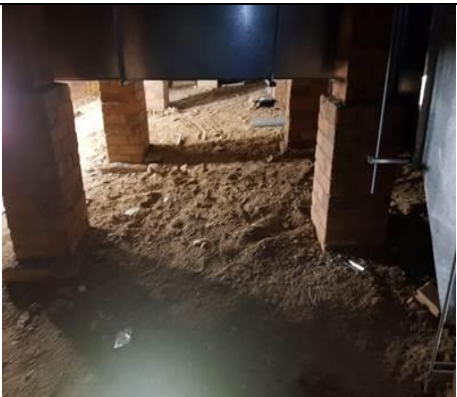
South Green Room Subfloor.  South Entrance Area. Timber Ceiling, Steel Bearers, Brick Piers, Brick & Walls, Air Conditioning Vents & Dirt Floor.	No Sample Taken.  No Asbestos Containing Material Sighted.	A5	N/A

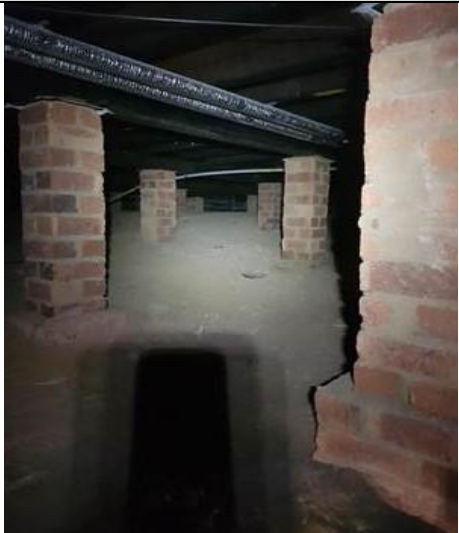
South Green Room Subfloor.  North Aspect. Timber Ceiling, Timber & Steel Bearers, Brick Piers, Brick & Cement Walls, PVC Piping & Dirt Floor.	No Sample Taken.  No Asbestos Containing Material Sighted.	A5	N/A

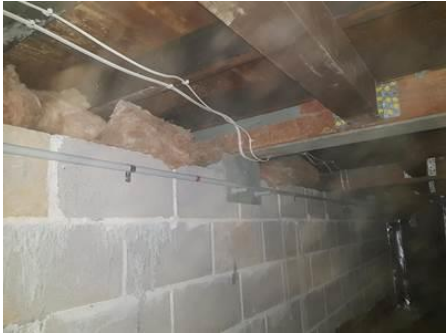
Theatre Plant Room Subfloor.  Theatre Plant Room Ceiling.  Synthetic Mineral Fibre Products Were Sighted	Visual Inspection	A4	Bonded, Good Condition.  Refer to Management Plan.
3 <sup>rd</sup> April 2018

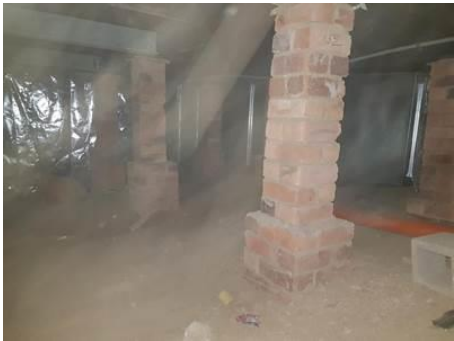
Theatre Plant Room Subfloor.  Insulated Air Conditioning Vents. Synthetic Mineral Fibre Products Were Sighted	Visual Inspection	A4	Bonded, Good Condition.  Refer to Management Plan.
3 <sup>rd</sup> April 2018

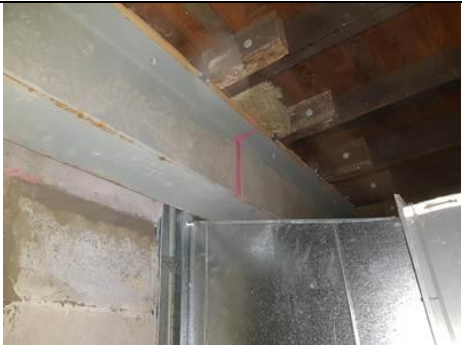
South Green Room Subfloor.  East Wall Insulation.  Synthetic Mineral Fibre Products Were Sighted	Visual Inspection	A4	Bonded, Good Condition.  Refer to Management Plan.

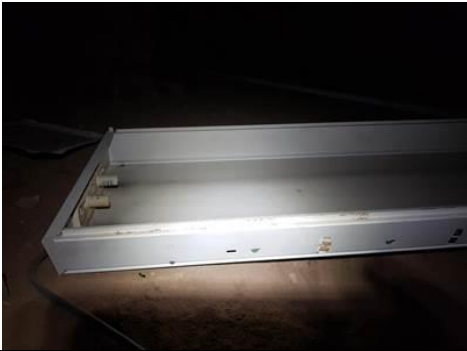
Theatre Plant Room Subfloor. 1x Double Fluorescent Light Assembly.	Visual Inspection. Sylvania FS-14 Type Capacitors. No PCB's Present.	A5	N/A
3 <sup>rd</sup> April 2018
