# Asbestos Register

Regional EnviroScience Pty Ltd was requested by Mr. Rick Harris of Blue Mountains City Council to undertake a Hazardous Building Materials Register and to prepare a Hazardous Materials Management Plan of the Storage Shed, Amenities Block and Soccer Pavilion at the property known as Pitt Park, located at 3-15 Matcham Street, Wentworth Falls, NSW, 2782. The purpose of the audit was to locate and identify asbestos based building materials and product within the building in accordance with the *NSW Work Health and Safety Act and Regulation 2017* and the *Code of Practice; How to Manage and Control Asbestos in the Workplace* [Safe Work Australia: 2016] and the *Code of Practice; How to Safely Remove Asbestos* [Safe Work Australia: 2016].

On the 8<sup>th</sup> December 2017, an Asbestos Audit was conducted at the Pitt Park Amenities Block, Soccer Pavilion and Storage Shed and asbestos containing materials were found to be present at the premises. Please refer Appendix I for results of products that were considered and consequently analysed but did not contain asbestos.

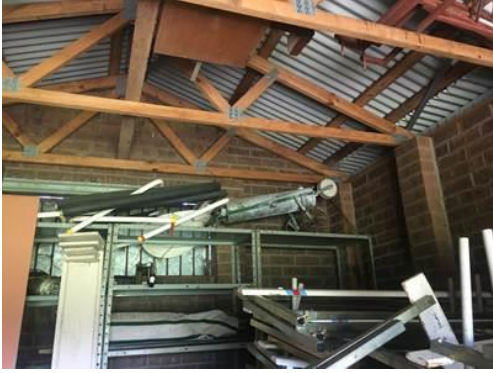
Storage Shed. Internal Storage Shed Brick Walls, Timber Supports, Iron Roof & Concrete Floor	No Asbestos Material Sighted <b>1134</b>	A5	N/A
8 <sup>th</sup> December 2017

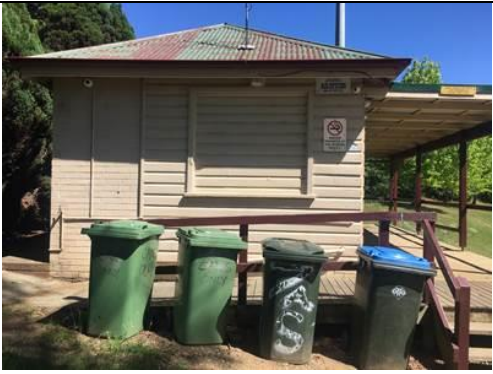
Soccer Pavilion.	N/A		N/A
8 <sup>th</sup> December 2017

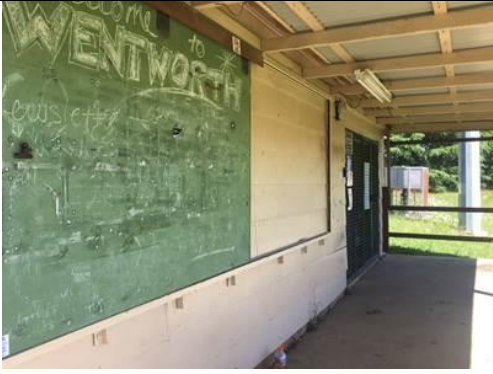
Soccer Pavilion. External Timber Cladding & Brick Walls, Timber Fascia & Pergola Frame, Metal Entrance Gates, Timber Ramp, Concrete Patio & Aluminium Guttering	N/A <b>1135</b>	A5	N/A

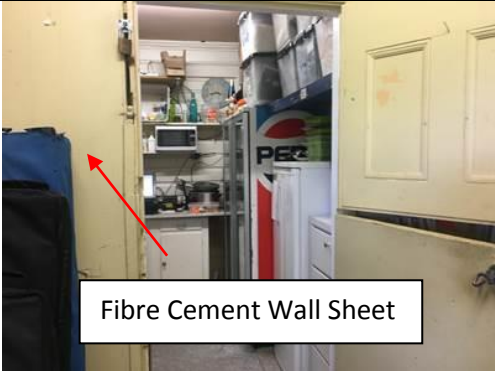
Soccer Pavilion. Internal Wall Adjacent to Storeroom Door Fibre Cement	Sample #B17398S03 No Asbestos Detected <b>1137</b>	A5	N/A
8 <sup>th</sup> December 2017

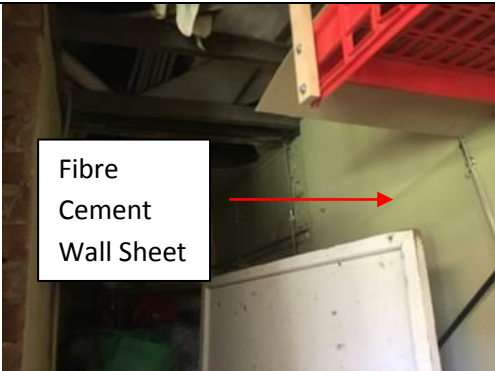
Soccer Pavilion. Internal South West Soccer Pavilion Brick Walls, Concrete Floor, Timber Shelving & Support Beams - Wall Lining Fibre Cement	Same as Sample #17398S03 No Asbestos Detected <b>1138</b>	A5	N/A

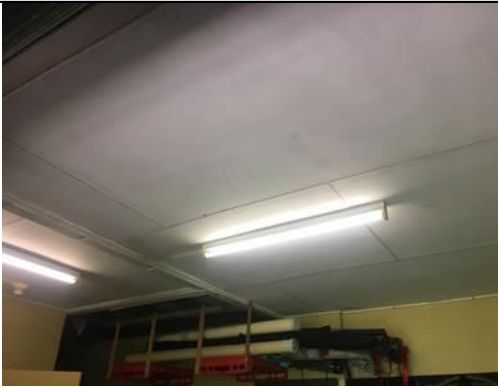
Soccer Pavilion. Ceiling Throughout Fibre Cement	Sample #B17398S04 No Asbestos Detected <b>1139</b>	A5	N/A
8 <sup>th</sup> December 2017

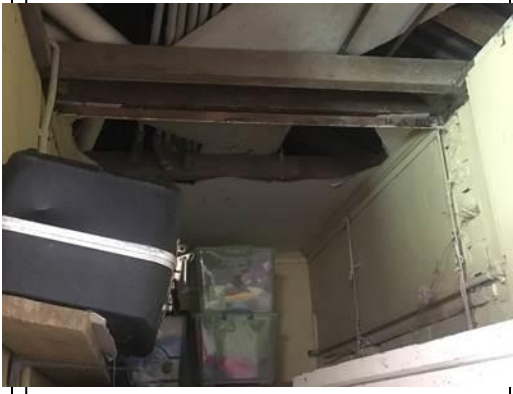
Soccer Pavilion. Store Room in Pavilion Rendered Brick Walls, Concrete Floor, Timber Shelving & Support Beams - Loose Board in Ceiling, Fibre Cement	Sample #B17398S05 No Asbestos Detected <b>1140</b>	A5	N/A
8 <sup>th</sup> December 2017

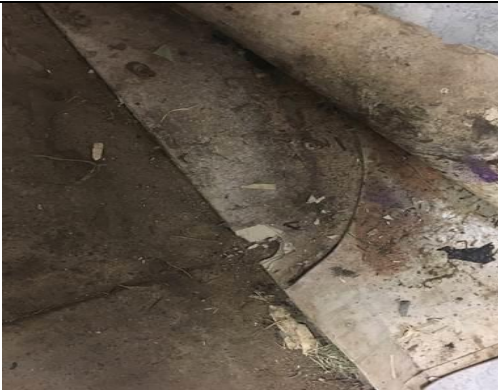
Soccer Pavilion. Old Flooring Under Kitchen Floor in Pavilion Fibre Cement	Sample #B17398S06 No Asbestos Detected <b>1141</b>	A5	N/A

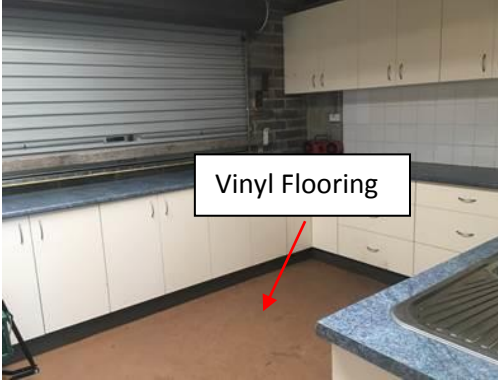
Soccer Pavilion. Kitchen/Canteen of Pavilion Compressed Wood Cupboards, Tile Splashback, Roller Door, Brick Walls, Benchtap - Vinyl Tile Floor	Sample #B17398S07 No Asbestos Detected <b>1142</b>	A5	N/A
8 <sup>th</sup> December 2017

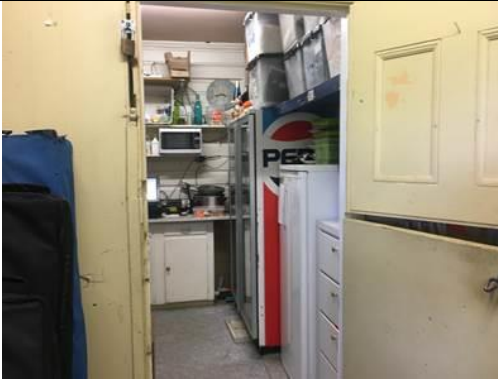
Soccer Pavilion. Store Area in Pavilion Wood Door, Brick Walls, Timber Cupboards - Floor Vinyl	Sample #B17398S08 No Asbestos Detected <b>1143</b>	A5	N/A
8 <sup>th</sup> December 2017

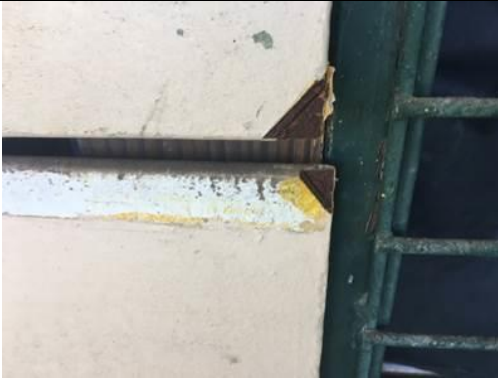
Soccer Pavilion. External Infill Panels Next to Canteen Window Fibre Cement	Sample #B17398S09 No Asbestos Detected <b>1142</b>	A5	N/A

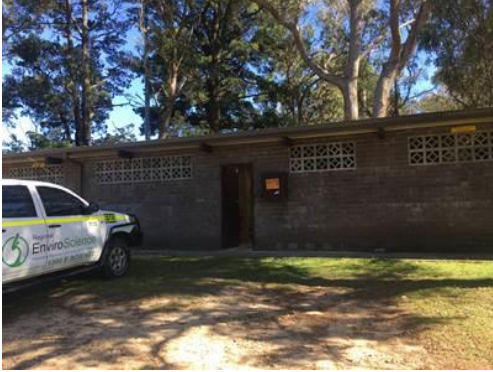
Amenities Block. External Brick Walls, Aluminium Eave Linings & Guttering, Cinder Block Windows & Skillion Roof	N/A <b>1145</b>		N/A
8 <sup>th</sup> December 2017

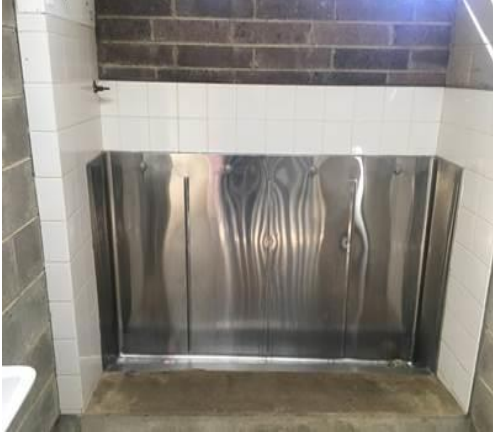
Amenities Block. Men's Toilets Brick & Cinder Block Walls, Ceramic Tiles Around Urinal, Concrete Floor, Aluminium Ceiling Lining, Terrazzo Partitions with Particleboard Doors	No Asbestos Material Identified <b>1146</b>	A5	N/A
8 <sup>th</sup> December 2017

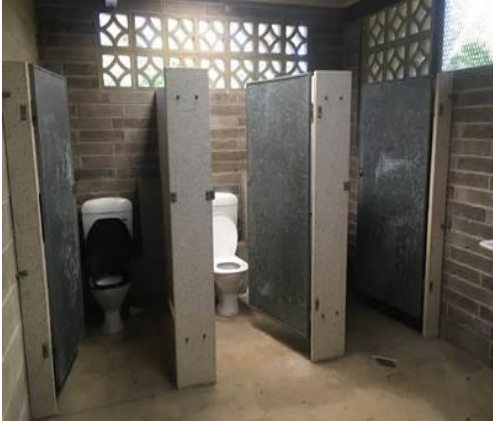
Amenities Block. Ladies Toilets Brick & Cinder Block Windows, Ceramic Tiles, Concrete Floor, Aluminium Ceiling Lining, Terrazzo Partitions with Particleboard Doors	No Asbestos Material Identified <b>1147</b>	A5	N/A

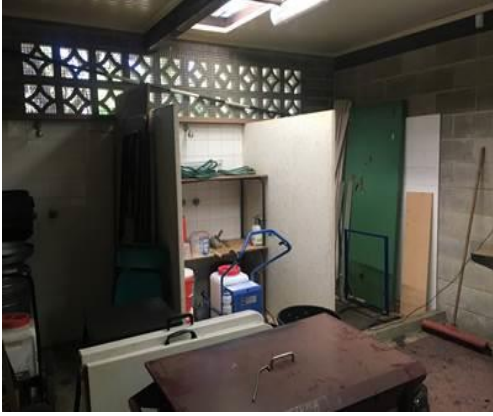
Amenities Block. Staff Only Area Brick & Cinder Block Windows, Ceramic Tiles Around Toilet, Concrete Floor, Aluminium Ceiling Lining, Terrazzo Partitions with Chipboard Doors	No Asbestos Material Identified  <b>1148</b>	A5	N/A
8 <sup>th</sup> December 2017

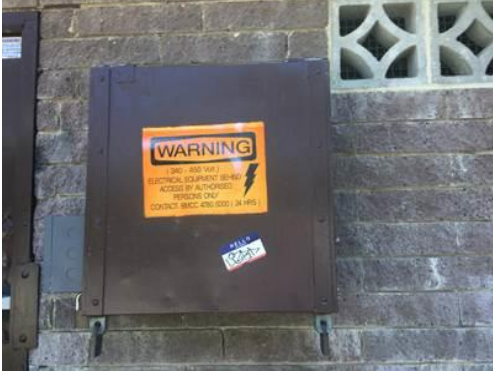
Amenities Block. External Power Board.  Assume Bakelite Backing Board Approximately 0.5m <sup>2</sup>	Assume Contains Asbestos Materials  Nil Access <b>1149</b>	A4	Presume in Good Condition Accessible to Tradespeople Refer to Asbestos Management Plan
8 <sup>th</sup> December 2017

As the Regional Enviroscience Assessor had nil access to the electrical cabinets within the amenities block, they are presumed to contain Asbestos Building Materials and other hazardous building materials were also identified as being present. The handbook for the identification of PCB containing capacitors does not list the Alpha capacitor, identified in the soccer pavilion building, as containing or not containing PCB's. Regional Enviroscience recommends the capacitor be treated as containing PCB's.

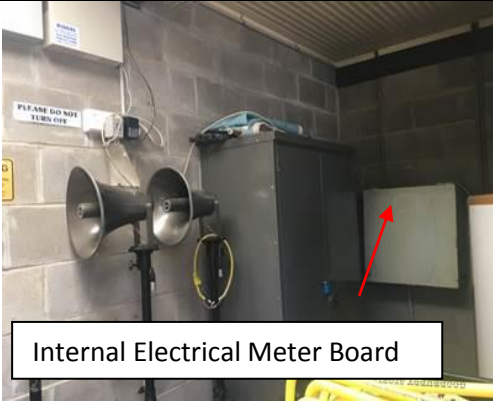
Internal Electrical Meter Board	Amenities Block. Internal Power Board.  Assume Bakelite Backing Board Approximately 0.5m <sup>2</sup>	Assume Contains Asbestos Materials  Nil Access <b>1150</b>	A4	Presume in Good Condition Accessible to Tradespeople Refer to Asbestos Management Plan

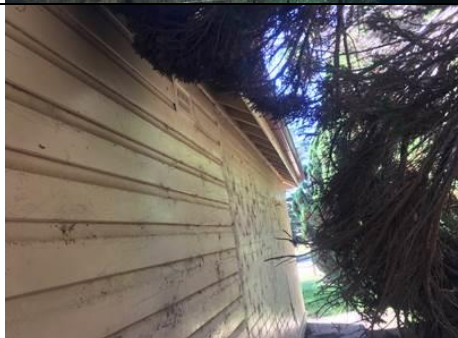
Exterior Cream Paint Soccer Pavilion	3.7% w/w	A3	<b>Paint is classified as lead based. Greater than 0.1% w/w</b>

The one (1) sample of cream coloured paint obtained from the exterior cladding of the Soccer Pavilion has recorded a result of 3.7% w/w for lead in paint, which is classified as a **Lead Based Paint**, therefore, remedial action is required. Good practice would dictate that existing paint, even though is below the recognised standard, should not be sanded and that dust minimisation techniques should be adopted, when undertaking renovation/ repair works particularly in heritage period buildings. It would be good practice to wear a P1 dust mask during any paint removal even if it does not contain lead but small particles of paint can still be inhaled or ingested.

As per legislation, the Lead (Pb) paint preparation works need to be undertaken by an experienced lead abatement contractor. It is also a requirement of legislation that the Contractor provide a Safe Work Method Statement as well as documentary evidence of personnel involved and their Lead (Pb) Biological Blood Level Monitoring program as per Part 7.6 of the NSW OH&S Regulation 2001, if regular lead works are to be undertaken.

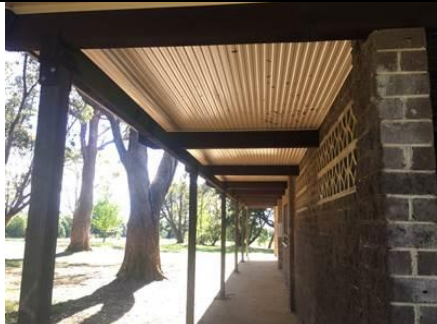
Exterior Brown Paint Amenities	0.08% w/w	A5	Paint is not classified as lead based. Less than 0.1% w/w

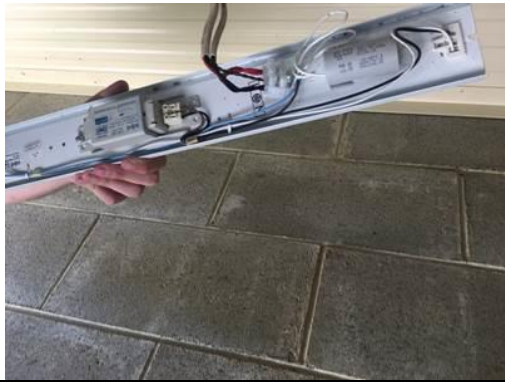
External Amenities Fluorescent Light No PCB's Observed	Visual Assessment	A5	N/A
8 <sup>th</sup> December 2017

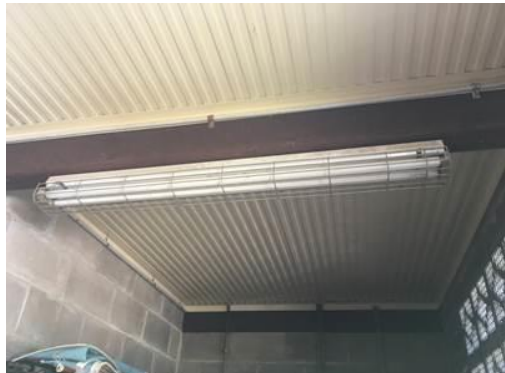
Internal Amenities Fluorescent Light No PCB's Observed	Visual Assessment	A5	N/A

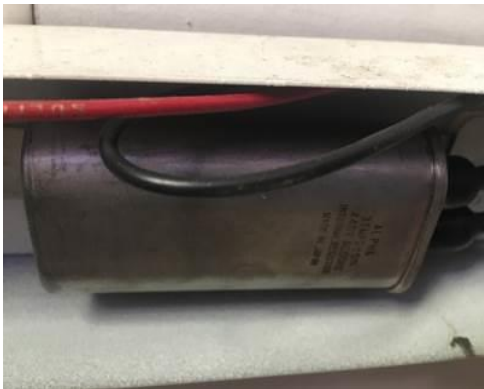
Internal Soccer Pavilion Fluorescent Lights PCB Type Capacitor Observed	Visual Assessment. Presume PCB Positive.	A4	Refer to Management Plan.  <b>NOTE:</b> The Alpha Capacitor is <b>NOT</b> Listed as Containing or Not Containing PCB's. No Signs of Leakage.
8 <sup>th</sup> December 2017

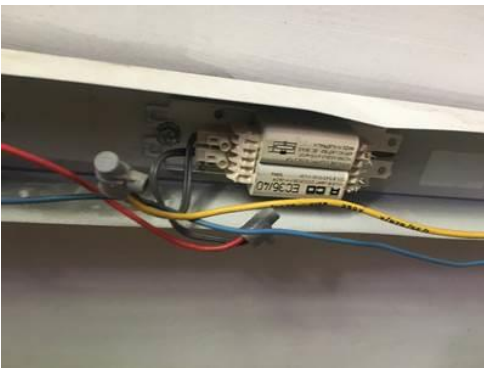
Kitchen Fluorescent Lights No PCB's Observed	Visual Assessment PCB Positive	A4	Refer to Management Plan
8 <sup>th</sup> December 2017

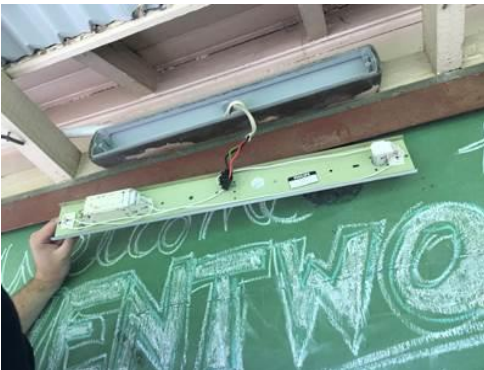
External Soccer Pavilion Fluorescent Light No PCB's Observed	Visual Assessment	A5	N/A

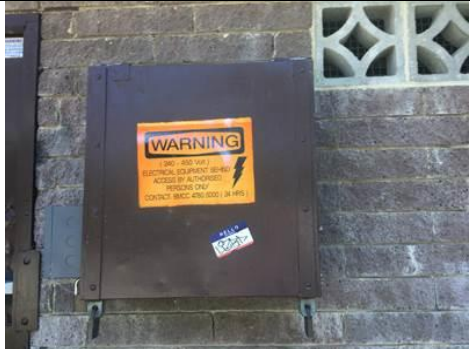
Amenities Block. External Power Board Assume Bakelite Backing Board. <b>NOTE: Nil Access</b>	No Access Assume Phenol Positive	A4	Presume Good Condition Accessible to Tradespeople Refer to Management Plan
8 <sup>th</sup> December 2017

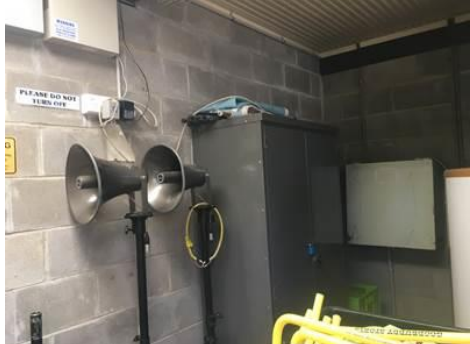
Amenities Block. Internal Power Board Assume Bakelite Backing Board. <b>NOTE: Nil Access</b>	No Access Assume Phenol Positive	A4	Presume Good Condition Accessible to Tradespeople Refer to Management Plan
