Amenities Block - Wentworth Falls Cemetery

Asbestos Register & Management Plan

Blue Mountains City Council were commissioned by Blue Mountains City Council to conduct Asbestos Management Register for the building located at 278-312 Great Western Highway Wentworth Falls NSW 2782.

The inspection was conducted on 24/11/2022, and the following items were identified:

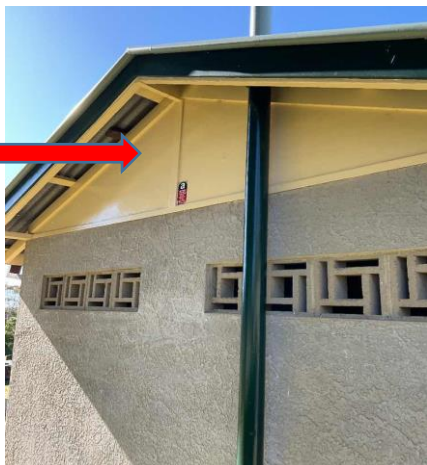
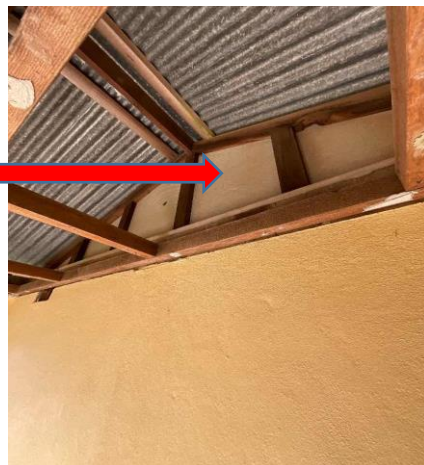
#	REF #	HAZARD	RESULT	SPECIFIC LOCATION	MATERIAL	QUANTITIY	FRIABILITY	OVERALL RISK	ACTION CODE	TIMEFRAME	COMMENTS
1&2	Previously sampled 37272-89	Asbestos	Chrysotile, Amosite and Crocidolite asbestos	Gable Linings	Fibre cement sheet	12 m2	Non-Friable	Very Low	A4	5 Yearly Reinspection	Accessible to tradespeople

External, GF, Exterior, Gable Linings - Fibre cement sheet, Chrysotile, Amosite and Crocidolite asbestos, Previously sampled 37272-89

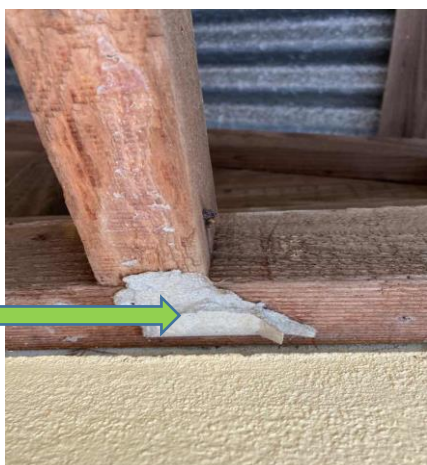
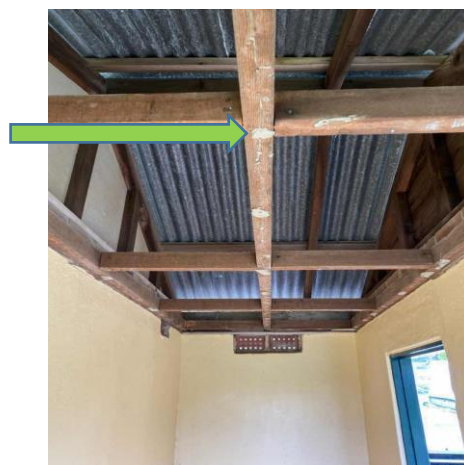
#	REF #	HAZARD	RESULT	SPECIFIC LOCATION	MATERIAL	QUANTITIY	FRIABILITY	OVERALL RISK	ACTION CODE	TIMEFRAME	COMMENTS
3&4	Previously sampled 37272-90	Asbestos	No Asbestos Detected	Ceiling Linings	Fibre Cement Sheet	6 m2	Not Applicable	-	A5	-	Ceiling removed but remnants of fibreboard can be seen on rafter.

Internal, GF, Storage Area/Walkway, Ceiling Linings - Fibre Cement Sheet, No Asbestos Detected, Previously sampled 37272-90

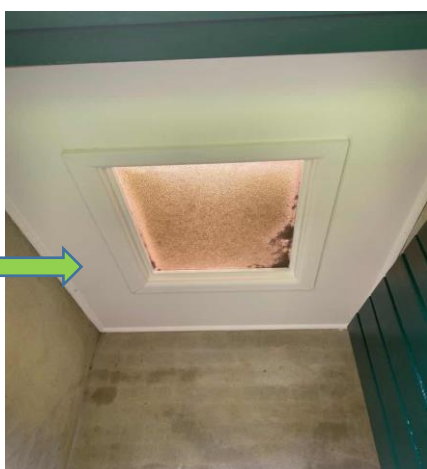
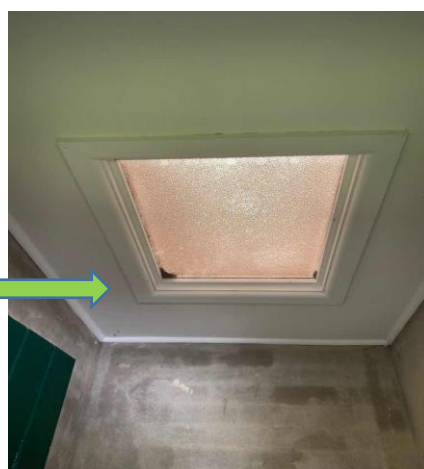
#	REF #	HAZARD	RESULT	SPECIFIC LOCATION	MATERIAL	QUANTITIY	FRIABILITY	OVERALL RISK	ACTION CODE	TIMEFRAME	COMMENTS
5&6	Previously sampled 37272-91	Asbestos	No Asbestos Detected	Ceiling Linings	Fibre Cement Sheet	6 m2	Not Applicable	-	A5	-	-

Internal, GF, Toilets, Ceiling Linings - Fibre Cement Sheet, No Asbestos Detected, Previously sampled 37272-91
