Asbestos Register

Management Plan

Browntown Oval,

183-189 Great Western Highway, MOUNT VICTORIA NSW 2786

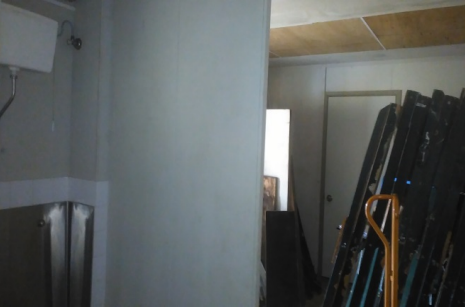
Ref No.	Date Identified	Clearance Cert Date	Onsite Register	Last Inspection Date	Next Inspection Date	
	1903	19/12/2014		Yes	17-Jun-2019	17-Jun-2024	
	Accessibility	Material	Extent	Result			
	Accessible	Fibreboard	15m2	Assumed Positive			
	Friability	Sealed / Surface Treatment	Risk Assessment	Control Actions	Labels Affixed

Non Friable	Sealed	RA04 - Very Low	No Remedial Action - Reinspect Periodically	No		
	Specific Location						
Browntown Oval Amenities Block - Internal Male Toilets Partition Wall X3							
Additional Comments					GPS Lat,Long		
Sample - Similar to 25132-13-1

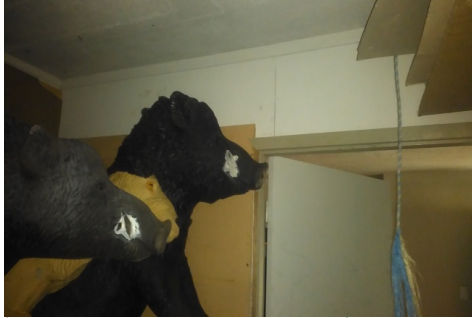
Ref No.	Date Identified	Clearance Cert Date	Onsite Register	Last Inspection Date	Next Inspection Date
	1905	19/12/2014		Yes	17-Jun-2019	17-Jun-2024

Accessibility	Material	Extent	Result		
	Accessible	Fibreboard	25m2	Assumed Positive		
	Friability	Sealed / Surface Treatment	Risk Assessment	Control Actions	Labels Affixed	
	Non Friable	Sealed	RA04 - Very Low	No Remedial Action - Reinspect Periodically	No	
	Specific Location					
Browntown Oval Amenities Block - Internal Male Toilets Storeroom within Internal Wall Cladding						
	Additional Comments					GPS Lat,Long
	Sample - Similar to 25132-13-1					
	Ref No.	Date Identified	Clearance Cert Date	Onsite Register	Last Inspection Date	Next Inspection Date
	1908	19/12/2014		Yes	17-Jun-2019	17-Jun-2024

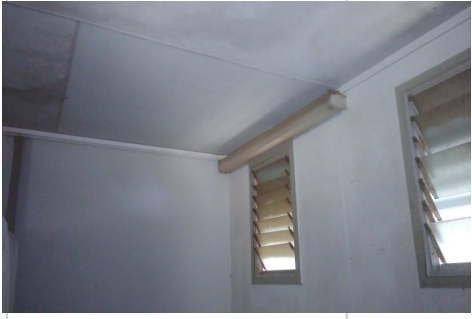
Accessibility	Material	Extent	Result		
	Accessible	Fibreboard	1.5m2	Assumed Positive		
	Friability	Sealed / Surface Treatment	Risk Assessment	Control Actions	Labels Affixed

Non Friable	Sealed	RA04 - Very Low	No Remedial Action - Reinspect Periodically	No	
	Specific Location					
Browntown Oval Amenities Block - Internal Female Toilets Ceiling Panel (x1)						
	Additional Comments					GPS Lat,Long
	Sample - Similar to 25132-13-2

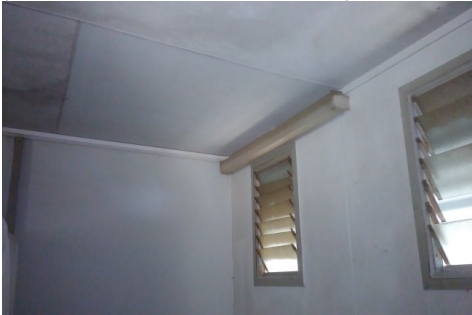
Ref No.	Date Identified	Clearance Cert Date	Onsite Register	Last Inspection Date	Next Inspection Date	
	1909	19/12/2014		Yes	17-Jun-2019	17-Jun-2024	
	Accessibility	Material	Extent	Result			
	Accessible	Fibreboard	25m2	Chrysotile			
	Friability	Sealed / Surface Treatment	Risk Assessment	Control Actions	Labels Affixed		
	Non Friable	Sealed	RA04 - Very Low	No Remedial Action - Reinspect Periodically	No		
	Specific Location						
Browntown Oval Amenities Block - Internal Female Toilets Internal Wall Cladding							
Additional Comments						GPS Lat,Long	
Sample - 25132-13-2

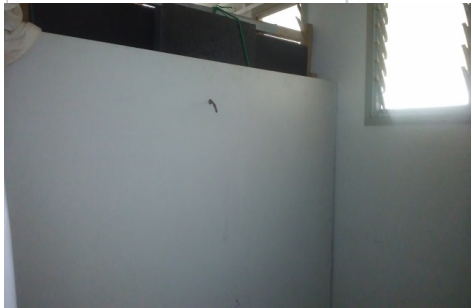
Ref No.	Date Identified	Clearance Cert Date	Onsite Register	Last Inspection Date	Next Inspection Date	
	1910	19/12/2014		Yes	17-Jun-2019	17-Jun-2024	
	Accessibility	Material	Extent	Result			
	Accessible	Fibreboard	5m2	Assumed Positive			
	Friability	Sealed / Surface Treatment	Risk Assessment	Control Actions	Labels Affixed

Non Friable	Sealed	RA04 - Very Low	No Remedial Action - Reinspect Periodically	No		
	Specific Location						
Browntown Oval Amenities Block - Internal Female Toilets Toilet Partition Wall							
Additional Comments						GPS Lat,Long	
Sample - Similar to 25132-13-2
