# Asbestos Register

# **Asbestos Register & Management Plan**

## Asbestos Register and Management Plan

The site is located: 8-50 Falls Road Wentworth Falls

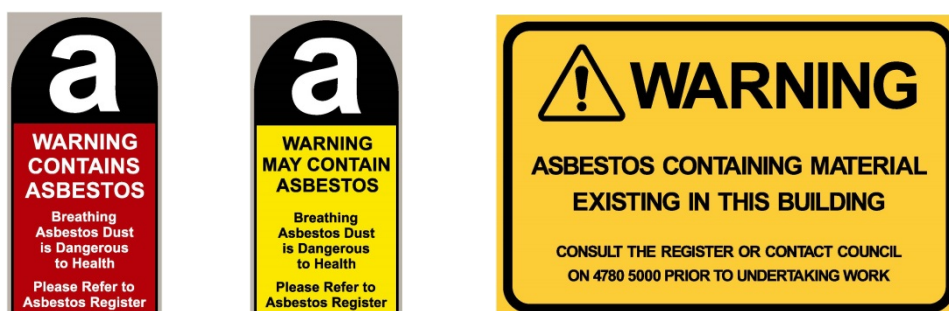
NSW Work Health and Safety Regulation 2017 R422, R424, R427 and R429 requires that the person with the management control of the workplace to identify asbestos containing materials and the asbestos material that has been identified to date must be labelled and ensure that it complies with the Australian Standard 1319: Safety Signs for the Occupational Environment; signage should be similar to the label detailed below.

Signage should also be placed at the entry points to the building/plant.
