Asbestos Register

Springwood Commuter Car Park 1-2 Station Street, Springwood

Asbestos Register and Management Plan

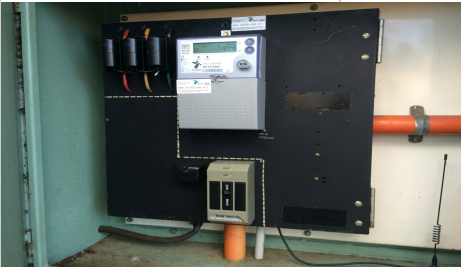
Ref No.	Date Identified	Clearance Cert Date	Onsite Register	Last Inspection Date	Next Inspection Date
	2265	19/12/2014		Yes	03-Dec-2019	03-Dec-2024
	Accessibility	Material	Extent	Result	Risk of Disturbance	
	Accessible	Bituminous backing board		Chrysotile		
	Friability	Sealed / Surface Treatment	Risk Assessment	Control Actions	Labels Affixed	
	Non Friable	Partially Sealed	RA04 - Very Low	Remove During Refurb or Maintenance	Yes	
Specific Location						
Springwood Community Car Park - Internal Western Perimeter Ground Level Electrical Box Electrical Backing Board						
Additional Comments						GPS Lat,Long
Sample - 25132-47-1

25132-47-1	Springwood Community Carpark - Western Perimeter – Ground Level – electrical box – electrical backing board	3x2x1mm backing board fragment	Chrysotile asbestos detected [Organic fibres detected]
25132-48-1	152 Megalong Street, Leura – External – south-eastern verandah – ceiling lining	3x3x1mm fibreboard fragment	Chrysotile asbestos detected [Organic fibres detected]
25132-48-2	152 Megalong Street, Leura – External – window frames – window putty	4x3x3mm window putty fragment	No asbestos detected
25132-48-3	152 Megalong Street, Leura – External – eastern perimeter – ground surface – debris	30x19x5mm fibrous cement sheet fragment	Chrysotile asbestos detected
25132-48-4	152 Megalong Street, Leura – Internal – Fudge Room – eastern wall – panel	2x1x1mm fibrous cement sheet fragment	Chrysotile asbestos detected
25132-48-5	152 Megalong Street, Leura – Internal – Bathroom – ceiling panels	4x3x1mm fibrous cement sheet fragment	Chrysotile asbestos detected
