Glenbrook Pool, Wascoe Park

# **Asbestos/Lead Register & Management Plan**

REPORT TYPE	Hazardous Materials Management Register
THE CLIENT	Blue Mountains City Council
AREA COVERED BY THE SCOPE	Aquatic Centre
LEAD SURVEYOR	Luke Trevena
ASSISTANT SURVEYOR	-
INSPECTION DATE	13/09/2022

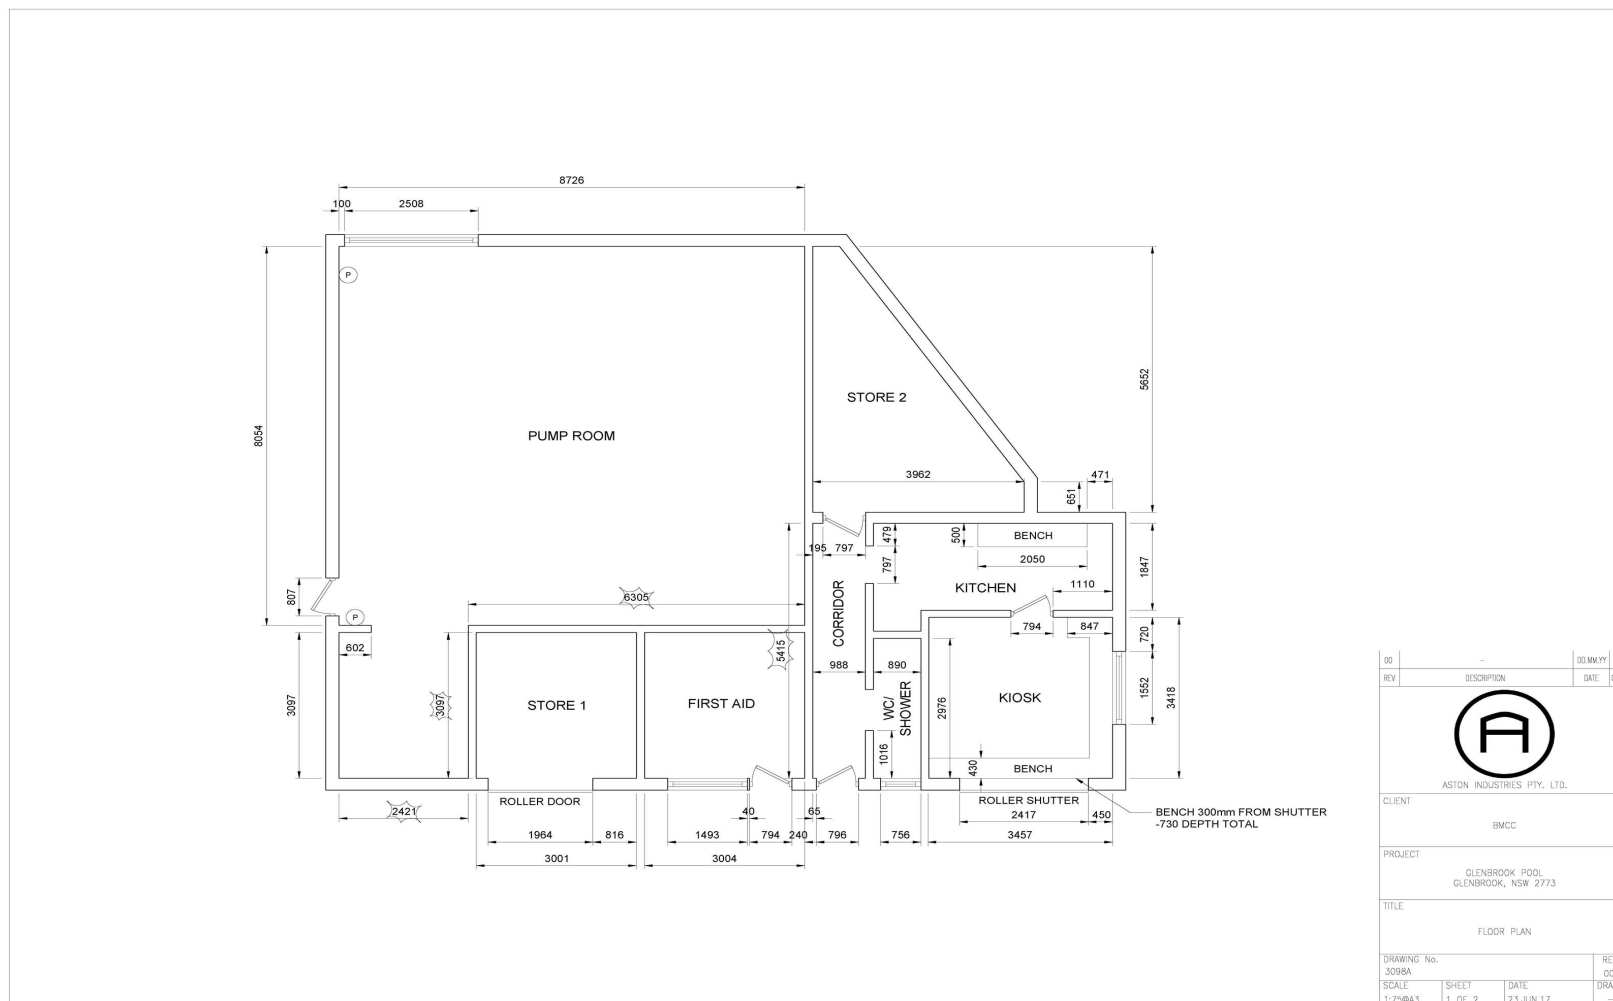
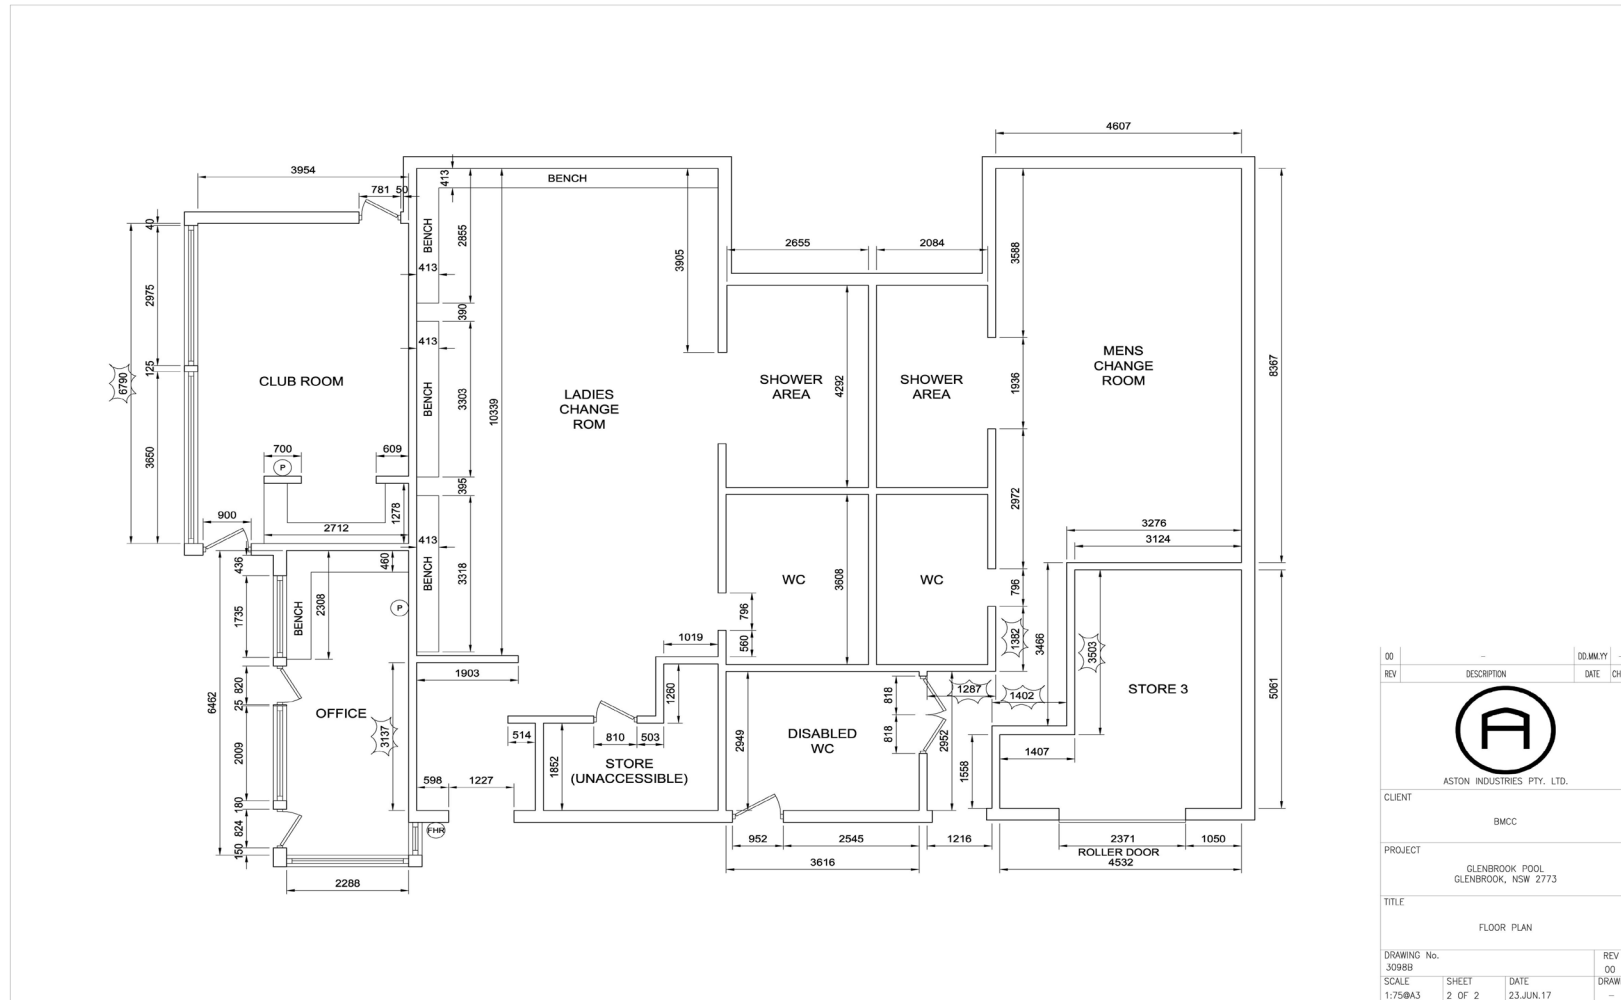
## Appendix B (Site Plan - Map)

Internal, GF, Womens Toilet, Ceiling - Fibre Cement, Assumed Positive, Similar to B17372-S10 - Assumed Chrysotile
