Katoomba Aquatic Centre - Main Centre

# **Asbestos/Lead Register & Management Plan**

<b>REPORT TYPE</b>	Hazardous Materials Management Register
<b>THE CLIENT</b>	Blue Mountains City Council
<b>AREA COVERED BY THE SCOPE</b>	Katoomba Aquatic Centre
<b>LEAD SURVEYOR</b>	Luke Trevena
<b>ASSISTANT SURVERYOR</b>	-
<b>INSPECTION DATE</b>	29/09/2022

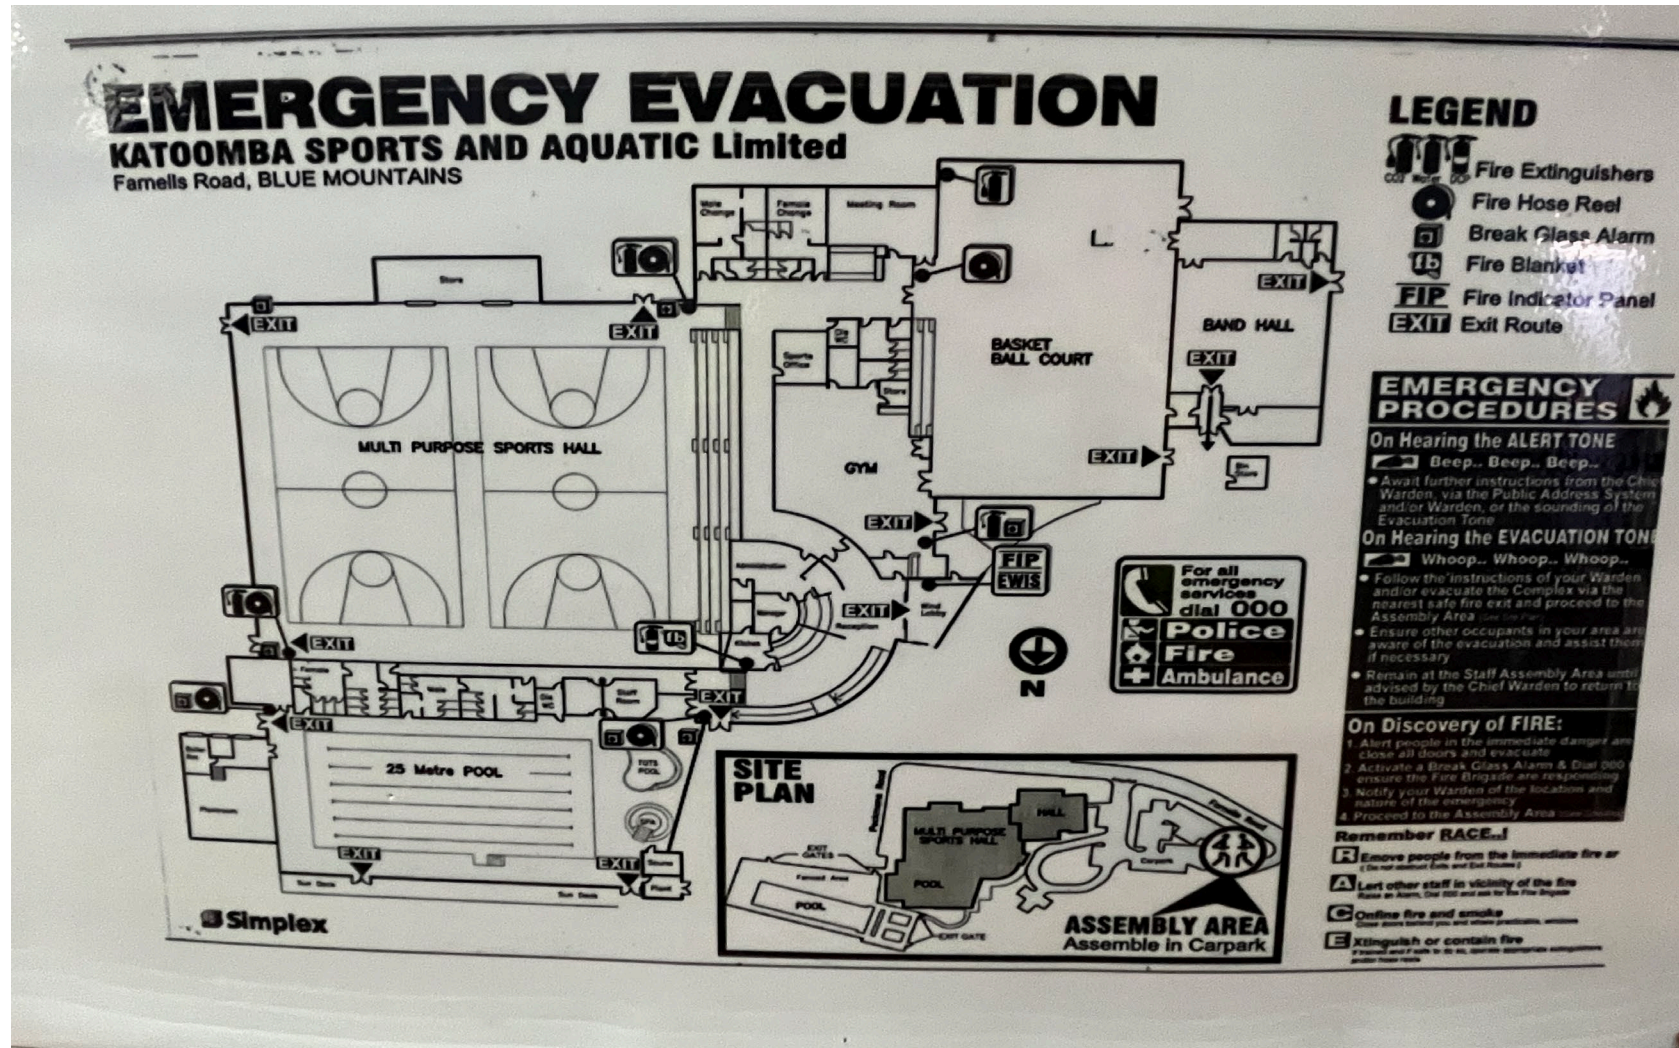
Appendix B (Site Plan - Map)

Internal, GF, Kids Kingdom Kitchen Foyer/Storage Room, Walls and Ceiling - Fibre Board, Chrysotile, B17382-S23
