Asbestos Risk Assessment
Blue Mountains City Council
Springwood Depot - Store, Office and Storage Buildings
2-20 Lawson Road, Springwood NSW 2777

Site Reference: 001

Our Reference : C109993 :

J154900 Date: February 2018

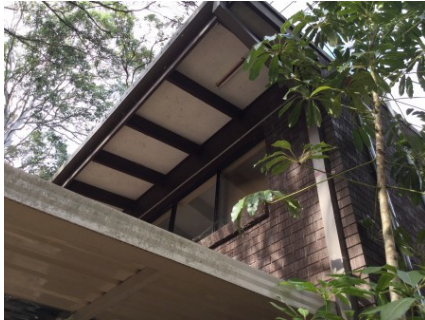
PHOTO NO.: ~~J154900-001-PHOTO158~~
 RESULT: ~~ASBESTOS - PREVIOUSLY SAMPLED POSITIVE~~
 BUILDING/LEVEL: ~~AMENITIES BUILDING - ALL LEVELS~~
 ROOM/LOCATION: ~~EXTERIOR - EAST & WEST~~
 FEATURE/MATERIAL: ~~AWNING - FIBRE CEMENT SHEETING~~
 SAMPLE NO.: ~~PREVIOUSLY SAMPLED REGIONAL ENVIROSCIENCE B17336-S12~~

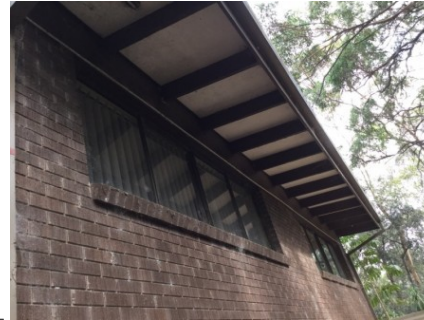
PHOTO NO.: ~~J154900-001-PHOTO159~~
 RESULT: ~~ASBESTOS - PREVIOUSLY SAMPLED POSITIVE~~
 BUILDING/LEVEL: ~~AMENITIES BUILDING - ALL LEVELS~~
 ROOM/LOCATION: ~~EXTERIOR - EAST & WEST~~
 FEATURE/MATERIAL: ~~AWNING - FIBRE CEMENT SHEETING~~
 SAMPLE NO.: ~~PREVIOUSLY SAMPLED REGIONAL ENVIROSCIENCE B17336-S12~~

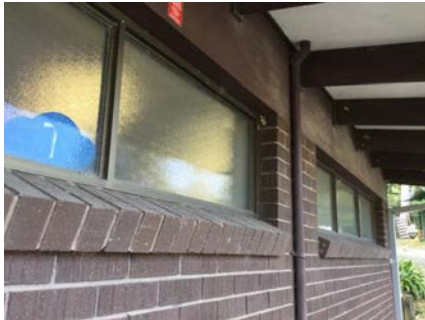
PHOTO NO.: ~~J154900-001-PHOTO125~~
 RESULT: ~~ASBESTOS - POSITIVE~~
 BUILDING/LEVEL: ~~AMENITIES BUILDING - ALL LEVELS~~
 ROOM/LOCATION: ~~EXTERIOR - EAST & WEST~~
 FEATURE/MATERIAL: ~~INFILL PANELS - FIBRE CEMENT SHEETING~~
 SAMPLE NO.: ~~J154900-001-049~~

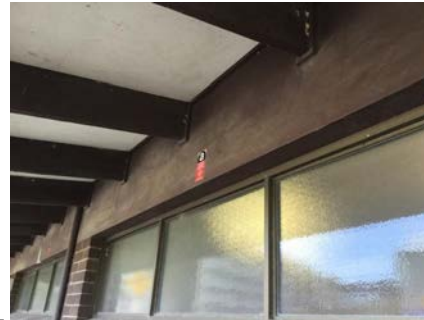
PHOTO NO.: ~~J154900-001-PHOTO126~~
 RESULT: ~~ASBESTOS - POSITIVE~~
 BUILDING/LEVEL: ~~AMENITIES BUILDING - ALL LEVELS~~
 ROOM/LOCATION: ~~EXTERIOR - EAST & WEST~~
 FEATURE/MATERIAL: ~~INFILL PANELS - FIBRE CEMENT SHEETING~~
 SAMPLE NO.: ~~J154900-001-049~~

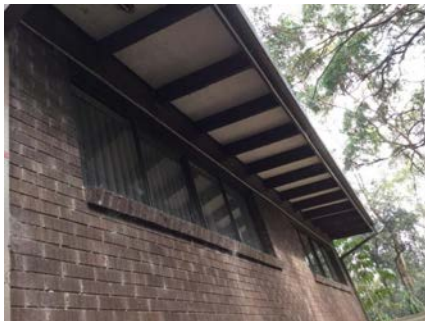
PHOTO NO.: ~~J154900-001-PHOTO127~~
 RESULT: ~~ASBESTOS - POSITIVE~~
 BUILDING/LEVEL: ~~AMENITIES BUILDING - ALL LEVELS~~
 ROOM/LOCATION: ~~EXTERIOR - EAST & WEST~~
 FEATURE/MATERIAL: ~~INFILL PANELS - FIBRE CEMENT SHEETING~~
 SAMPLE NO.: ~~J154900-001-049~~

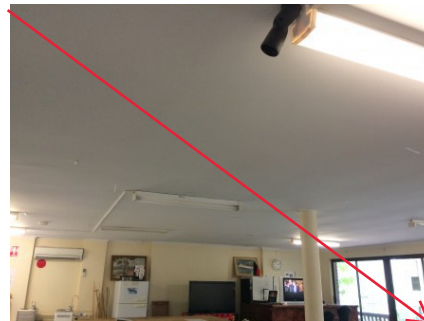
PHOTO NO.: ~~J154900-001-PHOTO133~~
 RESULT: ~~ASBESTOS - POSITIVE~~
 BUILDING/LEVEL: ~~AMENITIES BUILDING - LOWER GROUND LEVEL~~
 ROOM/LOCATION: ~~LUNCH ROOM - THROUGHOUT~~
 FEATURE/MATERIAL: ~~CEILING - FIBRE CEMENT SHEETING~~
 SAMPLE NO.: ~~J154900-001-015~~

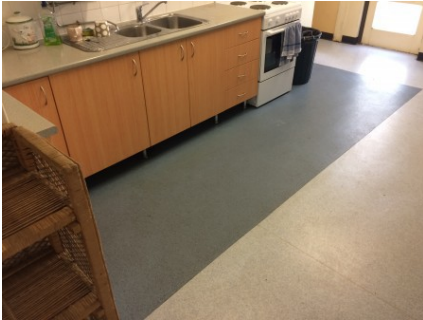
Amenities Building - Exterior - Lower Ground Level														
BBQ Area - Central Bench Top - Fibre Cement Sheeting - To BBQ serving table. 1365	Asbestos	J154900-001-016	Negative											
Amenities Building - Interior - Lower Ground Level														
Lunch Room - South Block-work - Compressed Cement Sheeting - Underneath pool table. 1367	Asbestos	J154900-001-017	Negative											
Lunch Room—Throughout Ceiling—Fibre Cement Sheeting 1368	Asbestos	J154900-001-015	Positive	J154900-001-P hoto133	80-m ²	Good	Non-Friable	Low	Low	Suspect	29/01/2023	P4	Maintain in current condition and incorporate into an AMP. Remove by licensed asbestos contractor prior to demolition or refurbishment.	Item removed Refer to Clearance certificate Greencap Reference June 2018 J155165-02
Lunch Room - Various Throughout Floor Covering - Sheet Vinyl & Adhesive - Blue colour . 1370	Asbestos	Previously Sampled Regional EnviroScience B17336-S32	Negative	J154900-001-P hoto161

PHOTO NO.: J154900-001-PHOTO161
 RESULT: ~~ASBESTOS - NEGATIVE~~
 BUILDING/LEVEL: ~~AMENITIES BUILDING - LOWER GROUND LEVEL~~
 ROOM/LOCATION: ~~LUNCH ROOM - VARIOUS THROUGHOUT~~
 FEATURE/MATERIAL: ~~FLOOR COVERING - SHEET VINYL & ADHESIVE~~
 SAMPLE NO.: ~~PREVIOUSLY SAMPLED REGIONAL ENVIROSCIENCE B17336-S32~~

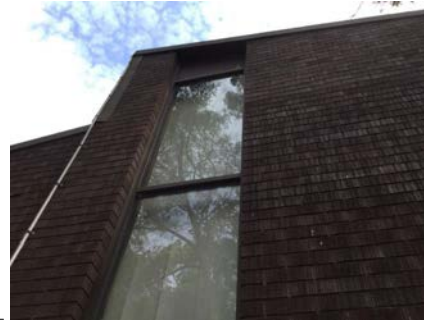
PHOTO NO.: J154900-001-PHOTO129
 RESULT: ~~ASBESTOS - POSITIVE~~
 BUILDING/LEVEL: ~~AMENITIES BUILDING - GROUND LEVEL~~
 ROOM/LOCATION: ~~EXTERIOR - NORTH & SOUTH~~
 FEATURE/MATERIAL: ~~INFILL PANELS - FIBRE CEMENT SHEETING~~
 SAMPLE NO.: ~~PREVIOUSLY SAMPLED REGIONAL ENVIROSCIENCE B17336-S13~~

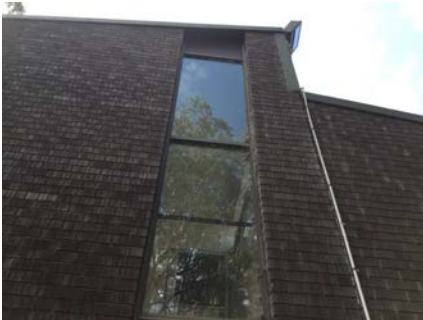
PHOTO NO.: J154900-001-PHOTO114
 RESULT: ~~ASBESTOS - POSITIVE~~
 BUILDING/LEVEL: ~~AMENITIES BUILDING - GROUND LEVEL~~
 ROOM/LOCATION: ~~EXTERIOR - NORTH & SOUTH~~
 FEATURE/MATERIAL: ~~INFILL PANELS - FIBRE CEMENT SHEETING~~
 SAMPLE NO.: ~~PREVIOUSLY SAMPLED REGIONAL ENVIROSCIENCE B17336-S13~~

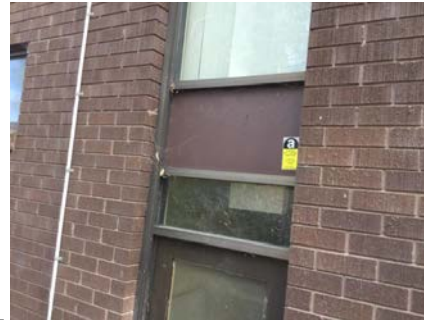
PHOTO NO.: J154900-001-PHOTO128
 RESULT: ~~ASBESTOS - POSITIVE~~
 BUILDING/LEVEL: ~~AMENITIES BUILDING - GROUND LEVEL~~
 ROOM/LOCATION: ~~EXTERIOR - NORTH & SOUTH~~
 FEATURE/MATERIAL: ~~INFILL PANELS - FIBRE CEMENT SHEETING~~
 SAMPLE NO.: ~~PREVIOUSLY SAMPLED REGIONAL ENVIROSCIENCE B17336-S13~~

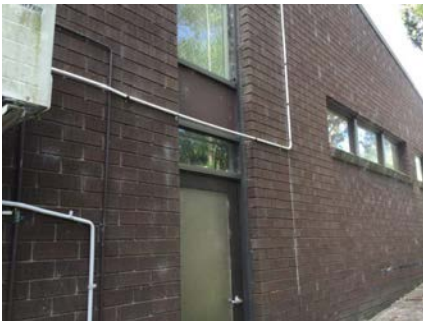
PHOTO NO.: J154900-001-PHOTO113
 RESULT: ~~ASBESTOS - POSITIVE~~
 BUILDING/LEVEL: ~~AMENITIES BUILDING - GROUND LEVEL~~
 ROOM/LOCATION: ~~EXTERIOR - NORTH & SOUTH~~
 FEATURE/MATERIAL: ~~INFILL PANELS - FIBRE CEMENT SHEETING~~
 SAMPLE NO.: ~~PREVIOUSLY SAMPLED REGIONAL ENVIROSCIENCE B17336-S13~~

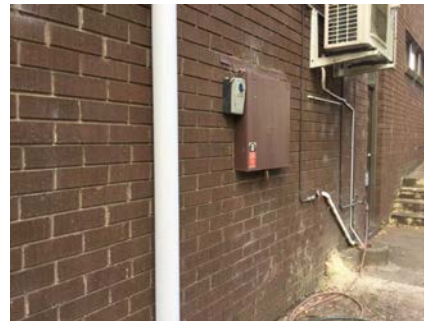
PHOTO NO.: J154900-001-PHOTO112
 RESULT: ~~ASBESTOS - PRESUMED POSITIVE~~
 BUILDING/LEVEL: ~~AMENITIES BUILDING - GROUND LEVEL~~
 ROOM/LOCATION: ~~EXTERIOR - SOUTH~~
 FEATURE/MATERIAL: ~~ELECTRICAL - SWITCH BOARD - COMPRESSED BITUMINOUS ELECTRICAL PANEL~~
 SAMPLE NO.: ~~NOT SAMPLED LOCKED~~

- It was noted that where asbestos electrical backing boards were identified components such as fuses have been installed into the asbestos. It would be prudent as a precaution to vacuum out these cabinets using an H-Type vacuum cleaner in accordance with the Code of Practice.

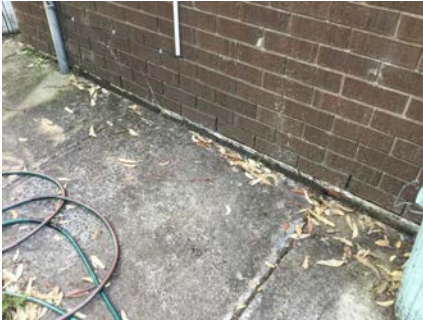
PHOTO NO.: J154900-001-PHOTO110
 RESULT: **ASBESTOS - NEGATIVE**
 BUILDING/LEVEL: **AMENITIES BUILDING - GROUND LEVEL**
 ROOM/LOCATION: **EXTERIOR - VARIOUS THROUGHOUT**
 FEATURE/MATERIAL: **EXPANSION JOINT - MASTIC SEALANT**
 SAMPLE NO.: **J154900-001-044**

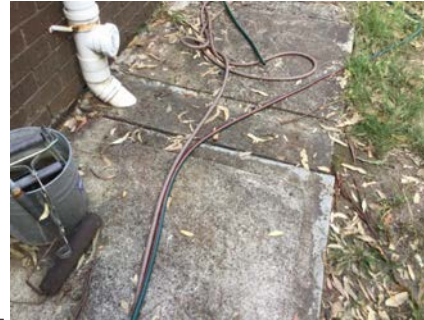
PHOTO NO.: J154900-001-PHOTO111
 RESULT: **ASBESTOS - NEGATIVE**
 BUILDING/LEVEL: **AMENITIES BUILDING - GROUND LEVEL**
 ROOM/LOCATION: **EXTERIOR - VARIOUS THROUGHOUT**
 FEATURE/MATERIAL: **EXPANSION JOINT - MASTIC SEALANT**
 SAMPLE NO.: **J154900-001-045**

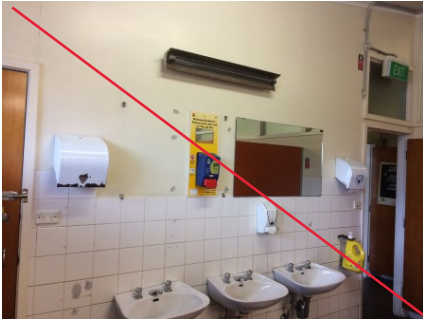
PHOTO NO.: J154900-001-PHOTO134
 RESULT: **ASBESTOS - POSITIVE**
 BUILDING/LEVEL: **AMENITIES BUILDING - GROUND LEVEL**
 ROOM/LOCATION: **MALE TOILET - SOUTH**
 FEATURE/MATERIAL: **WALL - FIBRE CEMENT SHEETING**
 SAMPLE NO.: **J154900-001-019**

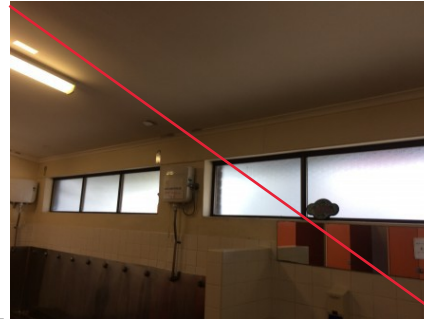
Male Toilet - Throughout Ceiling - Fibre Cement Sheeting 1389	Asbestos	Similar To: J154900-001-004	Presumed Positive	J154900-001-Photo135	40-m ²	Good	Non Friable	Low	Low	Suspect	29/01/2023	P4	Maintain in current condition and incorporate into an AMP. Remove by licensed asbestos contractor prior to demolition or refurbishment.	Item removed Refer to Clearance certificate Greencap Reference June 2018 J155165-02
Male Toilet - West Toilet Cubicle - Compressed Cement Sheeting - Orange painted material. 1391	Asbestos	Previously Sampled Regional EnviroScience B17336-S15	Positive	J154900-001-Photo131	60-m ²	Good	Non Friable	Low	Low	Not Labelled	29/01/2023	P4	Maintain in current condition, label and incorporate into an AMP. Remove by licensed asbestos contractor prior to demolition or refurbishment.	Item removed Refer to Clearance certificate Greencap Reference June 2018 J155165-02
Male Toilet - West Wall - Fibre Cement Sheeting - Behind ceramic tiles and to glass windows. 1393	Asbestos	J154900-001-018	Positive	J154900-001-Photo136	60-m ²	Good	Non Friable	Low	Low	Confirmed	29/01/2023	P4	Maintain in current condition and incorporate into an AMP. Remove by licensed asbestos contractor prior to demolition or refurbishment.	Item removed Refer to Clearance certificate Greencap Reference June 2018 J155165-02

PHOTO NO.: J154900-001-PHOTO135
 RESULT: **ASBESTOS - PRESUMED POSITIVE**
 BUILDING/LEVEL: **AMENITIES BUILDING - GROUND LEVEL**
 ROOM/LOCATION: **MALE TOILET - THROUGHOUT**
 FEATURE/MATERIAL: **CEILING - FIBRE CEMENT SHEETING**
 SAMPLE NO.: **SIMILAR TO: J154900-001-001**

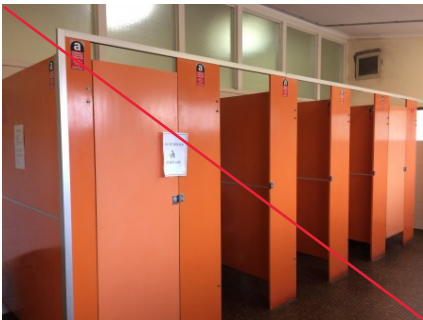
PHOTO NO.: J154900-001-PHOTO131
 RESULT: **ASBESTOS - POSITIVE**
 BUILDING/LEVEL: **AMENITIES BUILDING - GROUND LEVEL**
 ROOM/LOCATION: **MALE TOILET - WEST**
 FEATURE/MATERIAL: **TOILET CUBICLE - COMPRESSED CEMENT SHEETING**
 SAMPLE NO.: **PREVIOUSLY SAMPLED REGIONAL ENVIROSCIENCE B17336-S15**

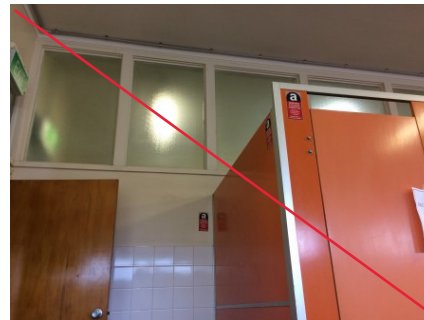
PHOTO NO.: J154900-001-PHOTO136
 RESULT: **ASBESTOS - POSITIVE**
 BUILDING/LEVEL: **AMENITIES BUILDING - GROUND LEVEL**
 ROOM/LOCATION: **MALE TOILET - WEST**
 FEATURE/MATERIAL: **WALL - FIBRE CEMENT SHEETING**
 SAMPLE NO.: **J154900-001-018**

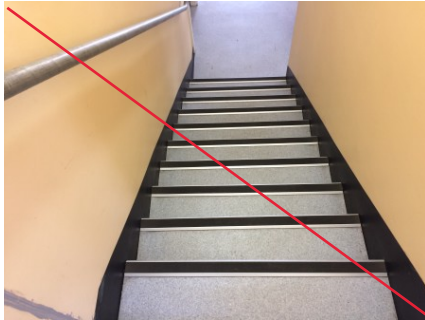
Stairwell to Lunch Room - Various Throughout Skirting - Sheet Vinyl & Adhesive - Black colour. 1400	Asbestos	Previously Sampled Regional EnviroScience B17336-S33	Negative	J154900-001-Photo162										
Stairwell to Lunch Room/Conference Room - Throughout Wall - Fibre Cement Sheeting 1403	Asbestos	Previously Sampled Regional EnviroScience B17336-S36	Positive	J154900-001-Photo163	80-m ²	Good	Non Friable	Low	Low	Not Labelled	29/01/2023	P4	Maintain in current condition, label and incorporate into an AMP. Remove by licensed asbestos contractor prior to demolition or refurbishment.	Item removed Refer to Clearance certificate Greencap Reference June 2018 J155165-02
Cleaner Room (within Male Toilet) - Throughout Ceiling - Fibre Cement Sheeting 1414	Asbestos	Similar To: J154900-001-004	Presumed Positive	J154900-001-Photo137	4-m ²	Good	Non Friable	Low	Low	Not Labelled	29/01/2023	P4	Maintain in current condition, label and incorporate into an AMP. Remove by licensed asbestos contractor prior to demolition or refurbishment.	Item removed Refer to Clearance certificate Greencap Reference June 2018 J155165-02

PHOTO NO.: J154900-001-PHOTO162
 RESULT: ASBESTOS - NEGATIVE
 BUILDING/LEVEL: AMENITIES BUILDING - GROUND LEVEL
 ROOM/LOCATION: STAIRWELL TO LUNCH ROOM - VARIOUS THROUGHOUT
 FEATURE/MATERIAL: SKIRTING - SHEET VINYL & ADHESIVE
 SAMPLE NO.: PREVIOUSLY SAMPLED REGIONAL ENVIROSCIENCE B17336-S33

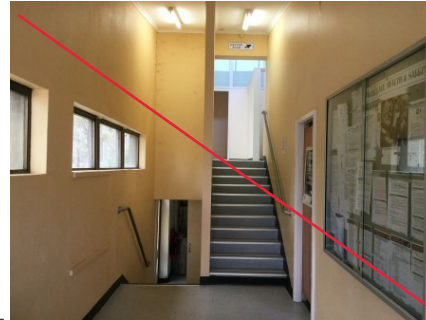
PHOTO NO.: J154900-001-PHOTO163
 RESULT: ASBESTOS - POSITIVE
 BUILDING/LEVEL: AMENITIES BUILDING - GROUND LEVEL
 ROOM/LOCATION: STAIRWELL TO LUNCH ROOM/CONFERENCE ROOM - THROUGHOUT
 FEATURE/MATERIAL: WALL - FIBRE CEMENT SHEETING
 SAMPLE NO.: PREVIOUSLY SAMPLED REGIONAL ENVIROSCIENCE B17336-S36

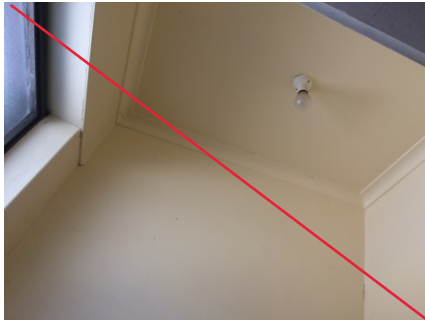
PHOTO NO.: J154900-001-PHOTO137
 RESULT: ASBESTOS - PRESUMED POSITIVE
 BUILDING/LEVEL: AMENITIES BUILDING - GROUND LEVEL
 ROOM/LOCATION: CLEANER ROOM (WITHIN MALE TOILET) - THROUGHOUT
 FEATURE/MATERIAL: CEILING - FIBRE CEMENT SHEETING
 SAMPLE NO.: SIMILAR TO: J154900-001-001

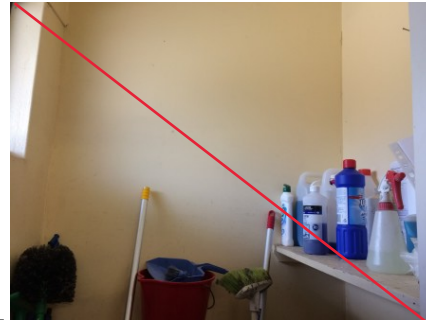
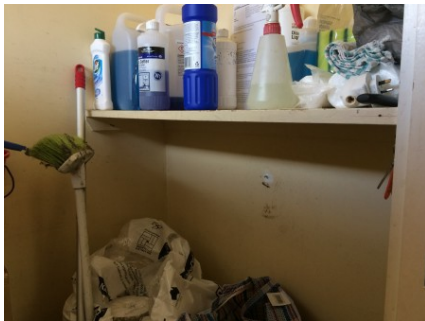
Cleaner Room (within Male Toilet) - West Wall - Fibre Cement Sheeting - West, south and north walls. Minor damages to wall was identified in this room. 1418	Asbestos	J154900-001-020	Positive	J154900-001-Photo138- J154900-001-Photo139	30-m ²	Fair	Non Friable	Low	Low	Not Labelled	29/01/2019	P3	Encapsulate exposed materials and maintain in current condition, label and incorporate into an AMP. Remove by licensed asbestos contractor prior to demolition or refurbishment.	Item removed Refer to Clearance certificate Greencap Reference June 2018 J155165-02
Foyer - Throughout Ceiling - Fibre Cement Sheeting 1426	Asbestos	J154900-001-004	Positive	J154900-001-Photo140	30-m ²	Good	Non Friable	Low	Low	Suspect	29/01/2023	P4	Maintain in current condition and incorporate into an AMP. Remove by licensed asbestos contractor prior to demolition or refurbishment.	Item removed Refer to Clearance certificate Greencap Reference June 2018 J155165-02

PHOTO NO.: J154900-001-PHOTO138
 RESULT: ASBESTOS - POSITIVE
 BUILDING/LEVEL: AMENITIES BUILDING - GROUND LEVEL
 ROOM/LOCATION: CLEANER ROOM (WITHIN MALE TOILET) - WEST
 FEATURE/MATERIAL: WALL - FIBRE CEMENT SHEETING
 SAMPLE NO.: J154900-001-020

PHOTO NO.: J154900-001-PHOTO139
 RESULT: ASBESTOS - POSITIVE
 BUILDING/LEVEL: AMENITIES BUILDING - GROUND LEVEL
 ROOM/LOCATION: CLEANER ROOM (WITHIN MALE TOILET) - WEST
 FEATURE/MATERIAL: WALL - FIBRE CEMENT SHEETING
 SAMPLE NO.: J154900-001-020

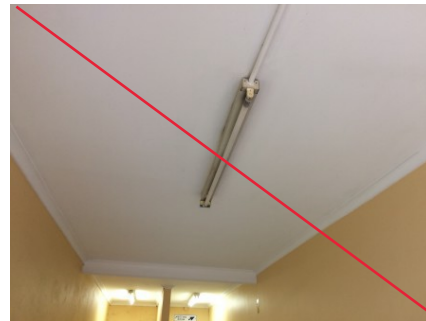
PHOTO NO.: J154900-001-PHOTO140
 RESULT: ASBESTOS - POSITIVE
 BUILDING/LEVEL: AMENITIES BUILDING - GROUND LEVEL
 ROOM/LOCATION: FOYER - THROUGHOUT
 FEATURE/MATERIAL: CEILING - FIBRE CEMENT SHEETING
 SAMPLE NO.: J154900-001-020

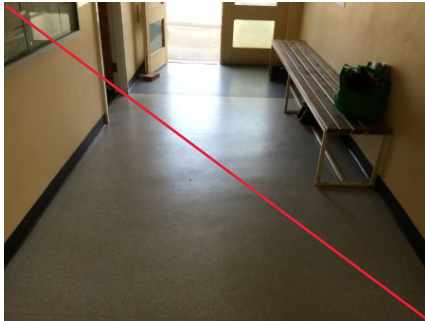
PHOTO NO.: ~~J154900-001-PHOTO166~~
 RESULT: ~~ASBESTOS - PRESUMED POSITIVE~~
 BUILDING/LEVEL: ~~AMENITIES BUILDING - GROUND LEVEL~~
 ROOM/LOCATION: ~~FOYER - VARIOUS THROUGHOUT~~
 FEATURE/MATERIAL: ~~WALL - FIBRE CEMENT SHEETING~~
 SAMPLE NO.: ~~SIMILAR TO: J154900-001-020~~

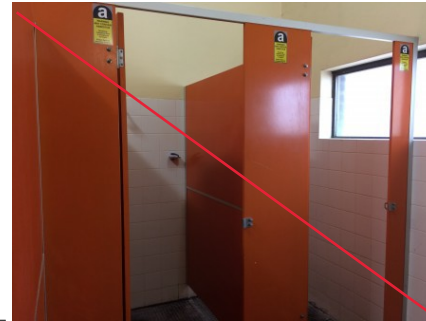
PHOTO NO.: ~~J154900-001-PHOTO132~~
 RESULT: ~~ASBESTOS - POSITIVE~~
 BUILDING/LEVEL: ~~AMENITIES BUILDING - GROUND LEVEL~~
 ROOM/LOCATION: ~~LOCKER ROOM - NORTH~~
 FEATURE/MATERIAL: ~~TOILET CUBICLE - COMPRESSED CEMENT SHEETING~~
 SAMPLE NO.: ~~PREVIOUSLY SAMPLED REGIONAL ENVIROSCIENCE B17336-S15~~

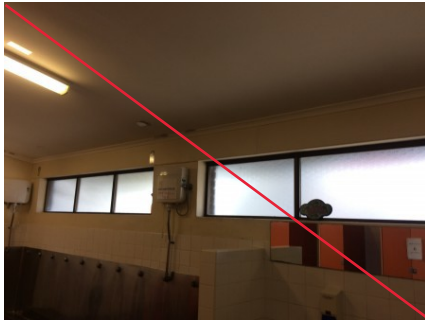
Locker Room - Throughout Ceiling - Fibre Cement Sheeting 1442	Asbestos	Similar To:- J154900-001-004	Presumed-Positive	J154900-001-Photo164	30 m ²	Good	Non-Friable	Low	Low	Not Labelled	29/01/2023	P4	Maintain in current condition, label and incorporate into an AMP. Remove by licensed asbestos contractor prior to demolition or refurbishment.	Item removed Refer to Clearance certificate Greencap Reference June 2018 J155165-02
Locker Room - Various Throughout Wall - Fibre Cement Sheeting 1447	Asbestos	Previously-Sampled-Regional-EnviroScience B17336-S39	Positive	J154900-001-Photo165	80 m ²	Good	Non-Friable	Low	Low	Not Labelled	29/01/2023	P4	Maintain in current condition, label and incorporate into an AMP. Remove by licensed asbestos contractor prior to demolition or refurbishment.	Item removed Refer to Clearance certificate Greencap Reference June 2018 J155165-02
Locker Room - West Debris - Dust - Settled dust on top of lockers (1-10). 1452	Asbestos	J154900-001-021	Negative

PHOTO NO.: ~~J154900-001-PHOTO164~~
 RESULT: ~~ASBESTOS - PRESUMED POSITIVE~~
 BUILDING/LEVEL: ~~AMENITIES BUILDING - GROUND LEVEL~~
 ROOM/LOCATION: ~~LOCKER ROOM - THROUGHOUT~~
 FEATURE/MATERIAL: ~~CEILING - FIBRE CEMENT SHEETING~~
 SAMPLE NO.: ~~SIMILAR TO: J154900-001-001~~

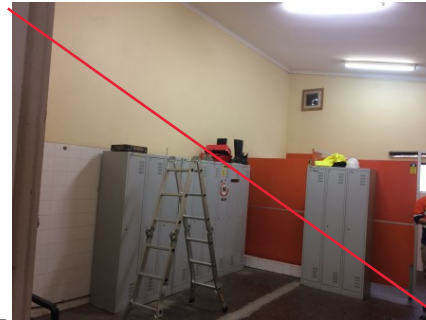
PHOTO NO.: ~~J154900-001-PHOTO165~~
 RESULT: ~~ASBESTOS - POSITIVE~~
 BUILDING/LEVEL: ~~AMENITIES BUILDING - GROUND LEVEL~~
 ROOM/LOCATION: ~~LOCKER ROOM - VARIOUS THROUGHOUT~~
 FEATURE/MATERIAL: ~~WALL - FIBRE CEMENT SHEETING~~
 SAMPLE NO.: ~~PREVIOUSLY SAMPLED REGIONAL ENVIROSCIENCE B17336-S39~~

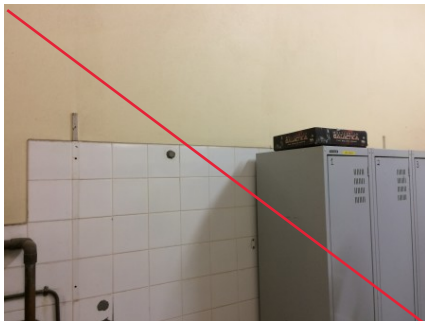
Locker Room - West Packer - Fibre Cement Sheeting - To wall behind locker (1-10). 1454	Asbestos	J154900-001-022	Positive	J154900-001-Photo141	1 m ²	Fair	Non-Friable	Medium	Medium	Not Labelled	29/04/2018	P2	Engage a licensed asbestos contractor to undertake remedial/removal works on this item as soon as practicable.	Item removed by BMCC Asbestos Response Team Date 8/08/2018

PHOTO NO.: ~~J154900-001-PHOTO141~~
 RESULT: ~~ASBESTOS - POSITIVE~~
 BUILDING/LEVEL: ~~AMENITIES BUILDING - GROUND LEVEL~~
 ROOM/LOCATION: ~~LOCKER ROOM - WEST~~
 FEATURE/MATERIAL: ~~PACKER - FIBRE CEMENT SHEETING~~
 SAMPLE NO.: ~~J154900-001-022~~

- Where the P2 item was identified within the Locker Room – Amenities Building, engage an appropriately licensed asbestos removal contractor to undertake remedial/removal works under controlled conditions as soon as practical. The works should include removal of identified packers, encapsulating damaged sections of walls and decontamination of hard surfaces including the metal lockers, floor surfaces etc.

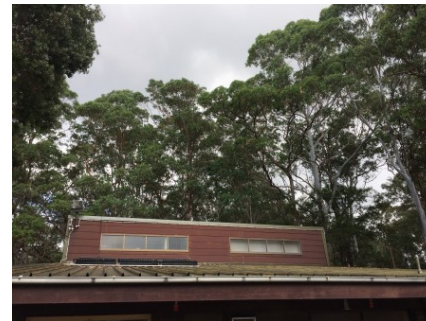
PHOTO NO.: ~~J154900-001-PHOTO130~~
 RESULT: ~~ASBESTOS - POSITIVE~~
 BUILDING/LEVEL: ~~AMENITIES BUILDING - LEVEL ONE~~
 ROOM/LOCATION: ~~EXTERIOR - EAST~~
 FEATURE/MATERIAL: ~~WALL CLADDING - FIBRE CEMENT SHEETING~~
 SAMPLE NO.: ~~PREVIOUSLY SAMPLED REGIONAL ENVIROSCIENCE B17336-S14~~

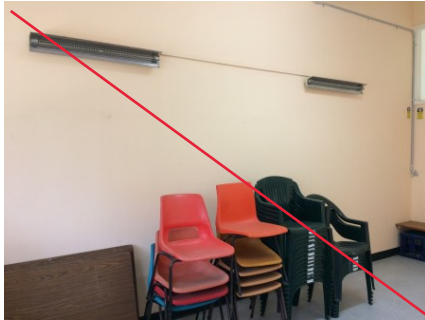
Female Change Room - North Wall - Fibre Cement Sheeting - North and east walls. 1557	Asbestos	J154900-001-005	Positive	J154900-001-Photo144	80 m ²	Good	Non-Friable	Low	Low	Suspect	29/01/2023	P4	Maintain in current condition and incorporate into an AMP. Remove by licensed asbestos contractor prior to demolition or refurbishment.	Item removed Refer to Clearance certificate Greencap Reference May 2018 J155165-02

PHOTO NO.: J154900-001-PHOTO144
 RESULT: ASBESTOS - POSITIVE
 BUILDING/LEVEL: AMENITIES BUILDING - LEVEL ONE
 ROOM/LOCATION: FEMALE CHANGE ROOM - NORTH
 FEATURE/MATERIAL: WALL - FIBRE CEMENT SHEETING
 SAMPLE NO.: J154900-001-005

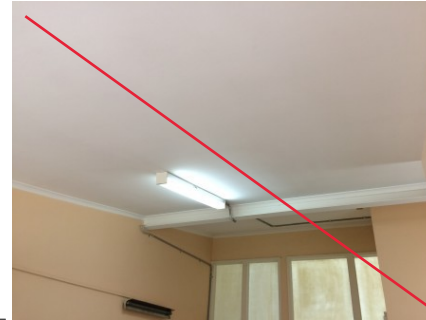
PHOTO NO.: J154900-001-PHOTO145
 RESULT: ASBESTOS - PRESUMED POSITIVE
 BUILDING/LEVEL: AMENITIES BUILDING - LEVEL ONE
 ROOM/LOCATION: FEMALE CHANGE ROOM - THROUGHOUT
 FEATURE/MATERIAL: CEILING - FIBRE CEMENT SHEETING
 SAMPLE NO.: SIMILAR TO: J154900-001-006

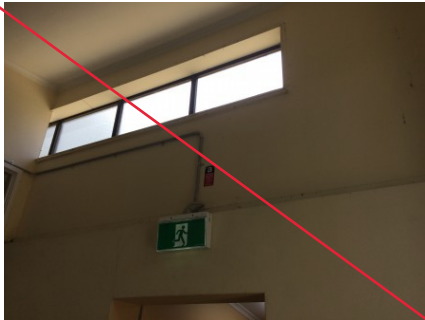
PHOTO NO.: J154900-001-PHOTO149
 RESULT: ASBESTOS - POSITIVE
 BUILDING/LEVEL: AMENITIES BUILDING - LEVEL ONE
 ROOM/LOCATION: CENTRAL FOYER - TO CONFERENCE/FEMALE TOILET/SHOWER/ CHANGE ROOMS - EAST
 FEATURE/MATERIAL: WALL - FIBRE CEMENT SHEETING
 SAMPLE NO.: J154900-001-011

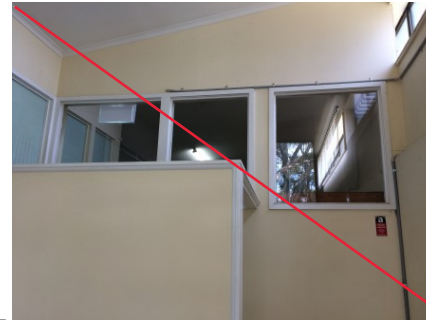
Central Foyer - To Conference/Female Toilet/Shower/ Change Rooms - Throughout Ceiling - Fibre Cement Sheeting 1688	Asbestos	Similar To:- J154900-001-006	Presumed-Positive	J154900-001-Photo150	40-m ²	Good	Non-Friable	Low	Low	Suspect	29/01/2023	P4	Maintain in current condition and incorporate into an AMP. Remove by licensed asbestos contractor prior to demolition or refurbishment.	Item removed Refer to Clearance certificate Greencap Reference May 2018 J155165-02
Entry - Female Toilet/Shower/Change Room - East Wall - Fibre Cement Sheeting - Above and below windows. 1690	Asbestos	J154900-001-008	Positive	J154900-001-Photo151	40-m ²	Good	Non-Friable	Low	Low	Suspect	29/01/2023	P4	Maintain in current condition and incorporate into an AMP. Remove by licensed asbestos contractor prior to demolition or refurbishment.	Item removed Refer to Clearance certificate Greencap Reference May 2018 J155165-02
Entry - Female Toilet/Shower/Change Room - North Wall - Fibre Cement Sheeting - North and west walls are visually similar. 1691	Asbestos	J154900-001-009	Negative

PHOTO NO.: J154900-001-PHOTO150
 RESULT: ASBESTOS - PRESUMED POSITIVE
 BUILDING/LEVEL: AMENITIES BUILDING - LEVEL ONE
 ROOM/LOCATION: CENTRAL FOYER - TO CONFERENCE/FEMALE TOILET/SHOWER/ CHANGE ROOMS - THROUGHOUT
 FEATURE/MATERIAL: CEILING - FIBRE CEMENT SHEETING
 SAMPLE NO.: SIMILAR TO: J154900-001-006

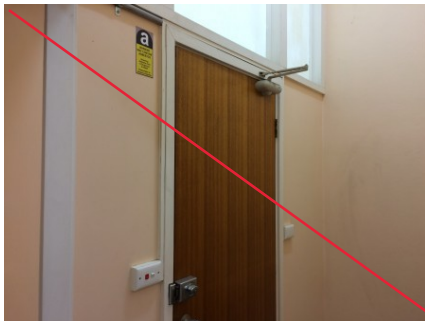
PHOTO NO.: J154900-001-PHOTO151
 RESULT: ASBESTOS - POSITIVE
 BUILDING/LEVEL: AMENITIES BUILDING - LEVEL ONE
 ROOM/LOCATION: ENTRY - FEMALE TOILET/SHOWER/CHANGE ROOM - EAST
 FEATURE/MATERIAL: WALL - FIBRE CEMENT SHEETING
 SAMPLE NO.: J154900-001-008

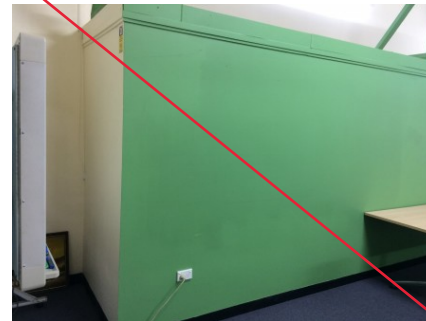
Conference Room - East Wall - Fibre Cement Sheeting - Stairwell entry wall. East (green-colour) and south (cream-colour) walls. 1692	Asbestos	J154900-001-012	Positive	J154900-001-Photo152	30-m ²	Good	Non-Friable	Low	Low	Suspect	29/01/2023	P4	Maintain in current condition and incorporate into an AMP. Remove by licensed asbestos contractor prior to demolition or refurbishment.	Item removed Refer to Clearance certificate Greencap Reference May 2018 J155165-02
Conference Room - South Wall - Fibre Cement Sheeting 1693	Asbestos	J154900-001-013	Positive	J154900-001-Photo153	40-m ²	Good	Non-Friable	Low	Low	Not-Labelled	29/01/2023	P4	Maintain in current condition, label and incorporate into an AMP. Remove by licensed asbestos contractor prior to demolition or refurbishment.	Item removed Refer to Clearance certificate Greencap Reference May 2018 J155165-02

PHOTO NO.: J154900-001-PHOTO152
 RESULT: ASBESTOS - POSITIVE
 BUILDING/LEVEL: AMENITIES BUILDING - LEVEL ONE
 ROOM/LOCATION: CONFERENCE ROOM - EAST
 FEATURE/MATERIAL: WALL - FIBRE CEMENT SHEETING
 SAMPLE NO.: J154900-001-012

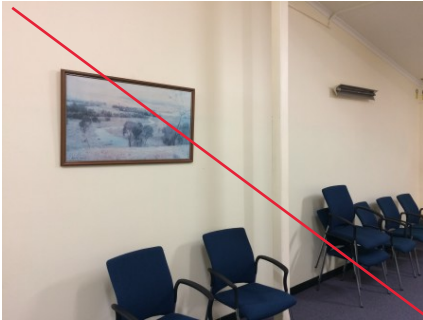
PHOTO NO.: J154900-001-PHOTO153
 RESULT: **ASBESTOS - POSITIVE**
 BUILDING/LEVEL: AMENITIES BUILDING - LEVEL ONE
 ROOM/LOCATION: CONFERENCE ROOM - SOUTH
 FEATURE/MATERIAL: WALL - FIBRE CEMENT SHEETING
 SAMPLE NO.: J154900-001-013

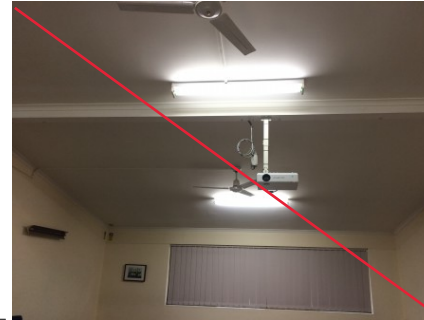
PHOTO NO.: J154900-001-PHOTO154
 RESULT: **ASBESTOS - PRESUMED POSITIVE**
 BUILDING/LEVEL: AMENITIES BUILDING - LEVEL ONE
 ROOM/LOCATION: CONFERENCE ROOM - THROUGHOUT
 FEATURE/MATERIAL: CEILING - FIBRE CEMENT SHEETING
 SAMPLE NO.: SIMILAR TO: J154900-001-006

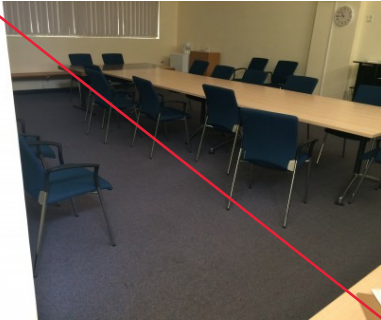
PHOTO NO.: J154900-001-PHOTO160
 RESULT: **ASBESTOS - POSITIVE**
 BUILDING/LEVEL: AMENITIES BUILDING - LEVEL ONE
 ROOM/LOCATION: CONFERENCE ROOM - THROUGHOUT
 FEATURE/MATERIAL: FLOOR COVERING - VINYL TILES & ADHESIVE
 SAMPLE NO.: PREVIOUSLY SAMPLED REGIONAL ENVIROSCIENCE B17336-S14

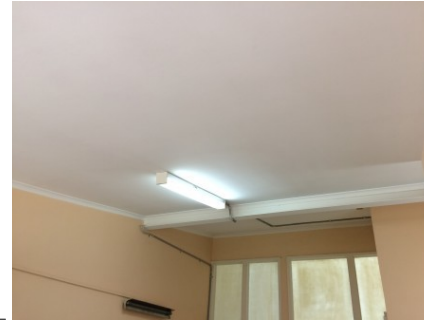
Female Toilet - East Wall - Fibre Cement Sheeting - East, west and north walls are visually similar. 1696	Asbestos	J154900-001-003	Negative											
Female Toilet - Throughout Ceiling - Fibre Cement Sheeting 1697	Asbestos	Similar To:- J154900-001-006	Presumed-Positive	J154900-001-Photo155	5-m ²	Good	Non-Friable	Low	Low	Suspect	29/01/2023	P4	Maintain in current condition and incorporate into an AMP. Remove by licensed asbestos contractor prior to demolition or refurbishment.	Item removed Refer to Clearance certificate Greencap Reference May 2018 J155165-02
Hand Wash Area (within Female Change Room) - East Wall - Fibre Cement Sheeting - East and west walls. 1698	Asbestos	J154900-001-004	Negative											
Hand Wash Area (within Female Change Room) - Throughout Ceiling - Fibre Cement Sheeting 1700	Asbestos	J154900-001-006	Positive	J154900-001-Photo156	5-m ²	Good	Non-Friable	Low	Low	Suspect	29/01/2023	P4	Maintain in current condition and incorporate into an AMP. Remove by licensed asbestos contractor prior to demolition or refurbishment.	Item removed Refer to Clearance certificate Greencap Reference May 2018 J155165-02

PHOTO NO.: ~~J154900-001-PHOTO155~~
 RESULT: ~~ASBESTOS - PRESUMED POSITIVE~~
 BUILDING/LEVEL: ~~AMENITIES BUILDING - LEVEL ONE~~
 ROOM/LOCATION: ~~FEMALE TOILET - THROUGHOUT~~
 FEATURE/MATERIAL: ~~CEILING - FIBRE CEMENT SHEETING~~
 SAMPLE NO.: ~~SIMILAR TO: J154900-001-006~~

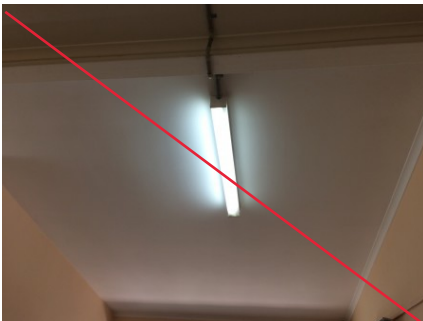
PHOTO NO.: J154900-001-PHOTO156
 RESULT: **ASBESTOS - POSITIVE**
 BUILDING/LEVEL: AMENITIES BUILDING - LEVEL ONE
 ROOM/LOCATION: HAND WASH AREA (WITHIN FEMALE CHANGE ROOM) - THROUGHOUT
 FEATURE/MATERIAL: CEILING - FIBRE CEMENT SHEETING
 SAMPLE NO.: J154900-001-006

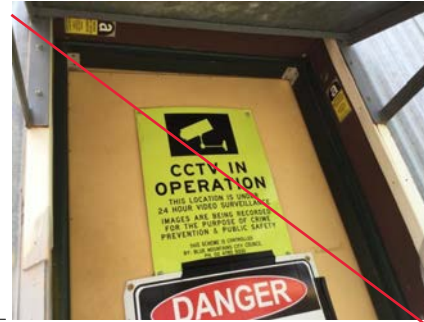
PHOTO NO.: J154900-001-PHOTO082
 RESULT: ASBESTOS - POSITIVE
 BUILDING/LEVEL: ADMINISTRATION BUILDING - GROUND LEVEL
 ROOM/LOCATION: EXTERIOR - SOUTHEAST
 FEATURE/MATERIAL: INFILL PANELS - FIBRE CEMENT SHEETING
 SAMPLE NO.: PREVIOUSLY SAMPLED REGIONAL ENVIROSCIENCE B17336-S07

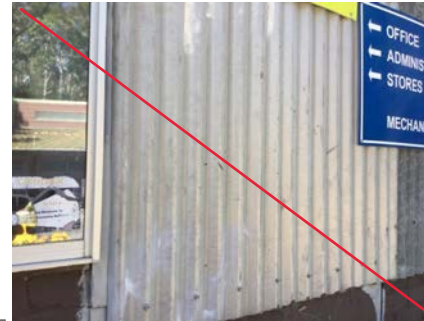
PHOTO NO.: J154900-001-PHOTO038
 RESULT: ASBESTOS - POSITIVE
 BUILDING/LEVEL: ADMINISTRATION BUILDING - GROUND LEVEL
 ROOM/LOCATION: EXTERIOR - SOUTHWEST
 FEATURE/MATERIAL: WALL LINING - FIBRE CEMENT SHEETING
 SAMPLE NO.: J154900-001-029

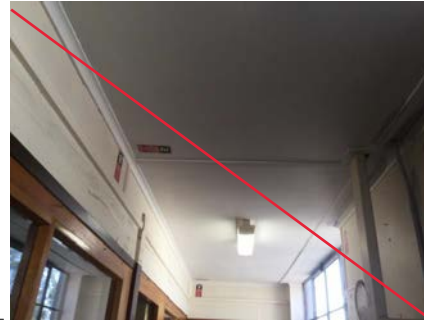
PHOTO NO.: J154900-001-PHOTO007
 RESULT: ASBESTOS - POSITIVE
 BUILDING/LEVEL: ADMINISTRATION BUILDING - GROUND LEVEL
 ROOM/LOCATION: HALLWAY - SOUTHERN OFFICE - THROUGHOUT
 FEATURE/MATERIAL: CEILING - FIBRE CEMENT SHEETING
 SAMPLE NO.: PREVIOUSLY SAMPLED REGIONAL ENVIROSCIENCE B17336-S10

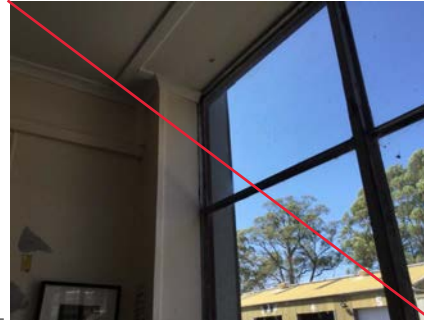
PHOTO NO.: J154900-001-PHOTO033
 RESULT: ASBESTOS - POSITIVE
 BUILDING/LEVEL: ADMINISTRATION BUILDING - GROUND LEVEL
 ROOM/LOCATION: HALLWAY - SOUTHERN OFFICE - VARIOUS THROUGHOUT
 FEATURE/MATERIAL: WALL - FIBRE CEMENT SHEETING
 SAMPLE NO.: PREVIOUSLY SAMPLED REGIONAL ENVIROSCIENCE B17336-S09

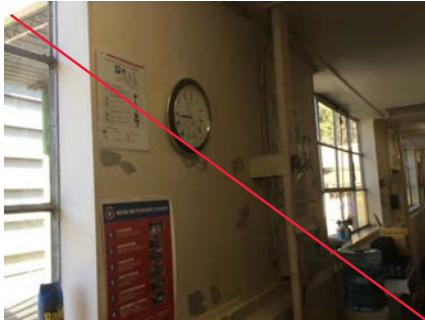
PHOTO NO.: J154900-001-PHOTO005
 RESULT: **ASBESTOS - POSITIVE**
 BUILDING/LEVEL: **ADMINISTRATION BUILDING - GROUND LEVEL**
 ROOM/LOCATION: **HALLWAY - SOUTHERN OFFICE - VARIOUS THROUGHOUT**
 FEATURE/MATERIAL: **WALL - FIBRE CEMENT SHEETING**
 SAMPLE NO.: **PREVIOUSLY SAMPLED REGIONAL ENVIROSCIENCE B17336-S09**

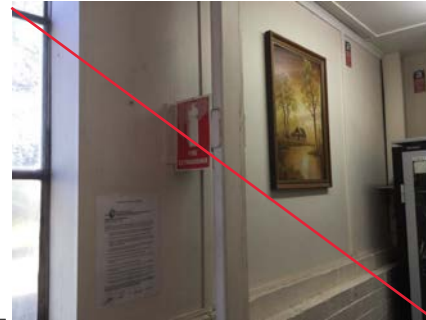
PHOTO NO.: J154900-001-PHOTO002
 RESULT: **ASBESTOS - POSITIVE**
 BUILDING/LEVEL: **ADMINISTRATION BUILDING - GROUND LEVEL**
 ROOM/LOCATION: **HALLWAY - SOUTHERN OFFICE - VARIOUS THROUGHOUT**
 FEATURE/MATERIAL: **WALL - FIBRE CEMENT SHEETING**
 SAMPLE NO.: **PREVIOUSLY SAMPLED REGIONAL ENVIROSCIENCE B17336-S09**

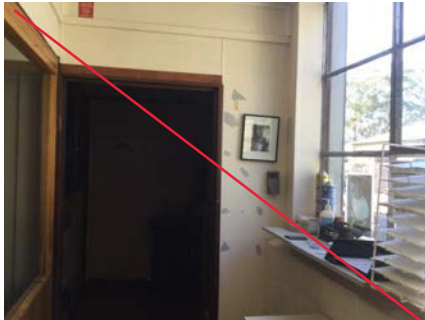
PHOTO NO.: J154900-001-PHOTO004
 RESULT: **ASBESTOS - POSITIVE**
 BUILDING/LEVEL: **ADMINISTRATION BUILDING - GROUND LEVEL**
 ROOM/LOCATION: **HALLWAY - SOUTHERN OFFICE - VARIOUS THROUGHOUT**
 FEATURE/MATERIAL: **WALL - FIBRE CEMENT SHEETING**
 SAMPLE NO.: **PREVIOUSLY SAMPLED REGIONAL ENVIROSCIENCE B17336-S09**

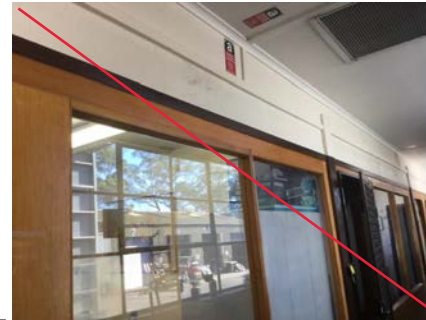
PHOTO NO.: J154900-001-PHOTO003
 RESULT: **ASBESTOS - POSITIVE**
 BUILDING/LEVEL: **ADMINISTRATION BUILDING - GROUND LEVEL**
 ROOM/LOCATION: **HALLWAY - SOUTHERN OFFICE - VARIOUS THROUGHOUT**
 FEATURE/MATERIAL: **WALL - FIBRE CEMENT SHEETING**
 SAMPLE NO.: **PREVIOUSLY SAMPLED REGIONAL ENVIROSCIENCE B17336-S09**

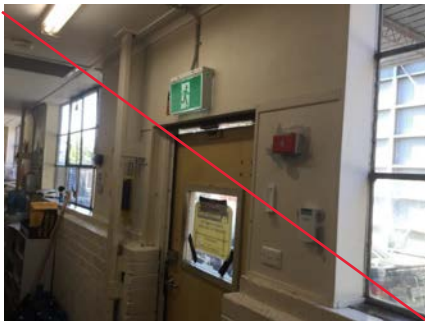
PHOTO NO.: J154900-001-PHOTO001
 RESULT: **ASBESTOS - POSITIVE**
 BUILDING/LEVEL: **ADMINISTRATION BUILDING - GROUND LEVEL**
 ROOM/LOCATION: **HALLWAY - SOUTHERN OFFICE - VARIOUS THROUGHOUT**
 FEATURE/MATERIAL: **WALL - FIBRE CEMENT SHEETING**
 SAMPLE NO.: **PREVIOUSLY SAMPLED REGIONAL ENVIROSCIENCE B17336-S09**

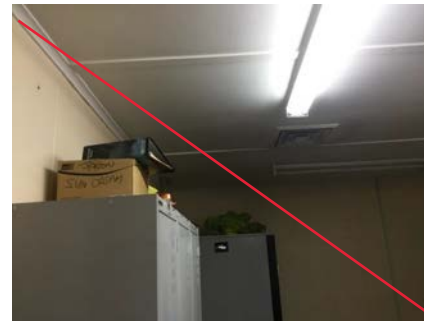
PHOTO NO.: J154900-001-PHOTO011
 RESULT: ASBESTOS - POSITIVE
 BUILDING/LEVEL: ADMINISTRATION BUILDING - GROUND LEVEL
 ROOM/LOCATION: SOUTHERN OFFICE - PRINTER ROOM - VARIOUS THROUGHOUT
 FEATURE/MATERIAL: CEILING - FIBRE CEMENT SHEETING
 SAMPLE NO.: PREVIOUSLY SAMPLED REGIONAL ENVIROSCIENCE B17336-S10

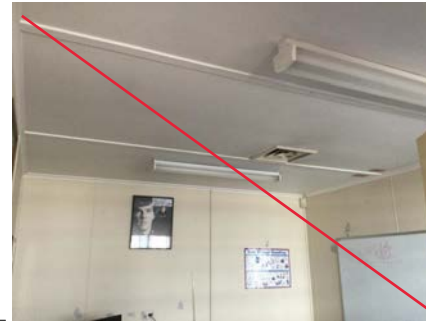
PHOTO NO.: J154900-001-PHOTO009
 RESULT: **ASBESTOS - POSITIVE**
 BUILDING/LEVEL: **ADMINISTRATION BUILDING - GROUND LEVEL**
 ROOM/LOCATION: **SOUTHERN OFFICE - WASTE KERBSIDE/ADMIN OFFICE - VARIOUS THROUGHOUT**
 FEATURE/MATERIAL: **CEILING - FIBRE CEMENT SHEETING**
 SAMPLE NO.: **PREVIOUSLY SAMPLED REGIONAL ENVIROSCIENCE B17336-S10**

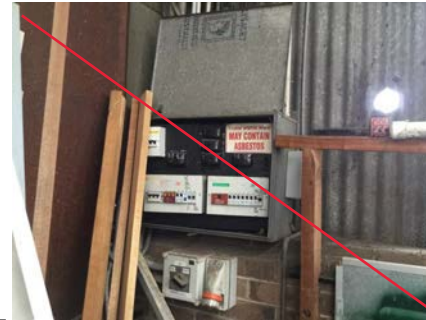
PHOTO NO.: J154900-001-PHOTO041
 RESULT: **ASBESTOS - POSITIVE**
 BUILDING/LEVEL: **ADMINISTRATION BUILDING - GROUND LEVEL**
 ROOM/LOCATION: **STORE SHED - NORTHEAST**
 FEATURE/MATERIAL: **ELECTRICAL - SWITCH BOARD - COMPRESSED BITUMINOUS ELECTRICAL PANEL**
 SAMPLE NO.: **SIMILAR TO: J154900-001-038**

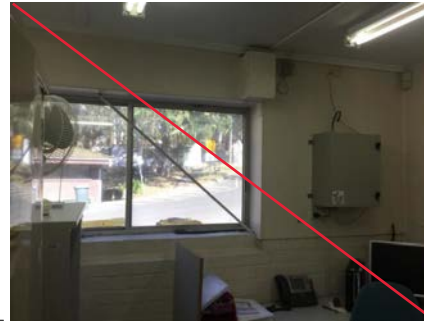
PHOTO NO.: J154900-001-PHOTO015
 RESULT: ASBESTOS - POSITIVE
 BUILDING/LEVEL: ADMINISTRATION BUILDING - GROUND LEVEL
 ROOM/LOCATION: WASTE SERVICES OFFICE - HUMAN RESOURCES ROOM - WEST
 FEATURE/MATERIAL: WALL LINING - FIBRE CEMENT SHEETING
 SAMPLE NO.: J154900-001-024

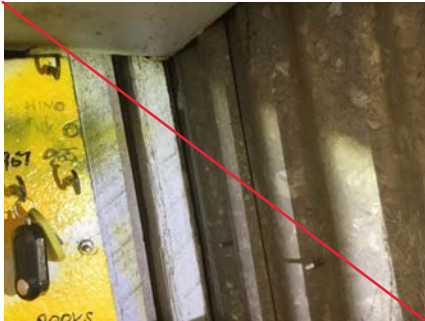
PHOTO NO.: J154900-001-PHOTO026
 RESULT: ASBESTOS - PRESUMED POSITIVE
 BUILDING/LEVEL: ADMINISTRATION BUILDING - GROUND LEVEL
 ROOM/LOCATION: WASTE SERVICES OFFICE - KEY RETURN AREA - SOUTH
 FEATURE/MATERIAL: WALL - FIBRE CEMENT SHEETING
 SAMPLE NO.: SIMILAR TO: J154900-001-026

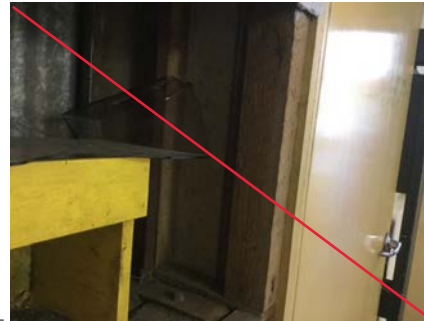
PHOTO NO.: J154900-001-PHOTO024
 RESULT: ASBESTOS - PRESUMED POSITIVE
 BUILDING/LEVEL: ADMINISTRATION BUILDING - GROUND LEVEL
 ROOM/LOCATION: WASTE SERVICES OFFICE - KEY RETURN AREA - SOUTH
 FEATURE/MATERIAL: WALL - FIBRE CEMENT SHEETING
 SAMPLE NO.: SIMILAR TO: J154900-001-026

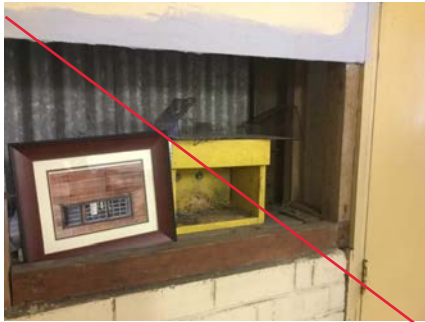
PHOTO NO.: J154900-001-PHOTO023
 RESULT: ASBESTOS - PRESUMED POSITIVE
 BUILDING/LEVEL: ADMINISTRATION BUILDING - GROUND LEVEL
 ROOM/LOCATION: WASTE SERVICES OFFICE - KEY RETURN AREA - SOUTH
 FEATURE/MATERIAL: WALL - FIBRE CEMENT SHEETING
 SAMPLE NO.: SIMILAR TO: J154900-001-026

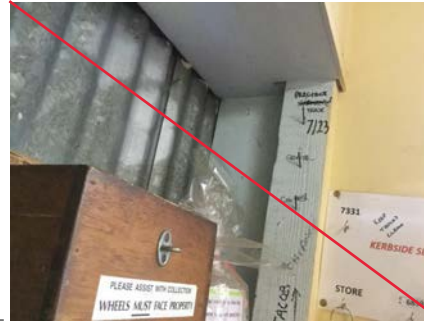
PHOTO NO.: J154900-001-PHOTO025
 RESULT: ASBESTOS - PRESUMED POSITIVE
 BUILDING/LEVEL: ADMINISTRATION BUILDING - GROUND LEVEL
 ROOM/LOCATION: WASTE SERVICES OFFICE - KEY RETURN AREA - SOUTH
 FEATURE/MATERIAL: WALL - FIBRE CEMENT SHEETING
 SAMPLE NO.: SIMILAR TO: J154900-001-026

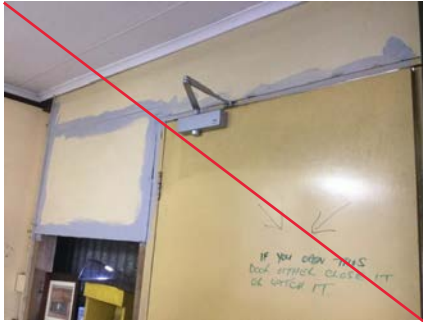
PHOTO NO.: J154900-001-PHOTO021
 RESULT: **ASBESTOS - POSITIVE**
 BUILDING/LEVEL: **ADMINISTRATION BUILDING - GROUND LEVEL**
 ROOM/LOCATION: **WASTE SERVICES OFFICE - KEY RETURN AREA - SOUTH**
 FEATURE/MATERIAL: **WALL - FIBRE CEMENT SHEETING**
 SAMPLE NO.: **J154900-001-026**

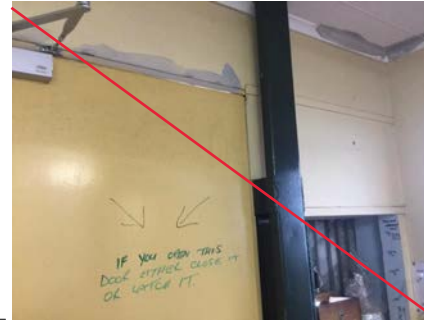
PHOTO NO.: J154900-001-PHOTO022
 RESULT: **ASBESTOS - POSITIVE**
 BUILDING/LEVEL: **ADMINISTRATION BUILDING - GROUND LEVEL**
 ROOM/LOCATION: **WASTE SERVICES OFFICE - KEY RETURN AREA - SOUTH**
 FEATURE/MATERIAL: **WALL - FIBRE CEMENT SHEETING**
 SAMPLE NO.: **J154900-001-026**

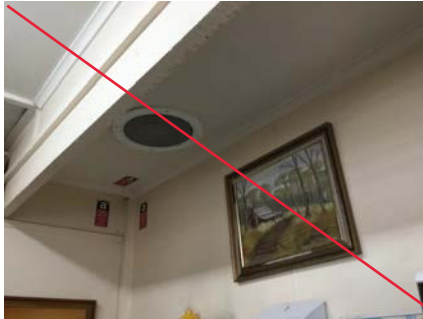
PHOTO NO.: J154900-001-PHOTO029
 RESULT: **ASBESTOS - PREVIOUSLY SAMPLED POSITIVE**
 BUILDING/LEVEL: **ADMINISTRATION BUILDING - GROUND LEVEL**
 ROOM/LOCATION: **WASTE SERVICES OFFICE - KITCHENETTE - THROUGHOUT**
 FEATURE/MATERIAL: **CEILING - FIBRE CEMENT SHEETING**
 SAMPLE NO.: **PREVIOUSLY SAMPLED REGIONAL ENVIROSCIENCE B17336-S10**

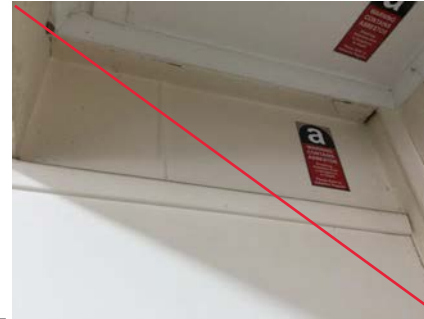
PHOTO NO.: J154900-001-PHOTO030
 RESULT: **ASBESTOS - POSITIVE**
 BUILDING/LEVEL: **ADMINISTRATION BUILDING - GROUND LEVEL**
 ROOM/LOCATION: **WASTE SERVICES OFFICE - KITCHENETTE - WEST**
 FEATURE/MATERIAL: **WALL - FIBRE CEMENT SHEETING**
 SAMPLE NO.: **PREVIOUSLY SAMPLED REGIONAL ENVIROSCIENCE B17336-S09**

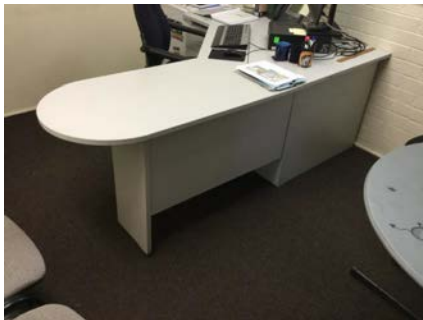
PHOTO NO.: J154900-001-PHOTO027
 RESULT: **ASBESTOS - PRESUMED NEGATIVE**
 BUILDING/LEVEL: **ADMINISTRATION BUILDING - GROUND LEVEL**
 ROOM/LOCATION: **WASTE SERVICES OFFICE - TRUCKS COORDINATOR ROOM - THROUGHOUT**
 FEATURE/MATERIAL: **FLOOR COVERING - VINYL TILES & ADHESIVE**
 SAMPLE NO.: **SIMILAR TO: J154900-001-023**

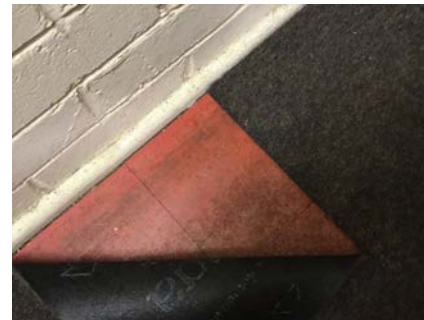
PHOTO NO.: J154900-001-PHOTO028
 RESULT: **ASBESTOS - PRESUMED NEGATIVE**
 BUILDING/LEVEL: **ADMINISTRATION BUILDING - GROUND LEVEL**
 ROOM/LOCATION: **WASTE SERVICES OFFICE - TRUCKS COORDINATOR ROOM - THROUGHOUT**
 FEATURE/MATERIAL: **FLOOR COVERING - VINYL TILES & ADHESIVE**
 SAMPLE NO.: **SIMILAR TO: J154900-001-023**

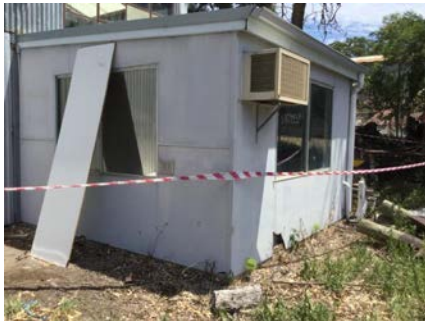
PHOTO NO.: J154900-001-PHOTO066
 RESULT: ASBESTOS - NEGATIVE
 BUILDING/LEVEL: TRADES SHED - GROUND LEVEL
 ROOM/LOCATION: MEALS ROOM - THROUGHOUT
 FEATURE/MATERIAL: WALL - FIBRE CEMENT SHEETING
 SAMPLE NO.: J154900-001-035

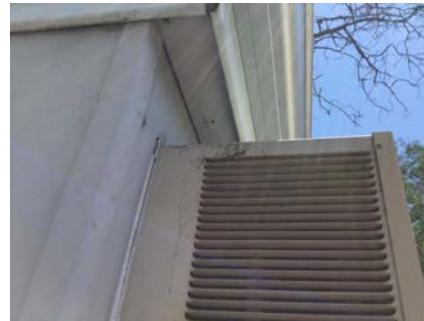
PHOTO NO.: J154900-001-PHOTO067
 RESULT: ASBESTOS - NEGATIVE
 BUILDING/LEVEL: TRADES SHED - GROUND LEVEL
 ROOM/LOCATION: MEALS ROOM - THROUGHOUT
 FEATURE/MATERIAL: WALL - FIBRE CEMENT SHEETING
 SAMPLE NO.: J154900-001-035

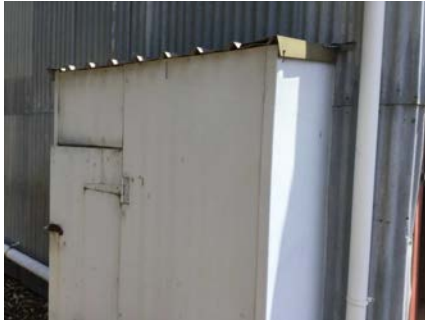
PHOTO NO.: J154900-001-PHOTO068
 RESULT: ASBESTOS - NEGATIVE
 BUILDING/LEVEL: TRADES SHED - GROUND LEVEL
 ROOM/LOCATION: PUMP SHED - SOUTHEAST - THROUGHOUT
 FEATURE/MATERIAL: WALL - FIBRE CEMENT SHEETING
 SAMPLE NO.: J154900-001-036

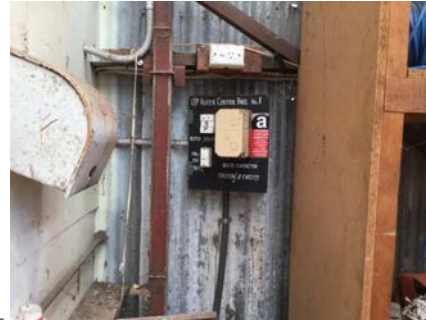
PHOTO NO.: J154900-001-PHOTO070
 RESULT: ASBESTOS - PRESUMED POSITIVE
 BUILDING/LEVEL: TRADES SHED - GROUND LEVEL
 ROOM/LOCATION: MAIN SHED - WEST
 FEATURE/MATERIAL: ELECTRICAL - SWITCH BOARD - COMPRESSED BITUMINOUS ELECTRICAL PANEL
 SAMPLE NO.: SIMILAR TO: J154900-001-038

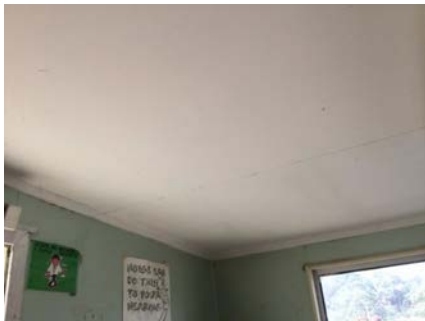
PHOTO NO.: J154900-001-PHOTO076
 RESULT: ASBESTOS - NEGATIVE
 BUILDING/LEVEL: TRADES SHED - GROUND LEVEL
 ROOM/LOCATION: MEALS ROOM - THROUGHOUT
 FEATURE/MATERIAL: CEILING - FIBRE CEMENT SHEETING
 SAMPLE NO.: J154900-001-041

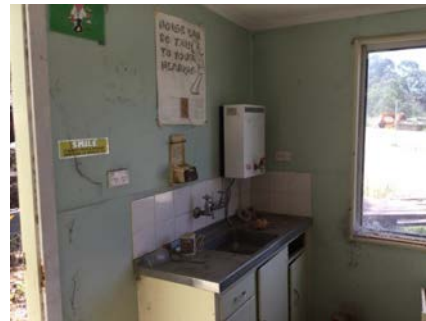
PHOTO NO.: J154900-001-PHOTO075
 RESULT: ASBESTOS - NEGATIVE
 BUILDING/LEVEL: TRADES SHED - GROUND LEVEL
 ROOM/LOCATION: MEALS ROOM - THROUGHOUT
 FEATURE/MATERIAL: WALL - FIBRE CEMENT SHEETING
 SAMPLE NO.: J154900-001-040

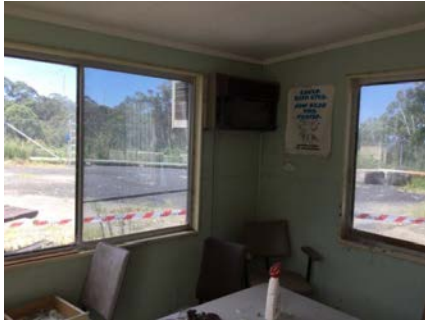
PHOTO NO.: J154900-001-PHOTO074
 RESULT: ASBESTOS - NEGATIVE
 BUILDING/LEVEL: TRADES SHED - GROUND LEVEL
 ROOM/LOCATION: MEALS ROOM - THROUGHOUT
 FEATURE/MATERIAL: WALL - FIBRE CEMENT SHEETING
 SAMPLE NO.: J154900-001-040

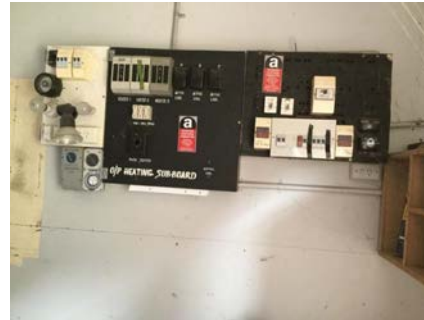
PHOTO NO.: J154900-001-PHOTO071
 RESULT: ASBESTOS - PRESUMED POSITIVE
 BUILDING/LEVEL: TRADES SHED - GROUND LEVEL
 ROOM/LOCATION: OFFICE/STORE - NORTHWEST - WEST
 FEATURE/MATERIAL: ELECTRICAL - SWITCH BOARD - COMPRESSED BITUMINOUS ELECTRICAL PANEL
 SAMPLE NO.: SIMILAR TO: J154900-001-038

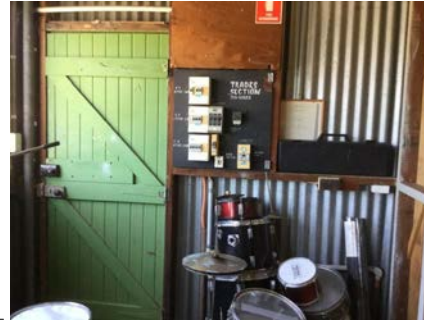
PHOTO NO.: J154900-001-PHOTO062
 RESULT: ASBESTOS - NEGATIVE
 BUILDING/LEVEL: GARDENERS SHED - GROUND LEVEL
 ROOM/LOCATION: LUNCH AREA - SOUTHEAST
 FEATURE/MATERIAL: ELECTRICAL - SWITCH BOARD - COMPRESSED BITUMINOUS ELECTRICAL PANEL
 SAMPLE NO.: J154900-001-034

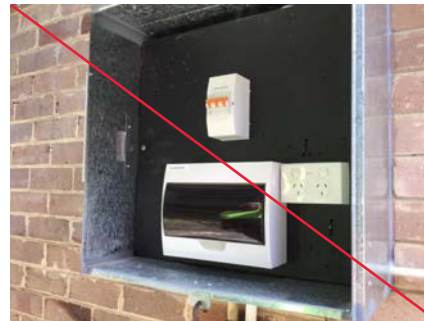
PHOTO NO.: J154900-001-PHOTO088
 RESULT: ASBESTOS - PRESUMED POSITIVE
 BUILDING/LEVEL: STORAGE SHED - GROUND LEVEL
 ROOM/LOCATION: EXTERIOR - NORTH
 FEATURE/MATERIAL: ELECTRICAL - SWITCH BOARD - COMPRESSED BITUMINOUS ELECTRICAL PANEL
 SAMPLE NO.: SIMILAR TO:

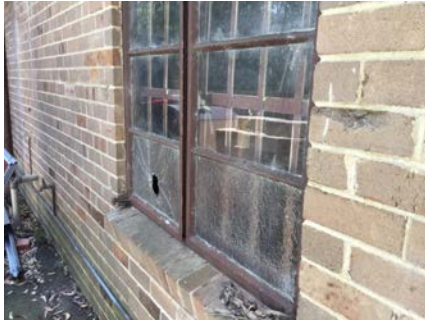
PHOTO NO.: J154900-001-PHOTO094
 RESULT: **ASBESTOS - NEGATIVE**
 BUILDING/LEVEL: **STORAGE SHED - GROUND LEVEL**
 ROOM/LOCATION: **EXTERIOR - SOUTH**
 FEATURE/MATERIAL: **WINDOW FRAMES - PUTTY**
 SAMPLE NO.: **J154900-001-042**

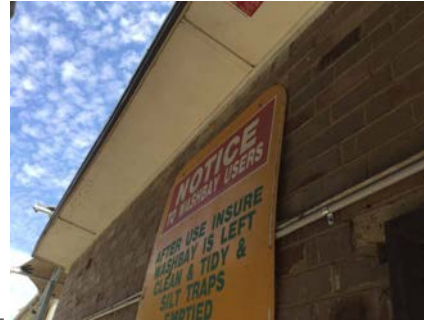
PHOTO NO.: J154900-001-PHOTO084
 RESULT: **ASBESTOS - POSITIVE**
 BUILDING/LEVEL: **STORAGE SHED - GROUND LEVEL**
 ROOM/LOCATION: **EXTERIOR - VARIOUS THROUGHOUT**
 FEATURE/MATERIAL: **EAVES - FIBRE CEMENT SHEETING**
 SAMPLE NO.: **PREVIOUSLY SAMPLED REGIONAL ENVIROSCIENCE B17336-S19**

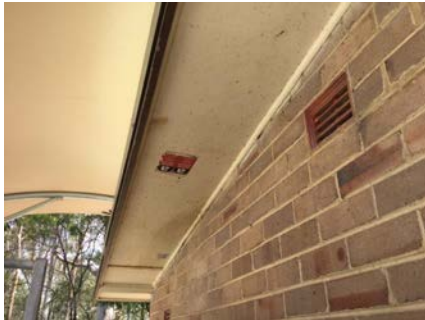
PHOTO NO.: J154900-001-PHOTO085
 RESULT: **ASBESTOS - POSITIVE**
 BUILDING/LEVEL: **STORAGE SHED - GROUND LEVEL**
 ROOM/LOCATION: **EXTERIOR - VARIOUS THROUGHOUT**
 FEATURE/MATERIAL: **EAVES - FIBRE CEMENT SHEETING**
 SAMPLE NO.: **PREVIOUSLY SAMPLED REGIONAL ENVIROSCIENCE B17336-S19**

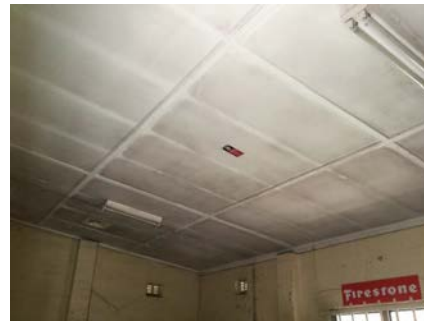
PHOTO NO.: J154900-001-PHOTO086
 RESULT: **ASBESTOS - POSITIVE**
 BUILDING/LEVEL: **STORAGE SHED - GROUND LEVEL**
 ROOM/LOCATION: **EAST STORE ROOM - THROUGHOUT**
 FEATURE/MATERIAL: **CEILING - FIBRE CEMENT SHEETING**
 SAMPLE NO.: **PREVIOUSLY SAMPLED REGIONAL ENVIROSCIENCE B17336-S19**

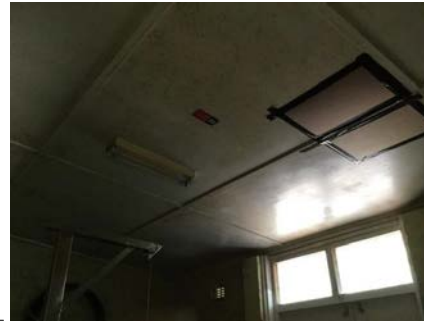
PHOTO NO.: J154900-001-PHOTO090

RESULT: ASBESTOS - POSITIVE

FEATURE/MATERIAL: CEILING - FIBRE CEMENT SHEETING

SAMPLE NO.: PREVIOUSLY SAMPLED REGIONAL ENVIROSCIENCE B17336-S19

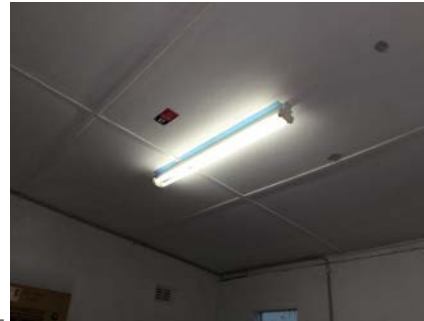
PHOTO NO.: J154900-001-PHOTO093

RESULT: ASBESTOS - POSITIVE

FEATURE/MATERIAL: CEILING - FIBRE CEMENT SHEETING

SAMPLE NO.: PREVIOUSLY SAMPLED REGIONAL ENVIROSCIENCE B17336-S19

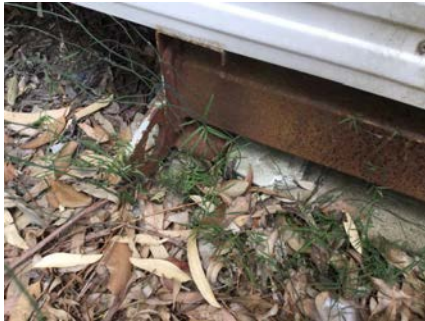
PHOTO NO.: J154900-001-PHOTO103
 RESULT: ASBESTOS - NEGATIVE
 BUILDING/LEVEL: WORKSHOP - GROUND LEVEL
 ROOM/LOCATION: EXTERIOR - SOUTH
 FEATURE/MATERIAL: PACKER - FIBRE CEMENT SHEETING
 SAMPLE NO.: PREVIOUSLY SAMPLED REGIONAL ENVIROSCIENCE B17336-S25

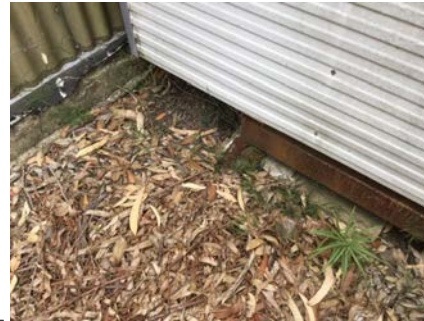
PHOTO NO.: J154900-001-PHOTO102
 RESULT: ASBESTOS - NEGATIVE
 BUILDING/LEVEL: WORKSHOP - GROUND LEVEL
 ROOM/LOCATION: EXTERIOR - SOUTH
 FEATURE/MATERIAL: PACKER - FIBRE CEMENT SHEETING
 SAMPLE NO.: PREVIOUSLY SAMPLED REGIONAL ENVIROSCIENCE B17336-S25

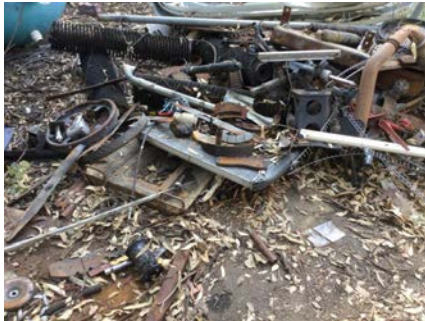
PHOTO NO.: J154900-001-PHOTO115
 RESULT: ASBESTOS - NEGATIVE
 BUILDING/LEVEL: WORKSHOP - GROUND LEVEL
 ROOM/LOCATION: EXTERIOR - SOUTHEAST
 FEATURE/MATERIAL: DUMPED MATERIAL - BRAKE PADS
 SAMPLE NO.: J154900-001-046

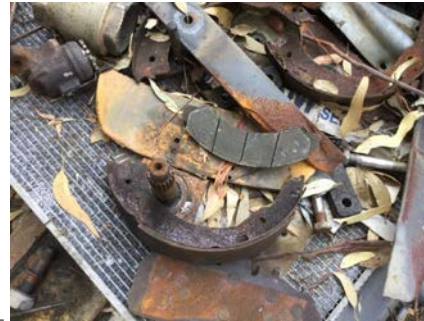
PHOTO NO.: J154900-001-PHOTO116
 RESULT: ASBESTOS - NEGATIVE
 BUILDING/LEVEL: WORKSHOP - GROUND LEVEL
 ROOM/LOCATION: EXTERIOR - SOUTHEAST
 FEATURE/MATERIAL: DUMPED MATERIAL - BRAKE PADS
 SAMPLE NO.: J154900-001-046

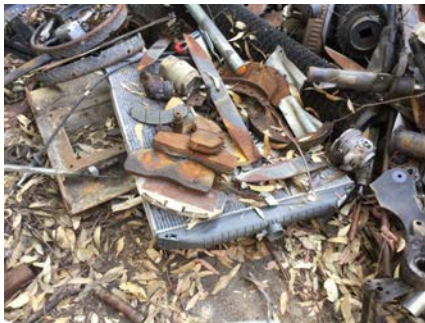
PHOTO NO.: J154900-001-PHOTO117
 RESULT: ASBESTOS - NEGATIVE
 BUILDING/LEVEL: WORKSHOP - GROUND LEVEL
 ROOM/LOCATION: EXTERIOR - SOUTHEAST
 FEATURE/MATERIAL: DUMPED MATERIAL - BRAKE PADS
 SAMPLE NO.: J154900-001-046

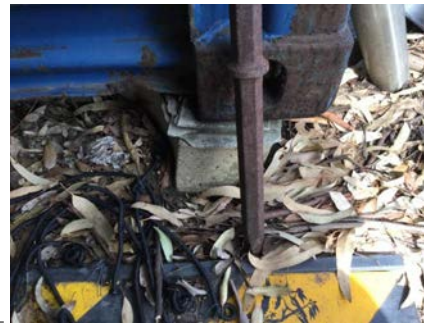
PHOTO NO.: J154900-001-PHOTO123
 RESULT: ASBESTOS - NEGATIVE
 BUILDING/LEVEL: WORKSHOP - GROUND LEVEL
 ROOM/LOCATION: EXTERIOR - SOUTHEAST
 FEATURE/MATERIAL: PACKER - FIBRE CEMENT SHEETING
 SAMPLE NO.: J154900-001-048

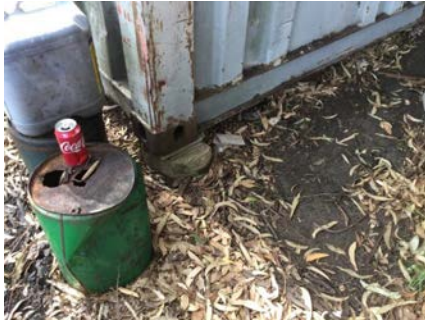
PHOTO NO.: J154900-001-PHOTO122
 RESULT: ASBESTOS - NEGATIVE
 BUILDING/LEVEL: WORKSHOP - GROUND LEVEL
 ROOM/LOCATION: EXTERIOR - SOUTHEAST
 FEATURE/MATERIAL: PACKER - FIBRE CEMENT SHEETING
 SAMPLE NO.: J154900-001-048

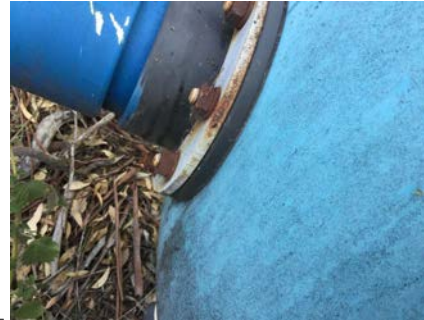
PHOTO NO.: J154900-001-PHOTO120
 RESULT: ASBESTOS - NEGATIVE
 BUILDING/LEVEL: WORKSHOP - GROUND LEVEL
 ROOM/LOCATION: EXTERIOR - SOUTHWEST
 FEATURE/MATERIAL: STORAGE TANK - GASKET
 SAMPLE NO.: J154900-001-047

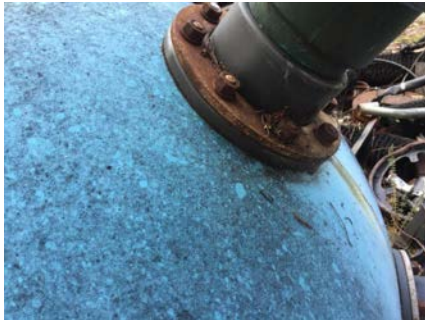
PHOTO NO.: J154900-001-PHOTO121
 RESULT: ASBESTOS - NEGATIVE
 BUILDING/LEVEL: WORKSHOP - GROUND LEVEL
 ROOM/LOCATION: EXTERIOR - SOUTHWEST
 FEATURE/MATERIAL: STORAGE TANK - GASKET
 SAMPLE NO.: J154900-001-047

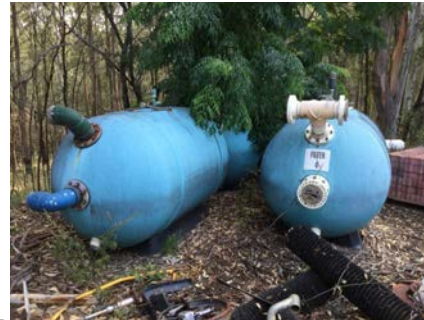
PHOTO NO.: J154900-001-PHOTO118
 RESULT: ASBESTOS - NEGATIVE
 BUILDING/LEVEL: WORKSHOP - GROUND LEVEL
 ROOM/LOCATION: EXTERIOR - SOUTHWEST
 FEATURE/MATERIAL: STORAGE TANK - GASKET
 SAMPLE NO.: J154900-001-047

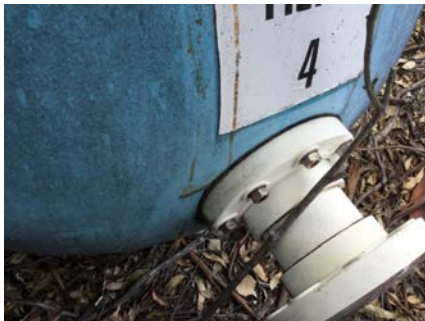
PHOTO NO.: J154900-001-PHOTO119
 RESULT: ASBESTOS - NEGATIVE
 BUILDING/LEVEL: WORKSHOP - GROUND LEVEL
 ROOM/LOCATION: EXTERIOR - SOUTHWEST
 FEATURE/MATERIAL: STORAGE TANK - GASKET
 SAMPLE NO.: J154900-001-047

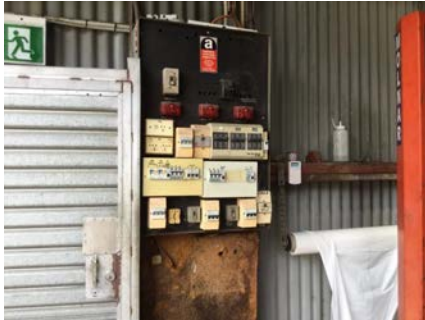
PHOTO NO.: **J154900-001-PHOTO105**
 RESULT: **ASBESTOS - PRESUMED POSITIVE**
 BUILDING/LEVEL: **WORKSHOP - GROUND LEVEL**
 ROOM/LOCATION: **MAIN WORKSHOP - NORTHEAST**
 FEATURE/MATERIAL: **ELECTRICAL - SWITCH BOARD - COMPRESSED BITUMINOUS ELECTRICAL PANEL**
 SAMPLE NO.: **SIMILAR TO: J154900-001-038**
