Asbestos Risk Assessment
Blue Mountains City Council
Springwood Depot - Store, Office and Storage Buildings
2-20 Lawson Road, Springwood NSW 2777

Site Reference: 001

Our Reference : C109993 :

J154900 Date: February 2018

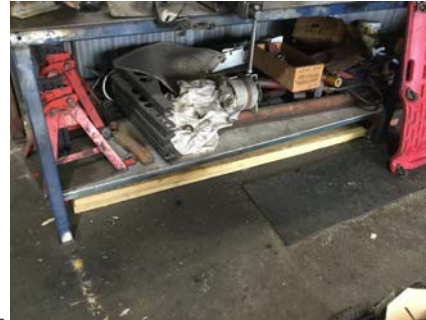
PHOTO NO.: **J154900-001-PHOTO106**
 RESULT: **ASBESTOS - NEGATIVE**
 BUILDING/LEVEL: **WORKSHOP - GROUND LEVEL**
 ROOM/LOCATION: **MAIN WORKSHOP - SOUTH**
 FEATURE/MATERIAL: **BENCH TOP - FIBRE CEMENT SHEETING**
 SAMPLE NO.: **J154900-001-043**

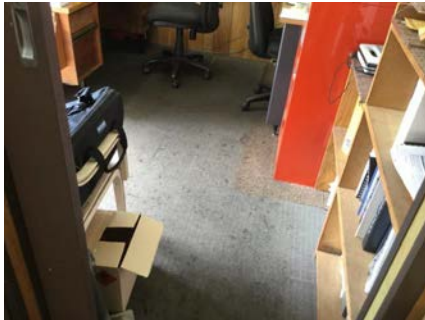
PHOTO NO.: **J154900-001-PHOTO099**
 RESULT: **ASBESTOS - NEGATIVE**
 BUILDING/LEVEL: **WORKSHOP - GROUND LEVEL**
 ROOM/LOCATION: **OFFICE (ADJACENT TEA ROOM) - THROUGHOUT**
 FEATURE/MATERIAL: **FLOOR COVERING - SHEET VINYL**
 SAMPLE NO.: **PREVIOUSLY SAMPLED REGIONAL ENVIROSCIENCE B17336-S24**

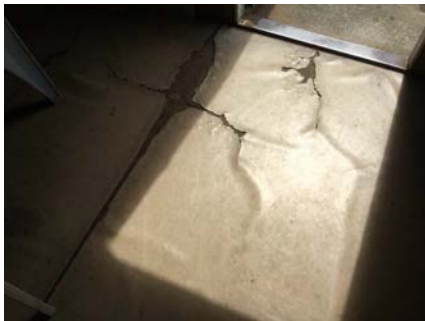
PHOTO NO.: **J154900-001-PHOTO098**
 RESULT: **ASBESTOS - NEGATIVE**
 BUILDING/LEVEL: **WORKSHOP - GROUND LEVEL**
 ROOM/LOCATION: **TEA ROOM - THROUGHOUT**
 FEATURE/MATERIAL: **FLOOR COVERING - SHEET VINYL**
 SAMPLE NO.: **PREVIOUSLY SAMPLED REGIONAL ENVIROSCIENCE B17336-S24**

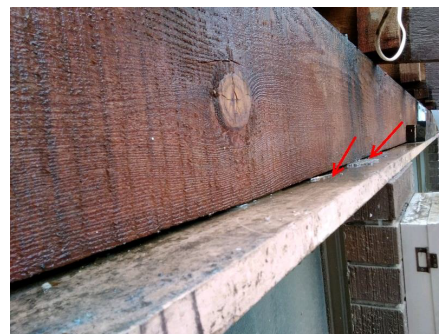
PHOTO NO.: **TRIN01**

RESULT: Assumed Positive
