Asbestos Register

Regional EnviroScience Pty Ltd was requested by Mr. Rick Harris of Blue Mountain City Council to undertake a Hazardous Building Materials Survey and to prepare a Hazardous Materials Register and Management Plan of the Mechanics Workshop, Toilet Block, Halfway House and Golf Cart Shed at the property known as Katoomba Golf Course located at 1-39 Acacia Street, Katoomba, NSW, 2780. The purpose of the audit was to locate and identify asbestos based building materials and product within the building in accordance with the *NSW Work Health and Safety Act and Regulation 2017* and the *Code of Practice; How to Manage and Control Asbestos in the Workplace* [Safe Work Australia: 2016] and the *Code of Practice; How to Safely Remove Asbestos* [Safe Work Australia: 2016].

On the 4th April 2018, an Asbestos Audit was conducted at the Halfway House, Toilet Block, Mechanics Workshop and Golf Cart Shed of the Katoomba Golf Course and asbestos containing materials were found to be present at the premises. Please refer Appendix I for results of products that were considered and consequently analysed but did not contain asbestos.

ASBESTOS MATERIALS REGISTER		ASSET: Katoomba Golf

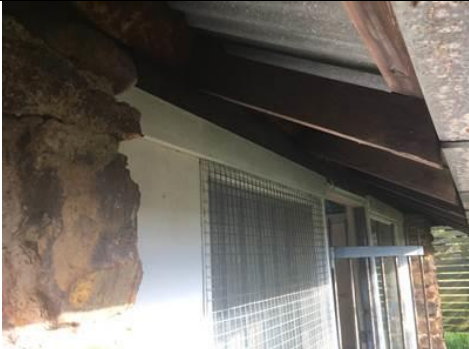
Half-Way House. East Aspect. Exposed Timber Trusses. 2669	No Sample Taken. No Asbestos Containing Materials Sighted.	A5	N/A
4 th April 2018

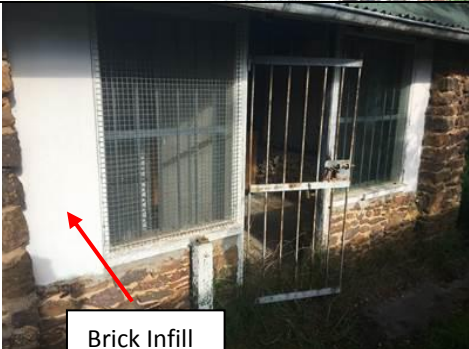
Half-Way House. East Aspect. Rendered Brick Infill. 2670	No Sample Taken. No Asbestos Containing Materials Sighted.	A5	N/A

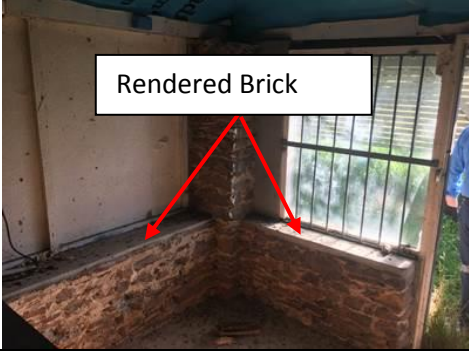
Half-Way House. 600mm up from East & North Wall Rendered Brick Infills.	No Sample Taken. No Asbestos Containing Materials Sighted. 2677	A5	N/A
4 th April 2018

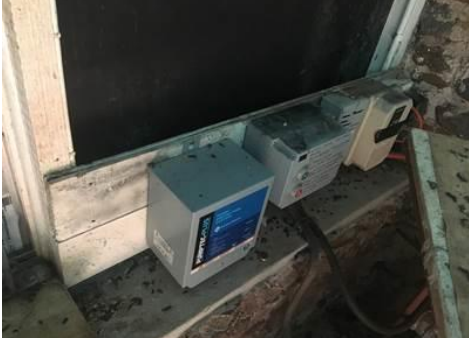
Half-Way House. Electrical Switchboards and Panels on South Wall. 2682	No Sample Taken. No Asbestos Containing Materials Sighted.	A5	N/A

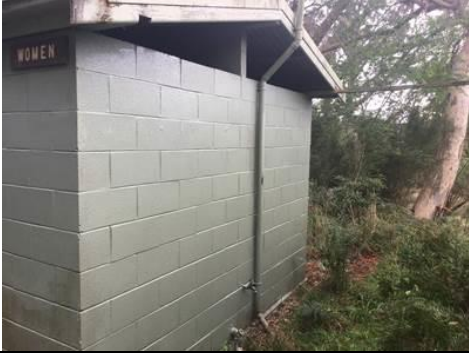
Toilet Block. South-East Aspect Corrugated Iron Roof, Steel Gutters, PVC Downpipe, Timber Fascia, Cement Block Walls, Concrete Floor.	No Sample Taken. No Asbestos Containing Materials Sighted. 2684	A5	N/A
4 th April 2018

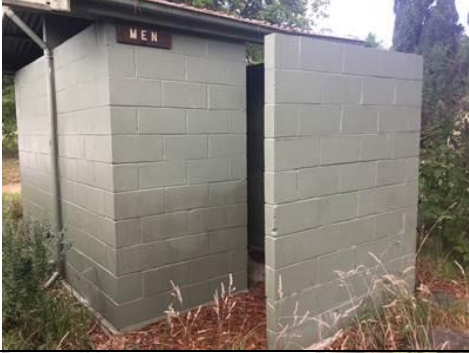
Toilet Block North-East Aspect Corrugated Iron Roof, Steel Gutters, PVC Downpipes, Timber Fascia, Cement Block Walls, Concrete Floor.	No Sample Taken. No Asbestos Containing Materials Sighted. 2685	A5	N/A

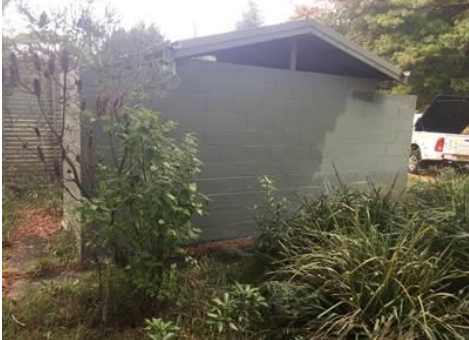
Toilet Block North-West Aspect Corrugated Iron Roof, Steel Gutters, PVC Downpipes, Timber Fascia, Cement Block Walls, Concrete Floor.	No Sample Taken. No Asbestos Containing Materials Sighted. 2686	A5	N/A

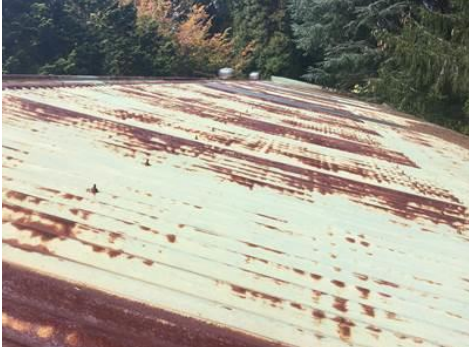
Mechanics Workshop. Roof – North Aspect Corrugated Iron Roofing, Steel Capping & Edging, Steel Guttering.	No Sample Taken. No Asbestos Containing Materials Sighted. 2690	A5	N/A
4 th April 2018

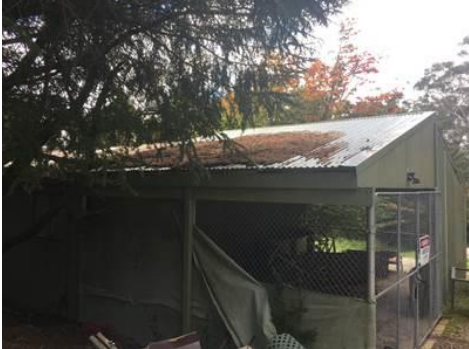
Mechanics Workshop Western Aspect South Extension. Corrugated Iron Roof, Timber Fascia, Steel & Mesh Walls, Timber and Steel Support Posts.	No Sample Taken. No Asbestos Containing Materials Sighted. 2693	A5	N/A
4 th April 2018

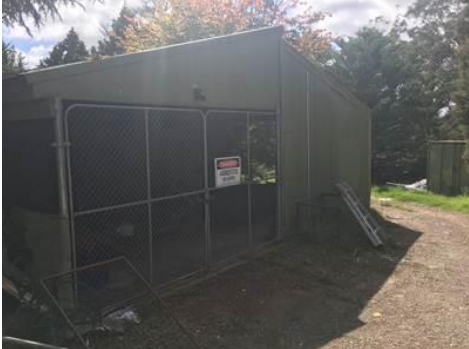
Mechanics Workshop. South Extension. Corrugated Iron Roof and Wall, Steel Capping, 2x Wire Gates, Concrete Floor.	No Sample Taken. No Asbestos Containing Materials Sighted. 2694	A5	N/A
4 th April 2018

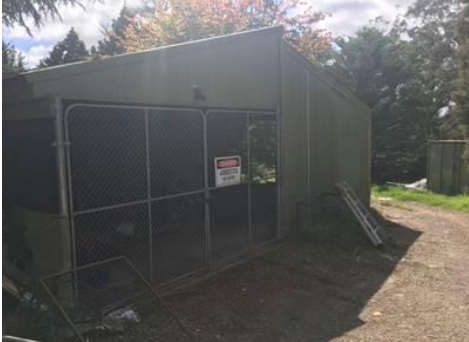
Mechanics Workshop. Southern Extension. Fibre Cement Sheet Gable.	Sample #B18166S06 No Asbestos Detected. 2695	A5	N/A

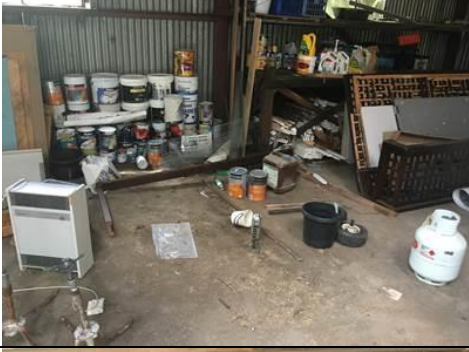
Mechanics Workshop. South End East Wall, Paint & Chemicals. Unknown Types or Quantities. 2702	No Samples Taken. No Asbestos Containing Material Sighted.	A5	N/A
4 th April 2018

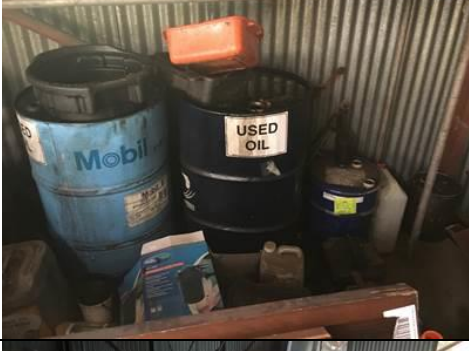
Mechanics Workshop. South End East Wall, Chemical Drums. Unknown Types or Quantities. 2703	No Samples Taken. No Asbestos Containing Material Sighted.	A5	N/A
4 th April 2018

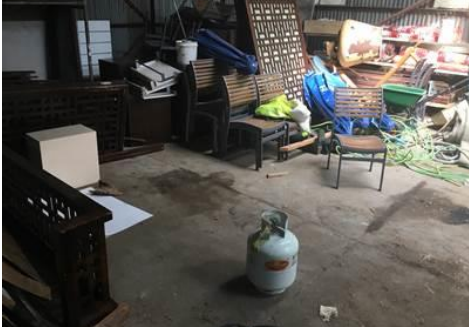
Mechanics Workshop. South End of Workshop. Stored Timber Furniture & Tools. 2704	No Samples Taken. No Asbestos Containing Material Sighted.	A5	N/A

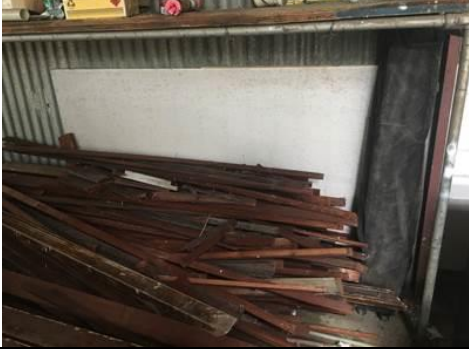
Mechanics Workshop. South End of Workshop. Stockpiled Fibre Cement Sheet. 2706	Similar to Sample #B18166S08 No Asbestos Detected.	A5	N/A
4th April 2018

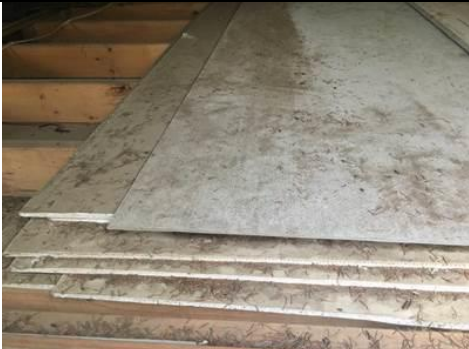
Mechanics Workshop. Southern Roof Aspect of Workshop Rooms. Stockpiled Fibre Cement Sheet. 27016	Sample #B18166S11 No Asbestos Detected.	A5	N/A

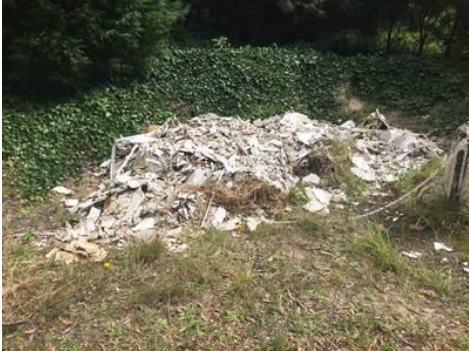
Mechanics Shed. Stockpile 1. Fibre Cement Sheet Debris & Building Material South West of Shed. 2732	No Sample Taken. No Asbestos Containing Materials Sighted.	A5	N/A
4th April 2018

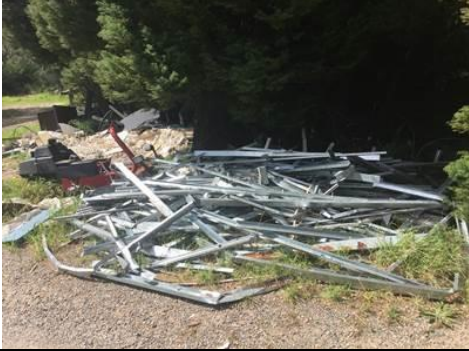
Mechanics Shed. Stockpile 2. Fibre Cement Sheet Debris & Steel Frame-work, South of Shed. 2733	Sample #B18166S15 No Asbestos Detected.	A5	N/A
4th April 2018

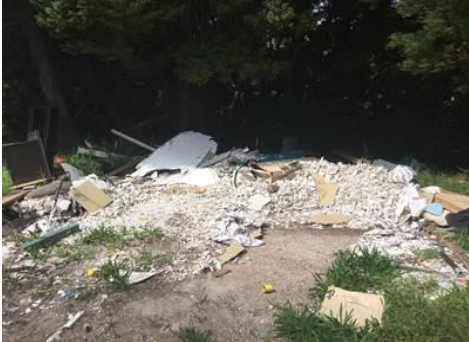
Mechanics Shed. Stockpile 3 Fibre Cement Sheet Debris & Building Debris, South of Shed. 2734	Sample #B18166S16 No Asbestos Detected.	A5	N/A

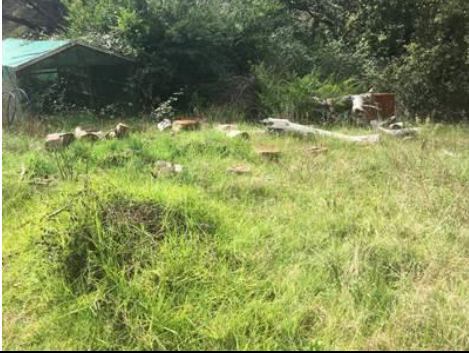
Mechanics Shed. East of Shed. Scattered Building Debris. 2736	No Sample Taken. No Asbestos Containing Materials Sighted.	A5	N/A
4th April 2018

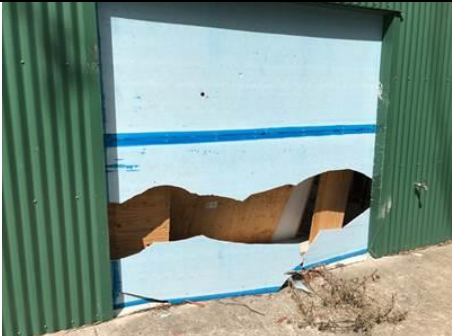
Golf Cart Shed. North Aspect. Fibre Cement Sheet Infill Over Western Roller Door. 2739	Sample #B18166S19 No Asbestos Detected.	A5	N/A
4th April 2018

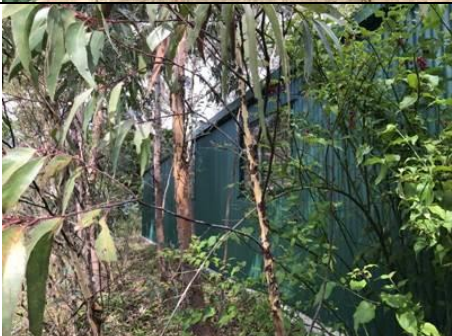
Golf Cart Shed. East Aspect. Corrugated Iron Wall & Roofing, Concrete Slab, Aluminium Window Frames, Steel Guttering. 2740	No Sample Taken. No Asbestos Containing Materials Sighted.	A5	N/A
4th April 2018

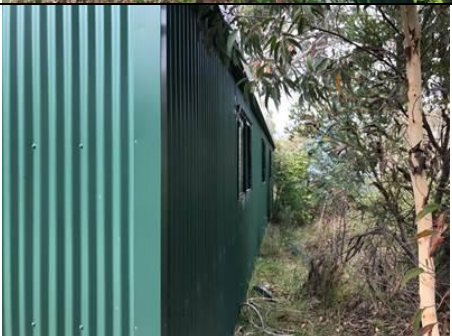
Golf Cart Shed. West Aspect. Corrugated Iron Wall & Roofing, Concrete Slab, Aluminium Window Frames, Steel Guttering. 2741	No Sample Taken. No Asbestos Containing Materials Sighted.	A5	N/A

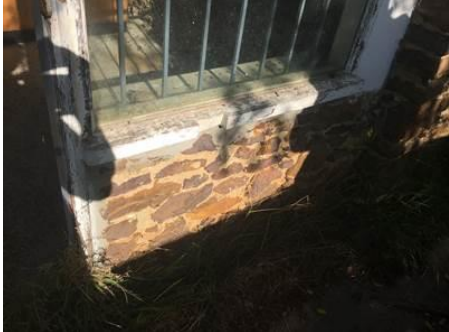
Half-Way House Exterior White Paint	0.1% w/w	A5	Paint not classified as lead based as less than or equal to 0.1% w/w
18166- S02 (189151-2)

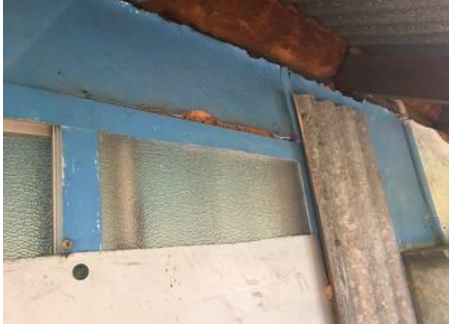
Half-Way House Exterior Blue Paint	<0.05 % w/w	A5	Paint not classified as lead based as less than or equal to 0.1% w/w

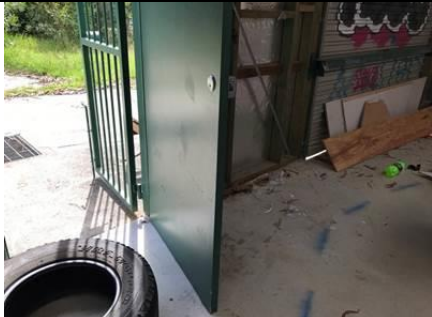
Golf Cart Shed. Green Paint	<0.05 % w/w	A5	Paint not classified as lead based as less than or equal to 0.1% w/w

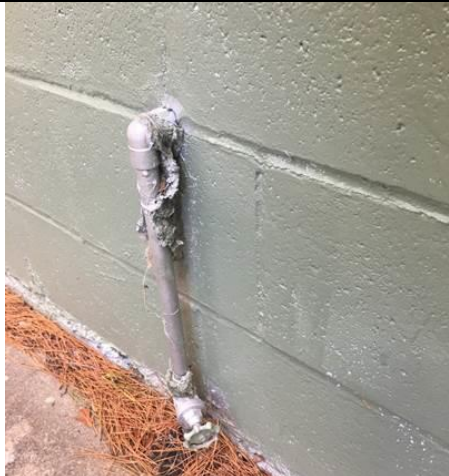
Toilet Block External. North West Aspect. SMF Lagged Piping. Approx. 0.02m ²	Visual Inspection.	A2	Poor Condition Accessible to Tradespeople Refer to Management Plan.

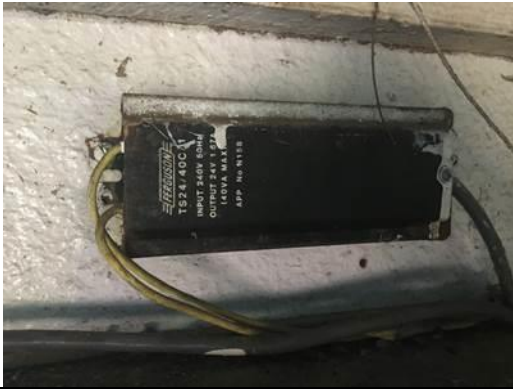
Half-Way House. Western Wall. Ferguson TS24 Type Capacitor.	Visual Observation Assume PCB's Present.	A4	Good Condition Accessible to Tradespeople Refer to Management Plan.
4 th April 2018

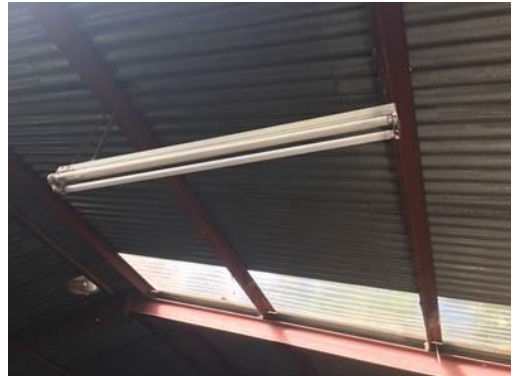
Mechanics Workshop. 5x Double Fluorescent Light Assembly.	Visual Observation No PCB's Present.	A5	N/A
4 th April 2018

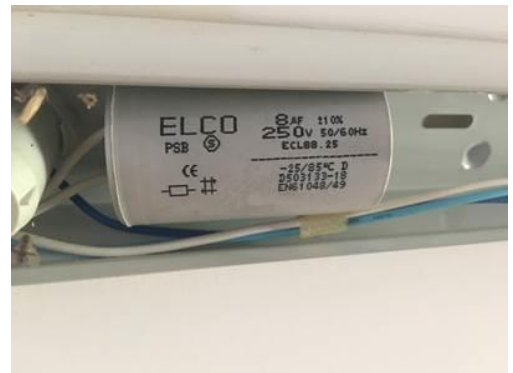
Mechanics Workshop. 1x Single Fluorescent Light Assembly.	Visual Observation Elco PSB Type Capacitor. No PCB's Present.	A5	N/A

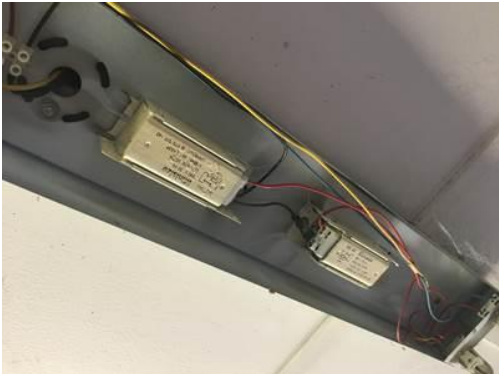
Mechanics Workshop. Welding Room. Double Fluorescent Light Assembly	Visual Observation No PCB's Present.	A5	N/A

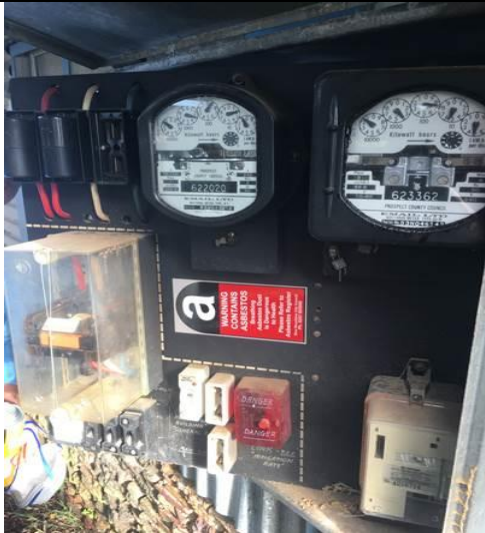
Half-Way House 'Lebah' Type Electrical Bakelite Backing Board.	Visual Inspection Assume Contains Phenols.	A4	Good Condition Accessible to Tradespeople Refer to Management Plan
4 th April 2018

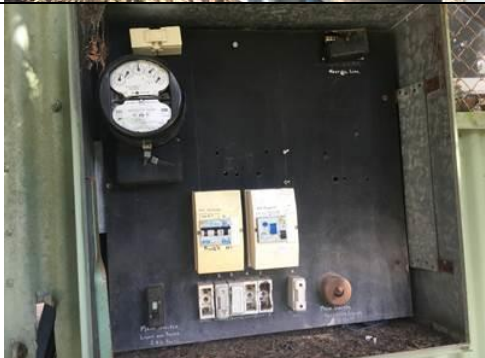
Mechanics Workshop East Aspect Electrical Bakelite Backing Board.	Visual Inspection Assume Contains Phenols.	A4	Good Condition Accessible to Tradespeople Refer to Management Plan
