Asbestos Register

Asbestos/Lead Register & Management Plan

Blue Mountains City Council conducted Hazardous Materials Management Register for the workplace located at 31 Waratah Street Katoomba NSW 2780.

REPORT TYPE	Hazardous Materials Management Register
THE CLIENT	Blue Mountains City Council
AREA COVERED BY THE SCOPE	Internal & external areas of building
LEAD SURVEYOR	Luke Trevena
ASSISTANT SURVERYOR	-
INSPECTION DATE	23/11/2022

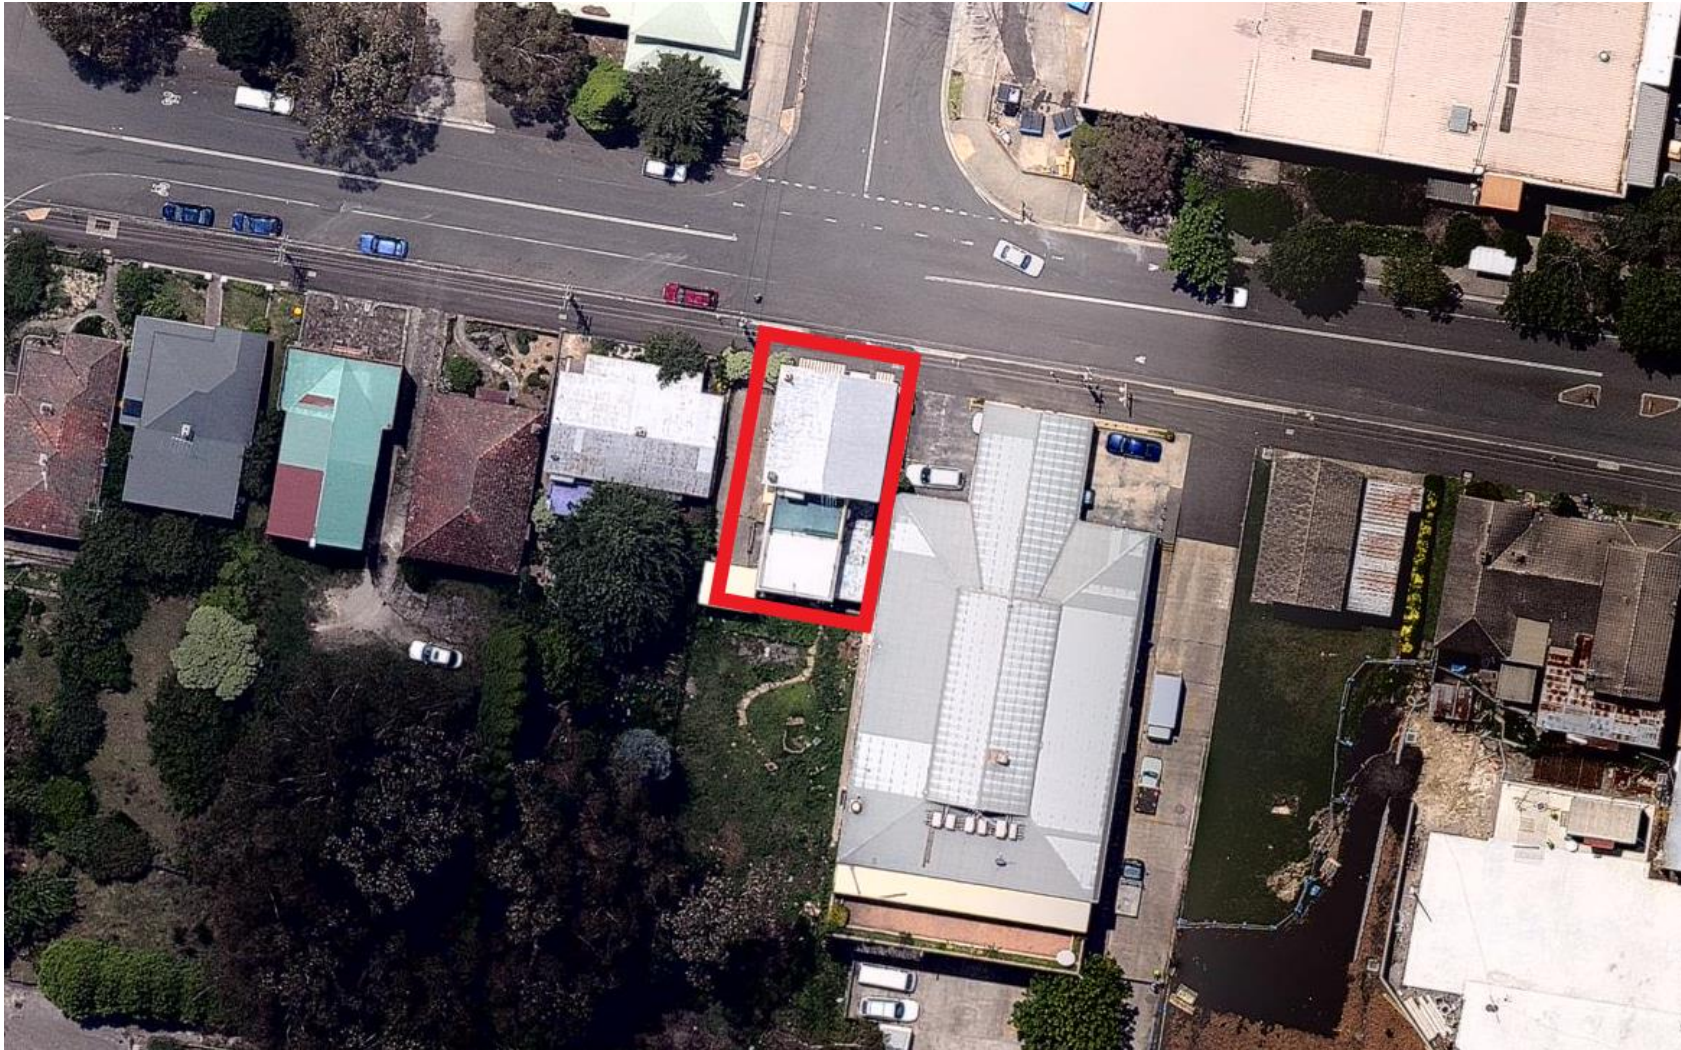
Appendix B (Site Plan - Map)

Internal, L1, North east office, North, Wall infills on left and right of window - Fibre cement sheet, Contains Chrysotile and Amosite Asbestos, 442261/AS01
