Asbestos Register

Prepared for:
Blue Mountains City Council,
2-6, Civic Place,
Katoomba,
NSW, 2780

On the 26th and 27th of February and the 23rd and 24th April 2018, an Asbestos Audit was conducted at the Katoomba Depot located at 22, South Street, Katoomba, NSW, 2780. Asbestos containing building materials were found to be present at the premises. Please refer Appendix I for results of products that were sampled and analysed but did not contain asbestos.

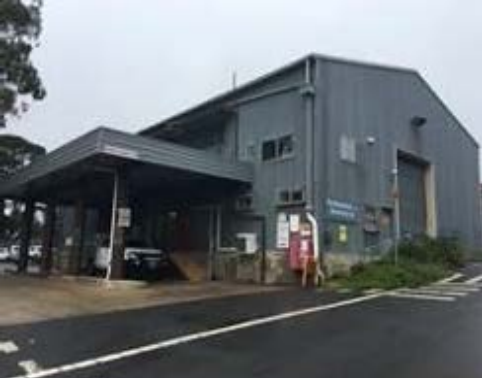
External - Northern Aspect Corrugated Iron Roof / Wall Cladding, Steel Frame, Steel & PVC Gutters / Downpipes, Concrete Pad, Timber Window Frames 2079	No Sample Taken No Asbestos Materials Sighted	A5	No Action Required
24 th April 2018

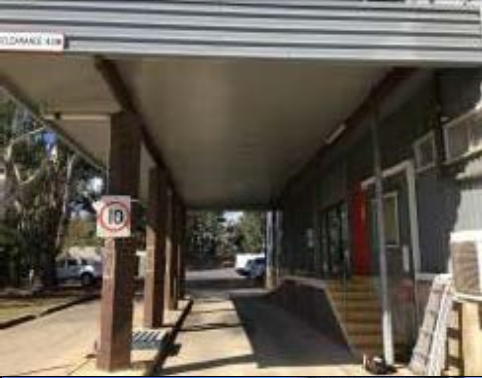
External - Northern Awning Aluminum Soffit, Brick Piers, Profiled Aluminum Siding 2080	No Sample Taken No Asbestos Materials Sighted	A5	No Action Required
24 th April 2018

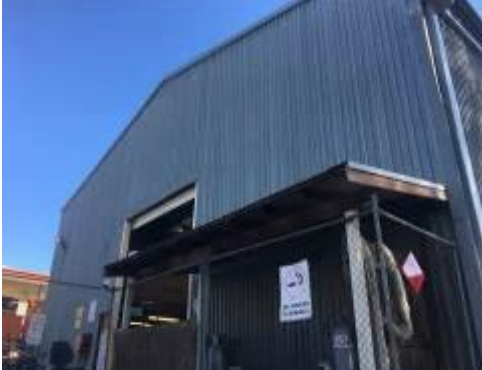
External - Eastern Aspect Corrugated Iron Roof / Wall Cladding, Steel Frame, Steel & PVC Gutters / Downpipes, Concrete Pad, Timber Window Frames 2081	No Sample Taken No Asbestos Materials Sighted	A5	No Action Required

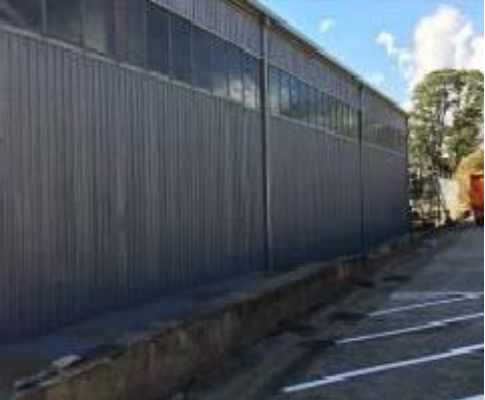
Exterior - Northern Aspect Corrugated Iron Roof / Wall Cladding, Steel Frame, Steel & PVC Gutters / Downpipes, Concrete Pad, Timber Window Frames, Block Retaining Wall	No Sample Taken No Asbestos Materials Sighted 2082	A5	No Action Required
24 th April 2018

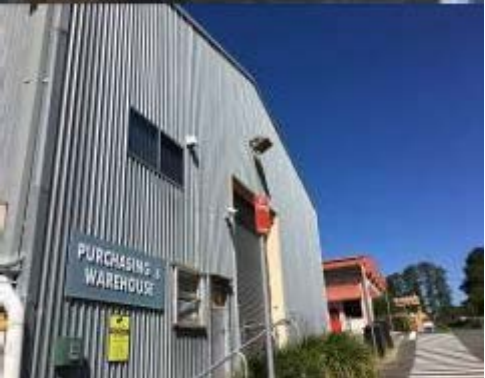
Exterior - Western Aspect Corrugated Iron Roof / Wall Cladding, Steel Frame, Steel & PVC Gutters / Downpipes, Concrete Pad, Timber Window Frames	No Sample Taken No Asbestos Materials Sighted 2083	A5	No Action Required
26 th February 2018

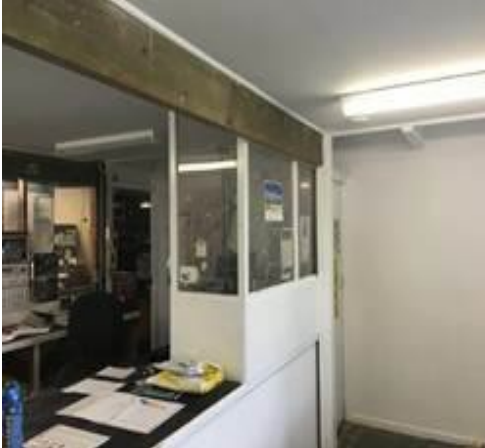
Internal - Ground Floor Entry Foyer of Reception Area Plasterboard Ceiling / Walls, Plywood Walls, Timber Skirtings / Architraves, Aluminum Windows, Masonite & Timber Counter	No Sample Taken No Asbestos Containing Materials Sighted 2084	A5	No Action Required

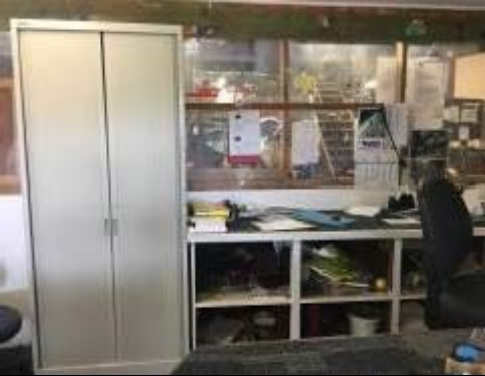
Internal - Ground Floor Behind Reception Plasterboard Ceiling / Walls, Plywood Walls, Timber Skirtings & Architraves, Perspex Windows	No Sample Taken No Asbestos Containing Materials Sighted 2085	A5	No Action Required
24 th April 2018

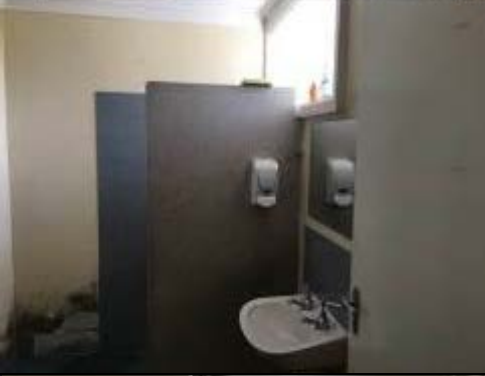
Internal - Ground Floor Amenities Plasterboard Ceiling / Infill Above Window, Brick & Render Wall, Terrazzo Partitions, Concrete Floor	No Sample Taken No Asbestos Containing Materials Sighted 2086	A5	No Action Required
26 th February 2018

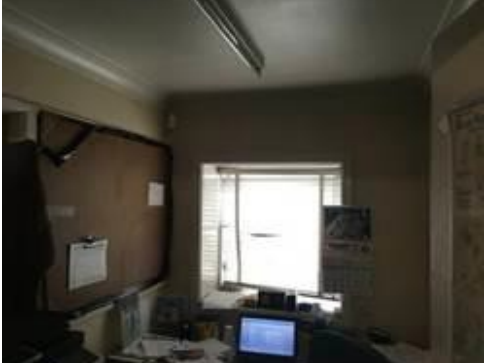
Internal - Ground Floor North-West Office Plasterboard Ceiling / Walls, Brick & Render Walls 2087	No Sample Taken No Asbestos Containing Materials Sighted	A5	No Action Required

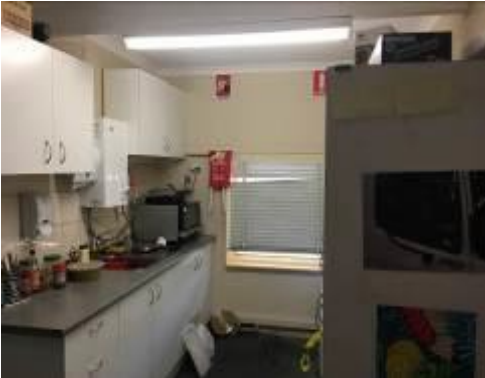
Internal - Ground Floor Kitchen Plasterboard Ceiling / Walls, Brick & Render Walls, Concrete Floor, Laminate and Particleboard Cupboards	No Sample Taken No Asbestos Containing Materials Sighted 2088	A5	No Action Required
26 th February 2018

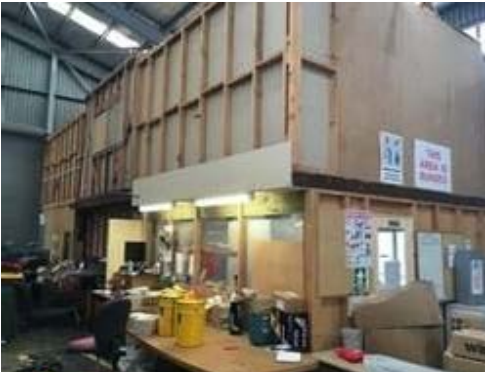
Internal - Warehouse Concrete Floor, Steel Roof / Walls / Shelves, Insulation Foil, Timber Stud Walls & Particleboard Linings 2089	No Sample Taken No Asbestos Containing Materials Sighted	A5	No Action Required
24 th April 2018

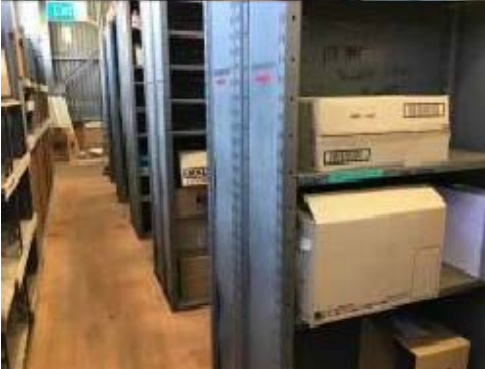
Internal - Warehouse Mezzanine Particleboard Ceiling / Floor, Steel Shelves 2090	No Sample Taken No Asbestos Containing Materials Sighted	A5	No Action Required

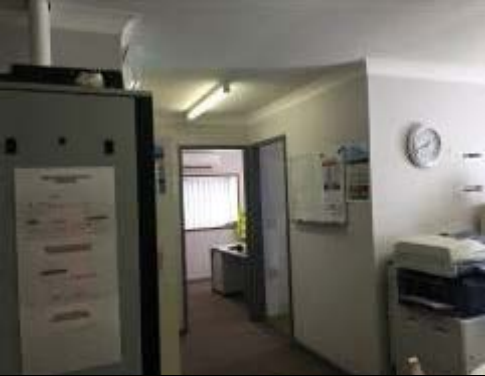
Internal - First Floor Meeting Room Plasterboard Ceiling / Walls, Timber Skirting / Door Frames, Carpet 2091	No Sample Taken No Asbestos Containing Materials Sighted	A5	No Action Required
24 th April 2018

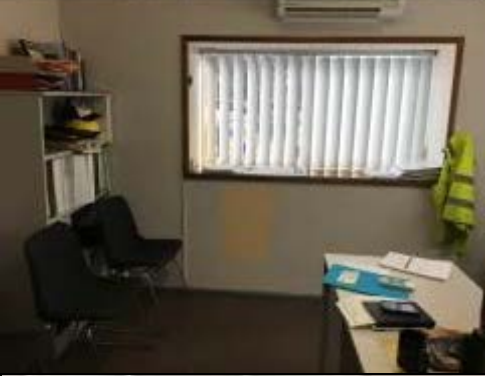
Internal - First Floor Western Office Plasterboard Ceiling / Walls, Carpet on Timber Floor 2092	No Sample Taken No Asbestos Containing Materials Sighted	A5	No Action Required
24 th April 2018

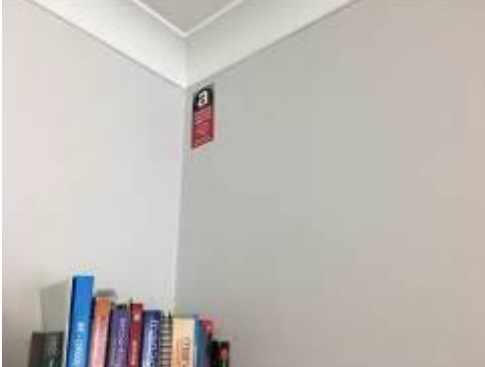
Internal - First Floor Western Office Note: The Western Wall Has Been Incorrectly Labelled as Potentially Asbestos Containing 2093	No Sample Taken No Asbestos Containing Materials Sighted 2093	A5	Remove Asbestos Label

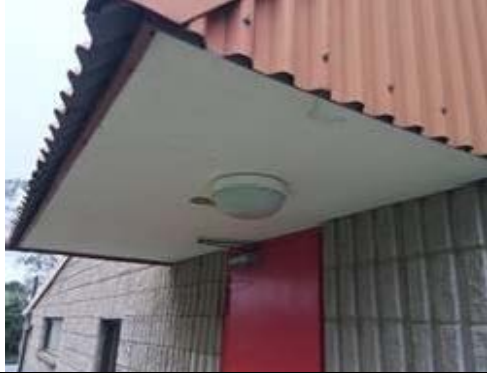
External - Western Doorway (Rear) Soffit Lining to Awning Fibre Cement Sheet 2104	Sample B17955-S7 No Asbestos Detected	A5	No Action Required
26 th February 2018

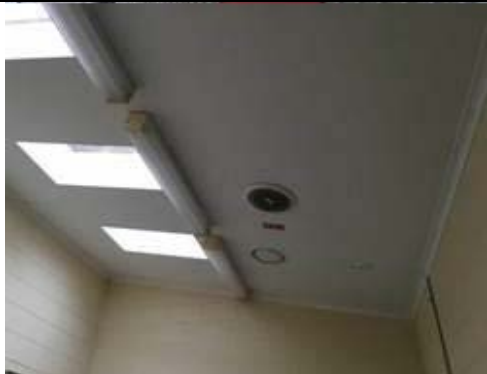
Internal - Male Toilet Ceiling Lining Fibre Cement Sheet 2105	Sample B17955-S8 No Asbestos Detected	A5	No Action Required
26 th February 2018

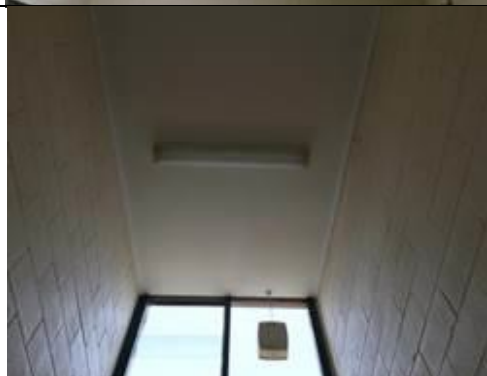
Internal - Female Shower Room Ceiling Lining Fibre Cement Sheet 2106	Similar to Sample B17955-S8 No Asbestos Detected.	A5	No Action Required

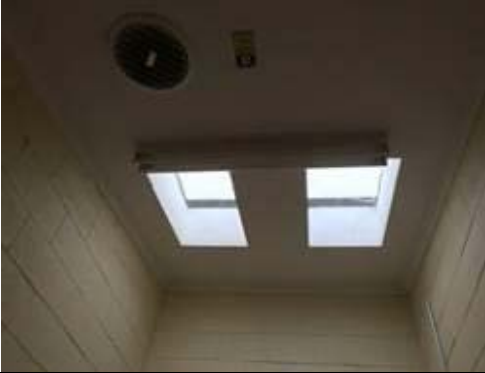
Internal - Female Toilet Ceiling Lining Fibre Cement Sheet 2107	Similar to Sample B17955-S8 No Asbestos Detected.	A5	No Action Required
4 th April 2018

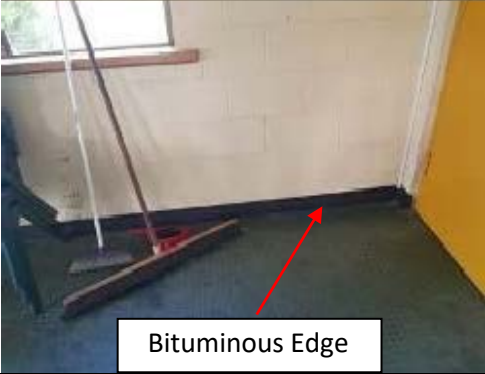
Internal - Lunch Room Plasterboard Ceiling, Block Walls, Aluminum Window Frames, Linoleum Floor Covering, Bituminous Edging 2108	Sample B17955-S23 Linoleum No Asbestos Detected	A5	No Action Required
4 th April 2018

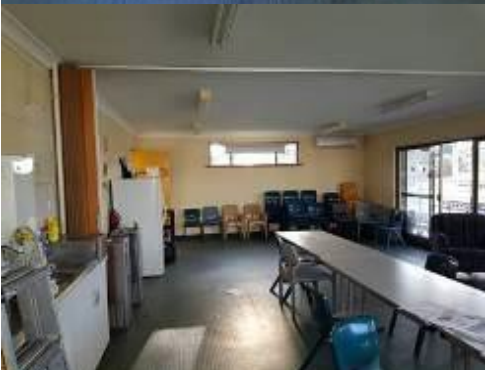
Internal - Lunch Room Vinyl Floor Tiles 2109	Sample B17955-S24 No Asbestos Detected	A5	No Action Required

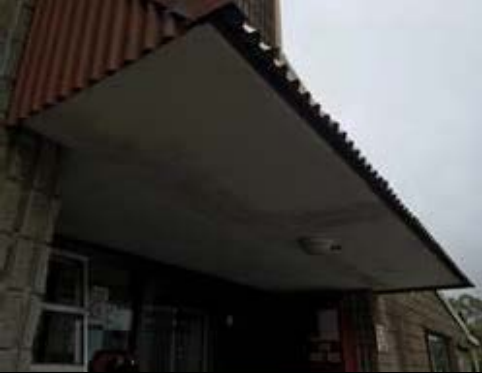
External - Eastern Doorway (Front) Soffit Lining to Awning Fibre Cement Sheet 2110	Sample B17955-S26 No Asbestos Detected	A5	No Action Required
24 th April 2018

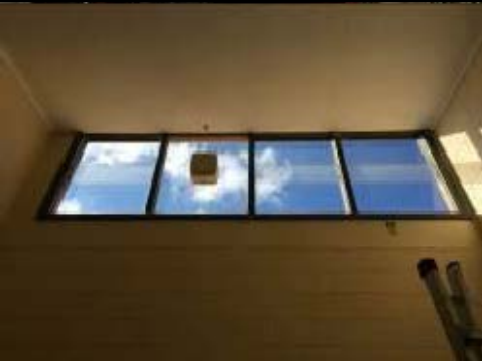
Internal - Male Shower Room Infill Panel Below Windows 2111	Sample B17955-S27 No Asbestos Detected	A5	No Action Required
24 th April 2018

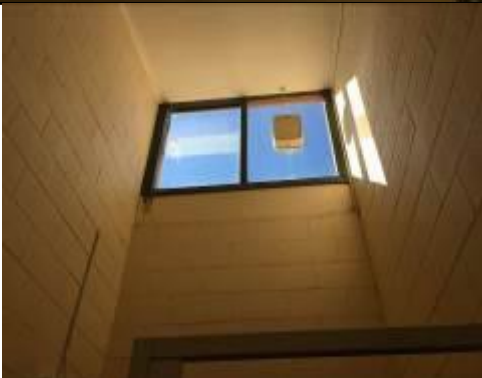
Internal - Female Shower Room Infill Below Window Fibre Cement 2112	Similar to Sample B17955-S27 No Asbestos Detected	A5	No Action Required

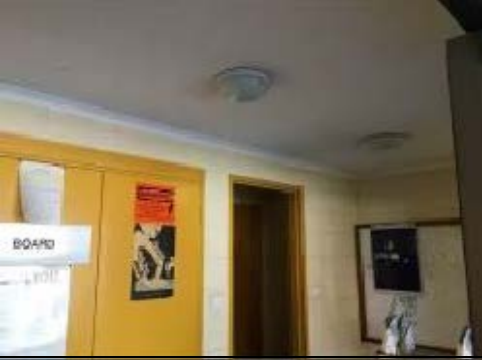
Internal - Entry Foyer Concrete Block Walls, Plasterboard infill above door, plasterboard ceiling, Green Linoleum Floor 2113	No Sample Taken No Asbestos Containing Materials Sighted	A5	No Action Required
26 th February 2018

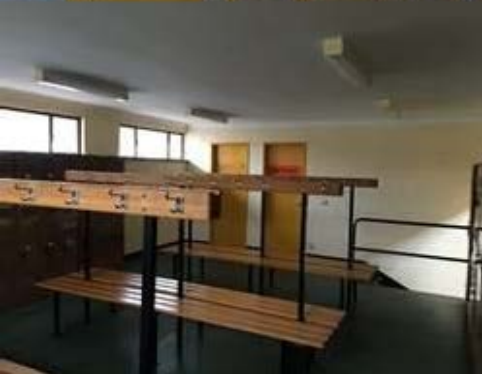
Internal - Male Locker Room Plasterboard Ceiling, Block Walls, Linoleum Flooring & skirting 2114	No Sample Taken No Asbestos Containing Materials Sighted	A5	No Action Required
24 th April 2018

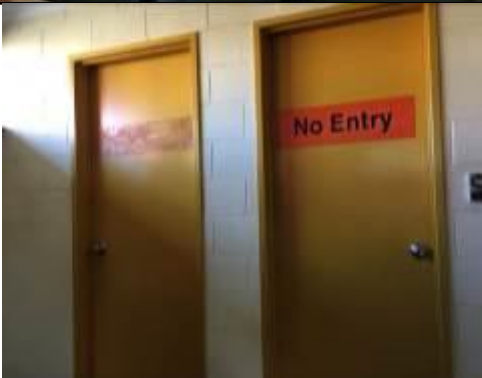
Internal - Male Locker Room Adjacent Rooms 2115	Nil Access	Assign Risk Rating Following	Reinspect Rooms When Accessible

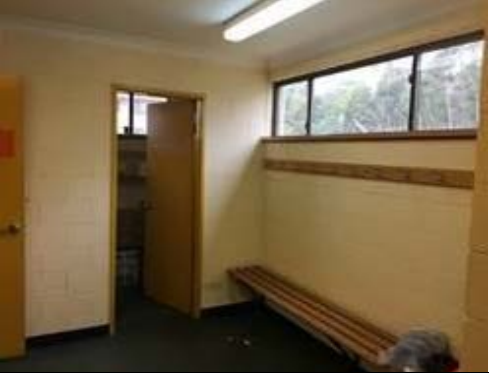
Internal - Female Locker Room Plasterboard Ceiling, Block Walls, Linoleum Floor Covering 2116	No Sample Taken No Asbestos Containing Materials Sighted	A5	No Action Required
24 th April 2018

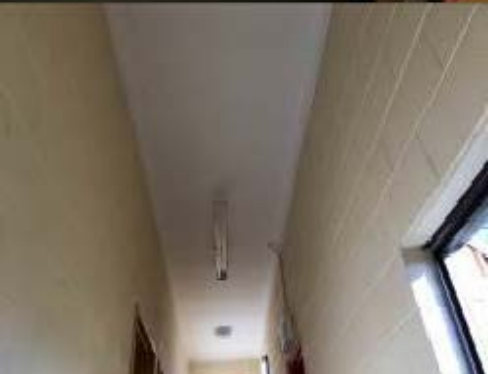
Internal - Female Amenities Entry Plasterboard Ceiling, Block Walls, Linoleum Covering 2117	No Sample Taken No Asbestos Containing Materials Sighted	A5	No Action Required
26 th February 2018

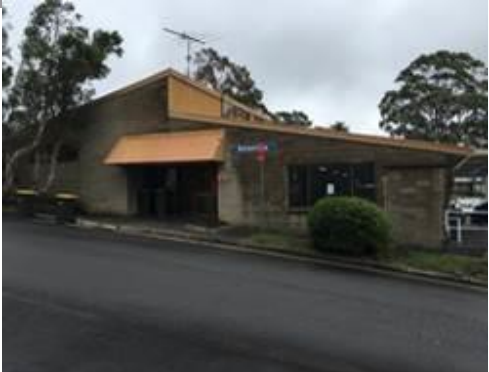
External - Eastern Aspect Steel Profiled Roof, Brick Veneer Walls, Fibre Cement Soffits, Aluminum Windows, Concrete Slab 2118	No Sample Taken No Asbestos Containing Materials Sighted	A5	No Action Required

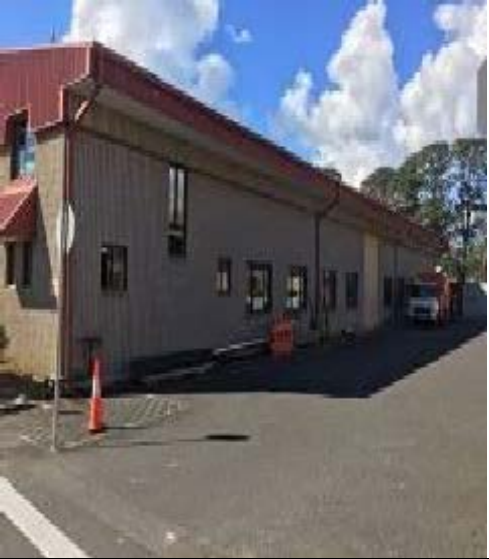
External - North Aspect Corrugated Iron Roof /Fascia / Soffit, Steel Gutters/Downpipes, Window Frames / Corner Capping, Steel Support Beams / Roller Doors Fibre Glass Lower Fascia, Concrete Brick Walls, Steel Bollards & Doorframe, Solid Timber Doors	Similar to Sample B17955-S10 No Asbestos Containing Materials 2121	A5	No Action Required Assumed Corrugated Iron Soffit Due to Height Restriction
26 th February 2018

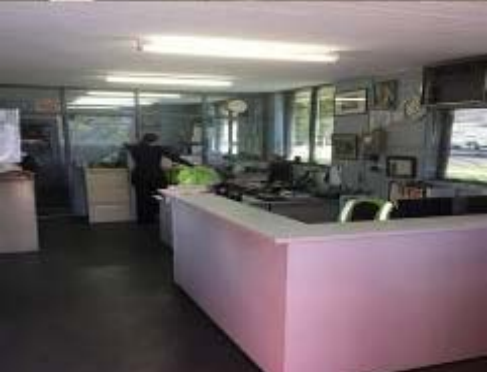
Internal – Office 1 Steel Ceiling, Block Walls, Masonite Infill, Timber Window Frame / Door Frame, Vinyl Floor Tile 2122	Sample B17955-S32 No Asbestos Detected Vinyl Floor Tiles Approximately 40m ²	A5	No Action Required

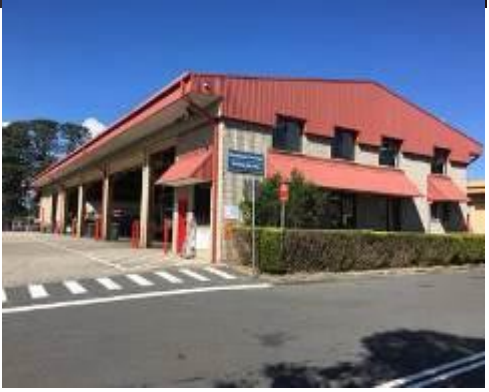
External – West Aspect Aluminum Capping/Window Frames, Corrugated Iron Gables/Awnings with Bonded Board Soffit, Concrete Brick Walls 2123	No Sample Taken No Asbestos Containing Materials Sighted	A5	No Action Required

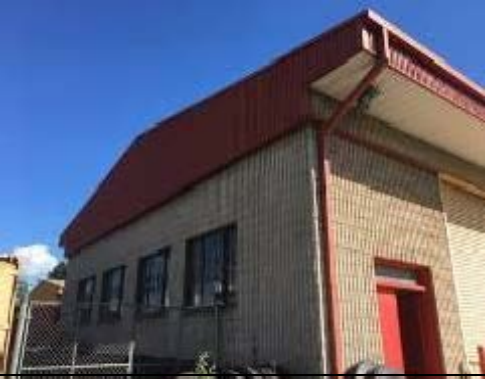
External – East Aspect Corrugated Iron Gable, Concrete Brick Walls, Aluminum Window Frames/Corner Capping, Steel Guard 2124	No Sample Taken No Asbestos Containing Materials Sighted	A5	No Action Required
26 th February 2018

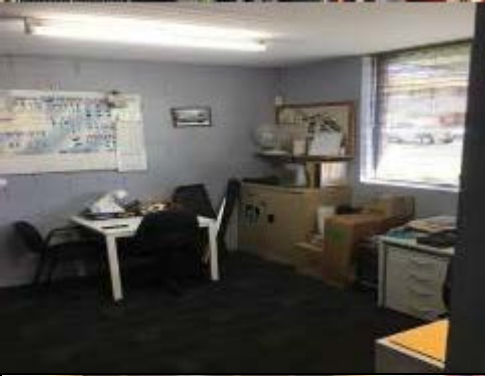
Internal – Office 2 Steel Ceiling, Block Walls, Masonite Infill, Timber Window Frame / Door Frame, Carpet 2125	No Sample Taken No Asbestos Containing Materials Sighted	A5	No Action Required
26 th February 2018

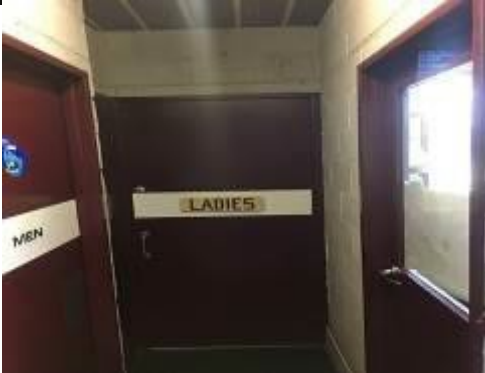
Internal – Void Steel Ceiling, Block Walls, Timber Door, Aluminum Doorframe, Ceramic Tile Floor 2126	No Sample Taken No Asbestos Containing Materials Sighted	A5	No Action Required

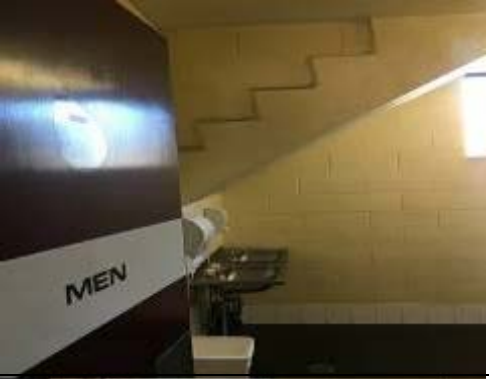
Internal – Male Bathroom Steel Ceiling, Block Walls, Aluminum Door & Window Frame, Ceramic Tile Floor and Skirting 2127	No Sample Taken No Asbestos Containing Materials Sighted	A5	No Action Required
26 th February 2018

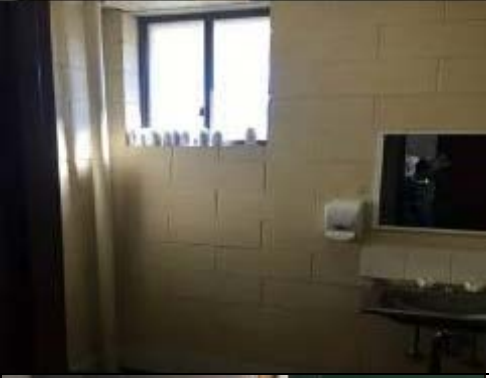
Internal – Female Bathroom Steel Ceiling, Block Walls, Aluminum Door & Window Frame, Ceramic Tile Floor and Skirting 2128	No Sample Taken No Asbestos Containing Materials Sighted	A5	No Action Required
26 th February 2018

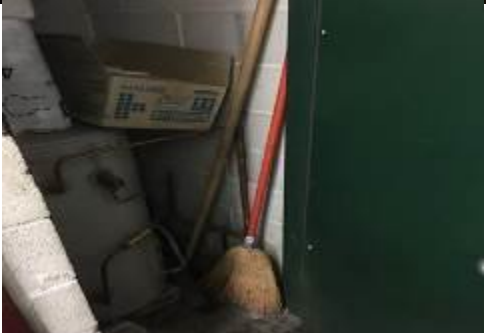
Internal – Void to Hot Water Storage Area Steel Ceiling, Block Walls, Concrete Floor 2129	No Sample Taken No Asbestos Containing Materials Sighted	A5	No Action Required

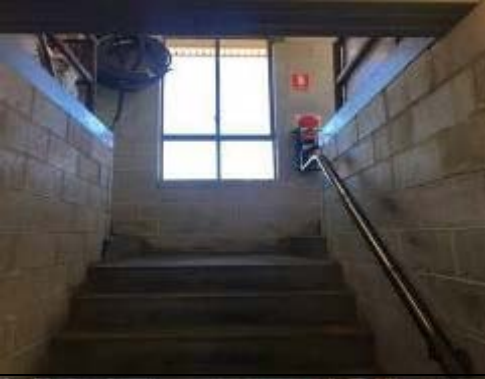
Internal – Stairwell to 1 st Floor Concrete Stairs, Steel Hand Rails, Block Walls 2130	No Sample Taken No Asbestos Containing Materials Sighted	A5	No Action Required
26 th February 2018

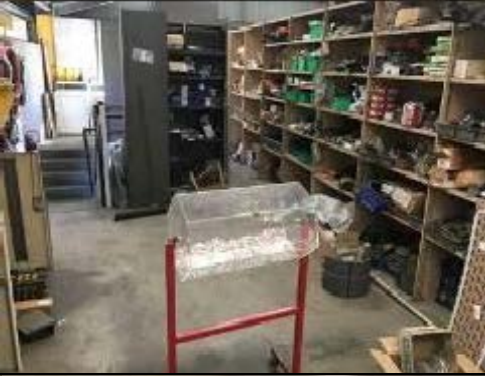
Internal – 1 st Floor Block Walls, Concrete Slab Floor, Steel Hand Rails / Shelves 2131	No Sample Taken No Asbestos Containing Materials Sighted	A5	No Action Required
26 th February 2018

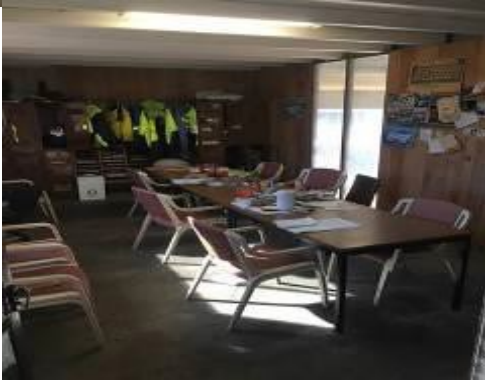
Internal - 1 st Floor Meal Room Compressed Timber Ceiling, RSJ Beams, Timber Walls, Block Walls, Concrete Slab Floor, Aluminum Window Frames 2132	No Sample Taken No Asbestos Containing Materials Sighted	A5	No Action Required

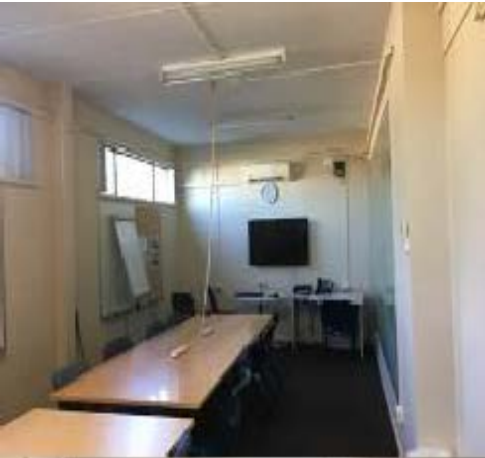
Internal - Ground Floor Conference Room Plasterboard Ceiling / Walls with Fibre Cement Linings Above, Carpet on Concrete Floors, Timber Skirtings and Architraves 2135	Sample B17955-S13 Fibre Cement Ceiling No Asbestos Detected	A5	No Action Required
26 th February 2018

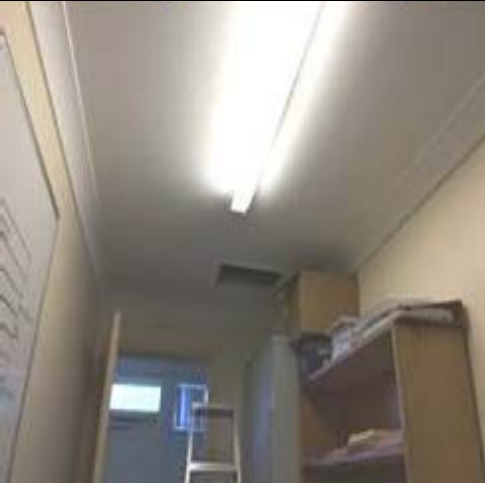
Internal - Ground Floor Conference Room Corridor Plasterboard Ceiling / Walls with Fibre Cement Linings Above, Carpet on Concrete Floors, Timber Skirtings and Architraves 2136	Similar to Sample B17955-S13 Fibre Cement Ceiling No Asbestos Detected	A5	No Action Required
26 th February 2018

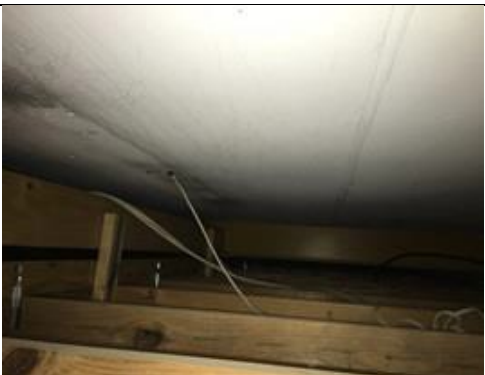
Internal - Ground Floor Conference Room Corridor Image Showing Fibre Cement Lining Above Plasterboard Ceiling 2137	Similar to Sample B17955-S13 Fibre Cement Ceiling No Asbestos Detected	A5	No Action Required

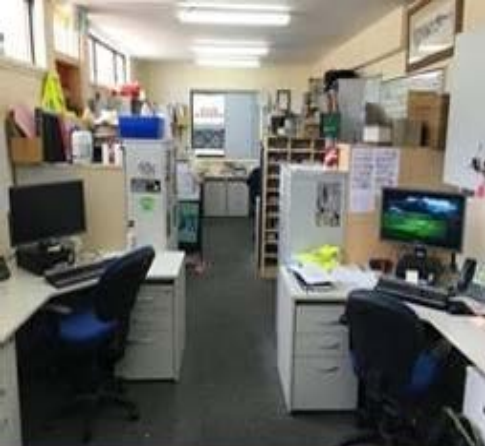
Internal - Ground Floor Southern Office Plasterboard Ceiling / Walls with Fibre Cement Linings Above, Carpet on Concrete Floors, Timber Skirtings & Architraves 2138	Similar to Sample B17955-S13 Fibre Cement Ceiling No Asbestos Detected	A4	Good Condition Accessible to Tradespeople Refer to Asbestos Management Plan
26 th February 2018

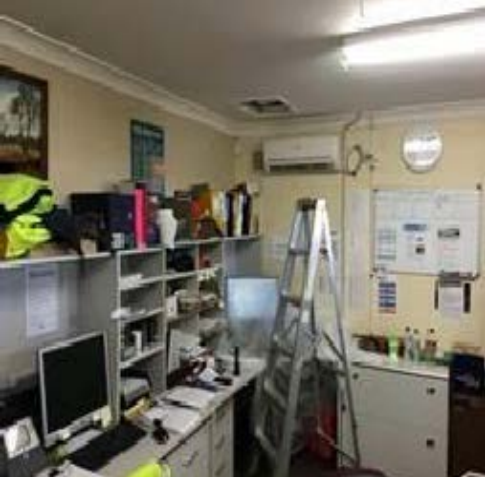
Internal - Ground Floor Central 'Noxious Weeds Team' Office Plasterboard Ceiling / Walls with Fibre Cement Linings Above, Carpet on Concrete Floors, Timber Skirtings & Architraves 2139	Similar to Sample B17955-S13 Fibre Cement Ceiling No Asbestos Detected	A5	No Action Required

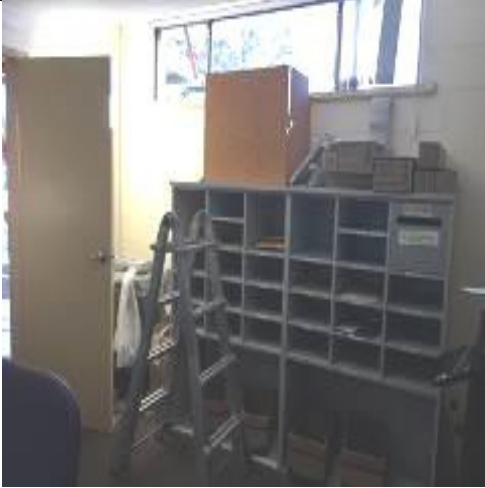
Internal - Administration Building Ground Floor Reception Area/Mail Room Plasterboard Ceiling / Walls with Fibre Cement Linings Above, Carpet on Concrete Floors, Timber Skirtings & Architraves 2140	Similar to Sample B17955-S13 Fibre Cement Ceiling No Asbestos Detected	A5	No Action Required

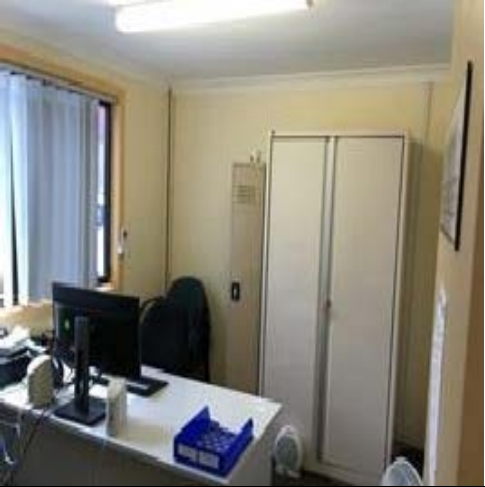
Internal - Ground Floor North 'Human Resources' Office Plasterboard Ceiling / Walls with Fibre Cement Linings Above, Carpet on Concrete Floors, Timber Skirtings & Architraves 2141	Similar to Sample B17955-S13 Fibre Cement Ceiling No Asbestos Detected	A5	No Action Required
26 th February 2018

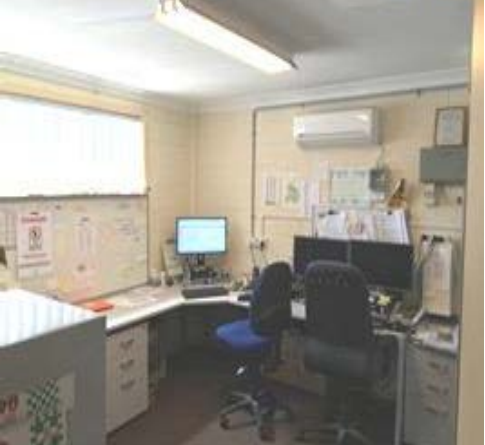
Internal - Ground Floor North-East Office Plasterboard Ceiling / Walls with Fibre Cement Linings Above, Carpet on Concrete Floors, Timber Skirtings & Architraves 2142	Similar to Sample B17955-S13 Fibre Cement Ceiling No Asbestos Detected	A5	No Action Required
26 th February 2018

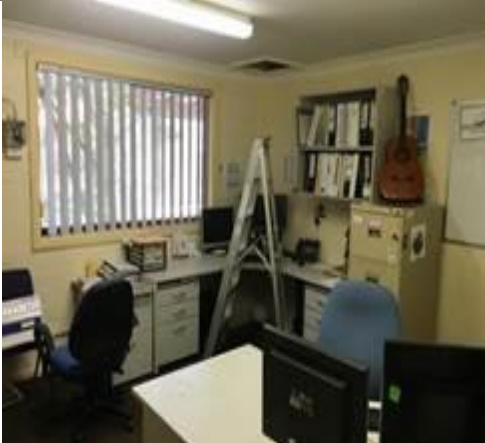
Internal - Ground Floor Eastern Office Plasterboard Ceiling / Walls with Fibre Cement Linings Above, Carpet on Concrete Floors, Timber Skirtings & Architraves 2143	Similar to Sample B17955-S13 Fibre Cement Ceiling No Asbestos Detected	A5	No Action Required

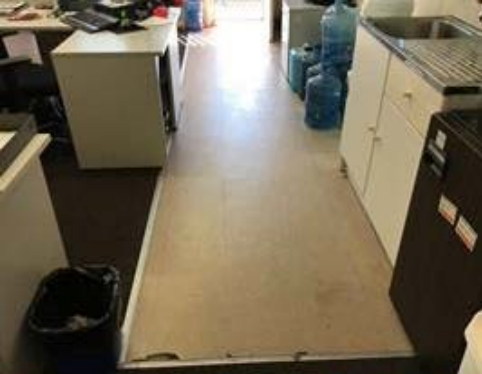
Internal – Waste Services Entrance & Kitchenette Brown Vinyl Floor Sheets 2144	Sample B17955-S14 No Asbestos Detected	A5	No Action Required
24 th April 2018

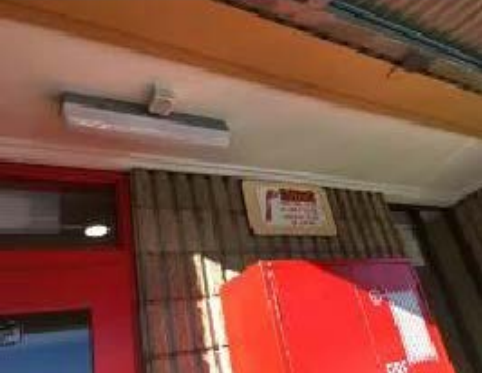
External - Main Entry Porch Soffit Lining 2145	Sample B17955-S29 No Asbestos Detected	A5	No Action Required
26 th February 2018

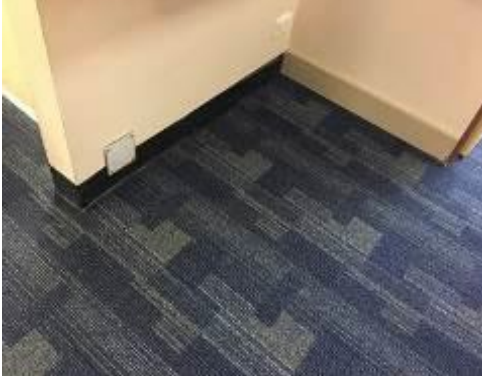
Internal - 1st Floor Foyer Area Low Density Fibre Board Inserts to Suspended Ceiling, Plasterboard Walls, Black Linoleum Skirting, Carpet Tiles, Concrete Floor 2146	Sample B17955-S31 No Asbestos Detected	A5	No Action Required

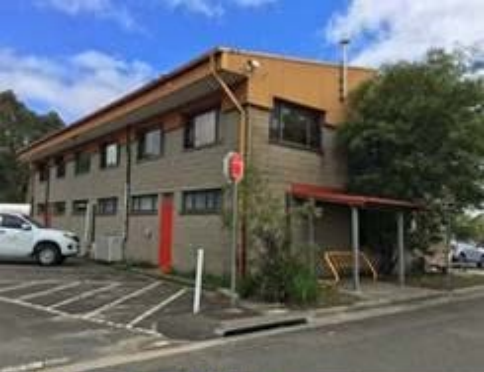
External - Northern Aspect Flat Steel Roof, Brick Veneer & Timber Cladding, Aluminum Windows, Steel Soffit Lining, Concrete Slab 2147	No Sample Taken No Asbestos Containing Material Sighted	A5	No Action Required
24 th April 2018

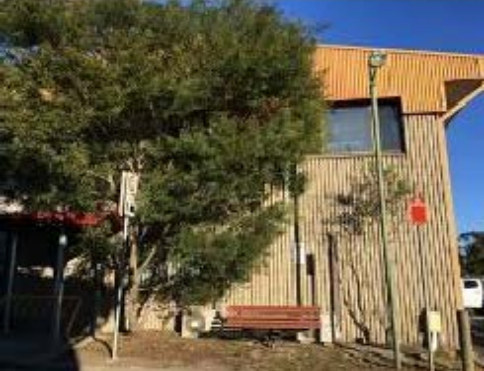
External - Eastern Aspect Flat Steel Roof, Brick Veneer & Timber Cladding, Aluminum Windows, Steel Soffit Lining, Concrete Slab 2148	No Sample Taken No Asbestos Containing Material Sighted	A5	No Action Required
24 th April 2018

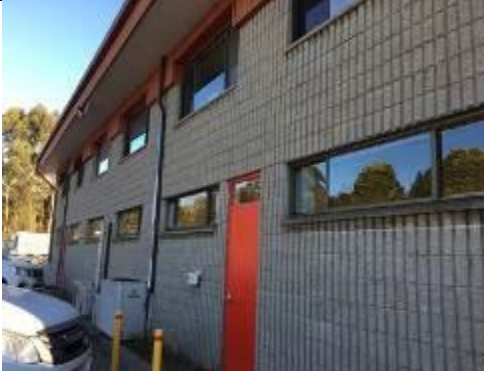
External - Southern Aspect Flat Steel Roof, Brick Veneer & Timber Cladding, Aluminum Windows, Steel Soffit Lining, Concrete Slab 2149	No Sample Taken No Asbestos Containing Material Sighted	A5	No Action Required

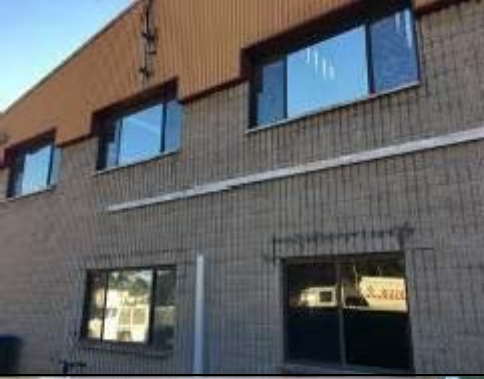
External - Western Aspect Flat Steel Roof, Brick Veneer & Timber Cladding, Aluminum Windows, Steel Soffit Lining, Concrete Slab 2150	No Sample Taken No Asbestos Containing Material Sighted	A5	No Action Required
24 th April 2018

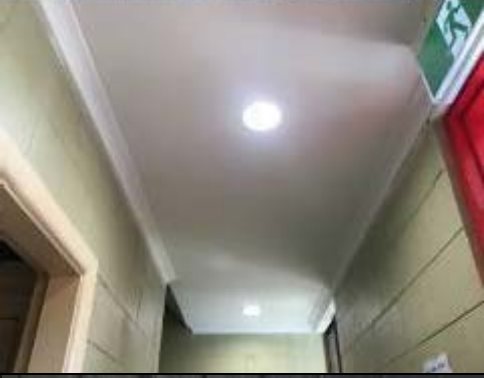
Internal - Ground Floor Main Entry Foyer & Area Above Stairs Plasterboard Ceiling, Block Walls, Ceramic Tile Floor 2151	No Sample Taken No Asbestos Containing Material Sighted	A5	No Action Required
24 th April 2018

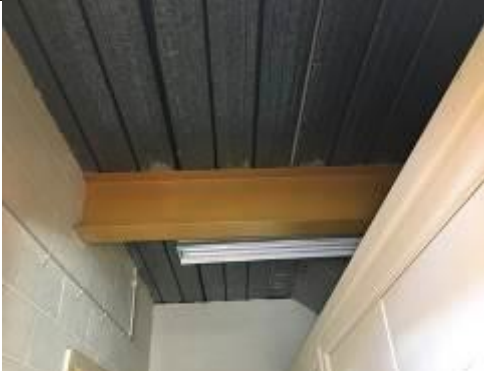
Internal - Ground Floor Corridor off Entry Foyer Steel Ceiling, Block Walls, Carpet Over Concrete 2152	No Sample Taken No Asbestos Containing Material Sighted	A5	No Action Required

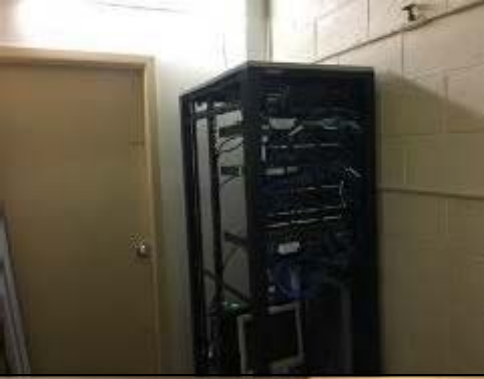
Internal - Ground Floor IT Room Steel Ceiling, Plasterboard & Block Walls, Timber Skirting & Architraves 2153	No Sample Taken No Asbestos Containing Material Sighted	A5	No Action Required
24 th April 2018

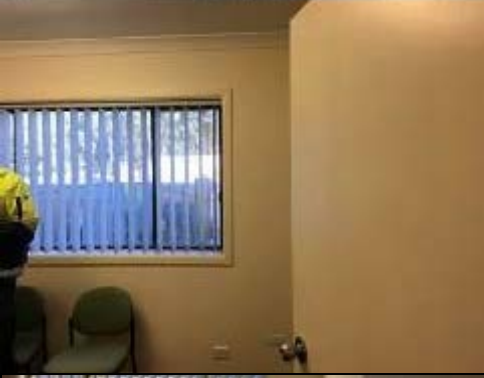
Internal - Ground Floor Waste Services West Office Plasterboard Ceiling / Walls, Timber Skirting & Architraves, Carpet 2154	No Sample Taken No Asbestos Containing Material Sighted	A5	No Action Required
24 th April 2018

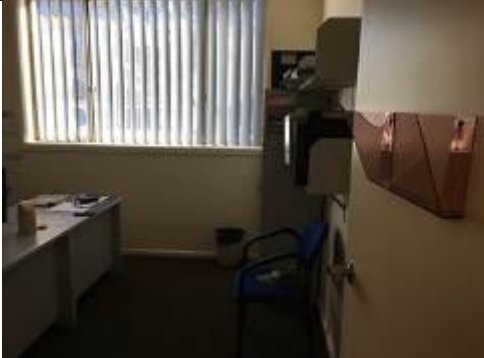
Internal - Ground Floor Waste Services West Office Plasterboard Ceiling / Walls, Timber Skirting & Architraves Carpet 2155	No Sample Taken No Asbestos Containing Material Sighted	A5	No Action Required

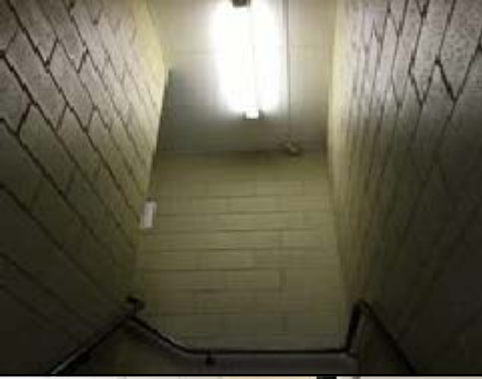
Internal - Stairs to 1 st Floor Offices Low Density Fibre Board Suspended Ceiling, Cement Block Walls 2156	No Sample Taken No Asbestos Containing Material Sighted	A5	No Action Required
26 th February 2018

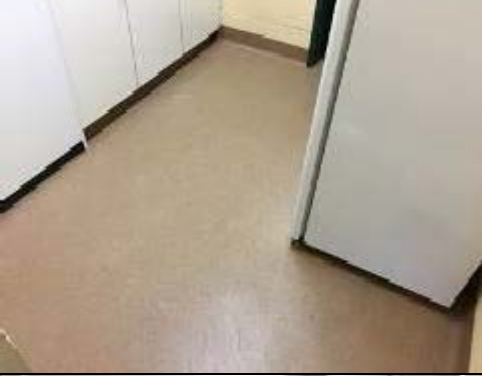
Internal - 1st Floor Kitchen Kitchenette Floor Vinyl Sheeting 2157	Sample B17955-S30 No Asbestos Detected	A5	No Action Required
26 th February 2018

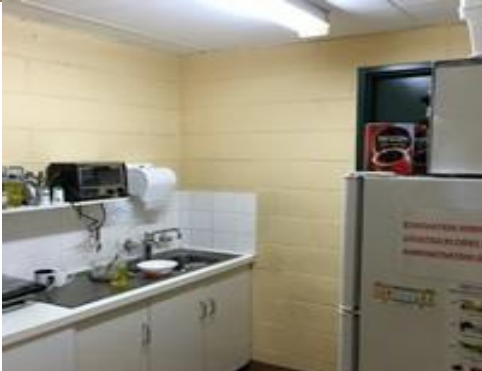
Internal - 1 st Floor Kitchenette Low Density Fibre Board Suspended Ceiling, Block / Plasterboard / Ceramic Tile Walls, Modular Cabinets 2158	No Sample Taken No Asbestos Containing Material Sighted	A5	No Action Required

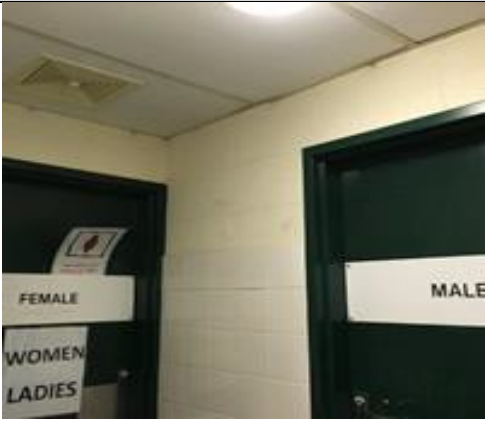
Internal - Administration Building 1 st Floor Female & Male Toilets Foyer Low Density Fibre Board Suspended Ceiling, Block / Plasterboard / Ceramic Tile Walls	No Sample Taken No Asbestos Containing Material Sighted 2159	A5	No Action Required
24 th April 2018

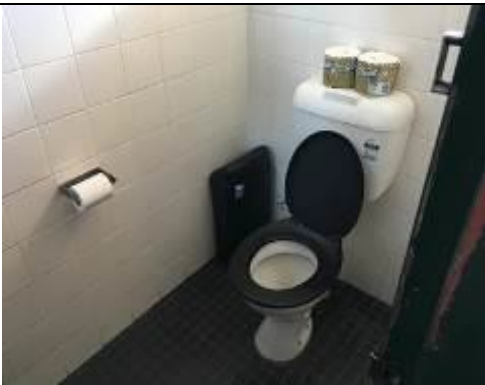
Internal - Administration Building 1 st Floor Female Toilet Low Density Fibre Board Suspended Ceiling, Block / Plasterboard / Ceramic Tile Walls	No Sample Taken No Asbestos Containing Material Sighted 2160	A5	No Action Required
24 th April 2018

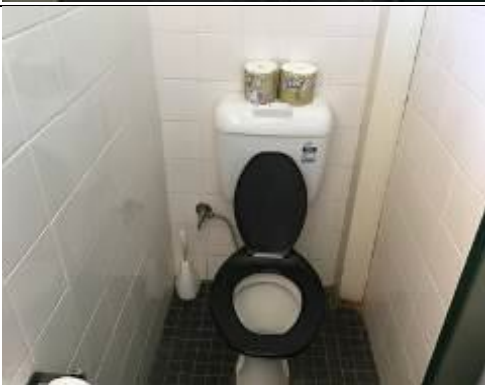
Internal - Administration Building 1 st Floor Male Toilet Low Density Fibre Board Suspended Ceiling, Block / Plasterboard / Ceramic Tile Walls	No Sample Taken No Asbestos Containing Material Sighted 2161	A5	No Action Required

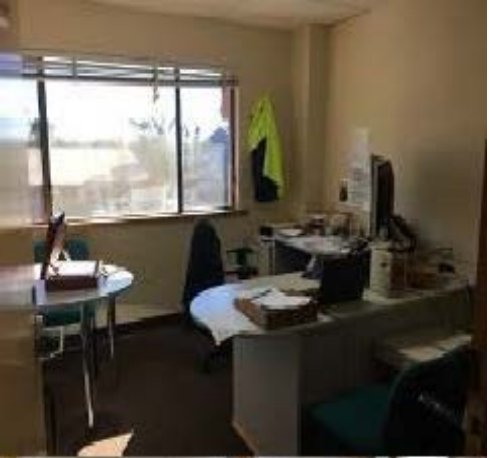
Internal - Administration Building 1 st Floor Central North Office Low Density Fibre Board Suspended Ceiling, Block Walls, Plasterboard Infill Above Aluminum Window Frames 2162	No Sample Taken No Asbestos Containing Material Sighted	A5	No Action Required
24 th April 2018

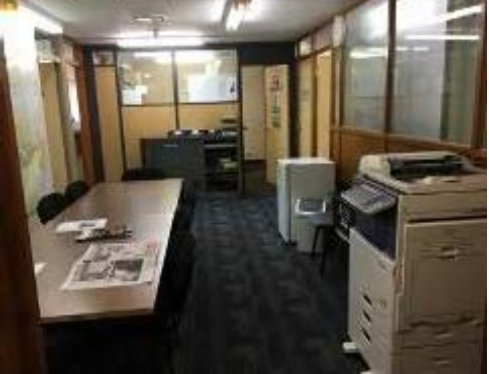
Internal - Administration Building 1 st Floor Lunchroom Area Low Density Fibre Board Suspended Ceiling, Plasterboard Walls, Carpet Tiles 2163	No Sample Taken No Asbestos Containing Material Sighted	A5	No Action Required
24 th April 2018

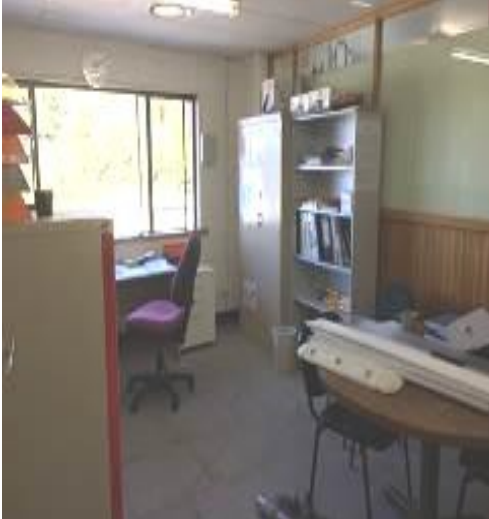
Internal - Administration Building 1 st Floor Maintenance Coordinator's Office Low Density Fibre Board Suspended Ceiling, Block Walls, Plasterboard Infill Above Aluminum Window Frame Timber & Glass Partitions, Carpet Tiles 2164	No Sample Taken No Asbestos Containing Material Sighted	A5	No Action Required

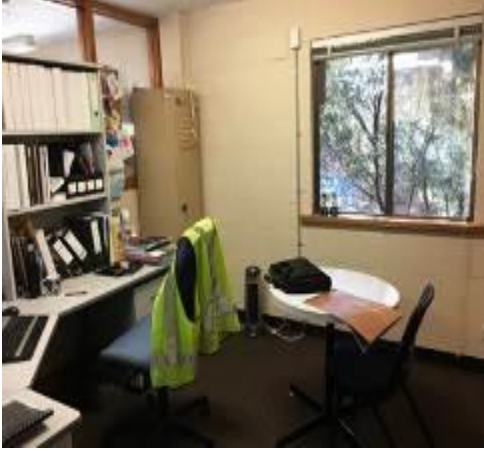
Internal - Administration Building 1 st Floor Program Leader Operations Office Low Density Fibre Board Suspended Ceiling, Block & Plasterboard Walls, Aluminum Window Frame, Carpet Tiles	No Sample Taken No Asbestos Containing Material Sighted 2165	A5	No Action Required
24 th April 2018

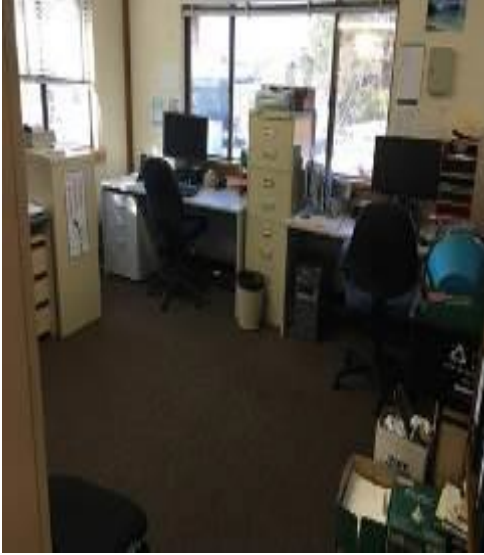
Internal - Administration Building 1 st Floor Pavement and Capital Works Coordinator Office Low Density Fibre Board Suspended Ceiling, Block & Timber Panel Walls, Plasterboard Infill Above Aluminum Window Frame, Carpet Tiles	No Sample Taken No Asbestos Containing Material Sighted 2166	A5	No Action Required

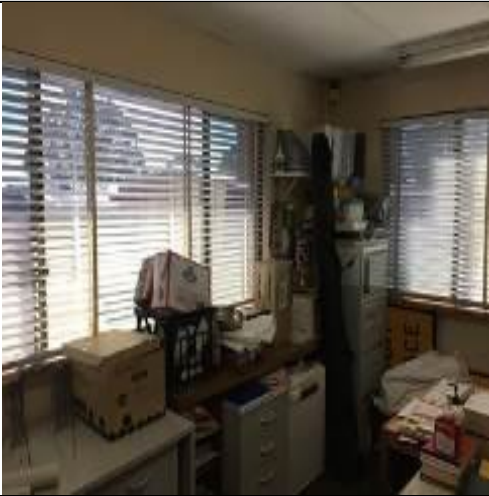
Internal - Administration Building 1 st Floor Asset Inspectors Office Low Density Fibre Board Suspended Ceiling, Block & Timber Panel Walls, Plasterboard Infill Above Aluminum Window Frame, Carpet Tiles	No Sample Taken No Asbestos Containing Material Sighted 2167	A5	No Action Required
24 th April 2018

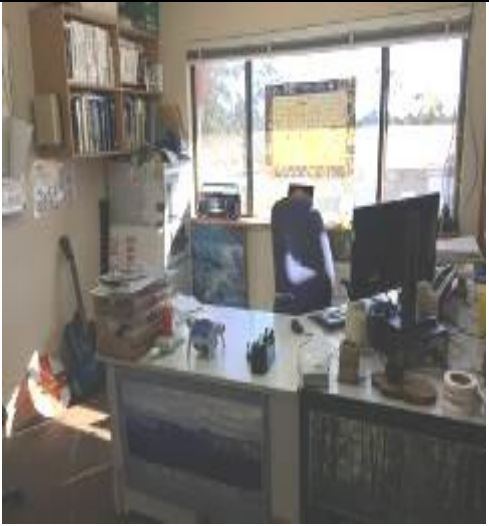
Internal - Administration Building 1 st Floor Public Lands Tree Inspector Low Density Fibre Board Suspended Ceiling, Block & Timber Panel Walls, Plasterboard Infill Above Aluminum Window Frame, Carpet Tiles	No Sample Taken No Asbestos Containing Material Sighted 2168	A5	No Action Required

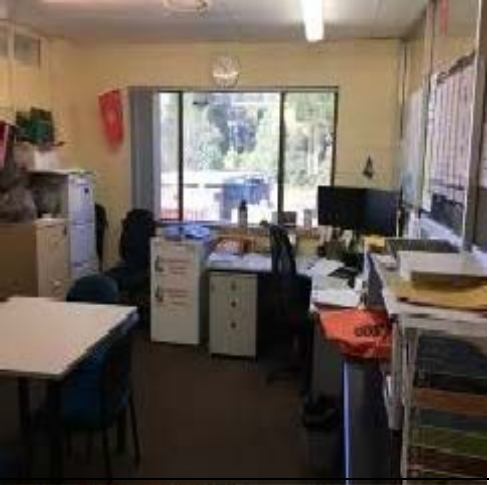
Internal - Administration Building 1 st Floor Operations Engineer Office Low Density Fibre Board Suspended Ceiling, Block & Plasterboard Walls, Aluminum Window Frame, Carpet Tiles	No Sample Taken No Asbestos Containing Material Sighted 2169	A5	No Action Required
24 th April 2018

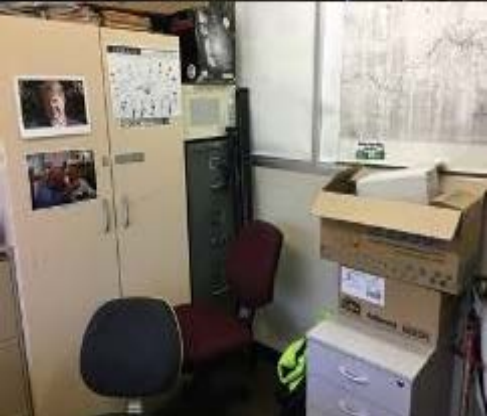
Internal - Administration Building 1 st Floor Plant Coordinator Office Low Density Fibre Board Suspended Ceiling, Block / Plasterboard / Ceramic Tile Walls	No Sample Taken No Asbestos Containing Material Sighted 2170	A5	No Action Required
26 th February 2018

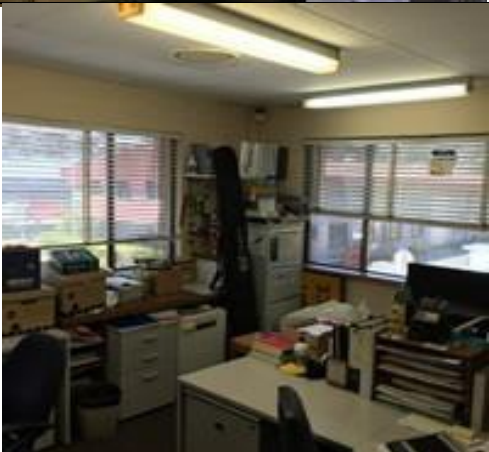
Internal - Administration Building 1 st Floor Administration Area North West Low Density Fibre Board Suspended Ceiling, Plasterboard / Walls, Aluminum Window Frames, Carpet	No Sample Taken No Asbestos Containing Material Sighted 2171	A5	No Action Required

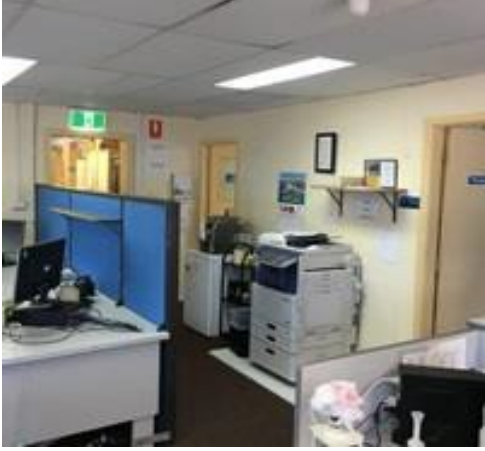
Internal - Administration Building 1 st Floor Administration Area South East Low Density Fibre Board Suspended Ceiling, Plasterboard Walls, Aluminum Window Frames, Carpet Tiles	No Sample Taken No Asbestos Containing Material Sighted 2172	A5	No Action Required
26 th February 2018

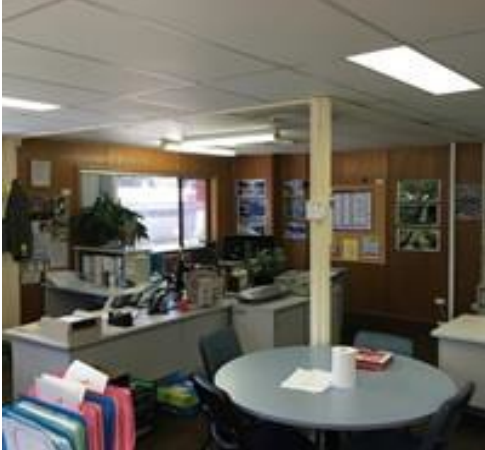
Internal - Administration Building 1 st Floor Administration Area North East Low Density Fibre Board Suspended Ceiling, Plasterboard Walls, Aluminum Window Frames, Carpet Tiles	No Sample Taken No Asbestos Containing Material Sighted 2173	A5	No Action Required
24 th April 2018

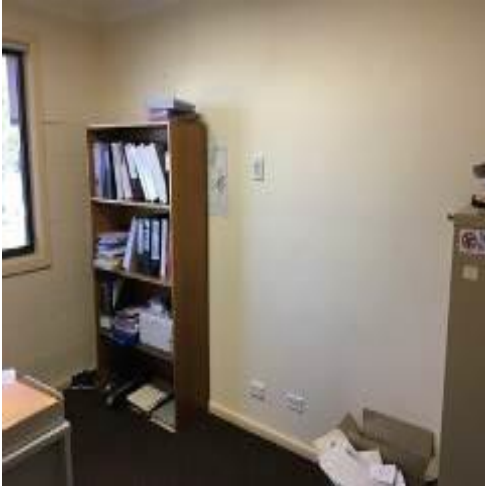
Internal - Administration Building 1 st Floor Program Leader Business & Systems Office Low Density Fibre Board Suspended Ceiling, Block & Plasterboard Walls, Aluminum Window Frames, Carpet	No Sample Taken No Asbestos Containing Material Sighted 2174	A5	No Action Required

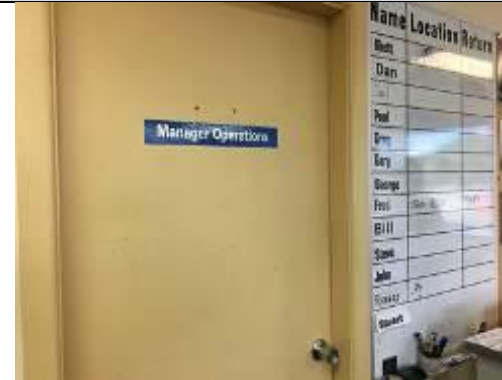
Internal - Administration Building 1 st Floor Manager Operations Office 2175	Nil Access Due to Locked Door & No Key On-Site at Time of Inspection	Assign Risk Rating following Inspection	Reinspect Room When Accessible

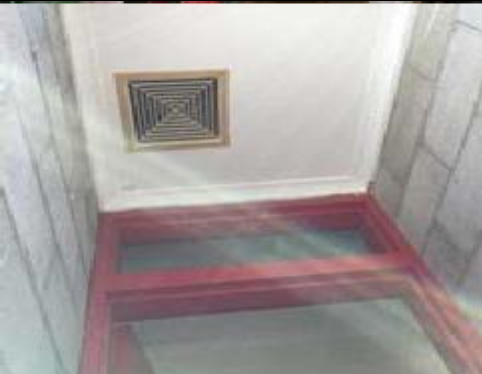
Internal - Trades Male Bathroom Northern Toilet Entrance Portico Fibre Cement Sheet Ceiling Lining 2180	Sample B17955-S15 Bonded Board No Asbestos Detected	A5	No Action Required
26 th February 2018

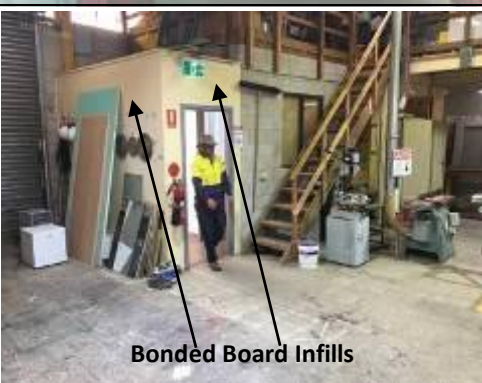
Bonded Board Infills	Internal - Trades Ground Floor Workshop Foil Insulation, RSJ Beams, Steel Roller Door, Block Walls, Aluminum Window Frames, Bonded Board Infills 2181	Sample B17955-S17 Bonded Board Infills No Asbestos Detected	A5	No Action Required

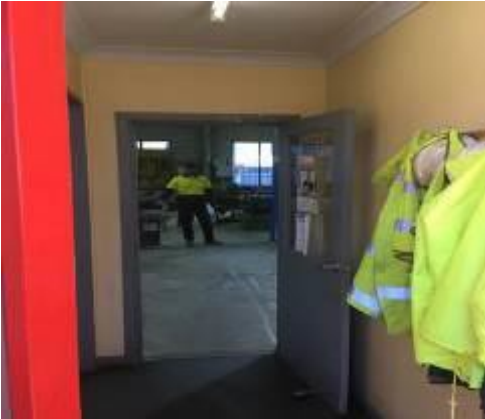
Internal - Trades Ground Floor Carpenters Shop Entry Plasterboard Ceiling / Cornices, Block Walls, Aluminum & Timber Door Frames, Solid Timber Doors, Vinyl Floor, Bonded Board to West Wall	Similar to Sample B17955-S17 Bonded Board to West Wall No Asbestos Detected 2182	A5	No Action Required
26 th February 2018

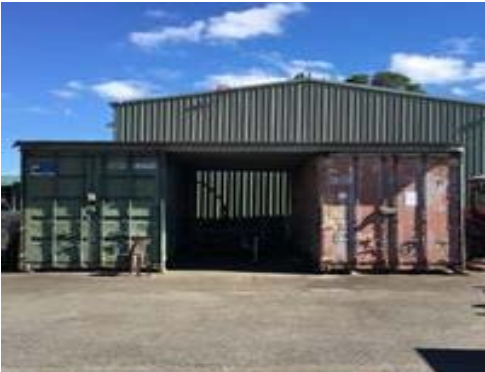
External – Trades Gardiners Shed Containers (x2) North Side of Emulsion Shed Fibre Cement Sheet Offcuts as Packers 2183	Sample B17955-S18 Fibre Cement Sheet No Asbestos Detected	A5	No Action Required
26 th February 2018

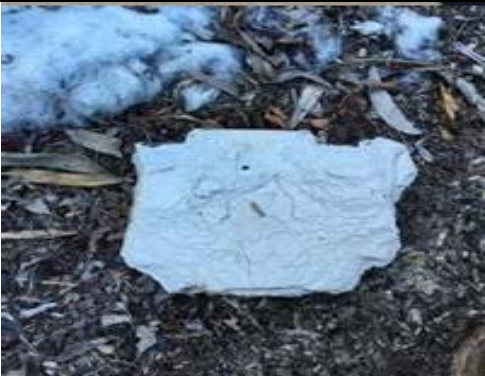
External – Yard Area Concrete Walled Dump – South-Western Corner of Yard Broken Fibre Cement Pipe on Ground 2184	Sample B17955-S19 Fibre Cement No Asbestos Detected	A5	No Action Required
