Asbestos Register

Prepared for:
Blue Mountains City Council,
2-6, Civic Place,
Katoomba,
NSW, 2780

On the 26th and 27th of February and the 23rd and 24th April 2018, an Asbestos Audit was conducted at the Katoomba Depot located at 22, South Street, Katoomba, NSW, 2780. Asbestos containing building materials were found to be present at the premises. Please refer Appendix I for results of products that were sampled and analysed but did not contain asbestos.

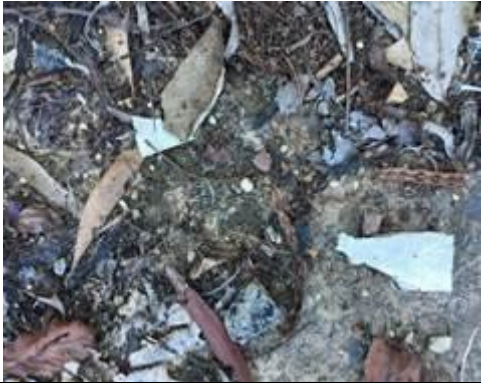
External – Yard Area South-Western Corner of Yard Broken Fibre Cement Sheet on Ground 2185	Sample B17955-S20 Fibre Cement No Asbestos Detected	A5	No Action Required
26 th February 2018

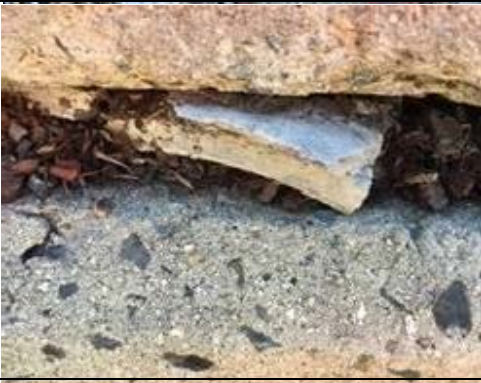
External - Yard South-Western Corner of Yard Broken Fibre Cement Pipe in Concrete Block Retaining Wall 2186	Sample B17955-S21 Fibre Cement No Asbestos Detected	A5	No Action Required
26 th February 2018

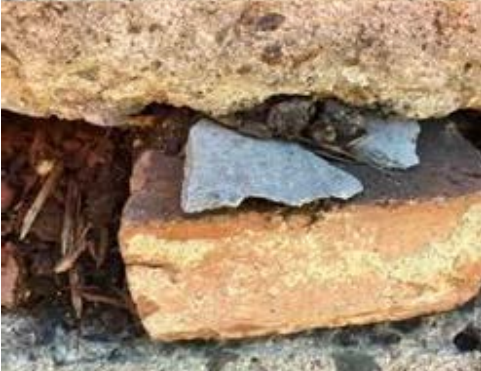
External – Yard Area South-Western Corner of Yard Broken Fibre Cement Pipe in Concrete Block Retaining Wall 2187	Sample B17955-S22 Fibre Cement No Asbestos Detected	A5	No Action Required

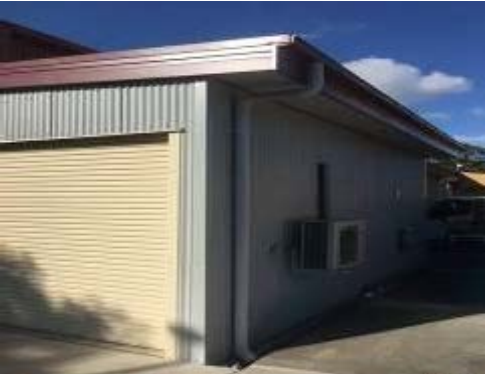
External - Trades South Extension Steel Gutters and Fascia, Corrugated Iron Walls, Bonded Board Soffit 2188	Sample B17955-S33 Bonded Board Soffit No Asbestos Detected	A5	No Action Required
26 th February 2018

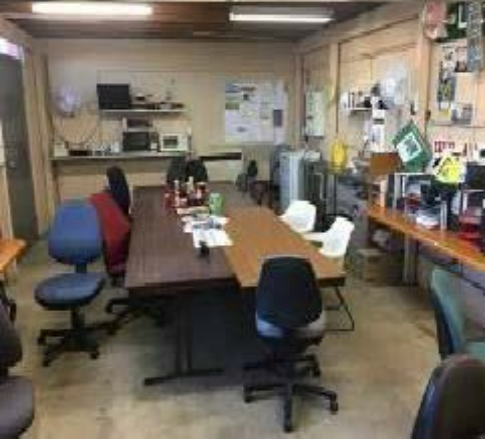
Internal - Trades Ground Floor Meal Room Particleboard Ceiling, Timber Support Beams, Block Walls, Aluminum & Timber Door Frames, Timber Doors, Concrete Slab, Board Beneath Water Unit	Sample B17955-S34 Bonded Board Base Under Water Heating Unit No Asbestos Detected 2189	A5	No Action Required
26 th February 2018

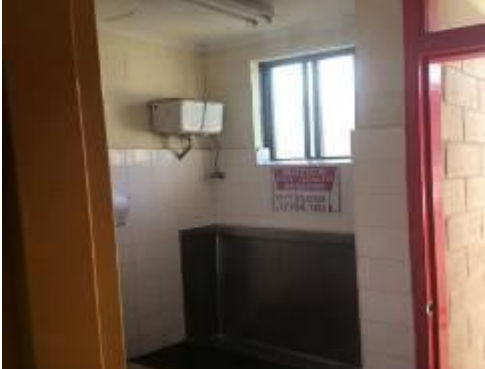
Internal - Trades Male Bathroom Bonded Board Ceiling, Plasterboard Cornice, Block / Ceramic Tile Walls, Ceramic Tile Floor, Aluminum Door Frames, Timber Door	Sample B17955-S35 Bonded Board Ceiling No Asbestos Detected 2190	A5	No Action Required

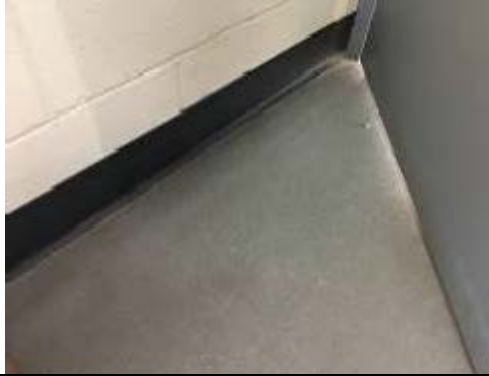
Internal - Trades Ground Floor Carpenters Office Vinyl Skirting 2191	Sample B17955-S36 Vinyl Skirting No Asbestos Detected	A5	No Action Required
26 th February 2018

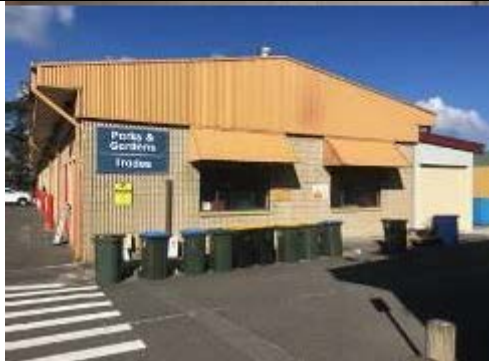
External - Trades Western Aspect Corrugated Iron Gable and Awning (Soffit has been Removed), Aluminum Corner Capping & Window Frames, Block Walls	No Sample Taken No Asbestos Containing Material Sighted 2192	A5	No Action Required
26 th February 2018

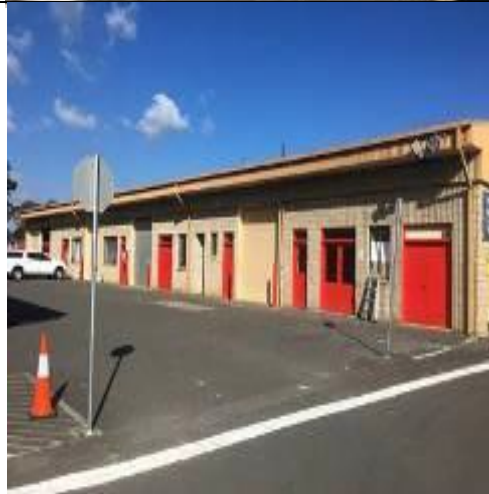
External - Trades Northern Aspect Corrugated Iron Roof, Steel Gutters / Fascia / Downpipes / Corner Capping / Soffit, Aluminum Window Frames, Fibre Glass Lower Fascia, Steel Roller Doors, Block Walls, Steel Bollards and Doorframes, Solid Timber Doors	No Sample Taken No Asbestos Containing Material Sighted 2193	A5	No Action Required

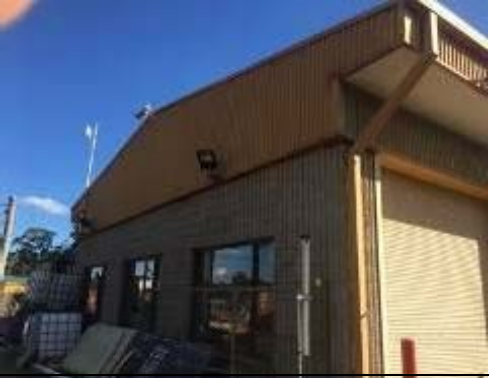
External - Trades Eastern Aspect Profiled Steel Gable, Block Walls, Aluminum Window Frames / Corner Capping 2194	No Sample Taken No Asbestos Containing Material Sighted	A5	No Action Required
26 th February 2018

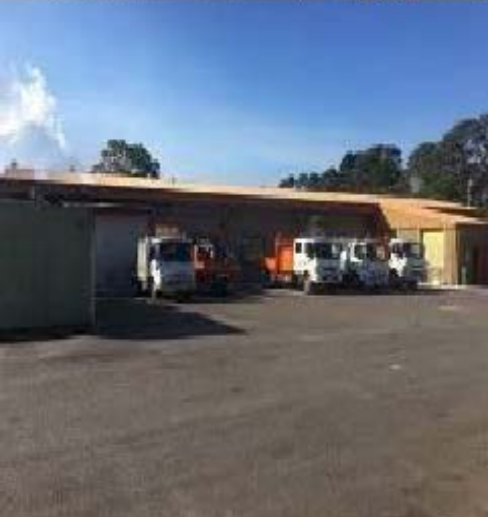
External - Trades Southern Aspect Corrugated Iron Roof, Steel Gutters / Fascia / Downpipes / Corner Capping / Soffit, Aluminum Window Frames, Fibre Glass Lower Fascia, Steel Roller Doors, Block Walls, Steel Bollards and Doorframes, Solid Timber Doors 2195	No Sample Taken No Asbestos Containing Material Sighted	A5	No Action Required
26 th February 2018

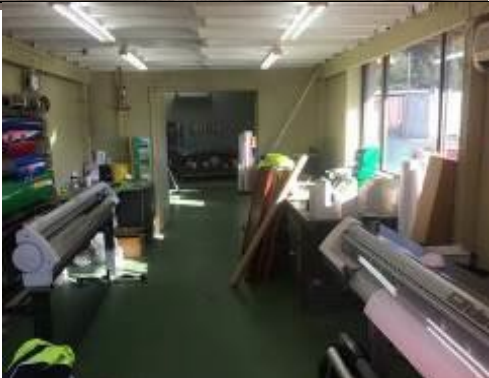
Internal - Trades Ground Floor Printing Room 1 Compressed Timber Ceiling, Timber Support Beams, Block Walls, Aluminum Door & Window Frames, Concrete Slab 2196	No Sample Taken No Asbestos Containing Material Sighted	A5	No Action Required

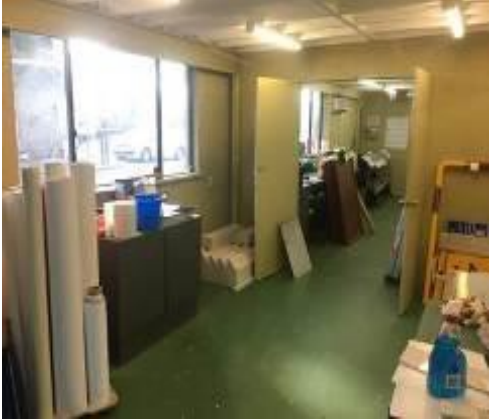
Internal - Trades, Ground Floor Printing Room 2 Compressed Timber Ceiling, Timber Support Beams, Block Walls, Aluminum Door & Window Frames, Concrete Slab, MDF Tool Board	No Sample Taken No Asbestos Containing Material Sighted 2197	A5	No Action Required
26 th February 2018

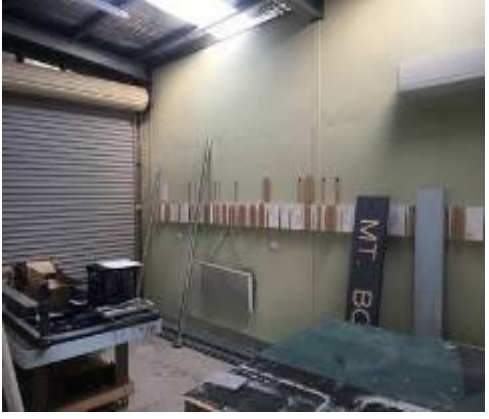
Internal - Trades Printing Room Extension Insulation Foil, Steel Support Beams, Timber Wall South, East & West Steel Roller Doors, Brick & Render North Wall, Concrete Slab	No Sample Taken No Asbestos Containing Material Sighted 2198	A5	No Action Required
26 th February 2018

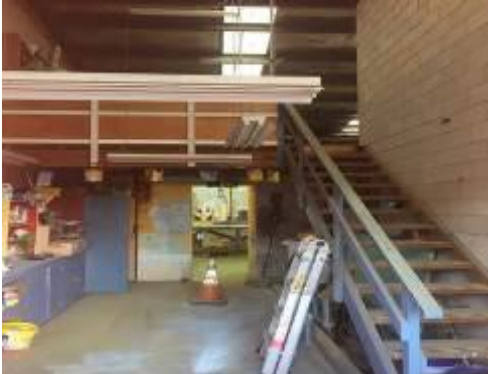
Internal - Trades Ground Floor Printing Room 3 Block Walls, Aluminum Door Frames, Timber Doors & Stairs 2199	No Sample Taken No Asbestos Containing Material Sighted	A5	No Action Required

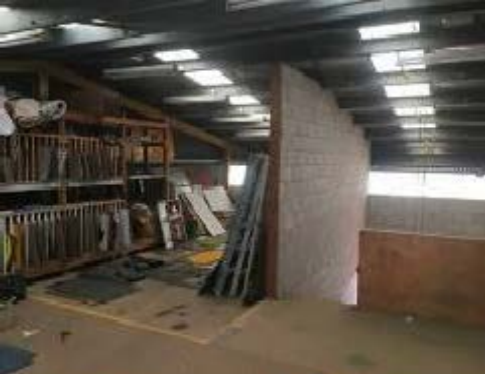
Internal – Trades 1 st Floor Printing Room Foil Insulation, RSJ Beams, Corrugated Iron & Block Wall, Particleboard Floor 2200	No Sample Taken No Asbestos Containing Material Sighted	A5	No Action Required
26 th February 2018

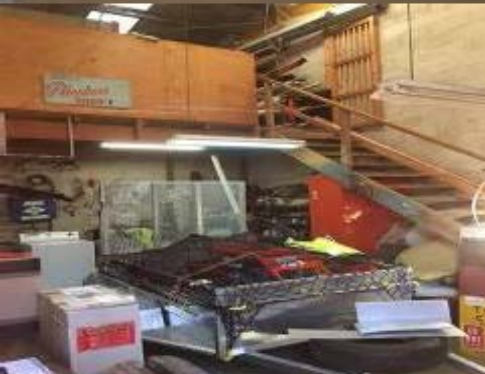
Internal - Trades Ground Floor Plumbers Shop Block Walls, Steel Roller Door, Timber Stairs, Concrete Slab 2201	No Sample Taken No Asbestos Containing Material Sighted	A5	No Action Required
26 th February 2018

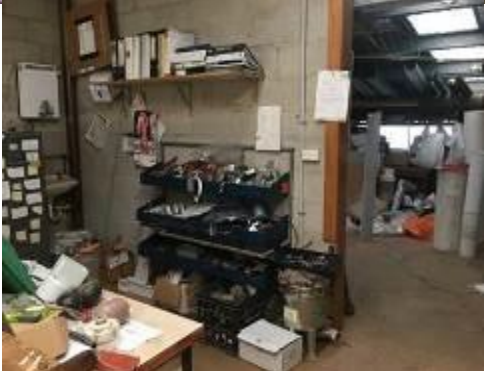
Internal – Trades 1 st Floor Plumbers Shop Insulation Foil, RSJ Beams, Corrugated Iron Western Wall / Block Wall, Particleboard Floor 2202	No Sample Taken No Asbestos Containing Material Sighted	A5	No Action Required

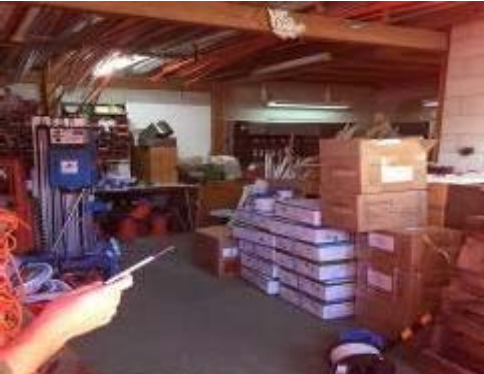
Internal - Trades Ground Floor Electricians Area Concrete Brick Walls, Steel Roller Door, Timber Stairs, Concrete Slab Floor 2203	No Sample Taken No Asbestos Containing Material Sighted	A5	No Action Required
26 th February 2018

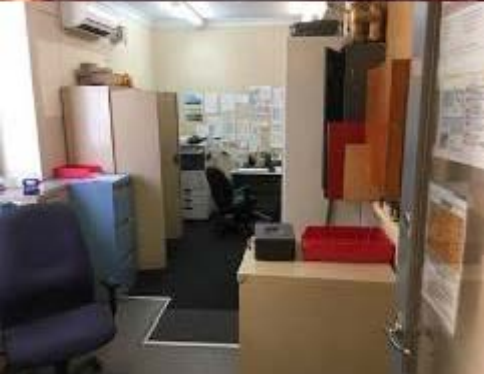
Internal - Trades Ground Floor Carpenters Office Plasterboard Ceiling / Cornices / Walls, Block Walls, PVC Corner Capping, Masonite Infill, Vinyl Skirting & Floor 2204	No Sample Taken No Asbestos Containing Material Sighted	A5	No Action Required
26 th February 2018

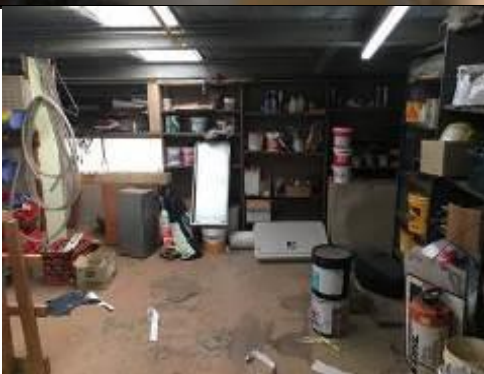
Internal - Trades 1 st Floor Carpenters Area Foil Insulation, RSJ Beams, Block & Corrugated Iron Walls / Block, Particleboard Floor 2205	No Sample Taken No Asbestos Containing Material Sighted	A5	No Action Required

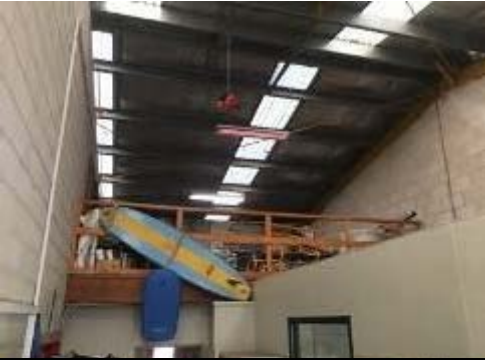
Internal - Trades 1 st Floor Offices Foil Insulation, RSJ Beams, Corrugated Iron & Block Walls, Particleboard Floor 2206	No Sample Taken No Asbestos Containing Material Sighted	A5	No Action Required
26 th February 2018

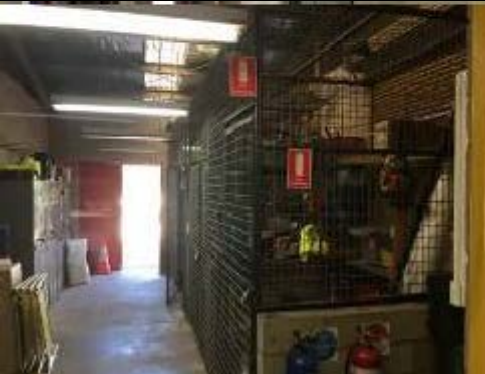
Internal - Trades Ground Floor Rear of Offices Foil Insulation, RSJ Beams, Block Walls, Steel Roller Doors / Cages / Frames, Solid Timber Doors 2207	No Sample Taken No Asbestos Containing Material Sighted	A5	No Action Required
26 th February 2018

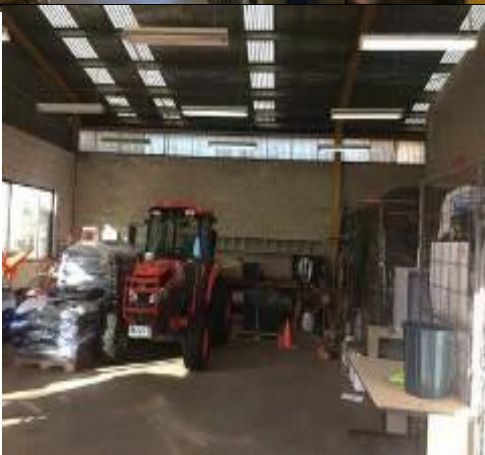
Internal - Trades Ground Floor Machinery Shed Foil Insulation, RSJ Beams, Block Walls, Steel Roller Doors / Cages / Frames, Solid Timber Doors, Aluminum Window Frames, Masonite Tool Board 2208	No Sample Taken No Asbestos Containing Material Sighted	A5	No Action Required

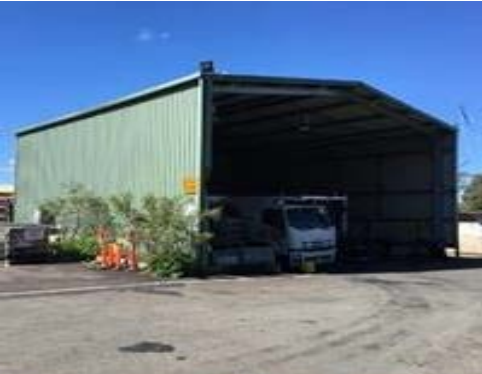
External - Emulsion Shed Steel Roof / Frame / Wall Cladding, Concrete Floor 2209	No Sample Taken No Asbestos Containing Material Sighted	A5	No Action Required
26 th February 2018

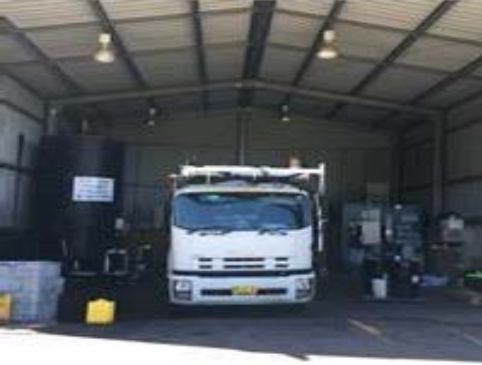
Internal - Emulsion Shed Steel Roof / Frame / Wall Cladding, Block Walls, Concrete Floor 2210	No Sample Taken No Asbestos Containing Material Sighted	A5	No Action Required
26 th February 2018

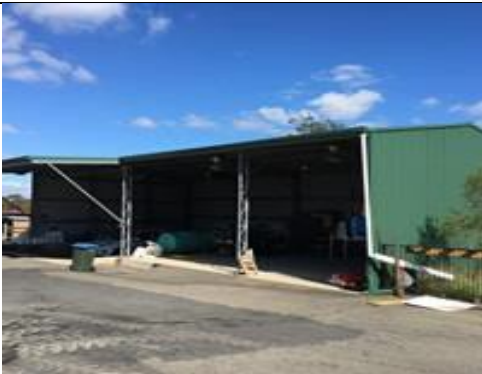
External - Storage Shed Steel Roof / Frame / Wall Cladding, Block Walls, Concrete Floor 2211	No Sample Taken No Asbestos Containing Material Sighted	A5	No Action Required

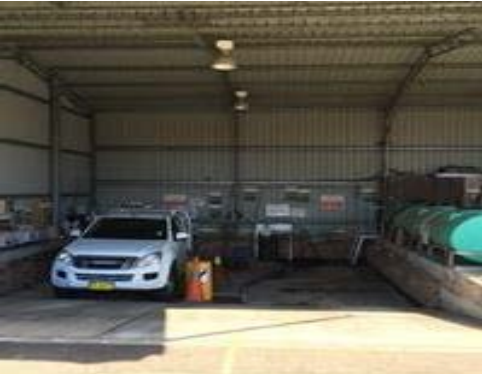
Internal - Storage Shed Steel Roof / Frame / Wall Cladding, Block Walls, Concrete Floor 2212	No Sample Taken No Asbestos Containing Material Sighted	A5	No Action Required
26 th February 2018

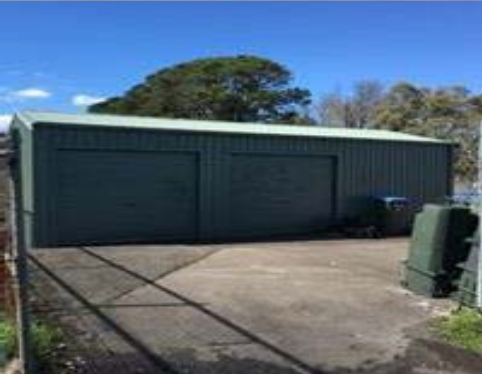
External - Storage Shed Steel Roof / Frame / Wall Cladding, Concrete Floor Note: Nil Access to Interior 2213	No Sample Taken No Asbestos Containing Material Sighted	A5	No Action Required for External Building However Reinspect Interior When Accessible
26 th February 2018

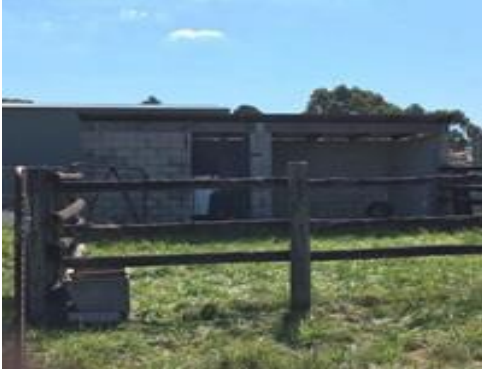
External - Animal Enclosure Corrugated Iron Roof & Wall Cladding, Block Walls, Timber Roof Frame 2214	No Sample Taken No Asbestos Containing Material Sighted	A5	No Action Required

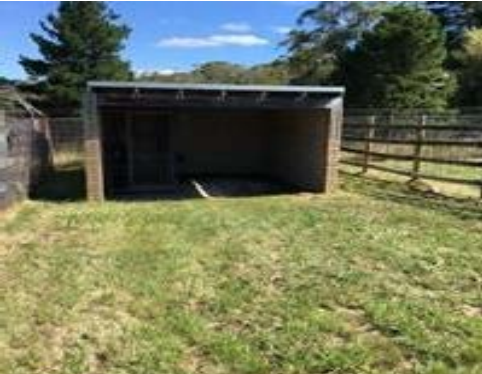
External - Animal Enclosure Corrugated Iron Roof & Wall Cladding, Block Walls, Timber Roof Frame 2215	No Sample Taken No Asbestos Containing Material Sighted	A5	No Action Required
26 th February 2018

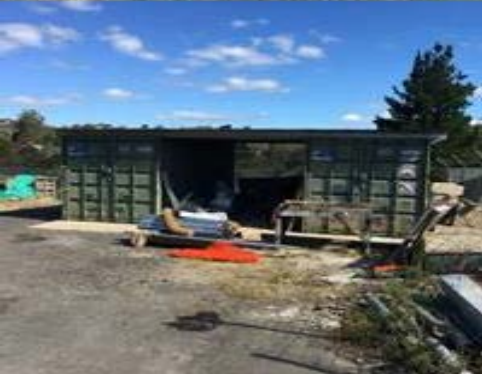
External - Roofed Containers Steel Frame & Cladding Roof, General Debris Within the Laydown Area 2216	No Sample Taken No Asbestos Containing Material Sighted	A5	No Action Required
26 th February 2018

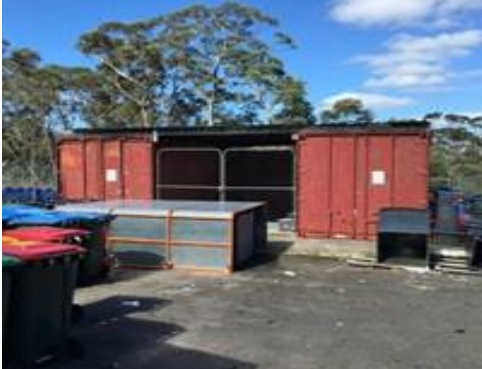
External - Roofed Containers Steel Frame & Cladding Roof, General Debris Within the Laydown Area 2217	No Sample Taken No Asbestos Containing Material Sighted	A5	No Action Required

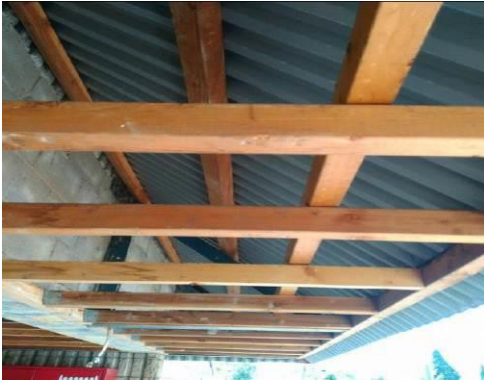
Amenities Carpark Entrance Carpark Exit Door Awning Ceiling Fibre Cement Sheets Sample B17955-S16 Chrysotile Asbestos Detected Non-Friable Approximately 3m ² 2219	Company Empire Contracting Pty Ltd SafeWork NSW Licence Number AD204967 Supervisor Buntha Thia SafeWork NSW Notification & Removal Number Not Provided	Company SLR Consulting Pty Ltd Clearance Signatory for Removal Area Occupancy Jordan Harley Clearance Report Number 610.17816.00000.36 0-RO1-v1.0-CLR

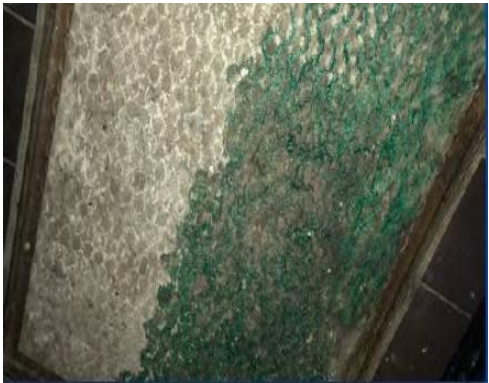
<p>Administration Building</p> <p>Entry Foyer</p> <p>Decontamination of Contaminated Common Area and Adjacent Areas</p> <p>2221</p>	<p>Company</p> <p>Empire Contracting Pty Ltd</p> <p>SafeWork NSW Licence Number</p> <p>AD204967</p> <p>Supervisor</p> <p>Not Provided</p> <p>SafeWork NSW Notification & Removal Number</p> <p>Not Provided</p>	<p>Company</p> <p>AIRSAFE OHC Pty Ltd</p> <p>Clearance Signatory for Removal Area Occupancy</p> <p>Ashley McDonald NSW LAA001261</p> <p>Clearance Report Number</p> <p>Job No: 40066 CC #4006 18/83001</p>

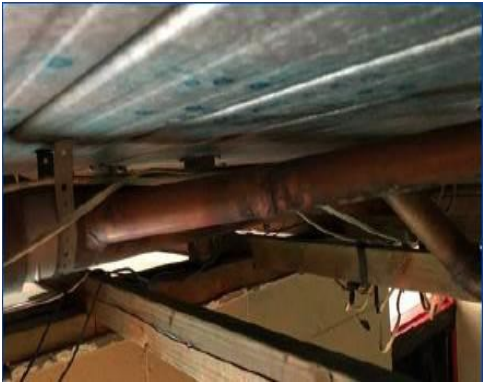
Administration Building Ground Entry Ceiling Space Decontamination of Contaminated Common Area and Adjacent Areas 2222	Company Empire Contracting Pty Ltd SafeWork NSW Licence Number AD204967 Supervisor Not Provided SafeWork NSW Notification & Removal Number Not Provided	Company AIRSAFE OHC Pty Ltd Clearance Signatory for Removal Area Occupancy Ashley McDonald NSW LAA001261 Clearance Report Number Job No: 40066 CC #4006 18/83001
3 rd – 7 th April 2018

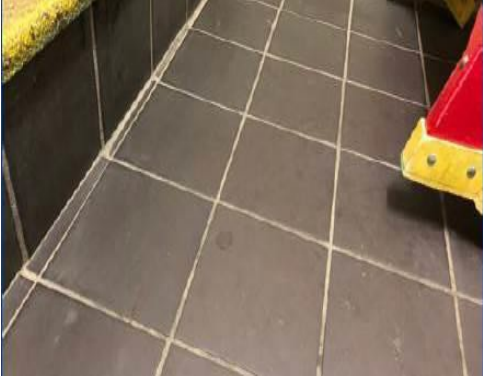
Administration Building Staircase Second Landing Floor Surface Decontamination of Contaminated Common Area and Adjacent Areas 2223	Company Empire Contracting Pty Ltd SafeWork NSW Licence Number AD204967 Supervisor Not Provided SafeWork NSW Notification & Removal Number Not Provided	Company AIRSAFE OHC Pty Ltd Clearance Signatory for Removal Area Occupancy Ashley McDonald NSW LAA001261 Clearance Report Number Job No: 40066 CC #4006 18/83001

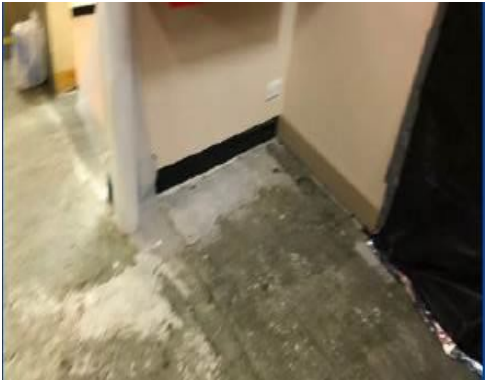
Administration Building Entry Foyer Floor Surface Decontamination of Contaminated Common Area and Adjacent Areas 2224	Company Empire Contracting Pty Ltd SafeWork NSW Licence Number AD204967 Supervisor Not Provided SafeWork NSW Notification & Removal Number Not Provided	Company AIRSAFE OHC Pty Ltd Clearance Signatory for Removal Area Occupancy Ashley McDonald NSW LAA001261 Clearance Report Number Job No: 40066 CC #4006 18/83001
3 rd – 7 th April 2018

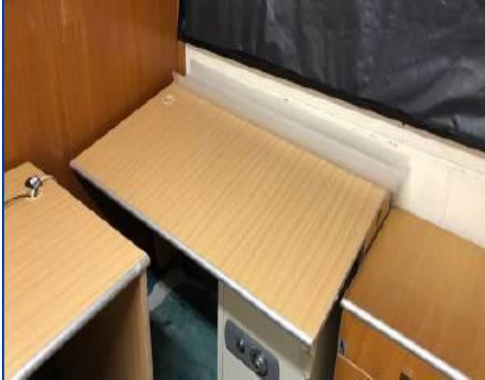
Administration Building Maintenance Coordinator Office West Decontamination of Contaminated Common Area and Adjacent Areas 2225	Company Empire Contracting Pty Ltd SafeWork NSW Licence Number AD204967 Supervisor Not Provided SafeWork NSW Notification & Removal Number Not Provided	Company AIRSAFE OHC Pty Ltd Clearance Signatory for Removal Area Occupancy Ashley McDonald NSW LAA001261 Clearance Report Number Job No: 40066 CC #4006 18/83001

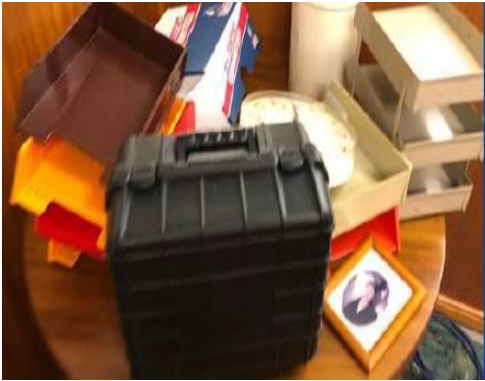
Administration Building Maintenance Coordinator Office West Office Items Decontamination of Contaminated Common Area and Adjacent Areas 2226	Company Empire Contracting Pty Ltd SafeWork NSW Licence Number AD204967 Supervisor Not Provided SafeWork NSW Notification & Removal Number Not Provided	Company AIRSAFE OHC Pty Ltd Clearance Signatory for Removal Area Occupancy Ashley McDonald NSW LAA001261 Clearance Report Number Job No: 40066 CC #4006 18/83001
3 rd – 7 th April 2018

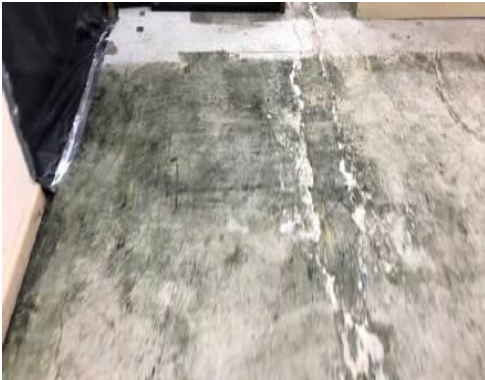
Administration Building Common Area South Floor Surface Decontamination of Contaminated Common Area and Adjacent Areas 2227	Company Empire Contracting Pty Ltd SafeWork NSW Licence Number AD204967 Supervisor Not Provided SafeWork NSW Notification & Removal Number Not Provided	Company AIRSAFE OHC Pty Ltd Clearance Signatory for Removal Area Occupancy Ashley McDonald NSW LAA001261 Clearance Report Number Job No: 40066 CC #4006 18/83001

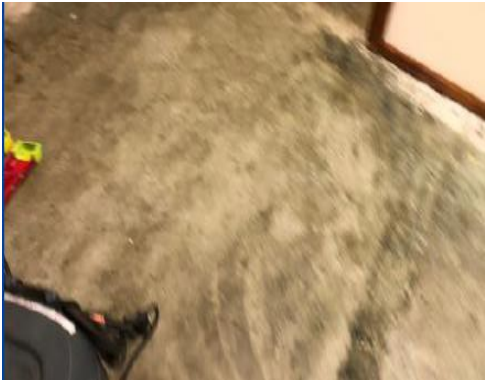
Administration Building Common Area North Floor Surface Decontamination of Contaminated Common Area and Adjacent Areas 2228	Company Empire Contracting Pty Ltd SafeWork NSW Licence Number AD204967 Supervisor Not Provided SafeWork NSW Notification & Removal Number Not Provided	Company AIRSAFE OHC Pty Ltd Clearance Signatory for Removal Area Occupancy Ashley McDonald NSW LAA001261 Clearance Report Number Job No: 40066 CC #4006 18/83001
3 rd – 7 th April 2018

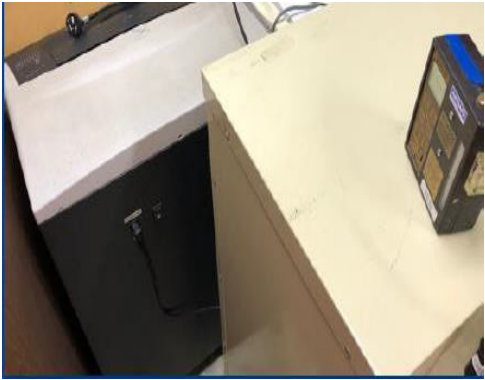
Administration Building Common Area Surfaces Decontamination of Contaminated Common Area and Adjacent Areas 2229	Company Empire Contracting Pty Ltd SafeWork NSW Licence Number AD204967 Supervisor Not Provided SafeWork NSW Notification & Removal Number Not Provided	Company AIRSAFE OHC Pty Ltd Clearance Signatory for Removal Area Occupancy Ashley McDonald NSW LAA001261 Clearance Report Number Job No: 40066 CC #4006 18/83001

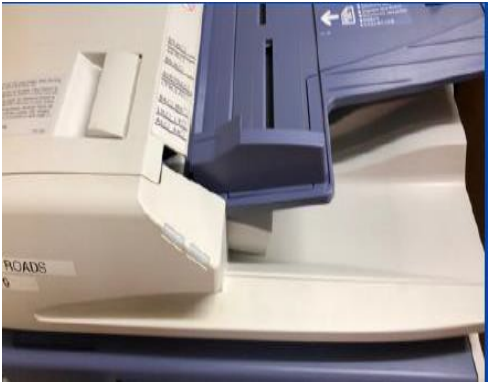
Administration Building Printer Surfaces Decontamination of Contaminated Common Area and Adjacent Areas 2230	Company Empire Contracting Pty Ltd SafeWork NSW Licence Number AD204967 Supervisor Not Provided SafeWork NSW Notification & Removal Number Not Provided	Company AIRSAFE OHC Pty Ltd Clearance Signatory for Removal Area Occupancy Ashley McDonald NSW LAA001261 Clearance Report Number Job No: 40066 CC #4006 18/83001
3 rd – 7 th April 2018

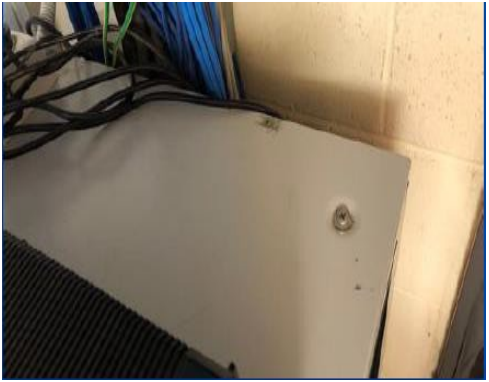
Administration Building Server Cabinet Surface Decontamination of Contaminated Common Area and Adjacent Areas 2231	Company Empire Contracting Pty Ltd SafeWork NSW Licence Number AD204967 Supervisor Not Provided SafeWork NSW Notification & Removal Number Not Provided	Company AIRSAFE OHC Pty Ltd Clearance Signatory for Removal Area Occupancy Ashley McDonald NSW LAA001261 Clearance Report Number Job No: 40066 CC #4006 18/83001

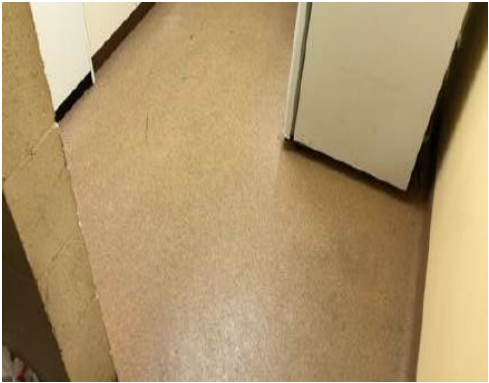
Administration Building Kitchen Surfaces Decontamination of Contaminated Common Area and Adjacent Areas 2232	Company Empire Contracting Pty Ltd SafeWork NSW Licence Number AD204967 Supervisor Not Provided SafeWork NSW Notification & Removal Number Not Provided	Company AIRSAFE OHC Pty Ltd Clearance Signatory for Removal Area Occupancy Ashley McDonald NSW LAA001261 Clearance Report Number Job No: 40066 CC #4006 18/83001
26 th February 2018

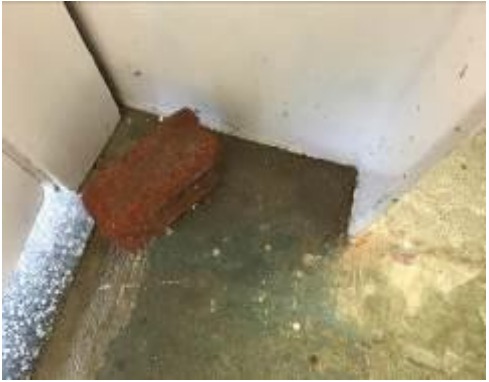
Stores Building Piece of Bonded Board Removed from under Brick by front door 0.1m ² 2094	Company Blue Mountains City Council Employee Licence Number N/A Supervisor N/A SafeWork NSW Notification & Removal Number N/A	No Clearance Report Available

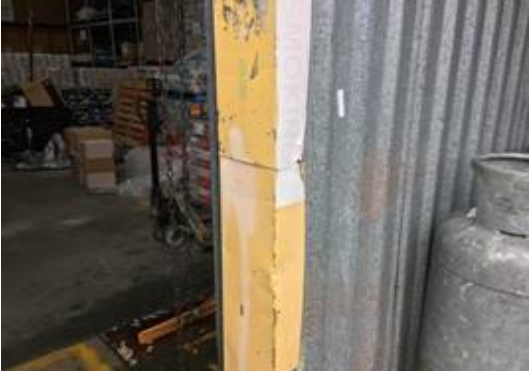
Store Yellow Paint to Metal Flashing Both Sides of East & West Roller Door	7.6%	A3	Paint is classified as lead based as greater than 0.1% w/w

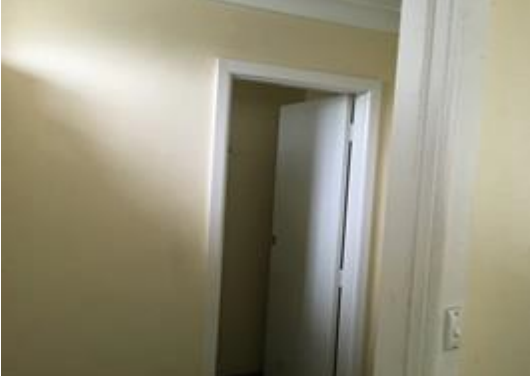
Store White Paint to Doors and Timber Trim in Office and Bathroom	0.3%	A4	Paint is classified as lead based as greater than 0.1% w/w
Envirolab# 190468-3

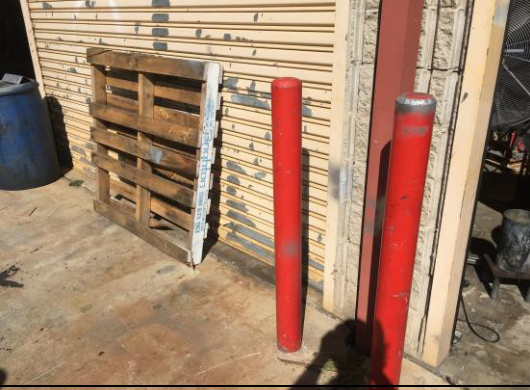
Garage / Workshop Cream Paint to External Roller Door	2.4%	A4	Paint is classified as lead based as greater than 0.1% w/w
Envirolab# 186271-9

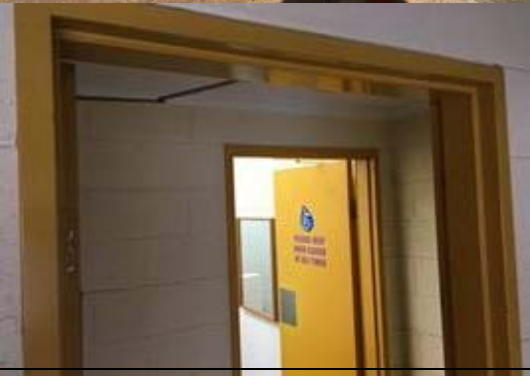
Amenities Building Yellow Paint to All Doors and Metal Door Jambs	0.4%	A4	Paint is classified as lead based as greater than 0.1% w/w
Envirolab# 186271-13

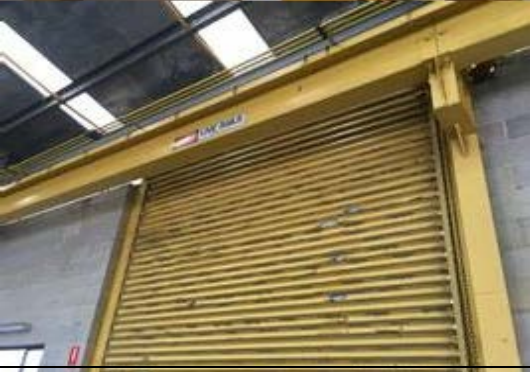
Garage / Workshop Yellow Paint to Roller Doors and Overhead Crane System	2.8%	A3	Paint is classified as lead based as greater than 0.1% w/w

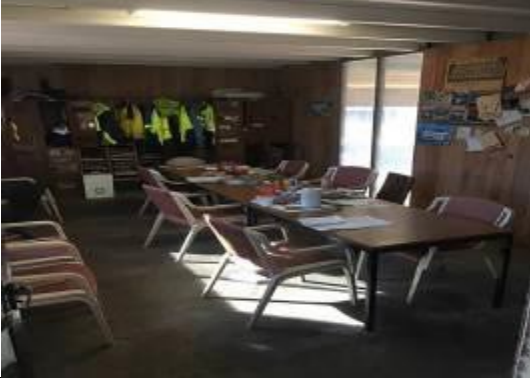
Garage / Workshop Upper Level Meal Room White Paint to Ceiling	0.4%	A3	Paint is classified as lead based as greater than 0.1% w/w
Envirolab# 186271-17

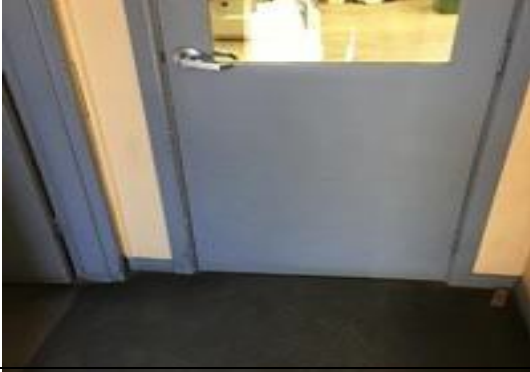
Trades / Gardeners Shed Grey Paint to Doors, Frames & Architrave	0.62%	A4	Paint is classified as lead based as greater than 0.1% w/w
Envirolab# 186271-1

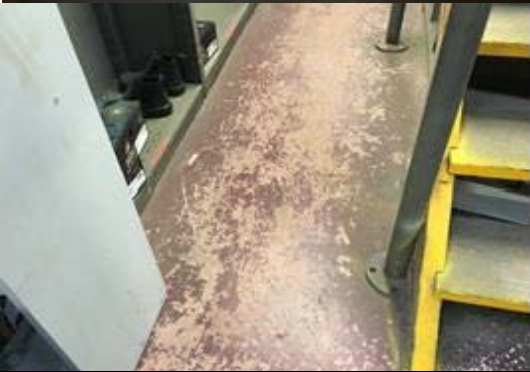
Store Red Paint to Concrete Floor in Mezzanine Storage Area	0.1%	A4	Paint is not classified as lead based as less than or Equal to 0.1% w/w
Envirolab# 186271-12

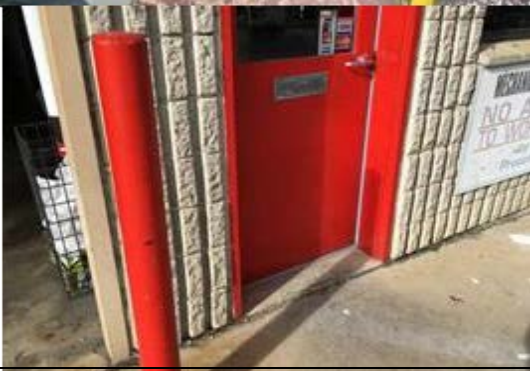
Garage / Workshop Red Paint to Office Front Door	0.1%	A4	Paint is not classified as lead based as less than or Equal to 0.1% w/w

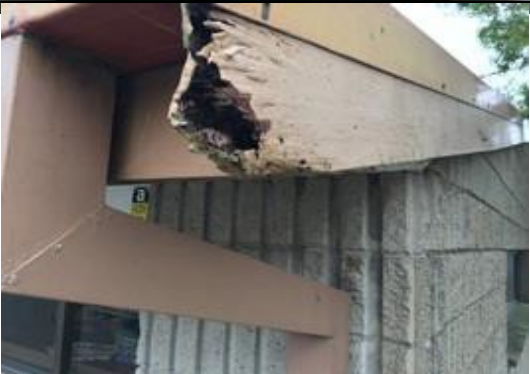
Amenities Building Orange/Brown Paint to Timber Fascia Boards Around Roofline and Downpipes	<0.05%	A5	Paint not classified as lead based as less than or Equal to 0.1% w/w

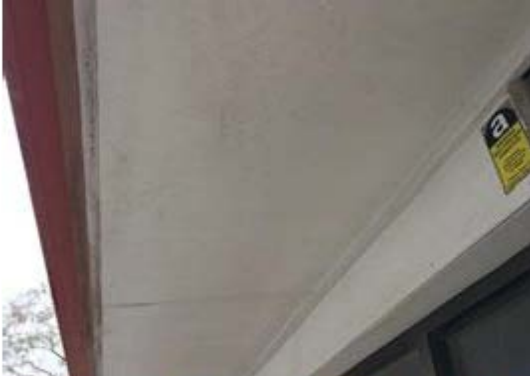
Amenities Building White Paint to Eaves and Soffits on Awnings	<0.05%	A5	Paint not classified as lead based as less than or Equal to 0.1% w/w
Envirolab# 186271-8

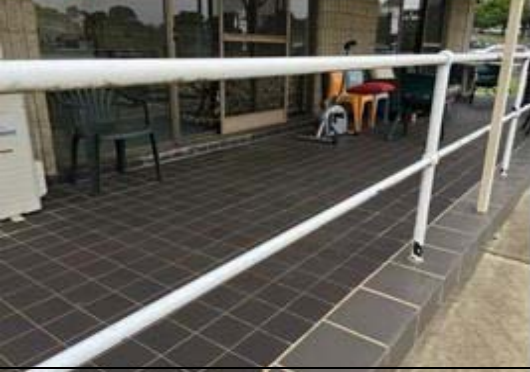
Amenities Building White Paint to Handrail at North Veranda	<0.05%	A5	Paint not classified as lead based as less than or Equal to 0.1% w/w
Envirolab# 186271-10	 	Garage / Workshop Dark Grey Paint to Doors and Timber Trim Inside Office Area	<0.05%	A5	Paint not classified as lead based as less than or Equal to 0.1% w/w
Envirolab# 186271-11	 	Garage / Workshop Burgundy Paint to External Doors and Timber Trim to Office	<0.05%	A5	Paint not classified as lead based as less than or Equal to 0.1% w/w

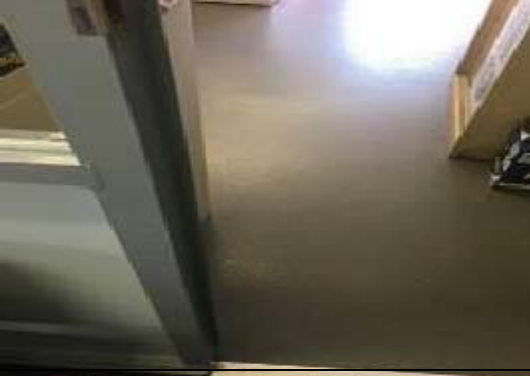
Garage / Workshop Office Blue Paint	<0.05%	A5	Paint not classified as lead based as less than or Equal to 0.1% w/w
Envirolab# 190468-6

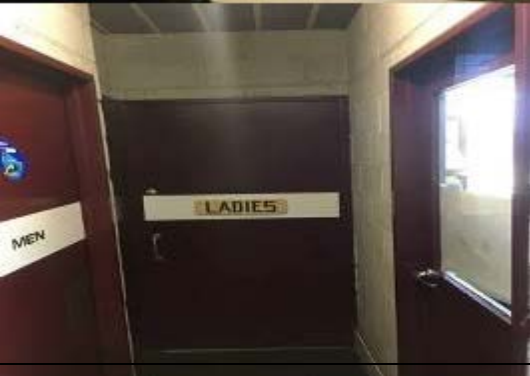
Garage / Workshop Void between Office and Toilets Maroon Paint	<0.05%	A5	Paint not classified as lead based as less than or Equal to 0.1% w/w
Envirolab# 186271-14

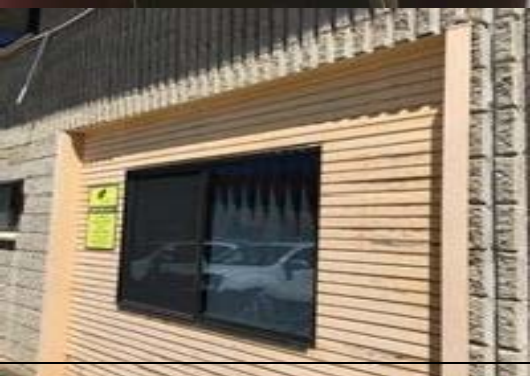
Administration Block Mustard Yellow Paint to Steel Beams, Columns, Timber Slat Weatherboards	<0.05%	A5	Paint not classified as lead based as less than or Equal to 0.1% w/w
Envirolab# 190468-2

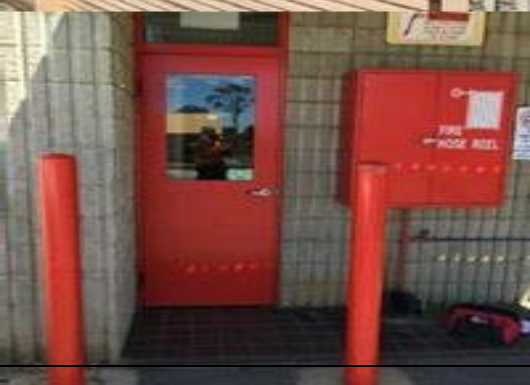
Administration Block Red Door Paint to Main Entry	<0.05%	A5	Paint not classified as lead based as less than or Equal to 0.1% w/w

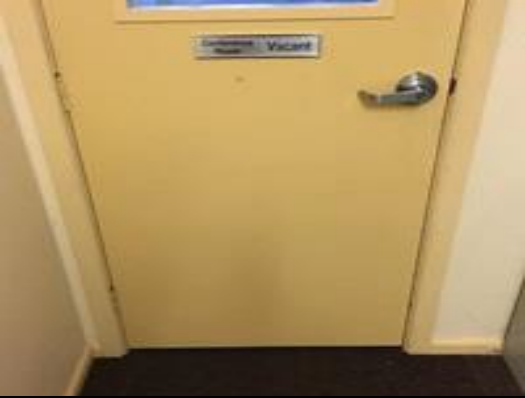
Administration Block – Ground Floor and 1 st Floor Offices Cream / Yellow Paint to Doors, Jambs, and Timber Trim	<0.05%	A5	Paint not classified as lead based as less than or Equal to 0.1% w/w
Envirolab# 186271-16

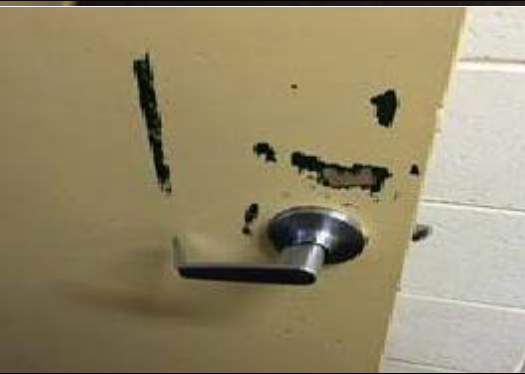
Administration Block Green Paint to 'Admin' Door on 1 st Floor Under Yellow Paint	<0.05%	A5	Paint not classified as lead based as less than or Equal to 0.1% w/w
Envirolab# 190468-8

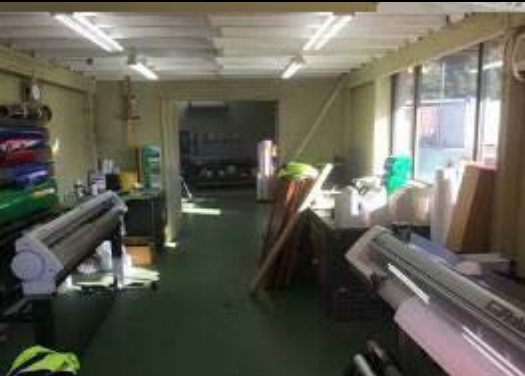
Trades / Gardiners Shed Printing Room Olive Green Wall Paint	<0.05%	A5	Paint not classified as lead based as less than or Equal to 0.1% w/w
Envirolab# 190468-9

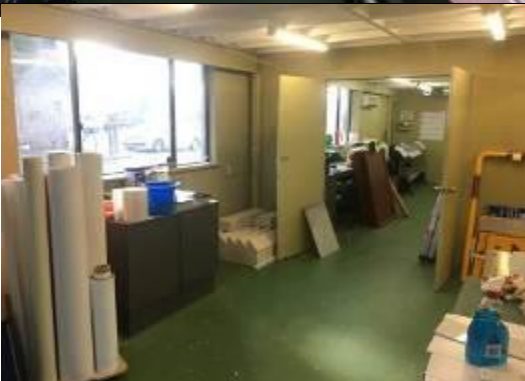
Trades / Gardiners Shed Printing Room Dark Green Floor Paint	<0.05%	A5	Paint not classified as lead based as less than or Equal to 0.1% w/w

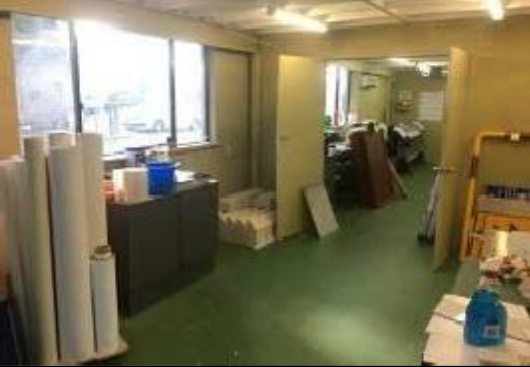
Trades / Gardiners Shed Printing Room White Paint	<0.05%	A5	Paint not classified as lead based as less than or Equal to 0.1% w/w
Envirolab# 190468-1

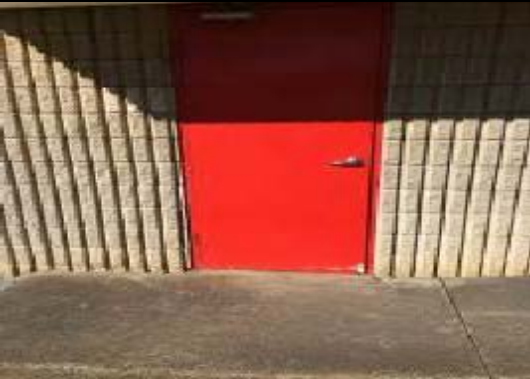
Amenities Block Red Paint on Entrance Door	<0.05%	A5	Paint not classified as lead based as less than or Equal to 0.1% w/w

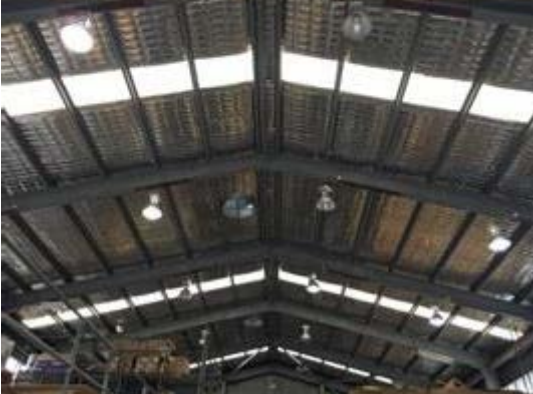
Store Roof Blanket to Underside of New Roof Sheets Approximately 390m ²	No Sample Taken Visual Inspection Only	A5	No Action Required
26 th February 2018

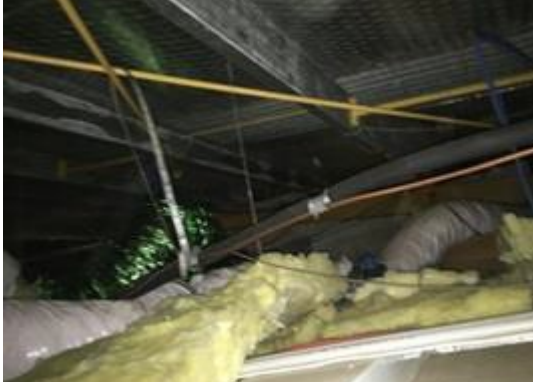
Administration Block SMF Battis in 1 st Floor Roof Space	No Sample Taken Visual Inspection	A5	Accessible to Tradespeople Refer to Management Plan

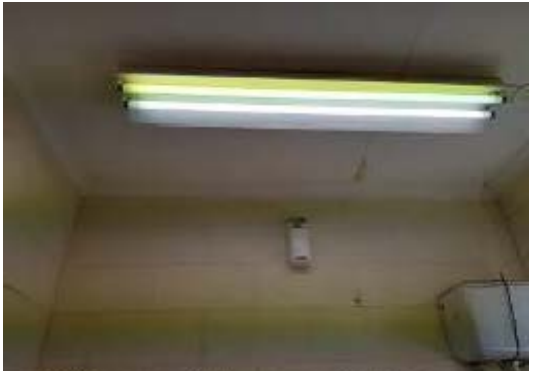
Parks & Gardens / Trades Male Toilets, Double Internal Fluorescent Light Assembly	RIFA PHN 3µF Type Capacitor Contains PCB's	A3	Accessible to Tradespeople Refer to Management Plan
4 th April 2018

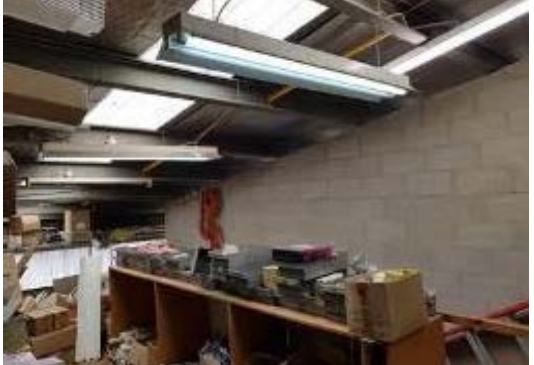
Parks & Gardens / Trades Electrical Room, 3 x Single Fluorescent Light Assemblies	RIFA PHN 3µF Type Capacitor Contains PCB's	A3	Accessible to Tradespeople Refer to Management Plan

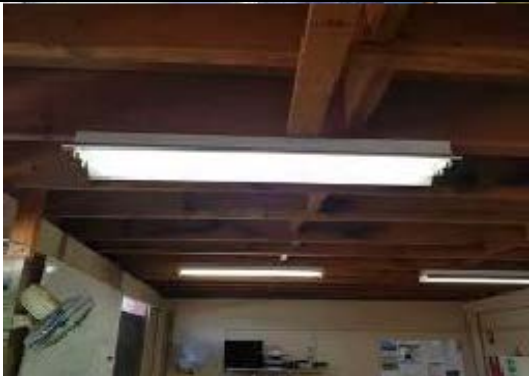
Parks & Gardens / Trades Carpentry Breakroom Double Fluorescent Light Assemblies	RIFA PHN 3µF Type Capacitor Present Contains PCB's	A3	Accessible to Tradespeople Refer to Management Plan
4 th April 2018

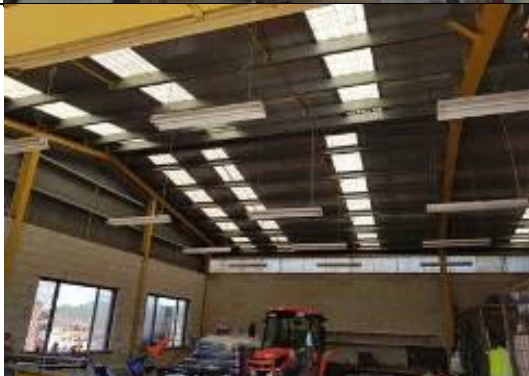
Parks & Gardens / Trades Tractor Shed 10 x Double Fluorescent Light Assemblies	RIFA PHN 3µF Type Capacitor Present Contains PCB's	A3	Accessible to Tradespeople Refer to Management Plan

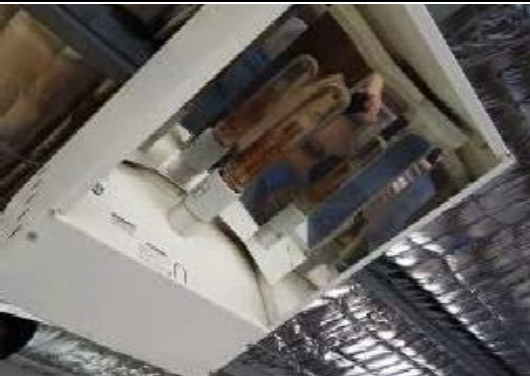
Stores 3 x New Style Fluorescent Lights in Warehouse	ICAR Capacitor No PCB's Present	A5	No Action Required
4 th April 2018

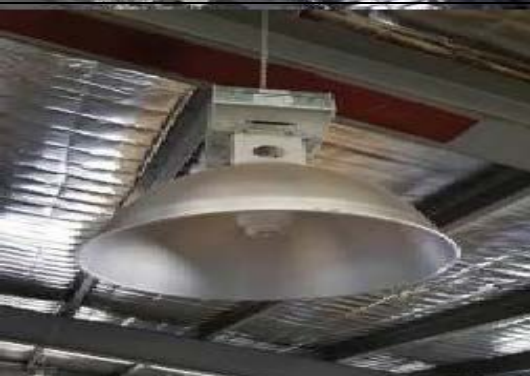
Stores 13 x New Style Fluorescent Hanging Lights in Warehouse Installed in Sept 2011.	No Access to Lights Due to Height Restrictions Assume no PCB's Due to Age of Lights	A5	No Action Required
4 th April 2018

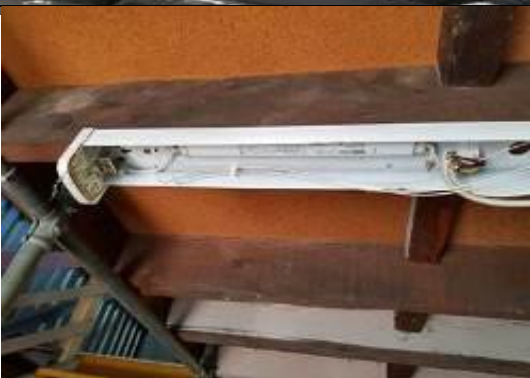
Stores 41 x Warehouse Double Fluorescent Light Assemblies	No PCB Containing Capacitors / Resistors Sighted	A5	No Action Required

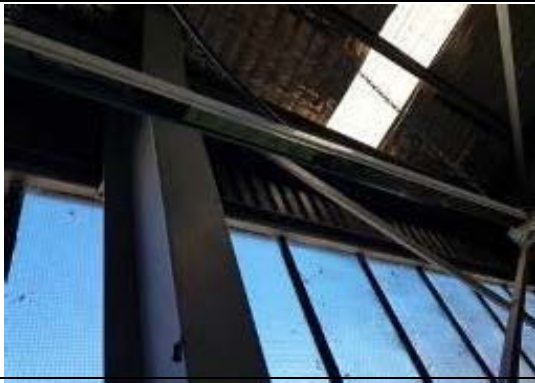
Stores 3 x Warehouse Single Fluorescent Light Assemblies	No PCB Containing Capacitors / Resistors Sighted	A5	No Action Required
26 th February 2018

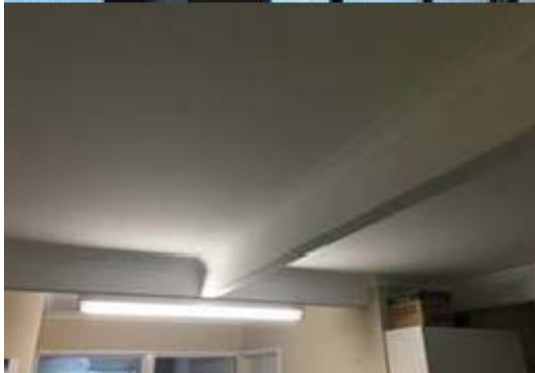
Stores Offices and Kitchens Throughout, Single and Double Fluorescent Light Assemblies.	No PCB Containing Capacitors / Resistors Sighted	A5	No Action Required
4 th April 2018

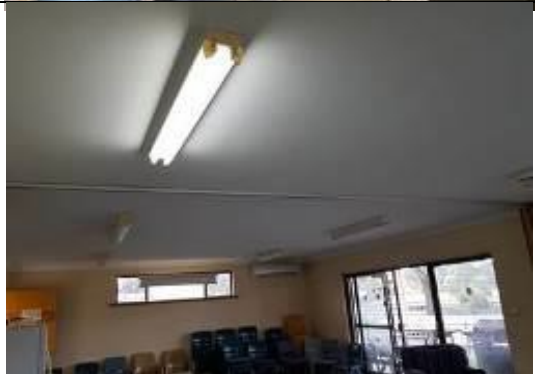
Amenities Building. Break Room. 7 x Double Fluorescent Light Assemblies.	RIFA PFN 453 Type Capacitor. No PCB's Present	A5	No Action Required

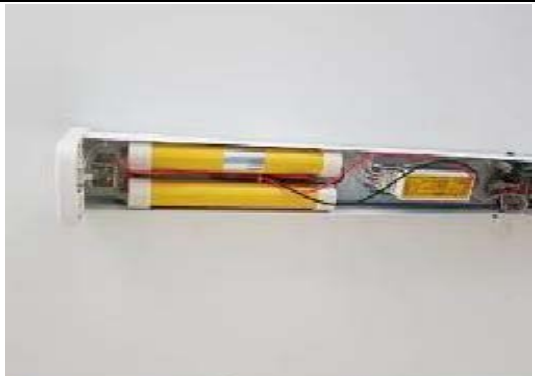
Amenities Building. Break Room. South-East Double Fluorescent Light Assembly.	New Light with New Style Capacitor No PCB Containing Capacitors / Resistors Sighted	A5	No Action Required
4 th April 2018

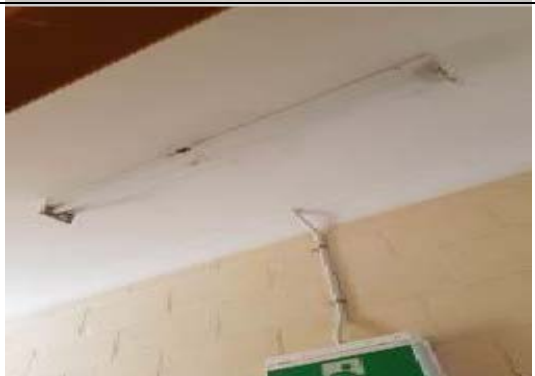
Amenities Building. Western Hallway, Double Fluorescent Light Assembly.	Comar MFE 6 Capacitor No PCB's Present	A5	No Action Required
26 th February 2018

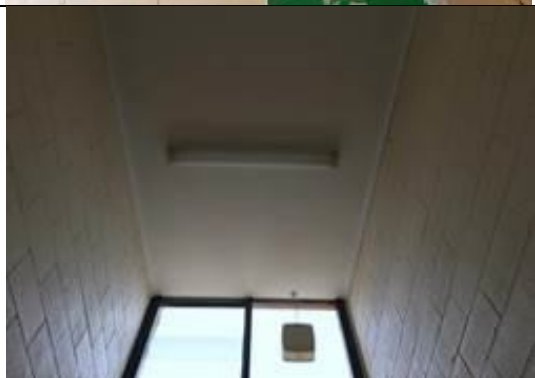
Amenities Building Female Shower	Vossloh Schwabe 40934 Type Capacitor No PCB's Present	A5	No Action Required

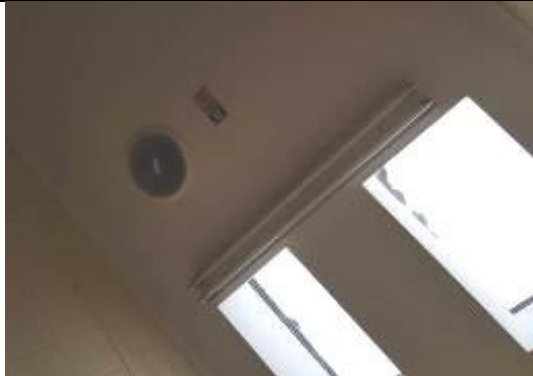
Amenities Building. Female Toilet	Vossloh Schwabe 40934 Type Capacitor No PCB's Present	A5	No Action Required
4 th April 2018

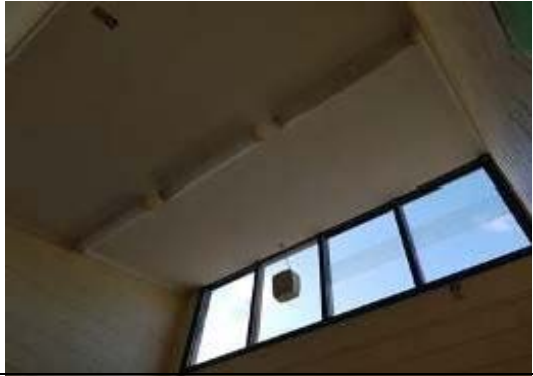
Amenities Building. 3 x Entrance Lights	Vossloh Schwabe 40934 Type Capacitor No PCB's Present	A5	No Action Required
4 th April 2018

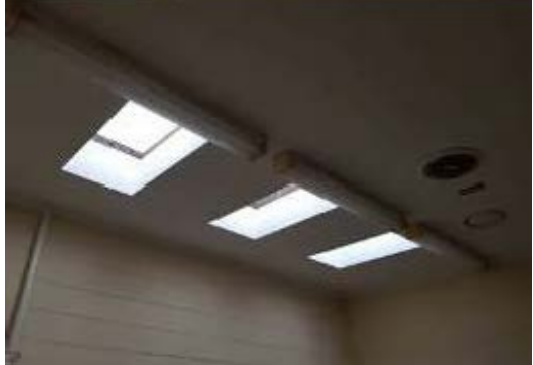
Amenities Building Male Toilet	Vossloh Schwabe 40934 Type Capacitor. No PCB's Present	A5	No Action Required
