Asbestos Register

Prepared for:
Blue Mountains City Council,
2-6, Civic Place,
Katoomba,
NSW, 2780

On the 26th and 27th of February and the 23rd and 24th April 2018, an Asbestos Audit was conducted at the Katoomba Depot located at 22, South Street, Katoomba, NSW, 2780. Asbestos containing building materials were found to be present at the premises. Please refer Appendix I for results of products that were sampled and analysed but did not contain asbestos.

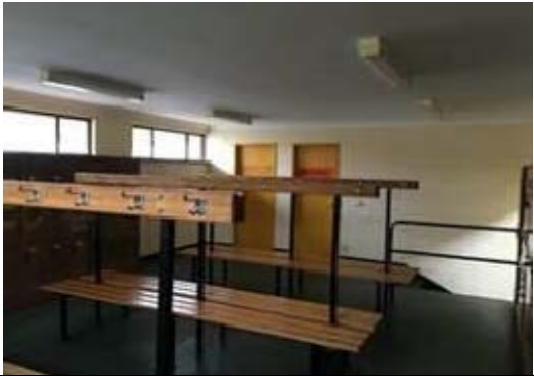
Amenities Building Male Locker Room	Vossloh Schwabe 40934 Type Capacitor No PCB's Present	A5	No Action Required
4 th April 2018

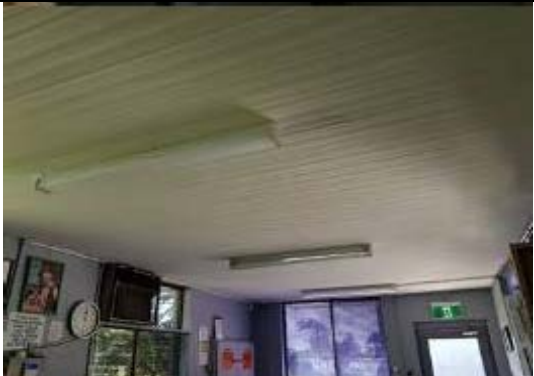
Mechanical Services 6x Double Fluorescent Light Assemblies in Office Areas	No PCB Containing Capacitors / Resistors Sighted	A5	No Action Required
4 th April 2018

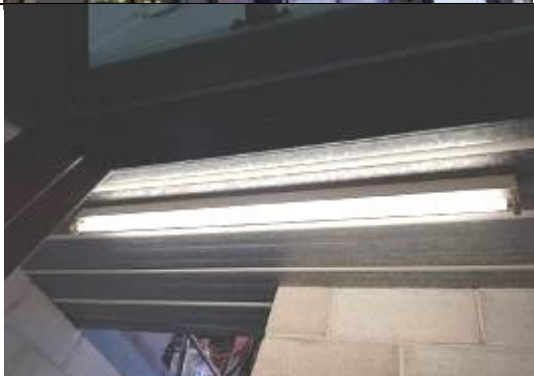
Mechanical Services Single Fluorescent Light Assembly in Hallway and Male Toilets	No PCB Containing Capacitors / Resistors Sighted	A5	No Action Required

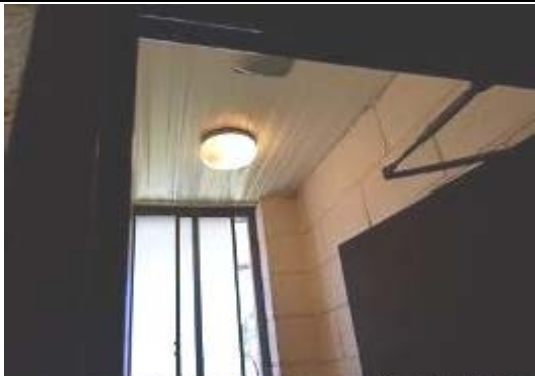
Mechanical Services Round Bulb Lights in Male and Female Toilets.	No PCB Containing Capacitors / Resistors Sighted	A5	No Action Required
4 th April 2018

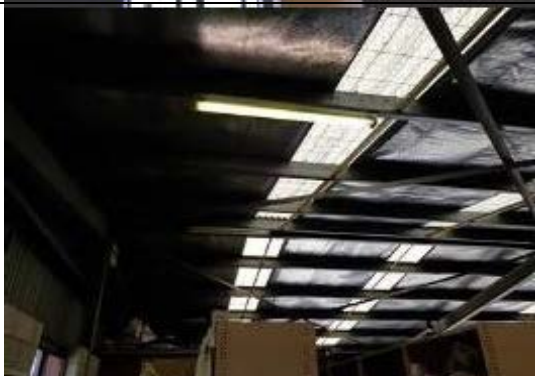
Mechanical Services 1 st Floor Store Area & Break Room 4 x Double Fluorescent Light Assemblies	No PCB Containing Capacitors / Resistors Sighted	A5	No Action Required
4 th April 2018

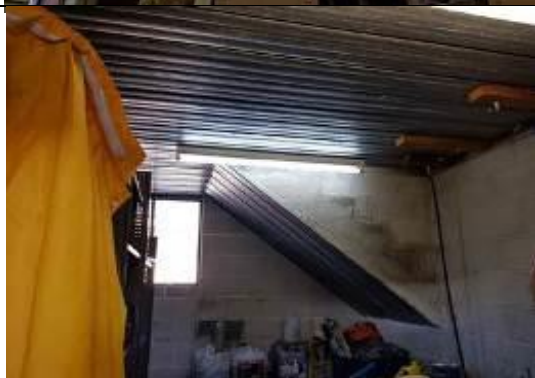
Mechanical Services Chemical Storeroom Single Fluorescent Light Assembly	No PCB Containing Capacitors / Resistors Sighted	A5	No Action Required

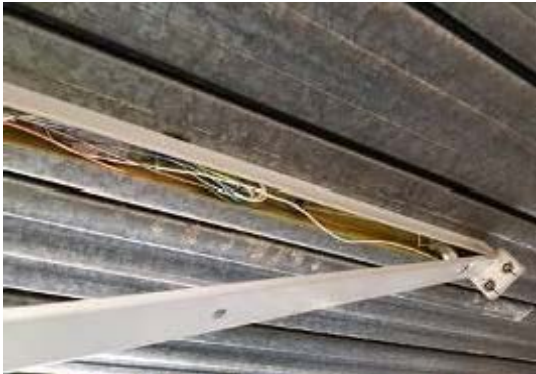
Mechanical Services 2 x Double Fluorescent Light Assemblies Storeroom	No PCB Containing Capacitors / Resistors Sighted	A5	No Action Required
4 th April 2018

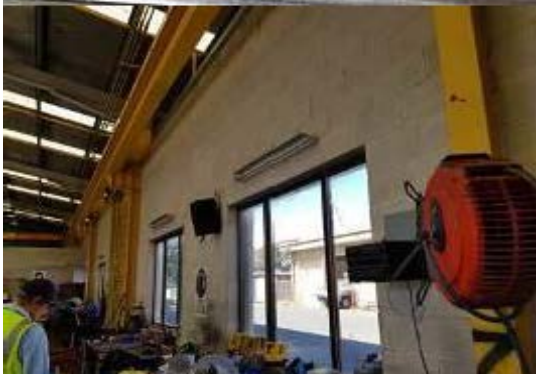
Mechanical Services 6 x Single Fluorescent Light Assemblies. South Wall of Workshop	No PCB Containing Capacitors / Resistors Sighted	A5	No Action Required
4 th April 2018

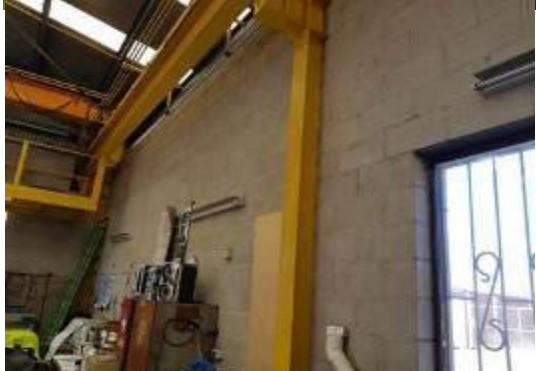
Mechanical Services Welding Room 3 x Single Fluorescent Light Assemblies	No PCB Containing Capacitors / Resistors Sighted	A5	No Action Required

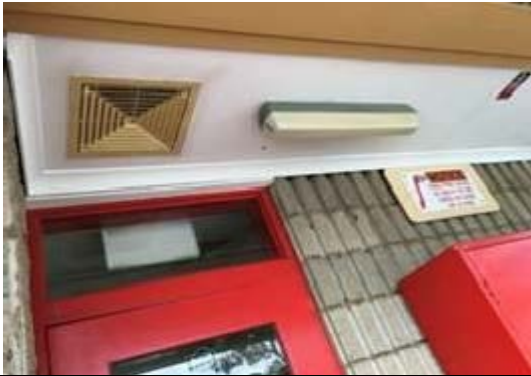
Administration Building Single External Fluorescent Light Assembly	No PCB Containing Capacitors / Resistors Sighted	A5	No Action Required
26 th February 2018

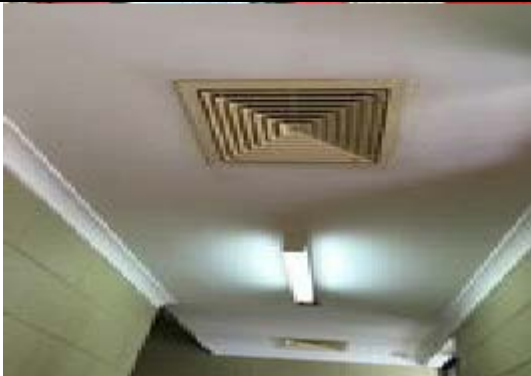
Administration Building Internal Fluorescent Light Assembly	No PCB Containing Capacitors / Resistors Sighted	A5	No Action Required
26 th February 2018

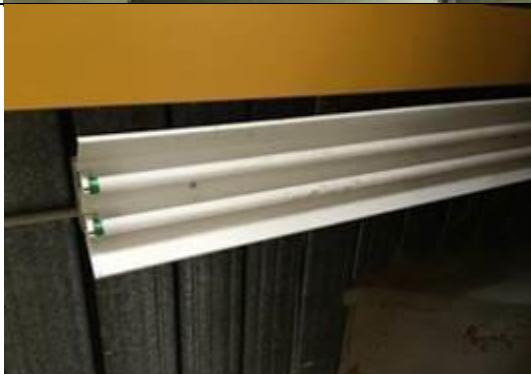
Administration Building Double Internal Fluorescent Light Assembly	No PCB Containing Capacitors / Resistors Sighted	A5	No Action Required

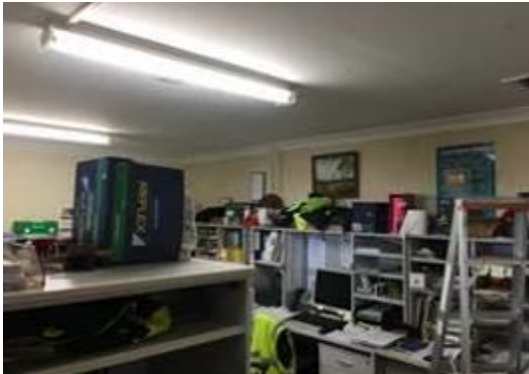
Administration Building Offices, Double Internal Fluorescent Light Assemblies	No PCB Containing Capacitors / Resistors Sighted	A5	No Action Required
26 th February 2018

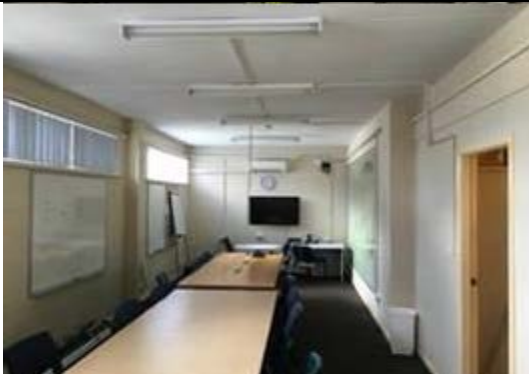
Administration Building Offices, Double Internal Fluorescent Light Assemblies	No PCB Containing Capacitors / Resistors Sighted	A5	No Action Required
26 th February 2018

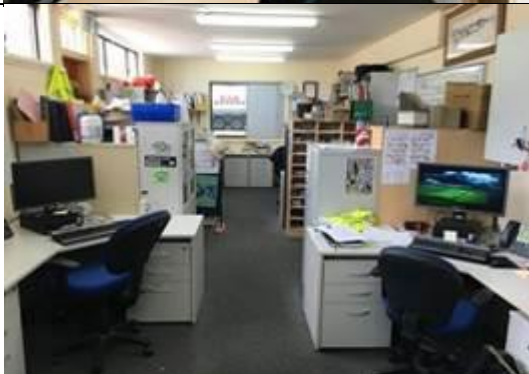
Administration Building Offices, Double Internal Fluorescent Light Assemblies	No PCB Containing Capacitors / Resistors Sighted	A5	No Action Required

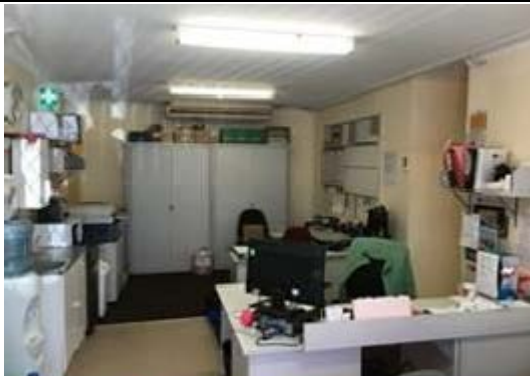
Administration Building Offices, Double Internal Fluorescent Light Assemblies	No PCB Containing Capacitors / Resistors Sighted	A5	No Action Required
26 th February 2018

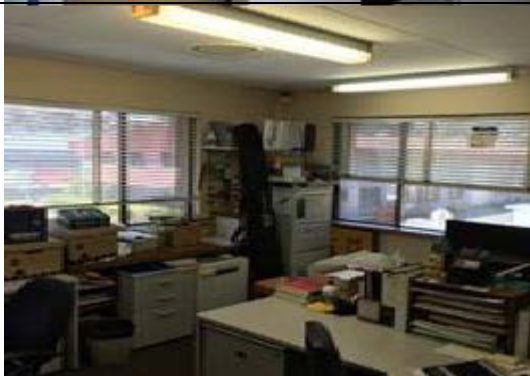
Administration Building Offices, Double Internal Fluorescent Light Assemblies	No PCB Containing Capacitors / Resistors Sighted	A5	No Action Required
4 th April 2018

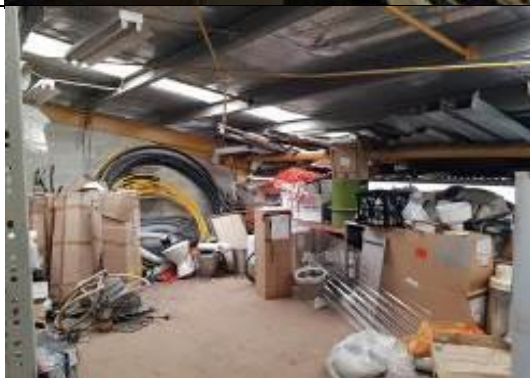
Parks & Gardens / Trades Plumbers Shop, 2 x Double Fluorescent Light Assemblies	Plessey P524 Type Capacitor No PCB's Present	A5	No Action Required

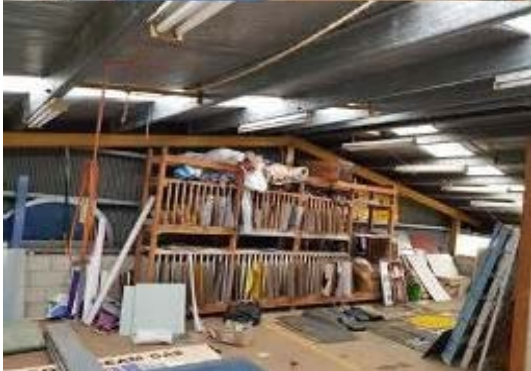
Parks & Gardens / Trades Sign Writer's Room Double Fluorescent Light Assemblies Throughout	No PCB Containing Capacitors / Resistors Sighted	A5	No Action Required
4 th April 2018

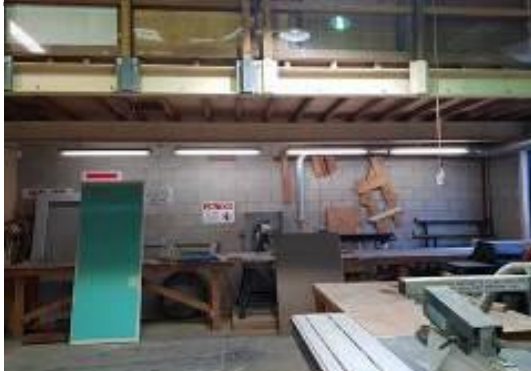
Parks & Gardens / Trades Carpentry Room 8 x Double Fluorescent Light Assemblies	No PCB Containing Capacitors / Resistors Sighted	A5	No Action Required

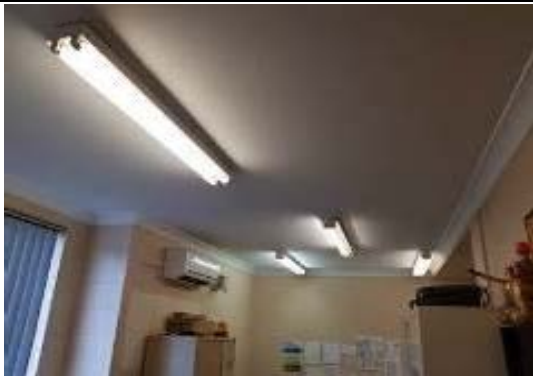
Parks & Gardens / Trades Carpentry Office 3 x Double Fluorescent Light Assemblies	No PCB Containing Capacitors / Resistors Sighted	A5	No Action Required
4 th April 2018

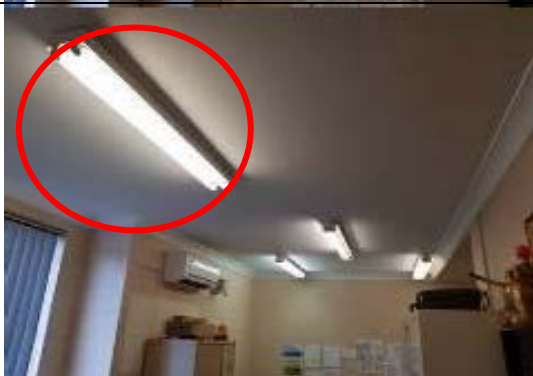
Parks & Gardens / Trades. Carpentry Office. Double Fluorescent Light Assemblies.	RIFA PHN 453 Type Capacitor No PCB's Present	A5	No Action Required
26 th February 2018

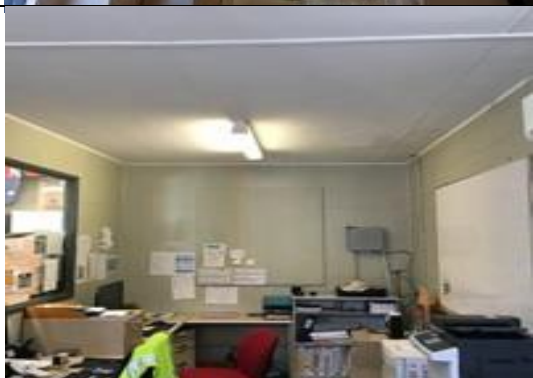
Parks & Gardens / Trades Offices & Tractor Shed Double Internal Fluorescent Light Assembly	No PCB Containing Capacitors / Resistors Sighted	A5	No Action Required

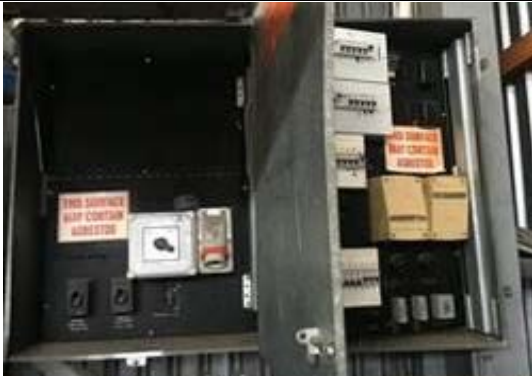
Stores- Warehouse Area Electrical Power Board	Visual Inspection May Contain Phenol Materials	A4	Accessible to Tradespeople Refer to Management Plan
24 th April 2018

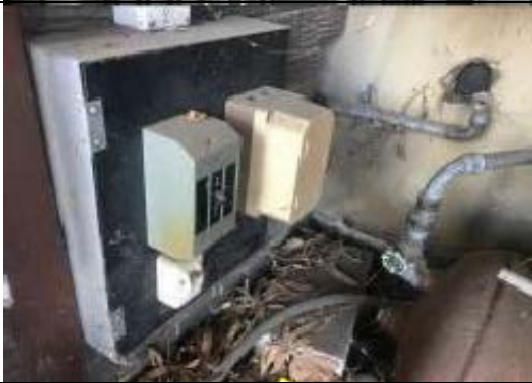
Stores Building- Exterior Compressor Room Meter Board	Visual Inspection May Contain Phenols Materials	A4	Accessible to Tradespeople Refer to Management Plan
26 th February 2018

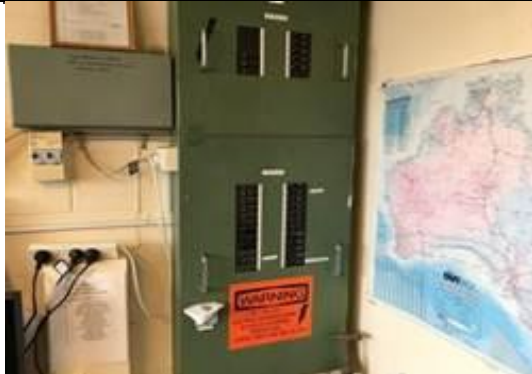
Administration Building- Ground Floor Electrical Power Board	Visual Inspection May Contain Phenol Materials	A4	Accessible to Tradespeople Refer to Management Plan

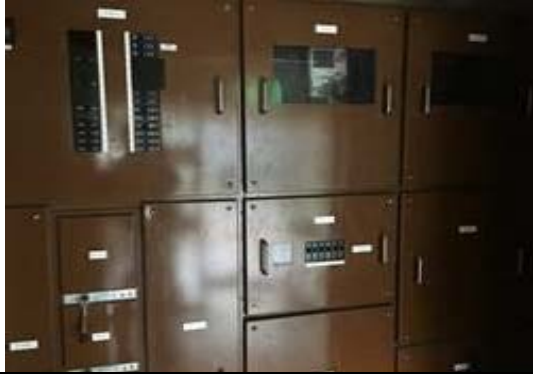
Amenities Building Electrical Cabinet in Foyer	Visual Inspection May Contain Phenol Materials	A4	Accessible to Tradespeople Refer to Management Plan
26 th February 2018

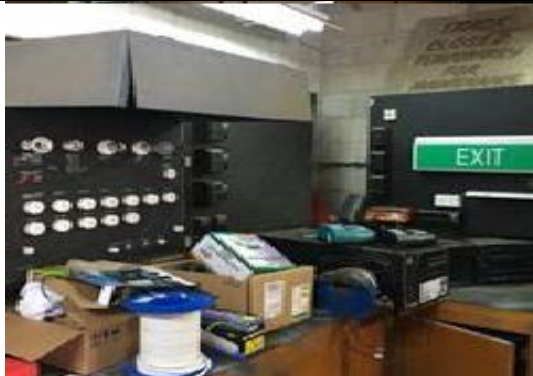
Parks & Gardens / Trades Electrical Power Board	Visual Inspection May Contain Phenol Materials	A4	Accessible to Tradespeople Refer to Management Plan
26 th February 2018

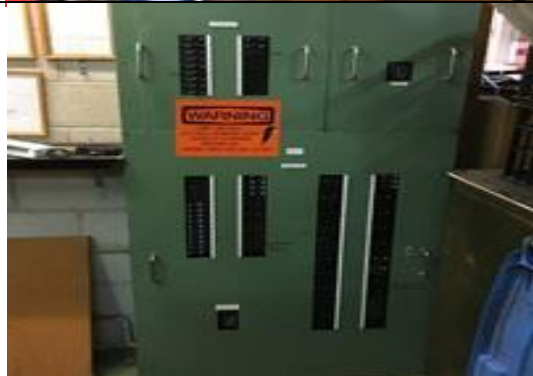
Parks & Gardens / Trades Electrical Power Board	Visual Inspection May Contain Phenol Materials	A4	Accessible to Tradespeople Refer to Management Plan

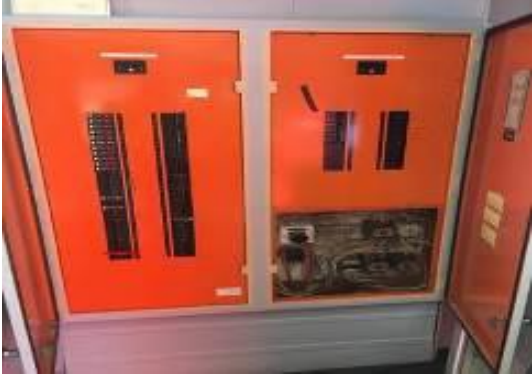
Workshop - Office Electrical Power Board	Visual Inspection May Contain Phenol Materials	A4	Accessible to Tradespeople Refer to Management Plan
